Purlear Creek - Phase II Stream Restoration Annual Monitoring Report

Monitoring Year: 2007

NCEEP Project Number: 010559701

PURLEAR CREEK - PHASE II STREAM RESTORATION 2007 MONITORING REPORT

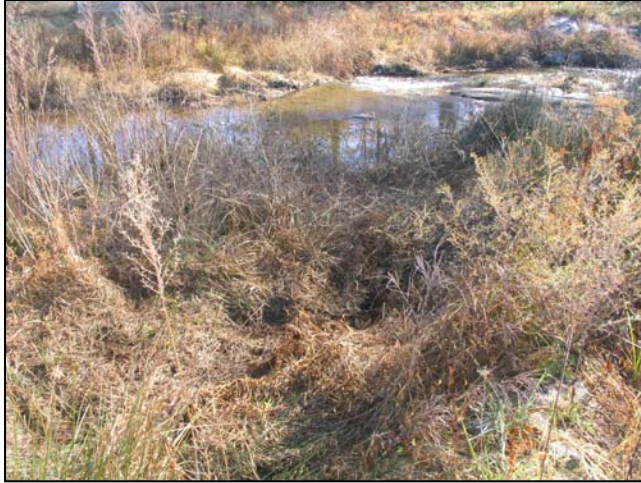
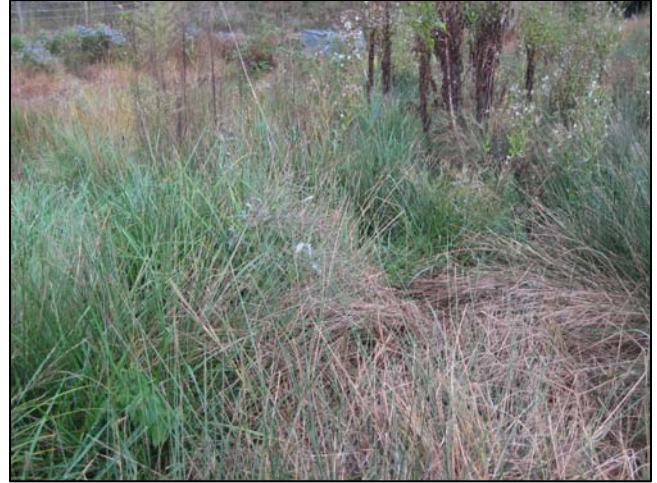
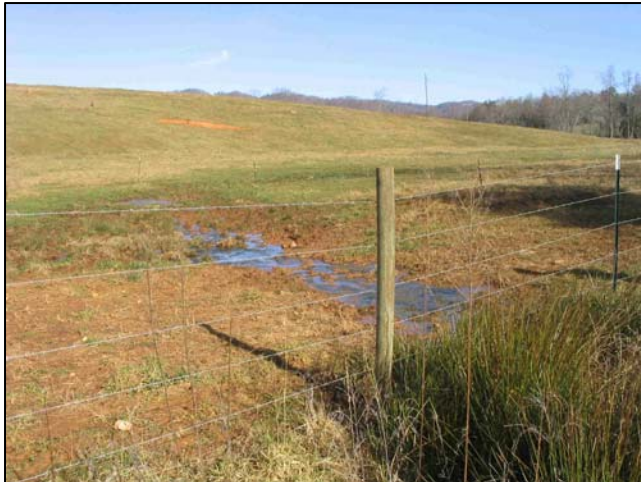
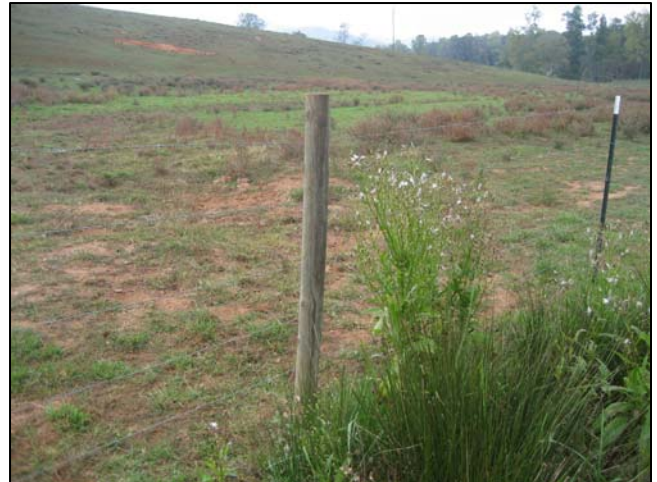
Feature Issue	Reach	Station numbers	Description	Suspected Cause	Photo number
Piping through Buffer	1	9+75	Nutrient laden water piping through buffer	Wet Seep and heavy cattle usage	PA02
	-			--	--
Beaver dam	1	7+69	Beaver dam backing up water and impeding flow	Beaver activity	PA03
	-			--	--

PA2. Reach 1 – Station 9+80 – Concentrated flow into and through the buffer (2006). (top photo – gully through buffer. Bottom photo – seep from field) No flow observed in 2007 due to drought conditions.

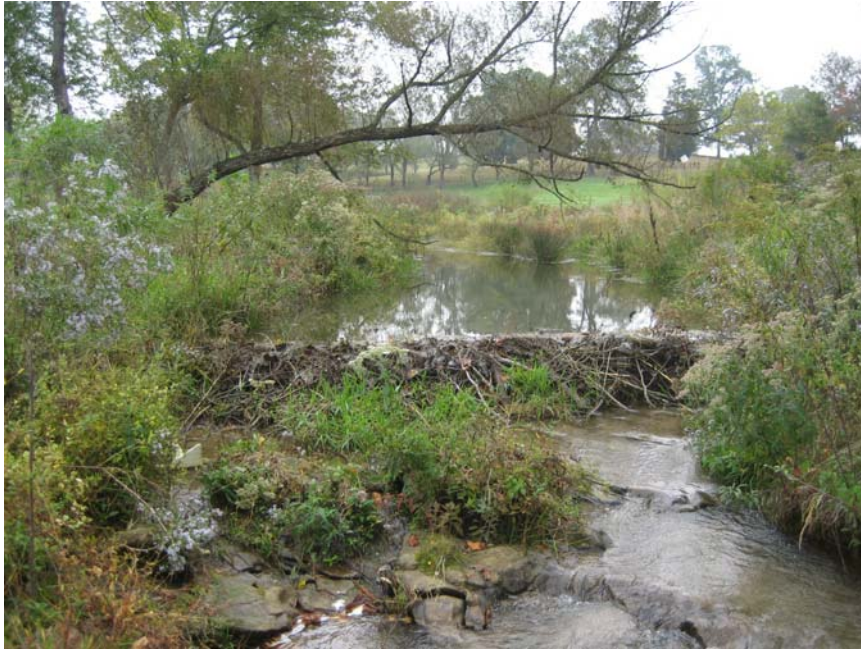
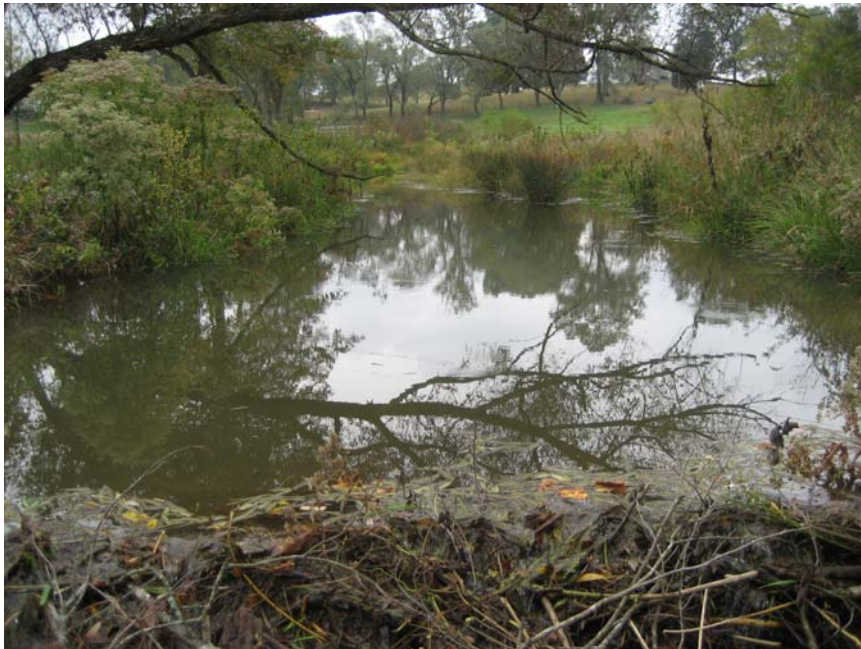
The problem area Table B1, plan sheet and photographs can be found in Appendix B. Two problem areas were identified in the 2006 monitoring report in Reach 1. Problem area 1 appeared to stabilize in 2007. Problem area 2 was less of an issue in 2007 due to the drought conditions. Both areas shall continue to be monitored. An additional problem area was identified on Reach 1 in 2007. Problem area 3 consists of a beaver dam on Reach 1, which is backing up water and obstructing flow. It is recommended that the beaver dam be removed so the stream can flow as intended.

PA3. Reach 1 – Station 7+69 – Beaver dam

Two problem areas were identified in the 2006 monitoring report in Reach 1. The first area was erosion along the outside meander at station 5+75. This area appeared to stabilize in 2007. The second problem area was concentrated flow from the adjacent cow pasture piping through the buffer at station 9+80. Problem area 2 was less of an issue in 2007 due to the drought conditions. However, it is recommended that the area outside of the buffer be fenced and the swale cutting through the buffer be turned into a level spreader to repair this location. Both areas shall continue to be monitored. An additional problem area was identified on Reach 1 in 2007. Problem area 3 consists of a beaver dam on Reach 1, which is backing up water and obstructing flow. It is recommended that the beaver dam be removed so the stream can flow as intended.
