# Puzzle Creek Mitigation Project

## Year 2 Monitoring Report

Rutherford County, North Carolina

Report Submitted: April 2013 (Draft); June 2013 (Final)

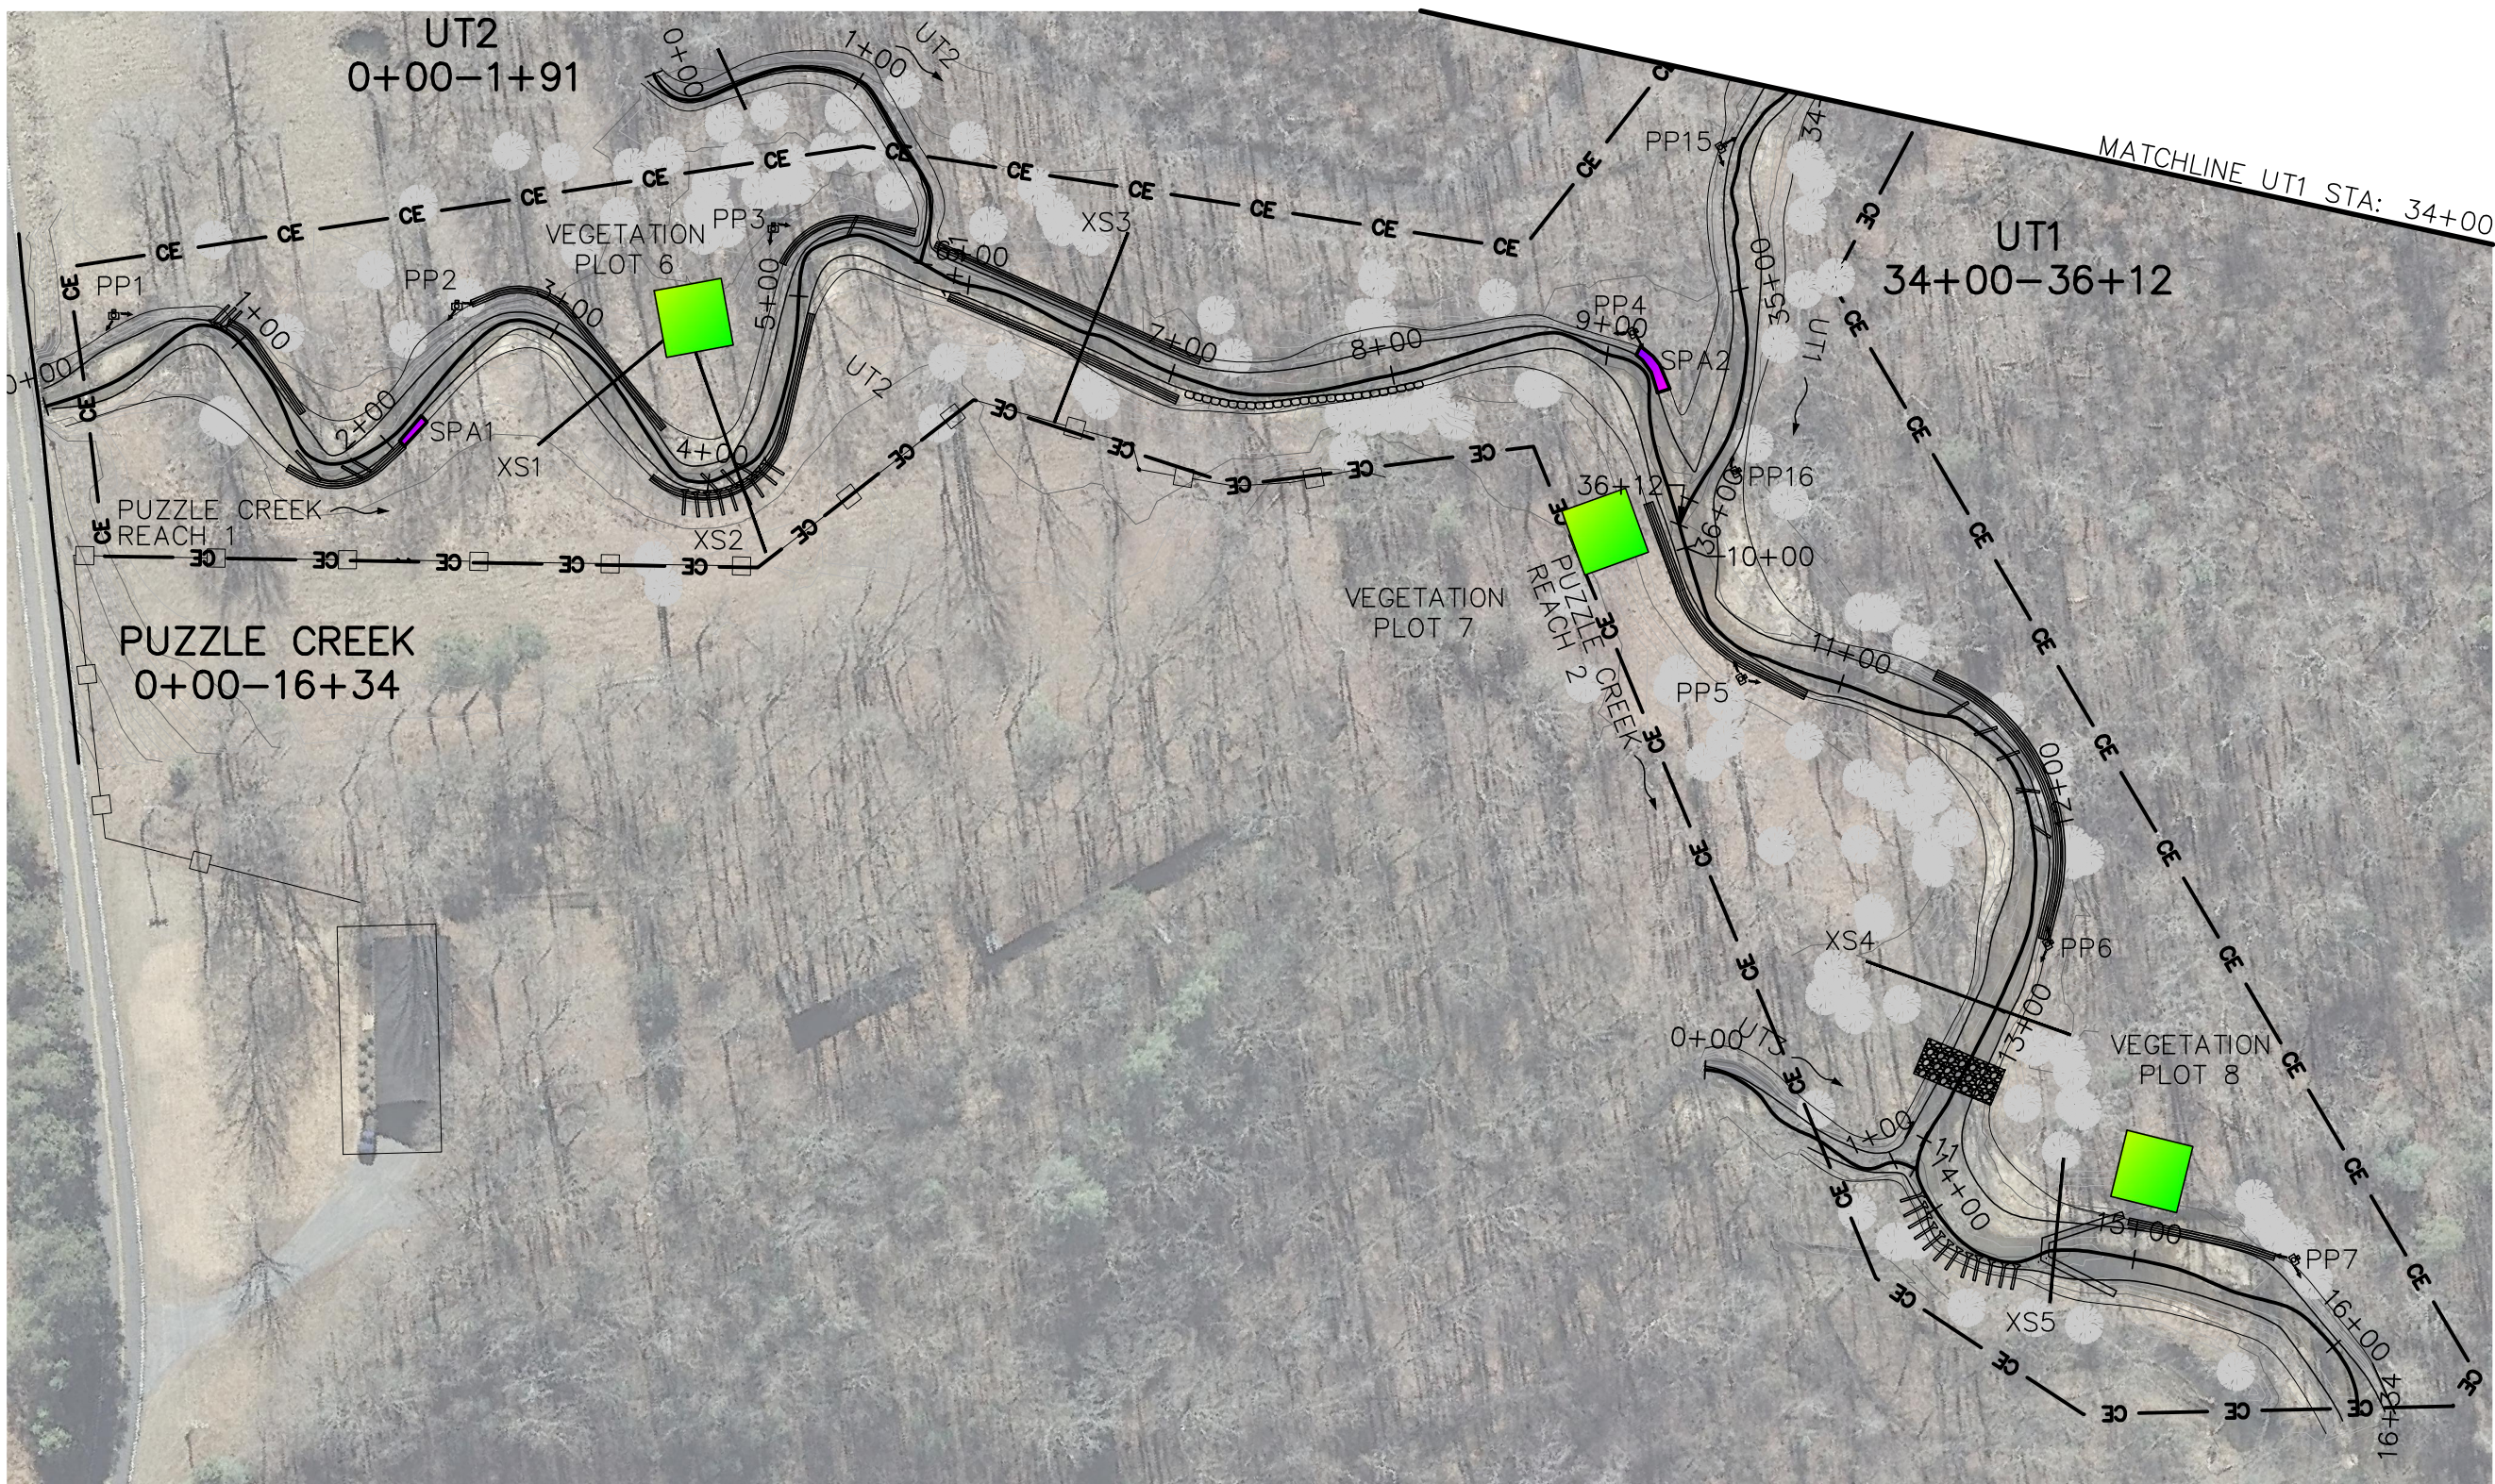
PUZZLE CREEK  
CURRENT CONDITION  
PLAN VIEW  
0+00-16+34  
YEAR 2 MONITORING

Two areas of bank erosion were noted in Reach 1 of Puzzle Creek near Stations 2+00 and 9+00. These areas, approximately 10 LF and 12LF respectively, have eroded due to shear stress. However, the extent of erosion is minor and the areas should stabilize without any repairs.

Maintenance of the site for invasive vegetation control is ongoing and the two areas where bank erosion was noted will continue to be monitored and treated as necessary. The planting and seeding contractor will be notified of the need for invasives treatment, and a site visit to remove and/or spray the vegetation will be scheduled this spring. Given the presence of seed sources and proximity of invasive vegetation to the easement boundary, it is anticipated that invasives treatment will be ongoing in subsequent monitoring years.
