# Puzzle Creek Mitigation Project

## Year 3 Monitoring Report

Rutherford County, North Carolina

Report Submitted: June 2014

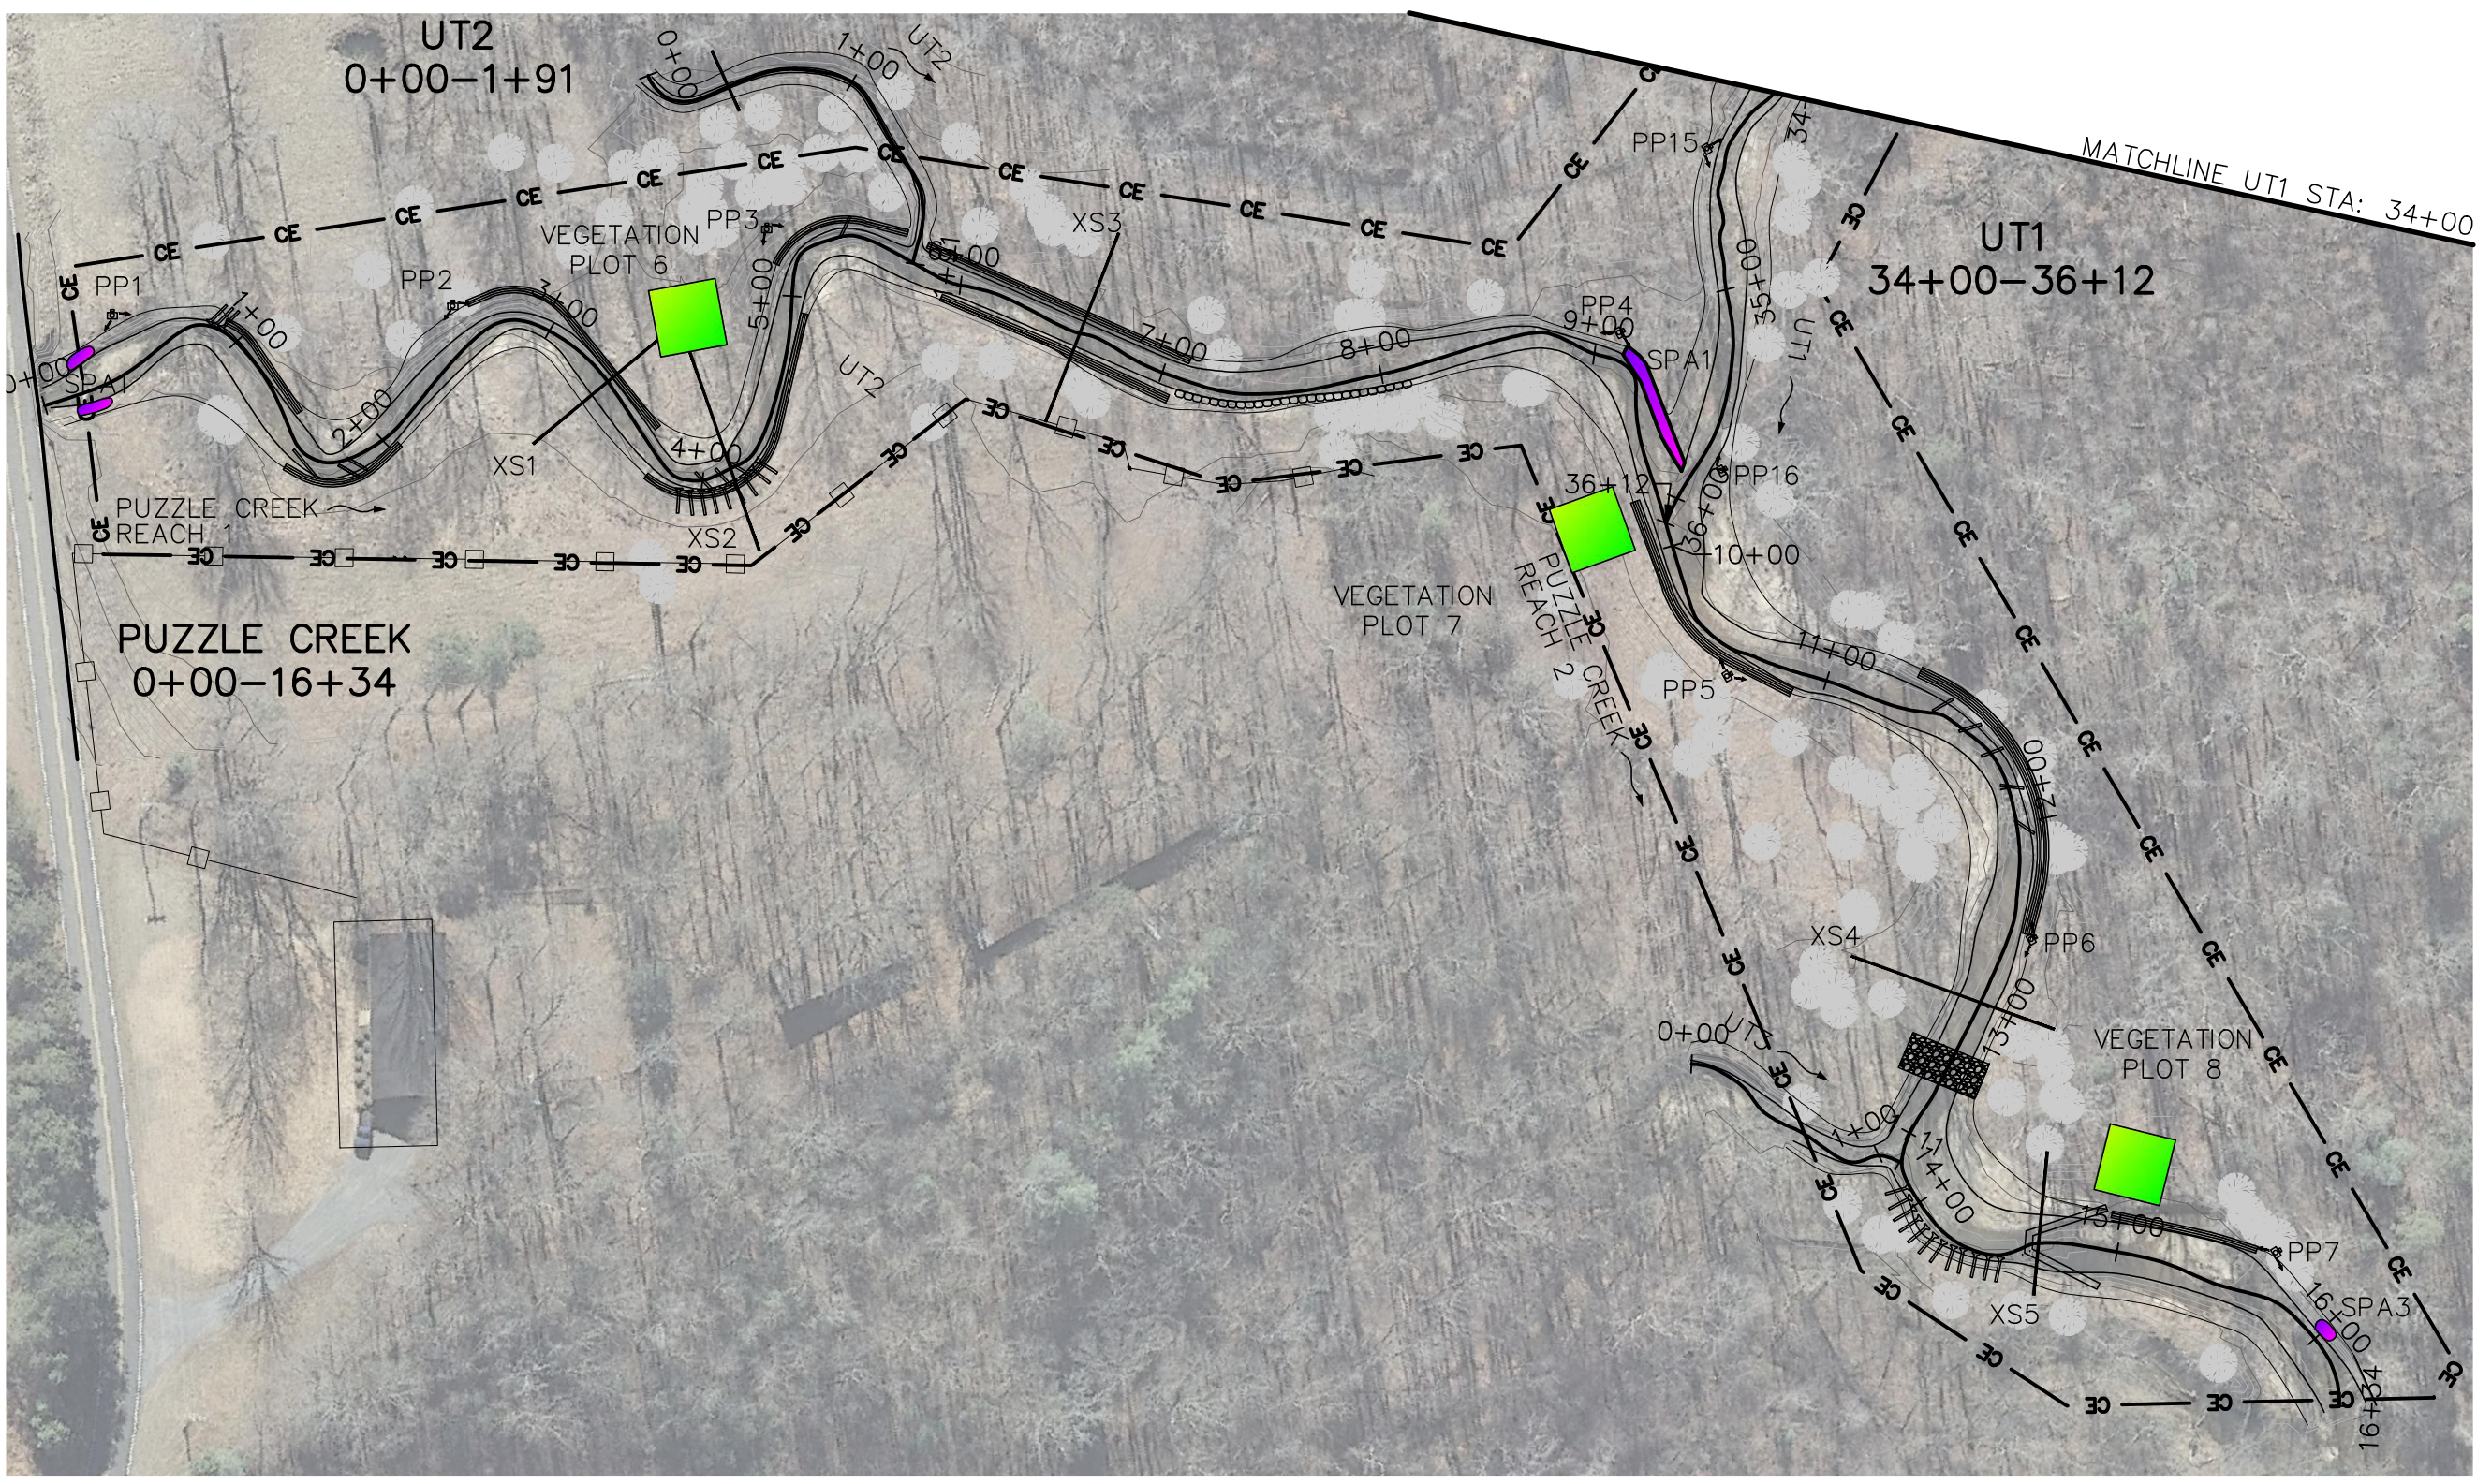
PUZZLE CREEK  
 CURRENT CONDITION  
 PLAN VIEW  
 0+00-16+34  
 YEAR 3 MONITORING

At this time, there are two areas of concern. The streambanks of Reach 1 of Puzzle Creek immediately downstream of the Piney Mountain Church Rd Bridge are eroding from station 0+15 to 0+30. This area is associated with a utility crossing under the stream and was not well protected after recent work. The area will continue to be monitored for possible impacts to the project area. The second area of concern is the eroding bank upstream of the confluence of Puzzle Creek and UT1. This area will require repair work. A repair plan is being designed and will be implemented in 2014.

Maintenance of the site for invasive vegetation control is ongoing and the two areas where bank erosion was noted will continue to be monitored and repaired as necessary. The planting and seeding contractor will be notified of the need for invasives treatment, and a site visit to remove and/or spray the vegetation will be scheduled this spring. Given the presence of seed sources and proximity of invasive vegetation to the easement boundary, it is anticipated that invasives treatment will be ongoing in subsequent monitoring years.
