Puzzle Creek Mitigation Project

Year 4 Monitoring Report - Final

Rutherford County, North Carolina

Report Submitted: April 2015

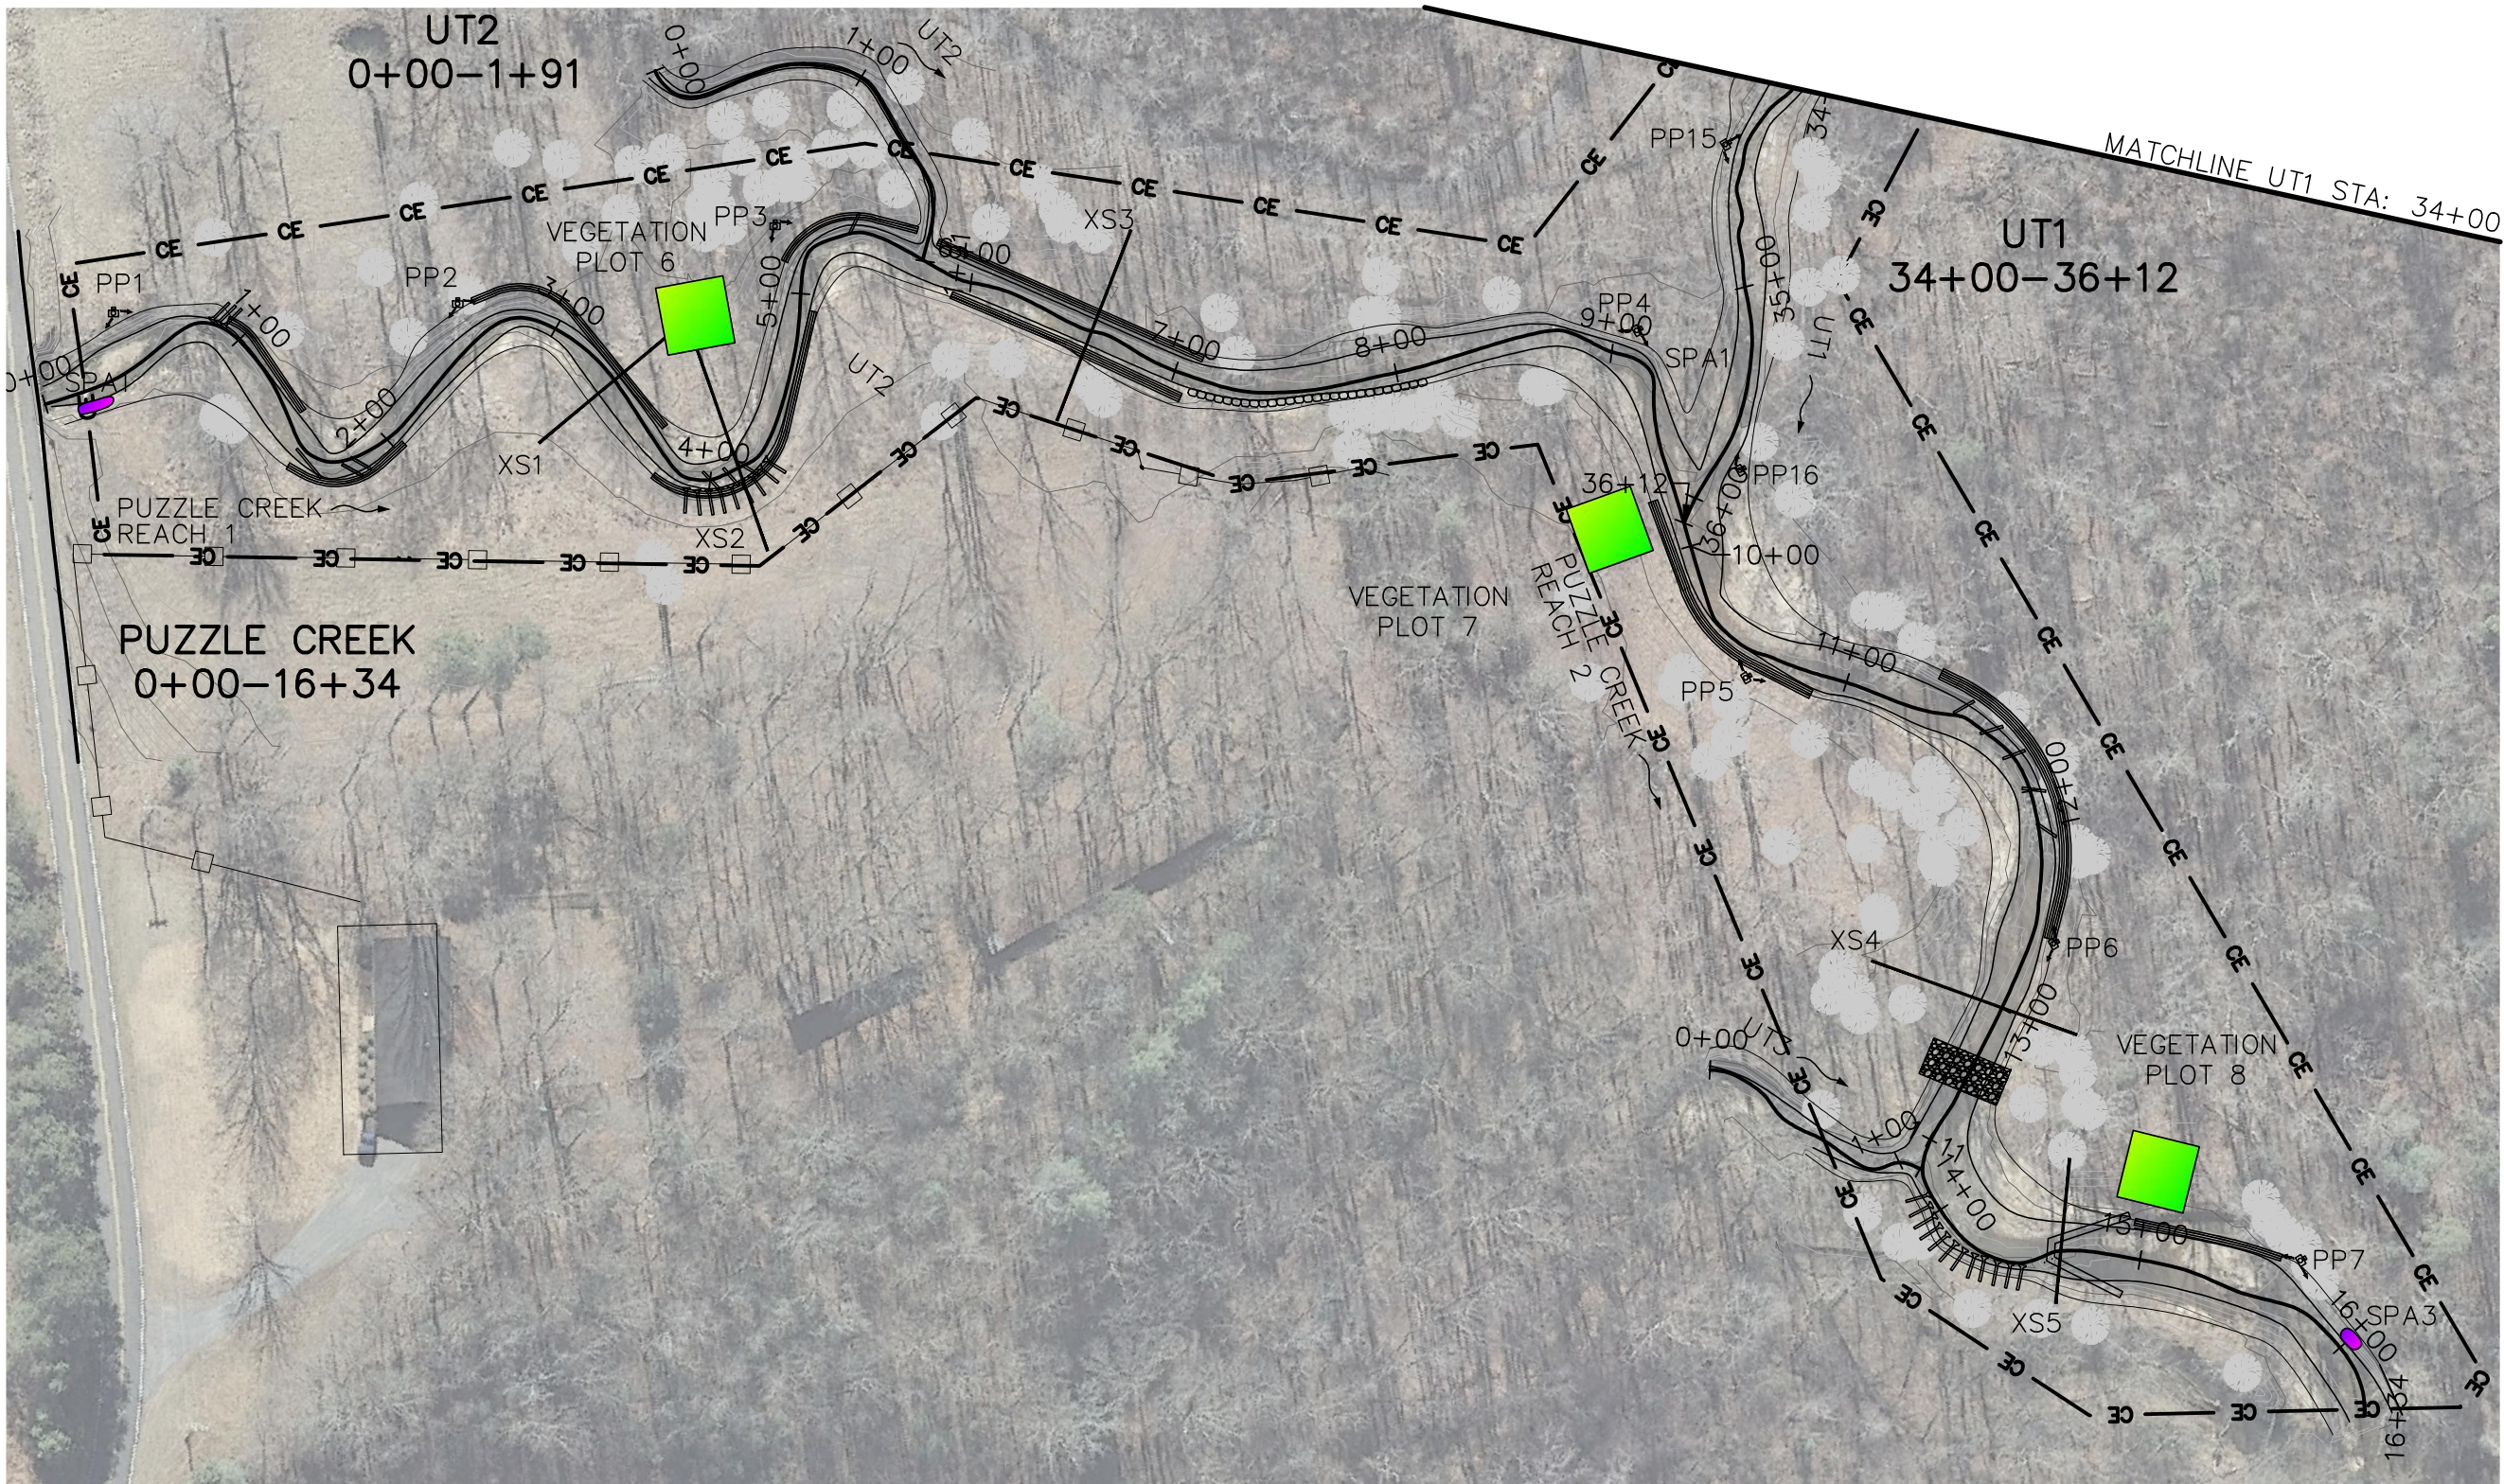
PUZZLE CREEK
CURRENT CONDITION
PLAN VIEW
0+00-16+34
YEAR 4 MONITORING

PROJECT CONDITION	
	VEG PLOT CRITERIA MET
	VEG PLOT CRITERIA UNMET (NO PLOTS CURRENTLY MEETING THIS CRITERIA)
	STREAM PROBLEM AREA (SPA) BANKS WITH SCOUR/EROSION

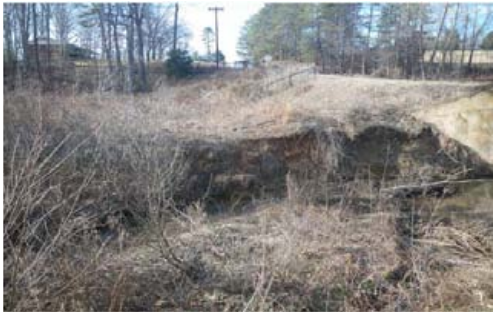
At this time, there are two areas of concern. The streambanks of Reach 1 of Puzzle Creek immediately downstream of the Piney Mountain Church Rd Bridge are eroding from station 0+15 to 0+30. This area is associated with a utility crossing under the stream that was not stabilized after utility work. The area will be seeded and continue to be monitored. The second area of concern is the eroded bank area at station 16+00 at the end of the project. This area appears to be stable but we will continue to monitor it's condition.

Photo 1. Area of bare bank at utility crossing at top of project on mainstem.

Maintenance of the site for invasive vegetation control is ongoing and the two areas where bank erosion was noted will continue to be monitored and repaired as necessary. A public herbicide applicator will be notified of the need for invasives treatment, and a site visit to remove and/or spray the vegetation will be scheduled this spring. Given the presence of seed sources and proximity of invasive vegetation to the easement boundary, it is anticipated that invasives treatment will be ongoing in subsequent monitoring years.

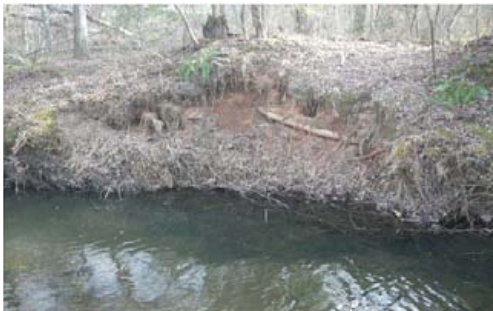
Photo 2. Bare area at Station 16+00 caused by past flooding, but appears stable at this time.

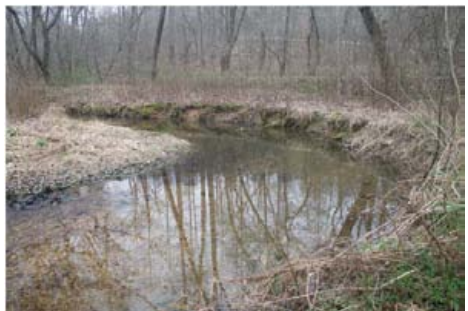
Photo 3. View downstream at area listed last year as an unstable, bare bank near confluence with UT1. It is stabilized by many trees along the top and vegetation growing on the surface.

Photo 4. Upstream view of bend shown in Photo 3. No No recent instability noted.

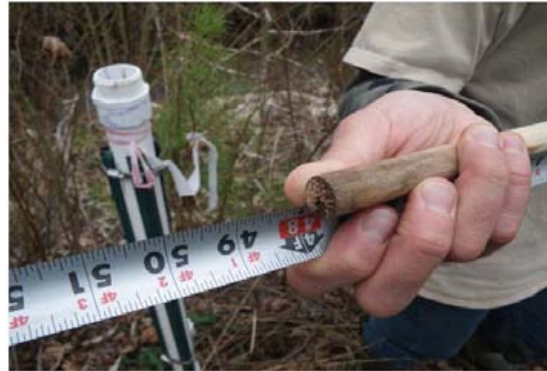
Between October 29, 2012 and the conclusion of Year 4 monitoring in March 2015, the Site was found to have had at least two bankfull events based on crest gauge readings obtained on UT1 and Puzzle Creek and observed wrack lines. Crest gauges and physical observations only indicate how high flows have been since the last observation, so they only indicate that flows have exceeded bankfull; however, based on the record rainfall in this area over the last year we believe that this site had multiple bankfull or greater events. During monitoring YR4 Puzzle Creek appears to have had a flow that exceeded the height of the crest gauge based on all the cork being on the top of the gauge staff (see Photo 1 in Table 9). Based on our

Photo 1. Crest gauge staff showing cork deposition on top of the staff indicating that flood waters were at or higher than 48 inches above
