# Puzzle Creek Mitigation Project

## Year 5 Monitoring Report

Rutherford County, North Carolina

Report Submitted: November 2015

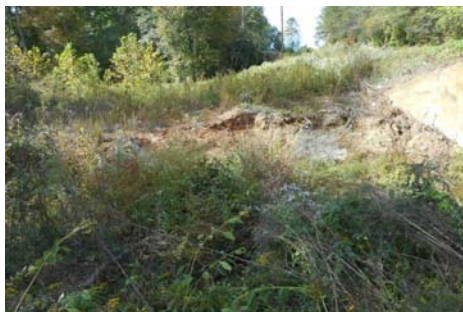
Photo 1. Area of bare bank at utility crossing at top of project on mainstem.

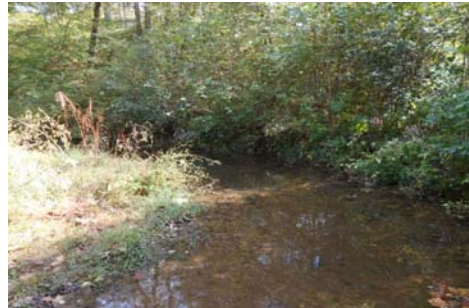
Photo 4. Upstream view of bend shown in Photo 3. No No recent instability noted.

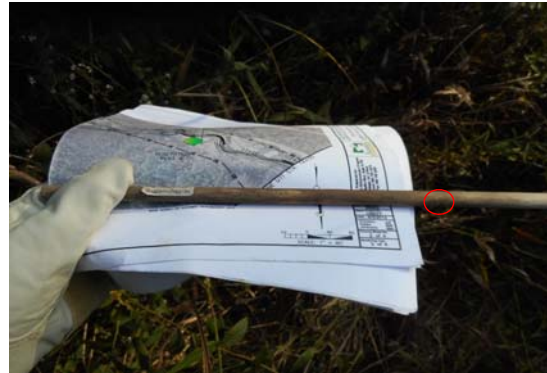
Photo 1. Crest gauge staff showing cork deposition in red circle at approximately 9 inches above bottom of staff, which is at bankfull, as measured against the 8.5 inch wide paper.
