**As-built report for the Racey Mitigation Site,  
Laxon Creek, Watauga County**

North Carolina Wildlife Resources Commission

May 2001

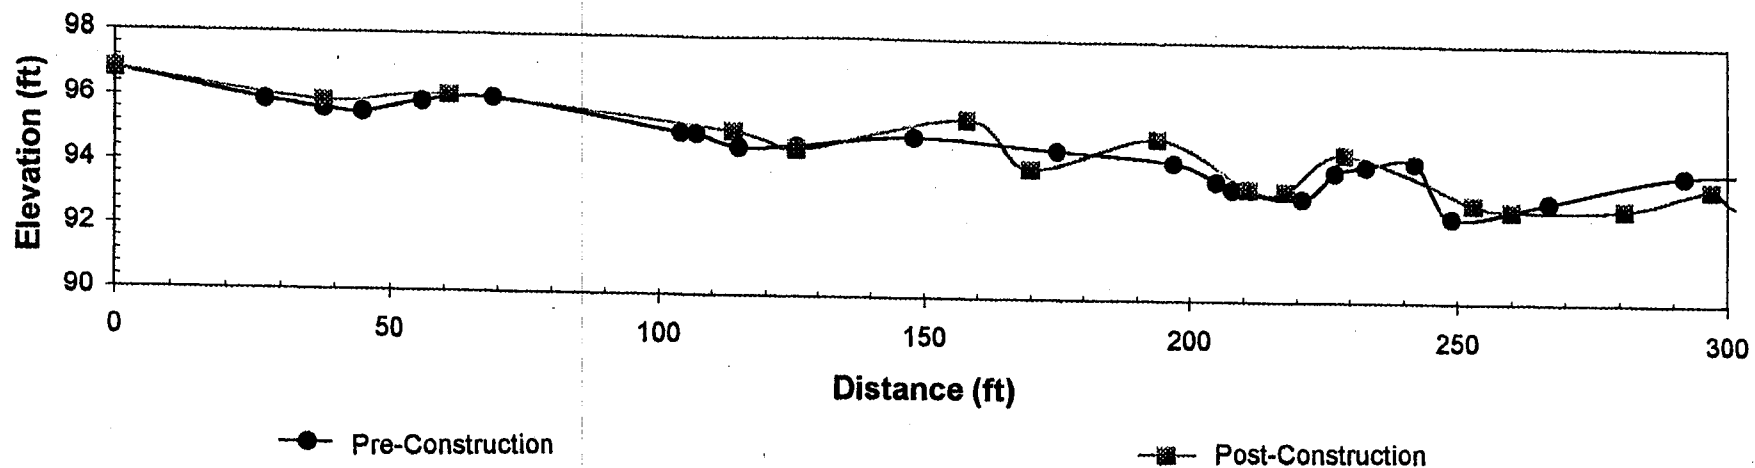
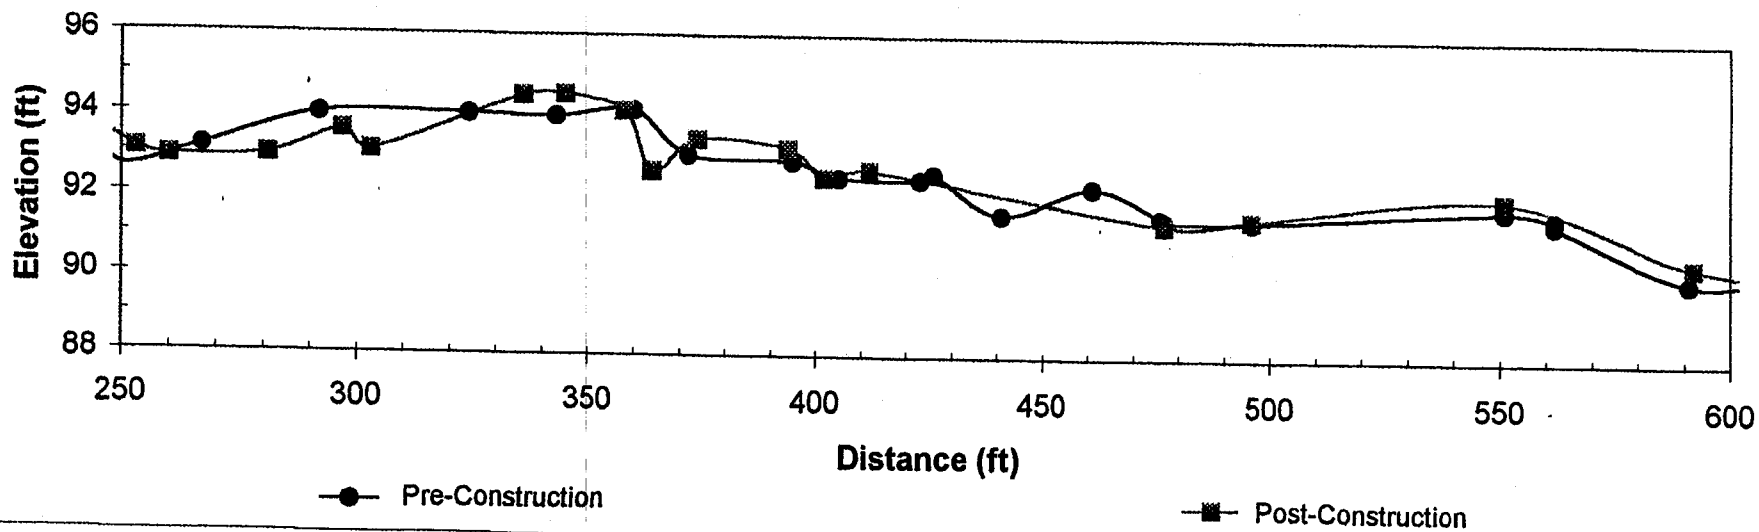
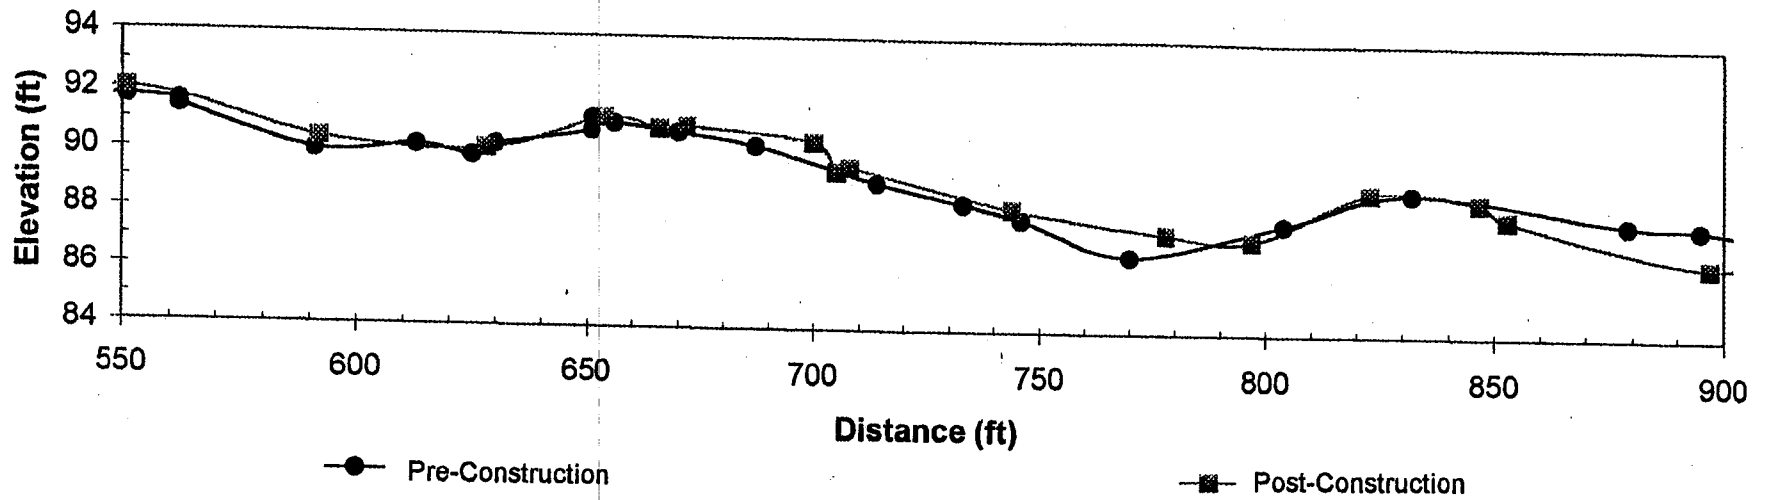
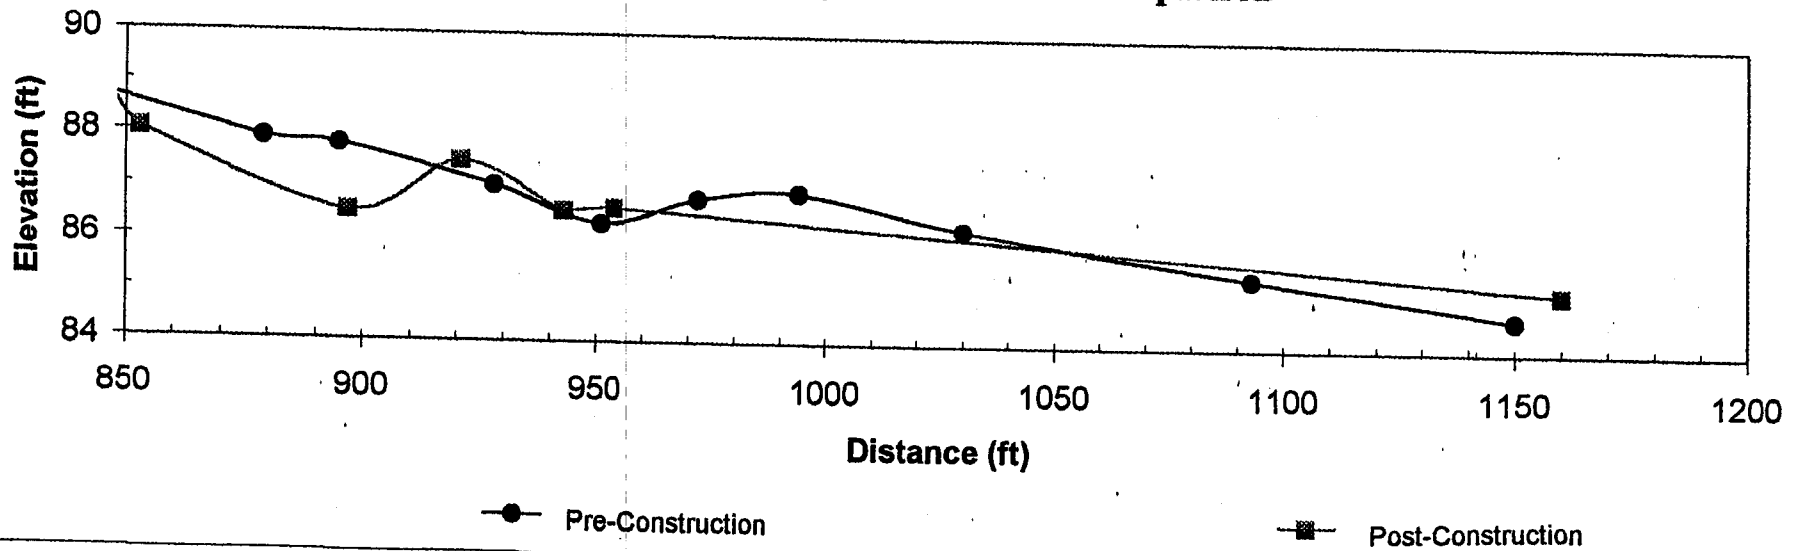
**Figure 3. Longitudinal Profile Comparison**

The pre-construction and post-construction thalweg longitudinal profiles (Figures 3) show how the project increased pool and deep-water habitat. Pool habitat has increased from 26% to 40%. The scour action of root wad meanders, rock weirs, and rock and log vanes can be observed from the as-built profile (Figure 4). The weirs and vanes are creating the desired deep-water habitat and sorting bed material in a way that will provide needed fish spawning gravel.

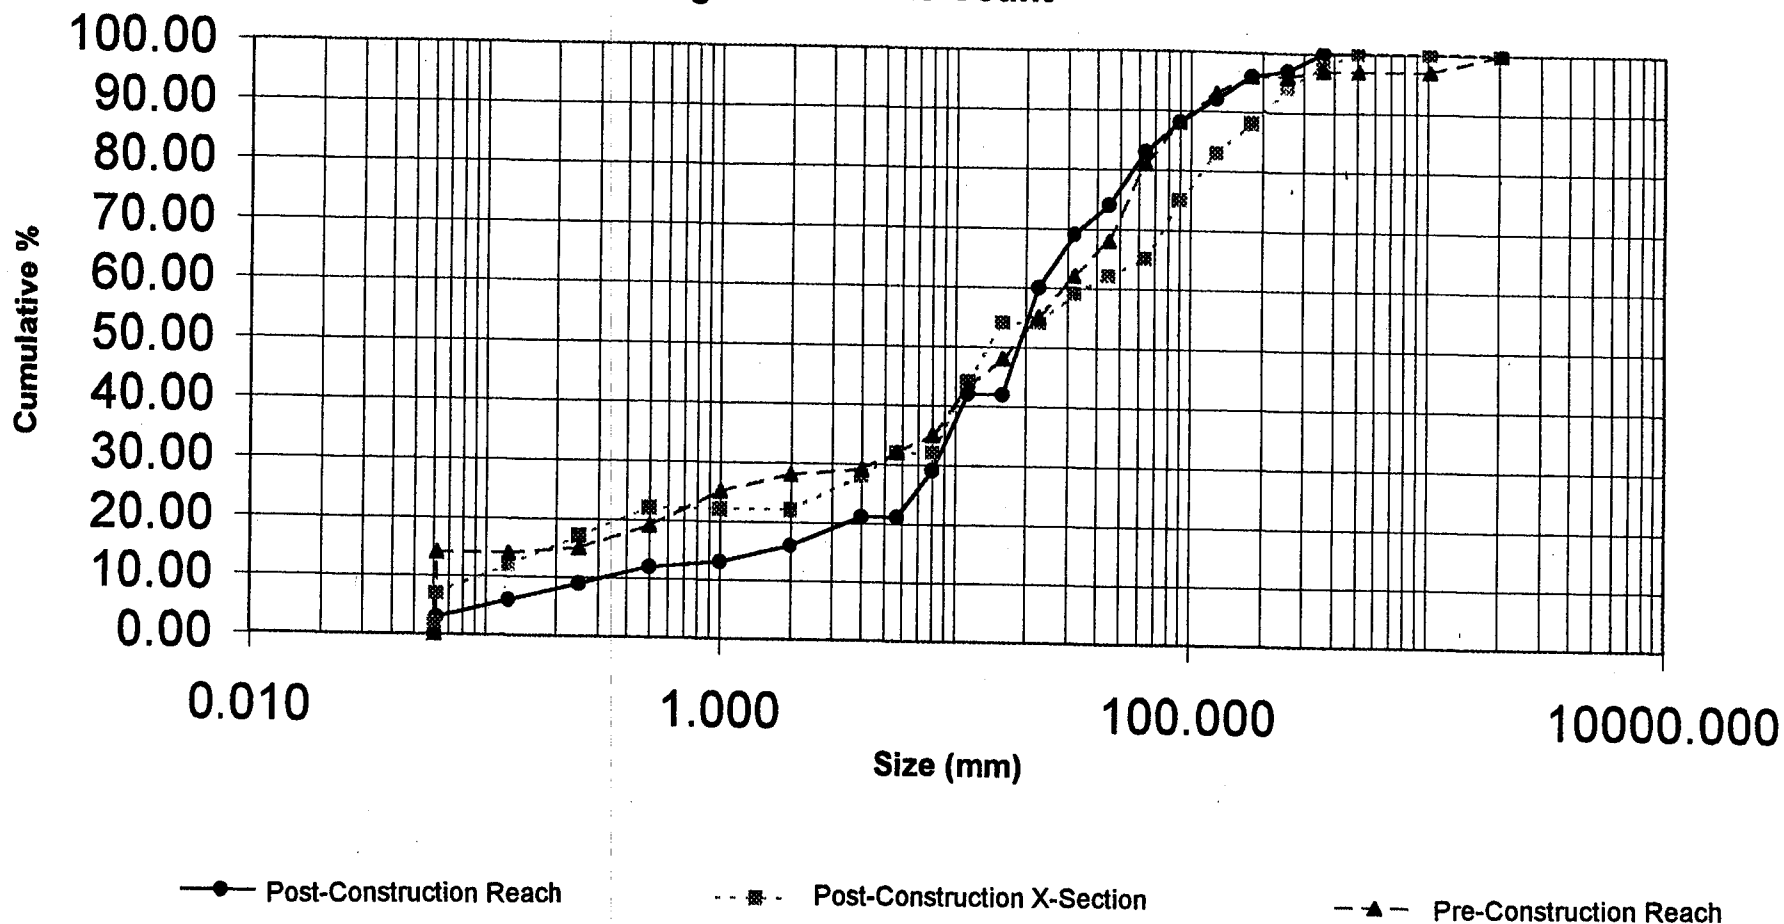
Figure 5. Pebble Count

Figure 5 summarizes pre and post-construction pebble count data. Post-construction pebble count data shows an overall increase in particle size when compared to pre-construction data. Improvements in stream profile and dimension have resulted in better transport of fine bed materials. This should have a positive impact on aquatic invertebrates and fish spawning substrate.

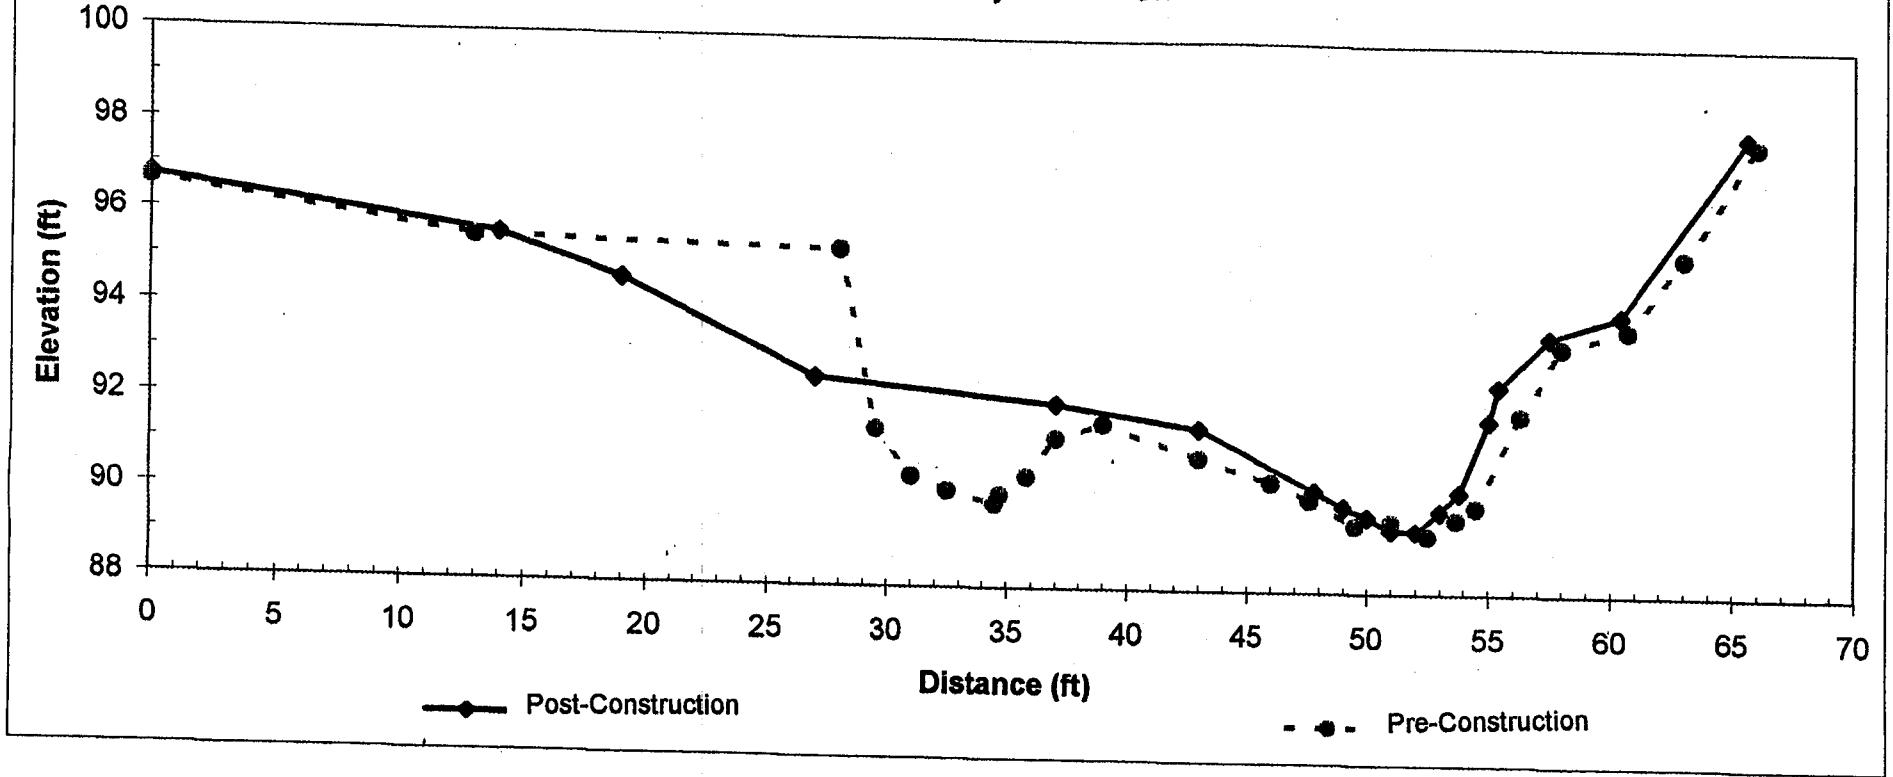
**Figure 6d. Cross Section STN 7+13**

but rather moving the slope of the stream bank back away from the water for approximately 3 to 5 feet. Above this floodplain the stream bank was sloped to the top of the bank and vegetated. As banks were sloped, sod mats salvaged from the site were used to stabilize the new banks. In some areas a blanket of erosion control fabric was installed to provide temporary bank protection until vegetation could be established. Rock weirs and rock vanes were installed to prevent stream head cutting and create pool habitat. Large footer rocks support all top boulders in the weirs and vanes. Holes were dug below the weir apex to accelerate and maintain pool formation by stream water velocities. Excess streambed materials were excavated at rock weirs and rock vanes and placed upstream of the structure near the bank where natural deposition would be expected. Rock vanes were used to divert water away from past eroding banks and for habitat diversity. At two sites root wads were used to block off an existing side channel, improve bank stability, decrease width and improve aquatic habitat. One rock vane was constructed near the confluence with the South Fork New River in order to reduce bank undercutting in order to protect the large white oak tree (*Quercus alba*). At approximately station 3+43 a stable ford crossing was constructed with a rock weir located at station 3+58 as a grade control structure. A rock weir stair step configuration and sloping point bar were constructed to eliminate a braided channel and vertical eroding left bank at cross-section 7+13 (Figure 6d and Photos).

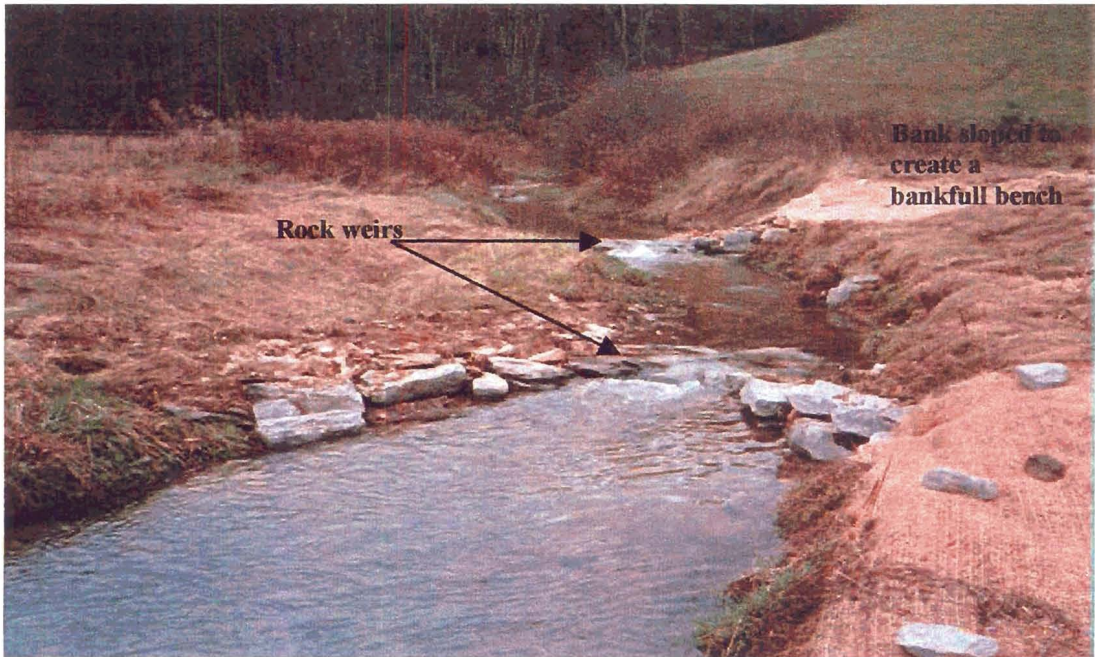
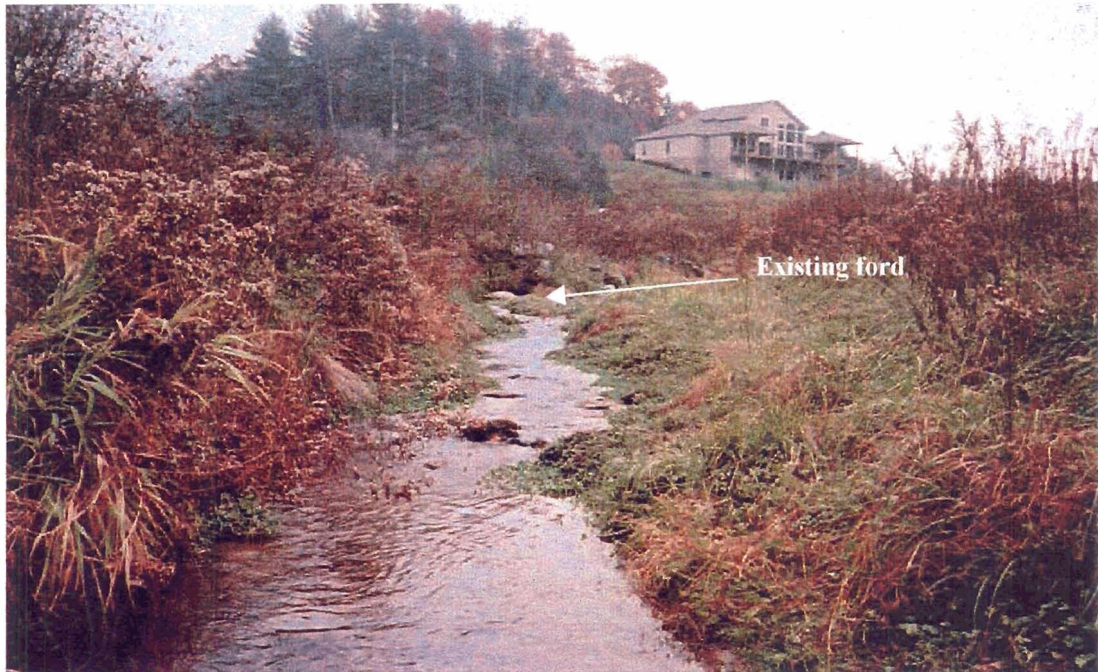
Looking upstream towards upper end of conservation easement. Laxon Creek before stream restoration work. This area contained a badly eroding bank and a riffle where a pool should have been. Banks were sloped and rock weirs installed to create a step/pool habitat. Location of cross-section 1+88.

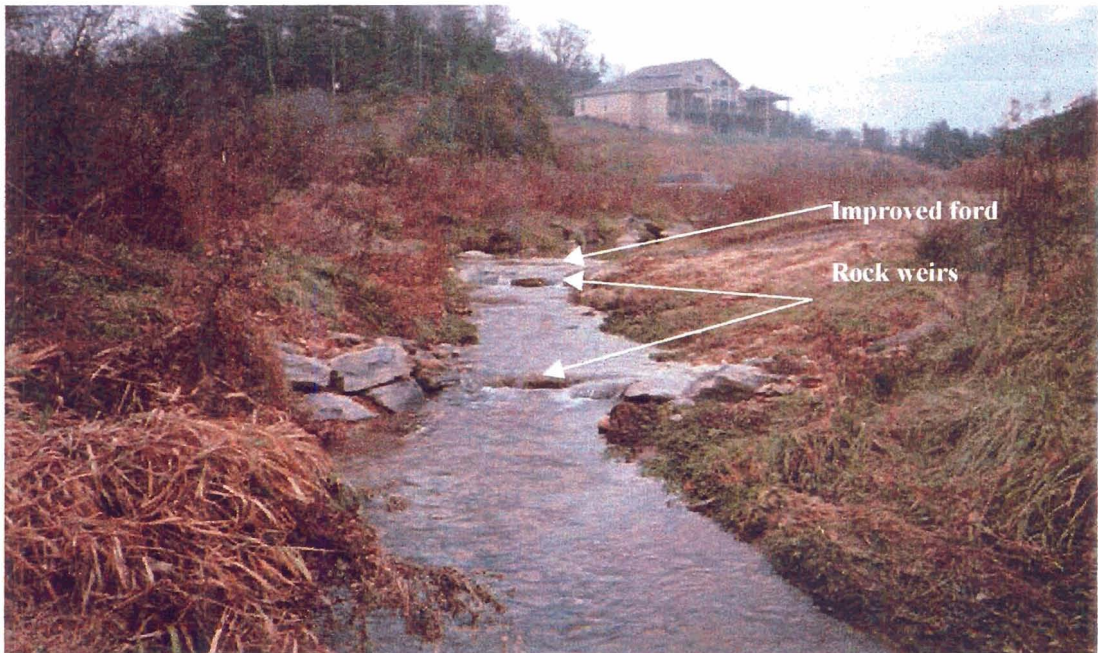
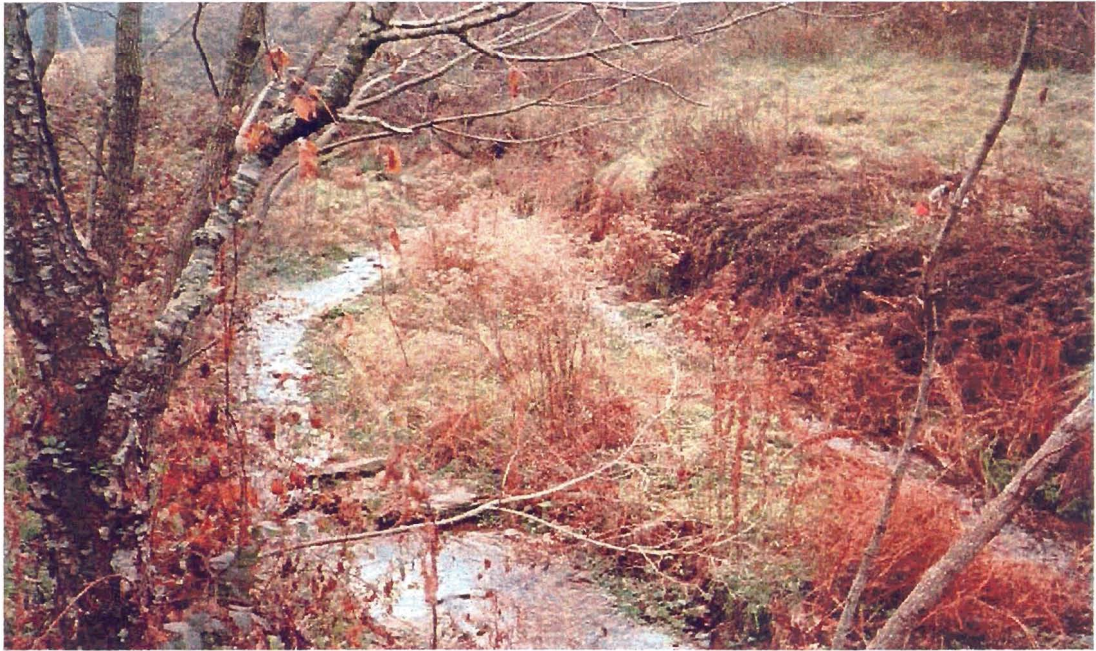
Looking upstream towards the ford. A stable ford was constructed with a rock weir immediately below it to maintain stream grade. Another rock weir was constructed to create fish habitat in a long riffle. Station 3+58 top of weir at ford.

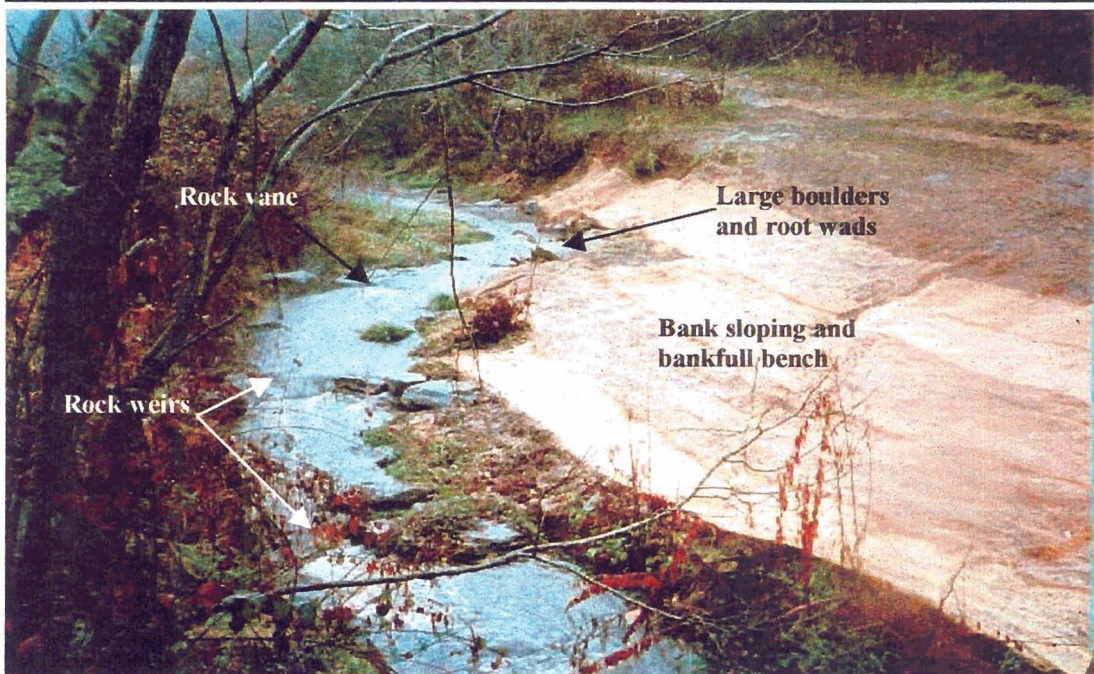
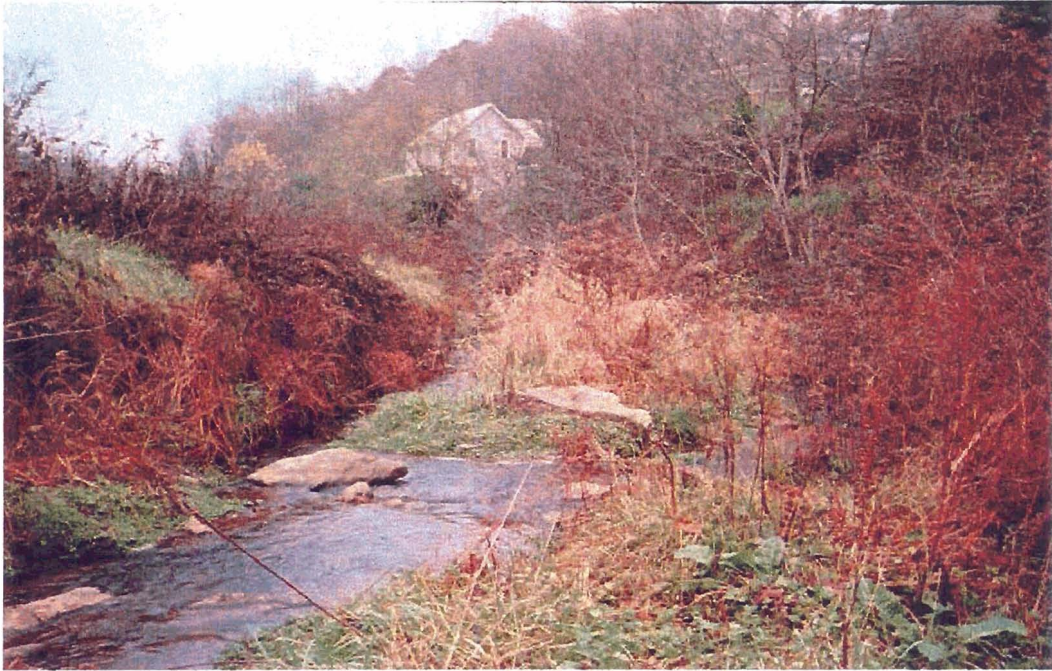
**Before construction (above):** Area of severely eroding right bank (facing upstream) and braided channel. **After construction (below):** The channel was consolidated into a single channel and the right bank was sloped to resist erosion and create a bankfull bench. Large boulders and root wads were used to block the right channel and the channel was filled. One rock vane and two rock weirs were constructed in the consolidated channel to provide for grade controls, step/pool habitat and bank stability. Cross-section 7+13.

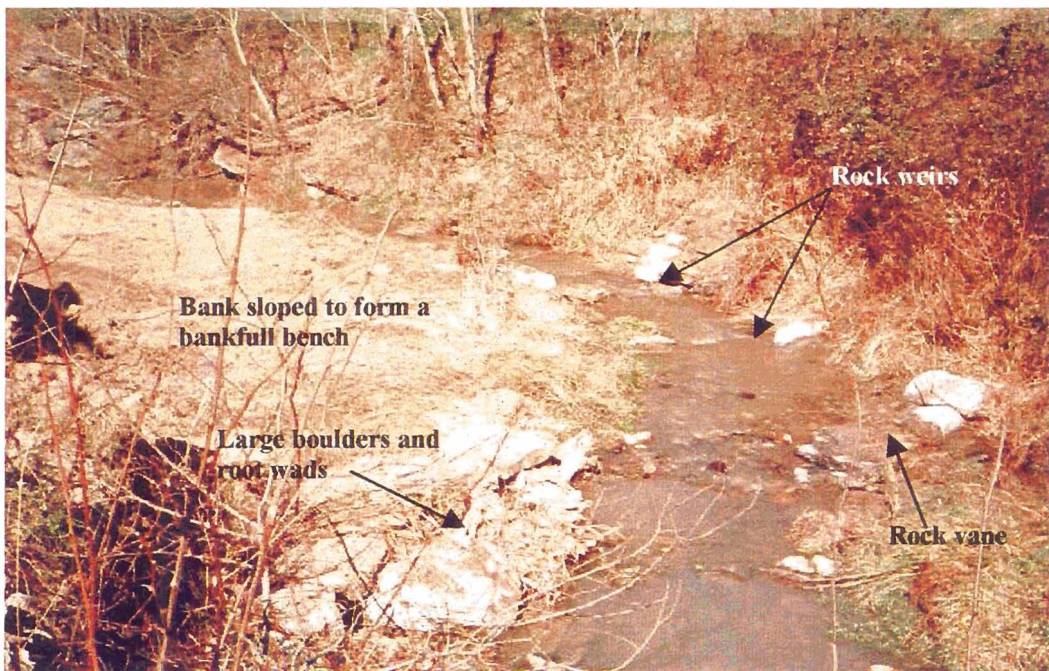
Braided channel and eroding left bank (looking downstream). **Above:** Before construction. **Below:** After construction showing bankfull bench, root wads and large boulders used to block off old channel and two rock weirs and one rock vane to create step/pool habitat and serve as grade controls. X-S 7+13
