**RACEY MITIGATION SITE ON LAXON CREEK,
WATAUGA COUNTY**

Monitoring Report

**NORTH CAROLINA DEPARTMENT OF TRANSPORTATION
STREAM MITIGATION PROGRAM**

Transportation Improvement Project R-529 BA, BB, BD

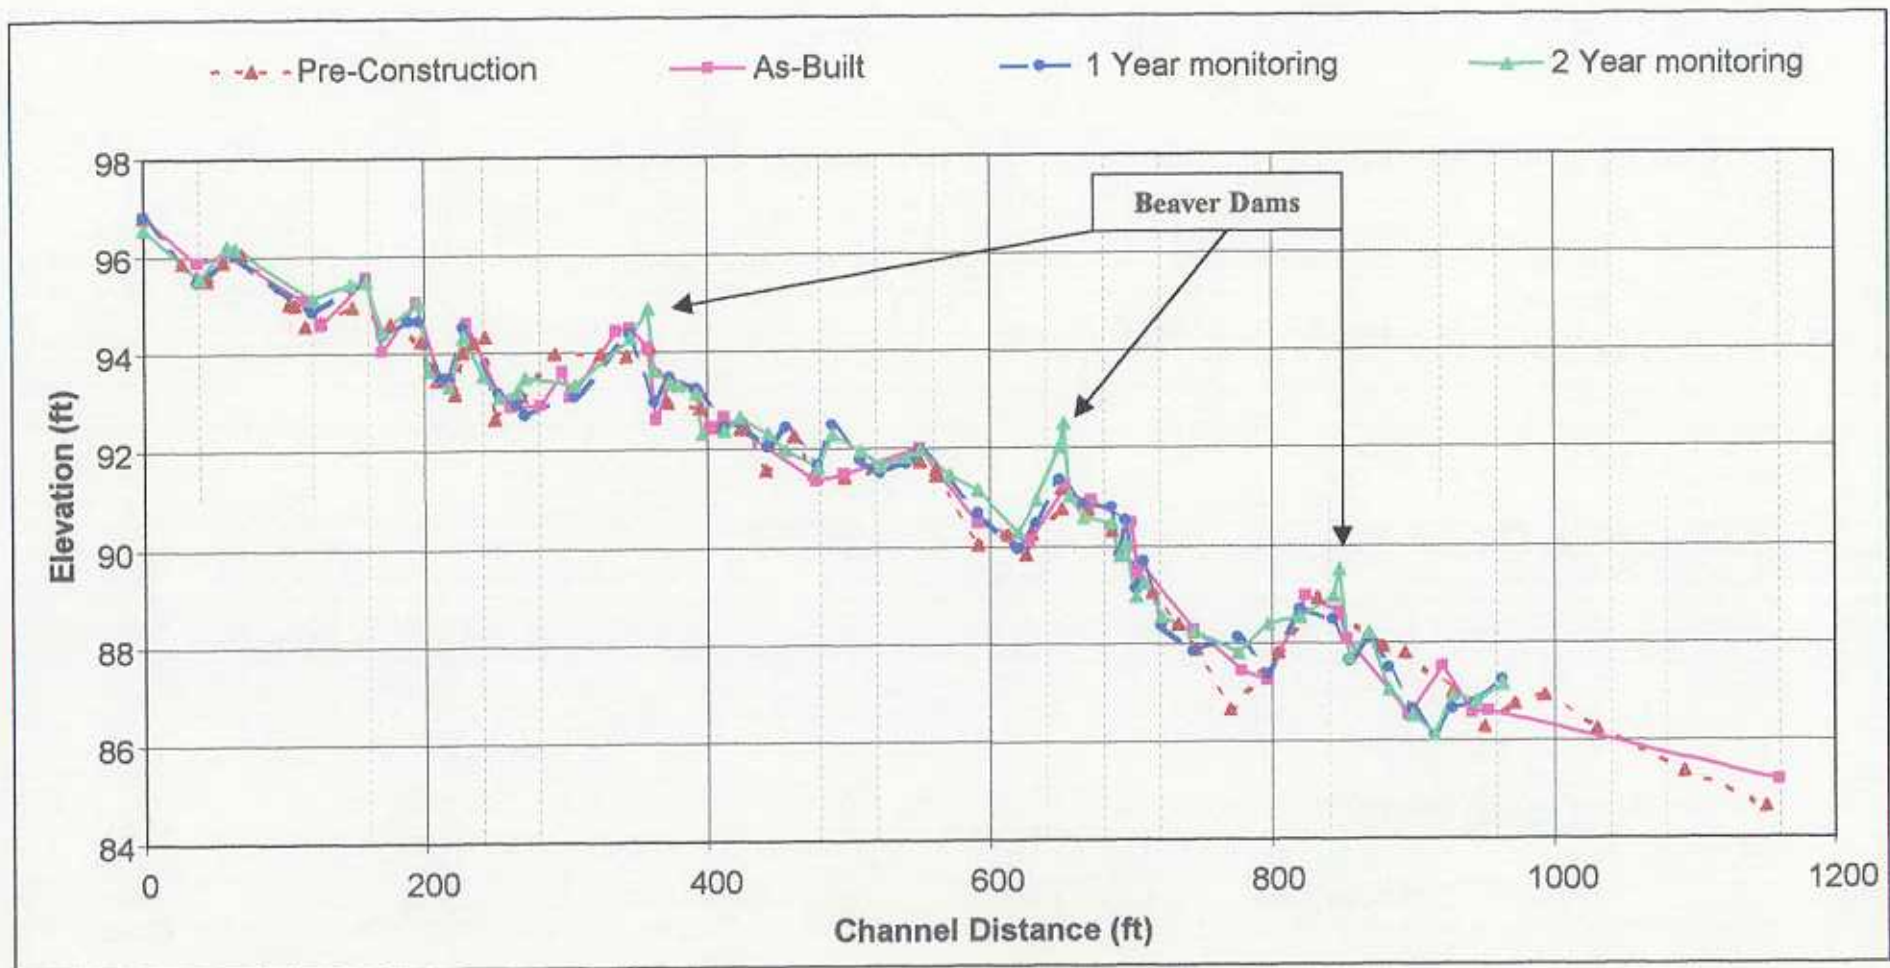
FIGURE 2. Longitudinal profile comparisons, Racey site, Laxon Creek, Watauga County, 2001-2003.

Longitudinal profile data were collected from 963 linear feet of the 1,150 ft in the project site. Longitudinal profile data plots were overlaid to show changes in bed form from previous years (Figure 2). The as-built survey data showed there were 40% pools in 2001 (Mickey and Scott 2001), whereas in 2002 and 2003 pool habitat comprised 50% and 65% of the total reach. Three beaver dams were present at stations 2+40, 3+58, and 6+50 during the 2003 survey. A small debris jam consisting of beaver cuttings was located at station 3+62.

The longitudinal thalweg profile has shifted little since 2001 (Figure 2). There has been aggradation of materials at some locations and deepening at other locations; however, none of this activity indicates a migration towards an unstable stream channel. These changes appear to be normal adjustments to stream flow and weather conditions. From 2002 to 2003 pool habitat increased from 50% to 65%. This pool habitat increase is the direct result of three new beaver dams. These dams have backed water over traditional riffle habitats. There has been no shift in

the meander pattern and in-stream structures are functioning as designed. No bank scour or erosion was evident and no problems were noted with any of the structures.

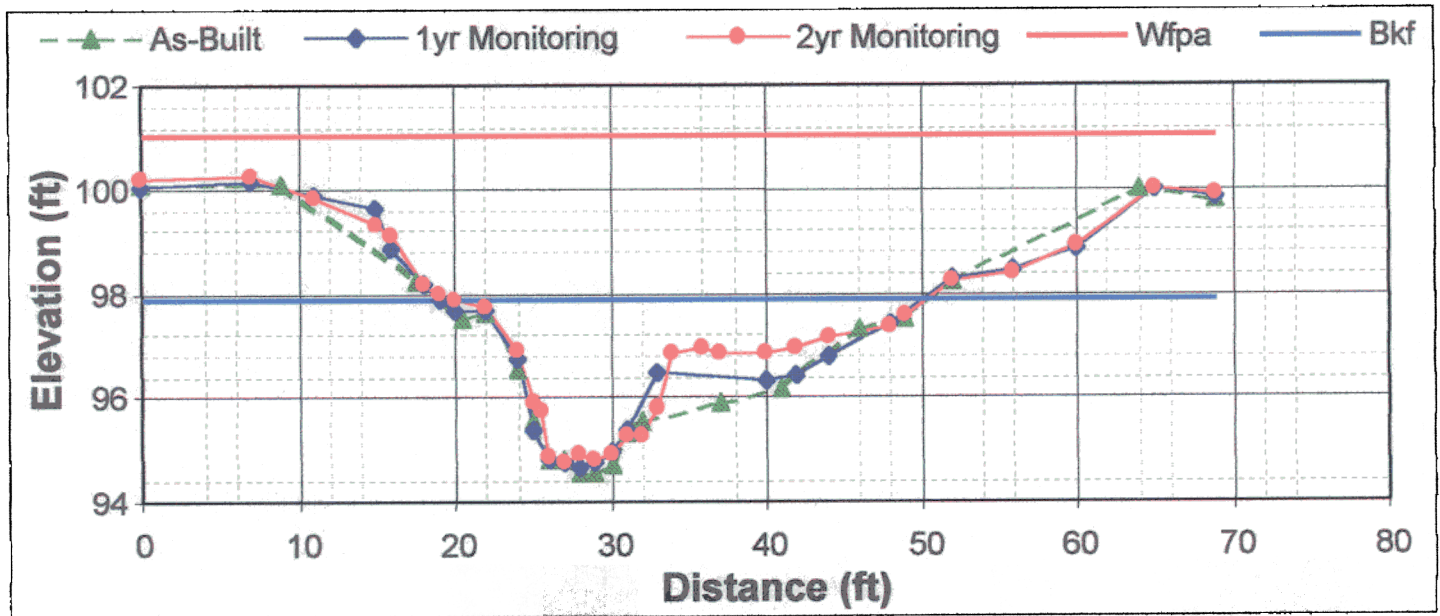
FIGURE 3.1. Cross section station 1+88, riffle.

Overlay of data from four cross-sections, as shown in Figures 3.1-3.4, indicate few changes have taken place in the channel. The width/depth ratio, cross-sectional area, and entrenchment ratio have remained fairly constant (Table 1). The data indicate that both C4 and B4c stream channel types (Rosgen 1996) are present in the reach. There has been little change in the cross-section dimensions since completion of the as-built survey in 2001 (Figures 3.1-3.4). However, an inner berm bench is forming at cross-section 1+88 (Figure 3.1). Bankfull and inner berm storm events have deposited sediments on the constructed floodplain.

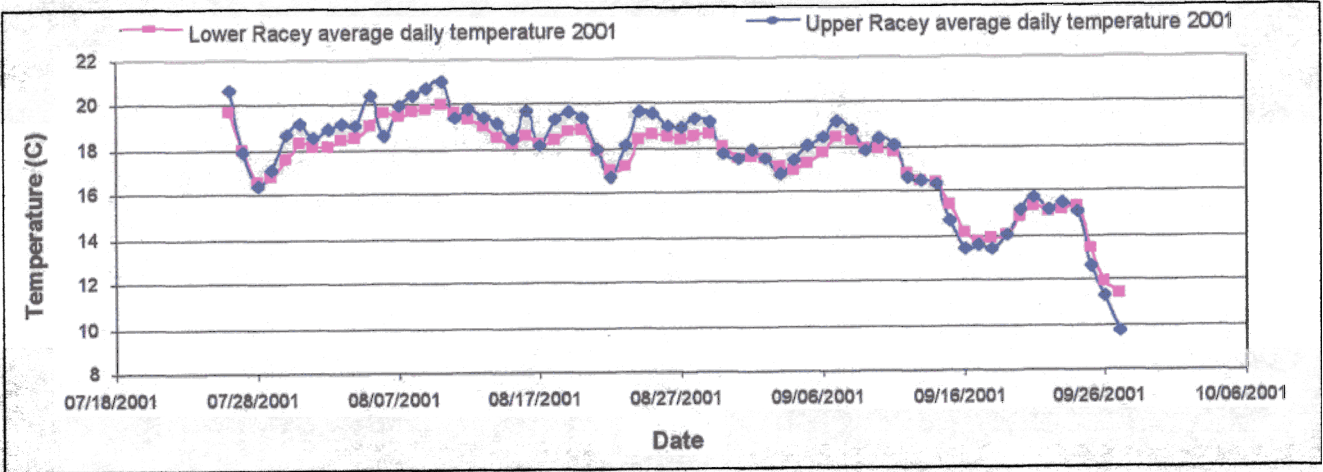
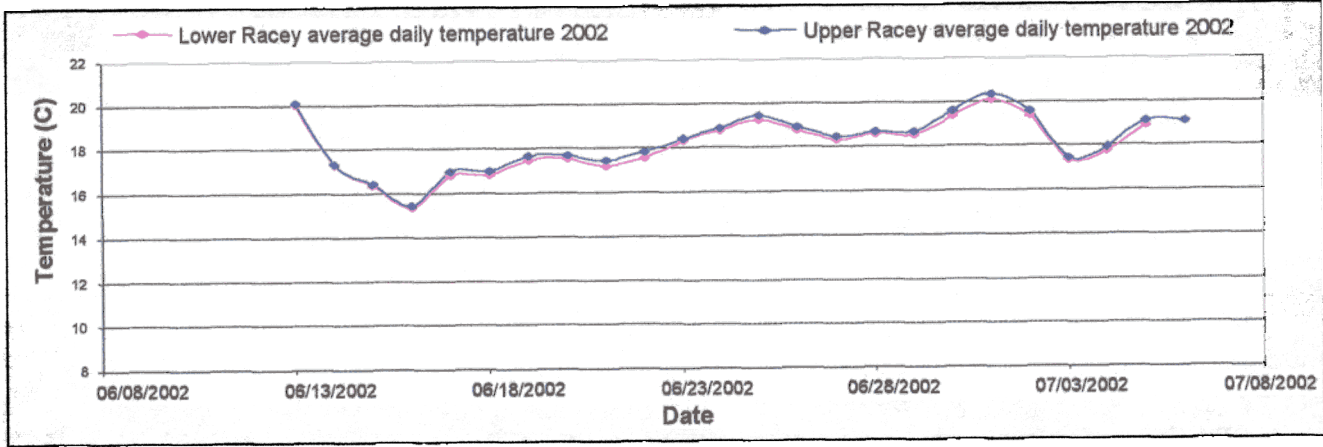
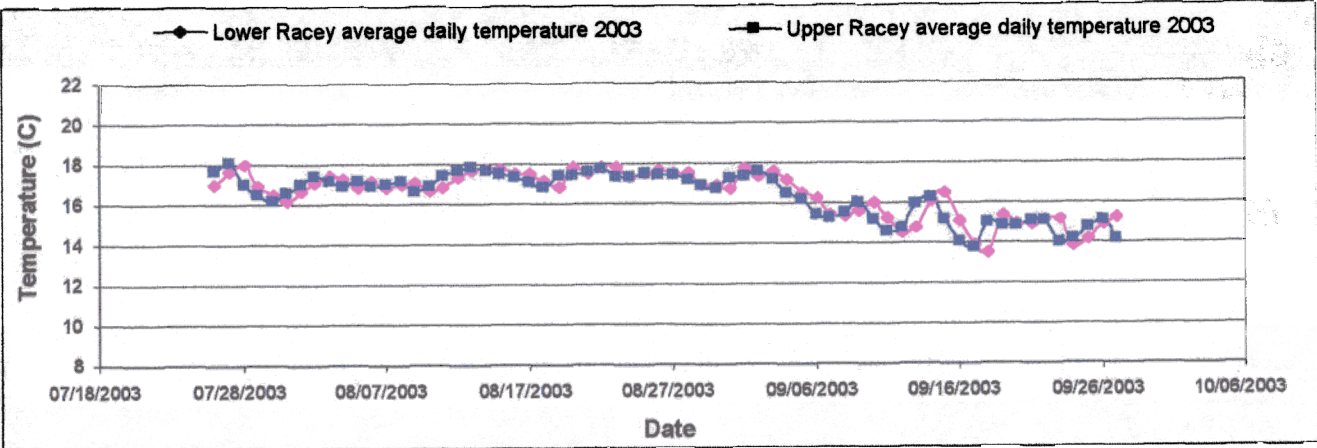
FIGURE 4. Comparisons of average daily water temperatures at the upper and lower boundaries of the Racey mitigation site 2001, 2003.

Temperature was recorded hourly from July 26 - September 27 during 2001 and 2003 (Appendix 3). During 2002, temperatures were recorded at the upper end of the project from June 13 through July 5 and at the lower end of the project from June 13 - July 5 and July 26-September 27(Appendix 3). The average daily water temperatures between the upper and lower boundaries of Laxon Creek at the Racey were determined (Figure 4). The average daily temperatures at the upper Racey location were 17.7°C, 18.1°C, and 16.5°C in 2001, 2002, and 2003, whereas at the lower location they were 17.4°C, 18.5°C and 16.5°C. In order to understand temperature fluctuations at the site, 20°C (68°F) was selected as a threshold point where water temperatures might begin to negatively impact cold-water fish populations. In 2001, from a total of 1510 hours of data collected over 45 days at the upper end of the site. At A total of 328 hours (22%) exceeded 20°C. At the lower end of the site there were 72 hours (5%) that exceeded 20°C. In 2002, the upper temperature recorder failed and data was only collected from June 13 - July 5. During this period, 527 hours of data were recorded over 20 days, of which 140 hours (27%) exceeded 20°C at the upper site. At the lower site 131 hours (25%) exceeded 20°C. In 2002, water temperature recorders collected 1535 hours of data over 64 days at the lower end of the site. A total of 351 hours (23%) exceeded 20°C.

In 2003, 1535 hours of data was collected over 64 days at the upper end and lower ends of the project. At the upper site, there were 30 hours (2%) exceeding 20°C, while at the lower site 72 hours (5%) exceeded 20°C. The upper temperature recorder was moved to a location downstream and below the confluence with an unnamed tributary to Laxon Creek. This resulted in the temperature recorder being placed in an area of cooler water from the unnamed tributary. In hindsight, the recorder should have been placed further downstream from the confluence of the unnamed tributary to allow for better mixing of water from the two streams to occur before the temperature was recorded. It is assumed that the fewer number of days the water temperature was over 20°C at the upper location when compared to the lower location was a result of moving the temperature recorder. Data indicate that the average daily temperature at the lower Racey location was 2.0°C cooler in 2003 when compared with 2002 data and 0.9°C cooler when compared with 2001 data. The lower water temperatures recorded in 2003 at the lower end of the project when compared to 2001 and 2002 data is attributed to an increase in streamside vegetation, resulting in more shading and a narrowing of the channel, and a possible increase in stream flows due to the end of the 2001-2003 drought. As the riparian vegetation matures, the

number of hours water temperatures exceed 20°C should decrease. This will make habitat conditions more favorable to coldwater fish species.

7. Move the upper temperature recorder back to the 2001 and 2002 location.

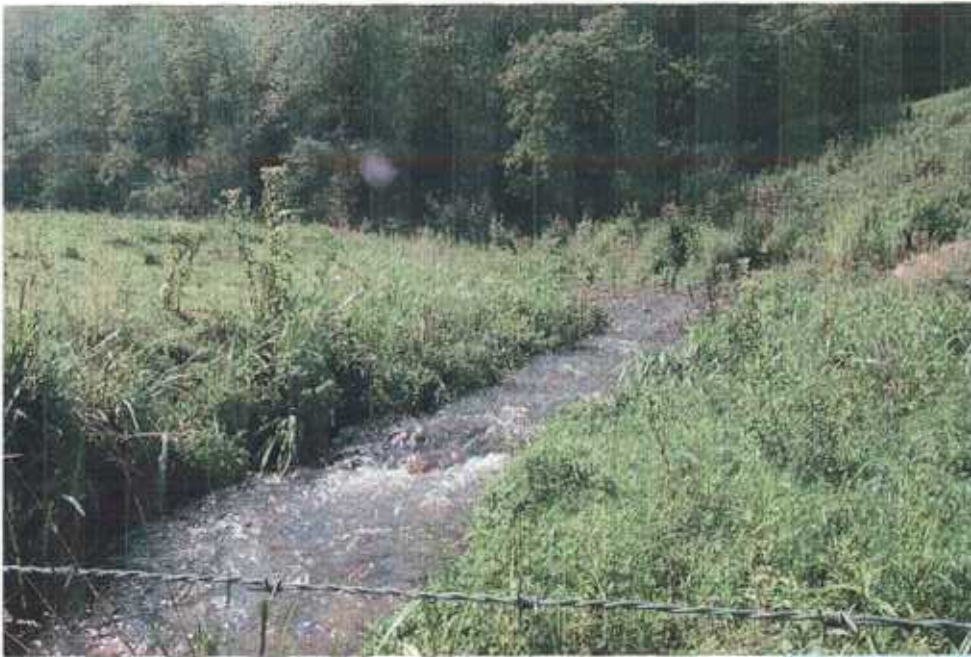
A.2.1. Looking upstream from upper easement boundary, outside easement, July 2003. This area is grazed by cattle.

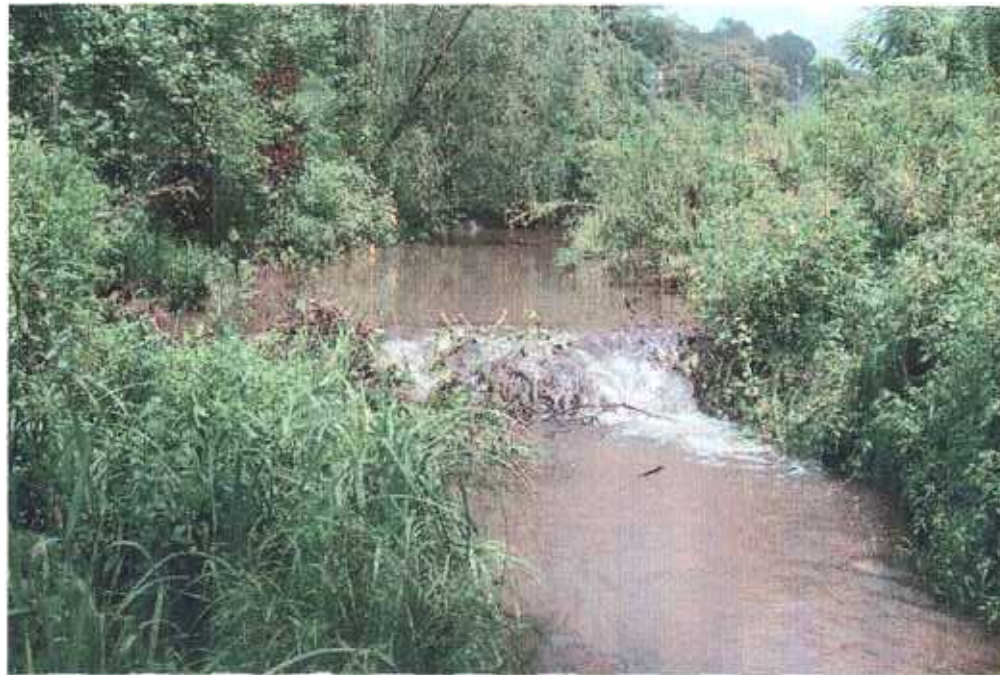
A.2.23. On of th bea er dam located within the mitigation site during th July 2003 monitoring ey station 8+48.
