**RACEY MITIGATION SITE ON LAXON CREEK,
WATAUGA COUNTY**

Year 3 (2004) and 4 (2005) Monitoring Report

Transportation Improvement Project R-0529

Period Covered, January 9, 2001 – September 27, 2005

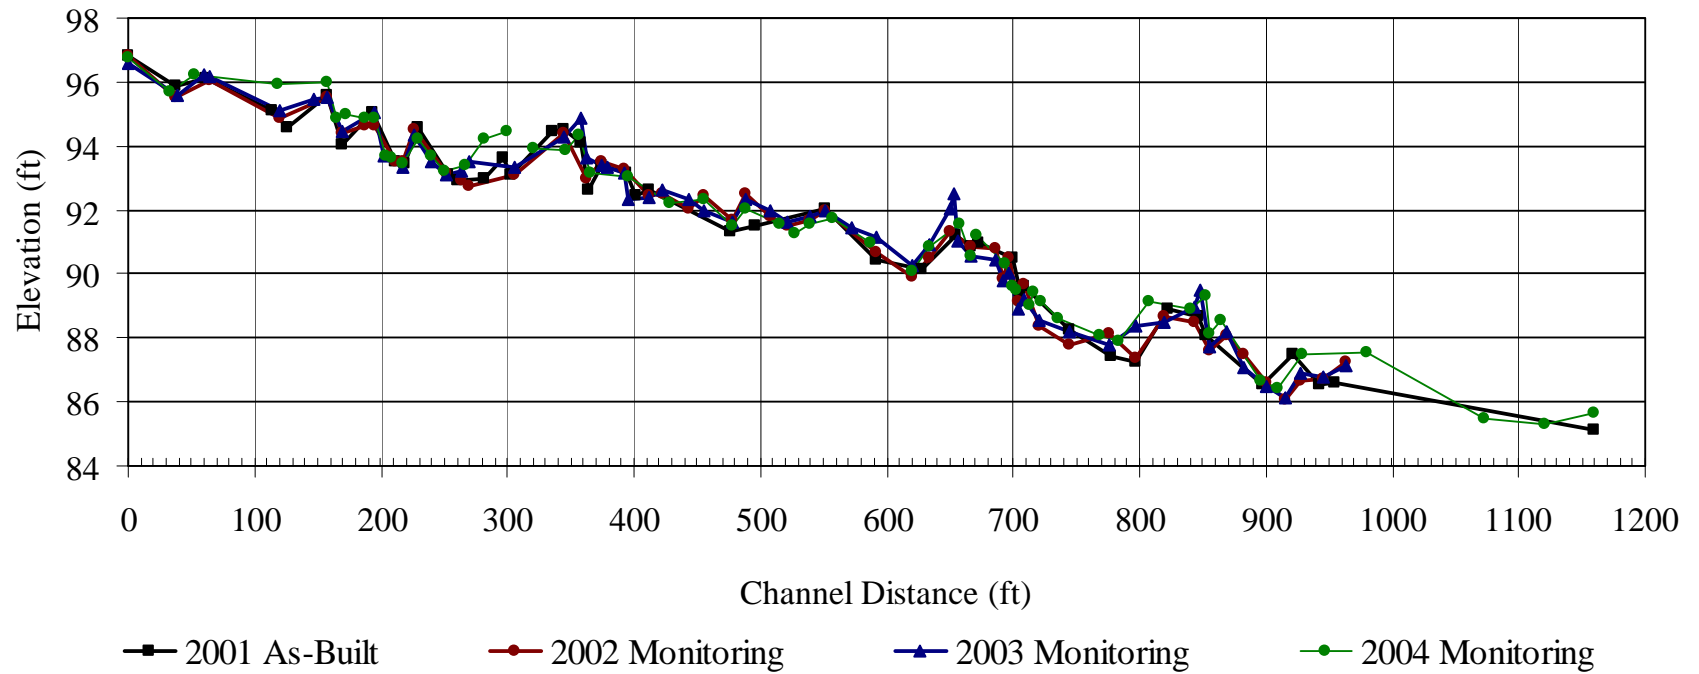
The 2004 longitudinal profile data was surveyed from stations 0+0 to 11+63 (Figure 2). There was no appreciable change in the profile between the 2001 (as-built) and 2003; however, the 2004 data reveals differences in stream bed elevation at stations 0+53 - 1+58, 8+08 - 8+52, and 9+29 - 9+80, which can be attributed to dams constructed by beavers at this site.. These dams were subsequently washed out during the flood events associated with the 2004 hurricanes. It should be noted that the 2001 and 2002 longitudinal profile surveys ended at station 9+23 because little construction activity occurred between this point and the confluence of the South Fork New River. The longitudinal profile has remained stable with no identified aggradation or degradation areas other than the changes caused by the beavers. Comparison of the 2004 data with previous years indicates that the minor changes in the longitudinal profile are the result of normal storm events and not the result of stream enhancement activities. Due to the longitudinal profile being stable following the 2004 survey, it was not surveyed in 2005.

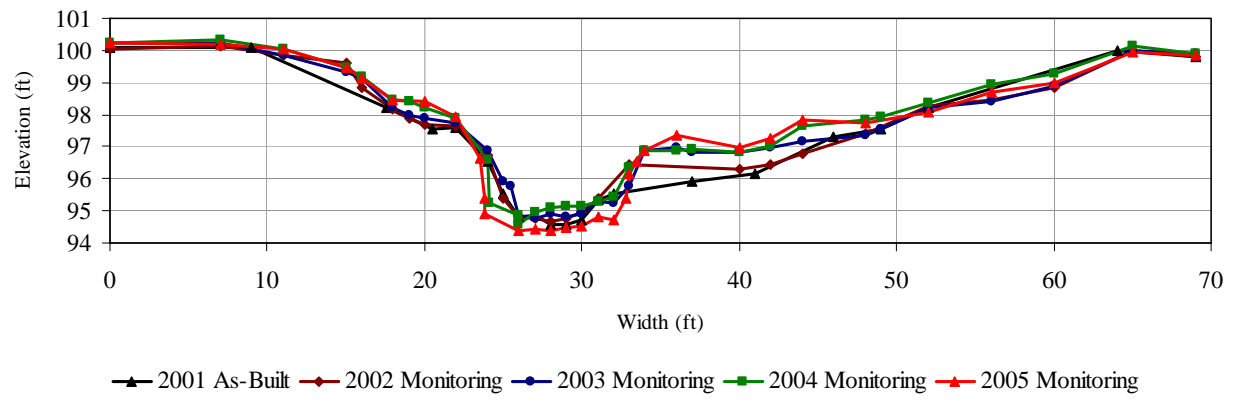
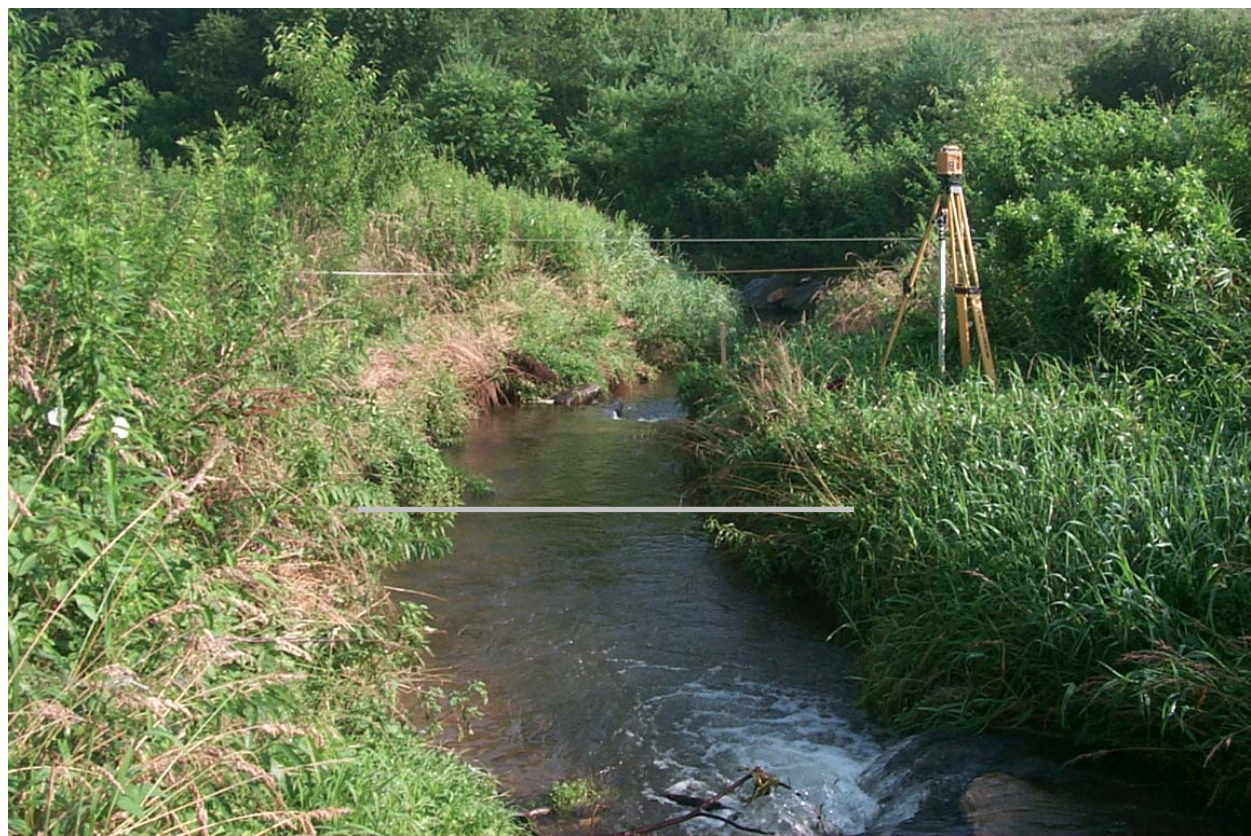
FIGURE 3.1. Cross-section 1+88, run.

CROSS-SECTION 1+88 – run (Figure 3.1): This cross-section is located just above a root wad. There has been little change in the cross-section from 2001 thru 2005. The thalweg has deepened and the channel has widened slightly following the three September 2004 hurricanes; in spite of this the banks are stable and well vegetated.

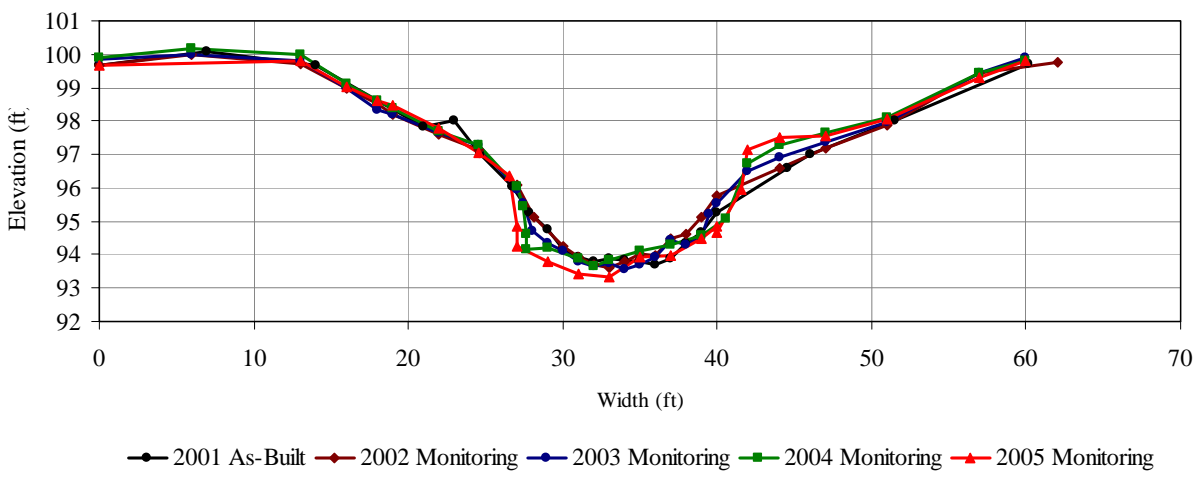
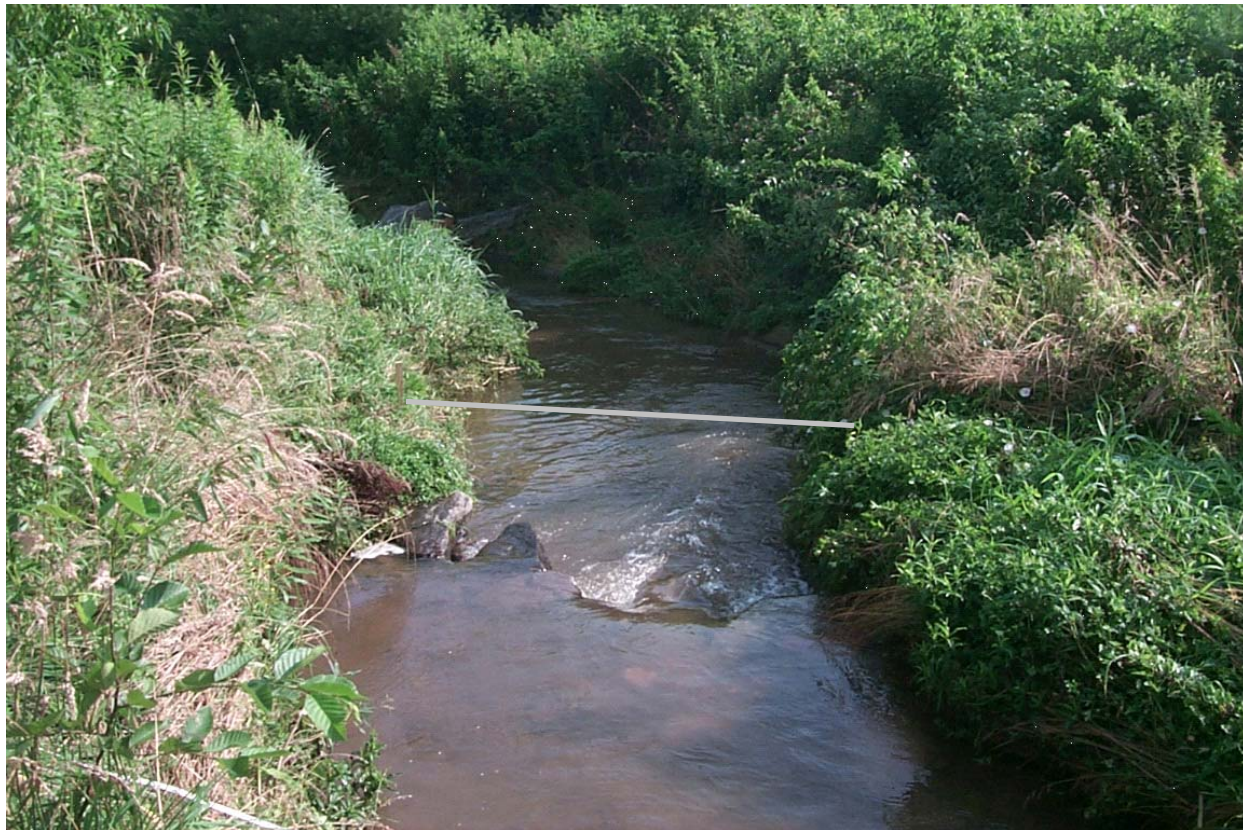
FIGURE 3.2. Cross-section 2+08, pool.

CROSS-SECTION 2+08 – pool (Figure 3.2): This cross-section is located over the middle of a pool just below a rock weir and has shown very little change over time. The thalweg has deepened and the channel has widened slightly following the three September 2004 hurricanes; in spite of this the banks are stable and well vegetated.

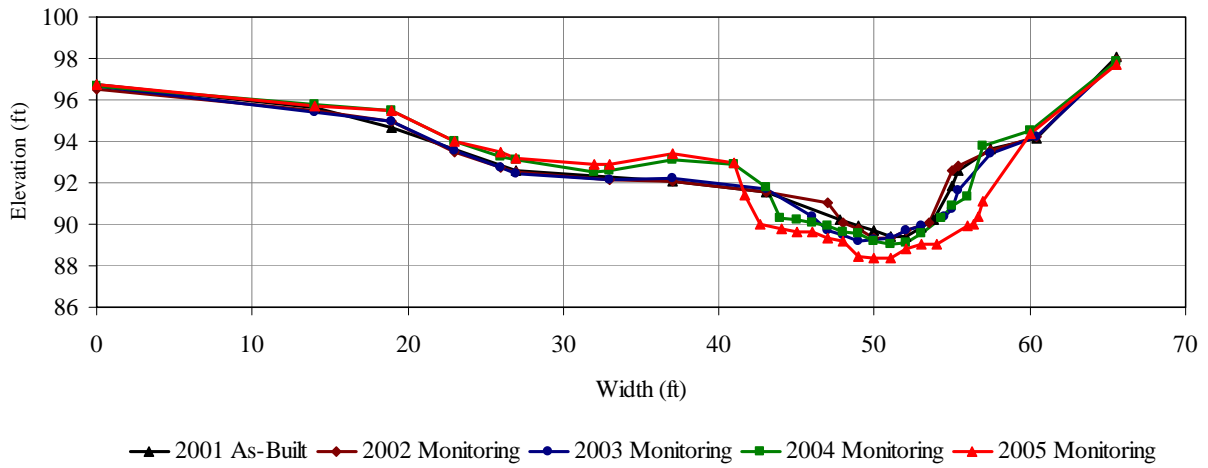
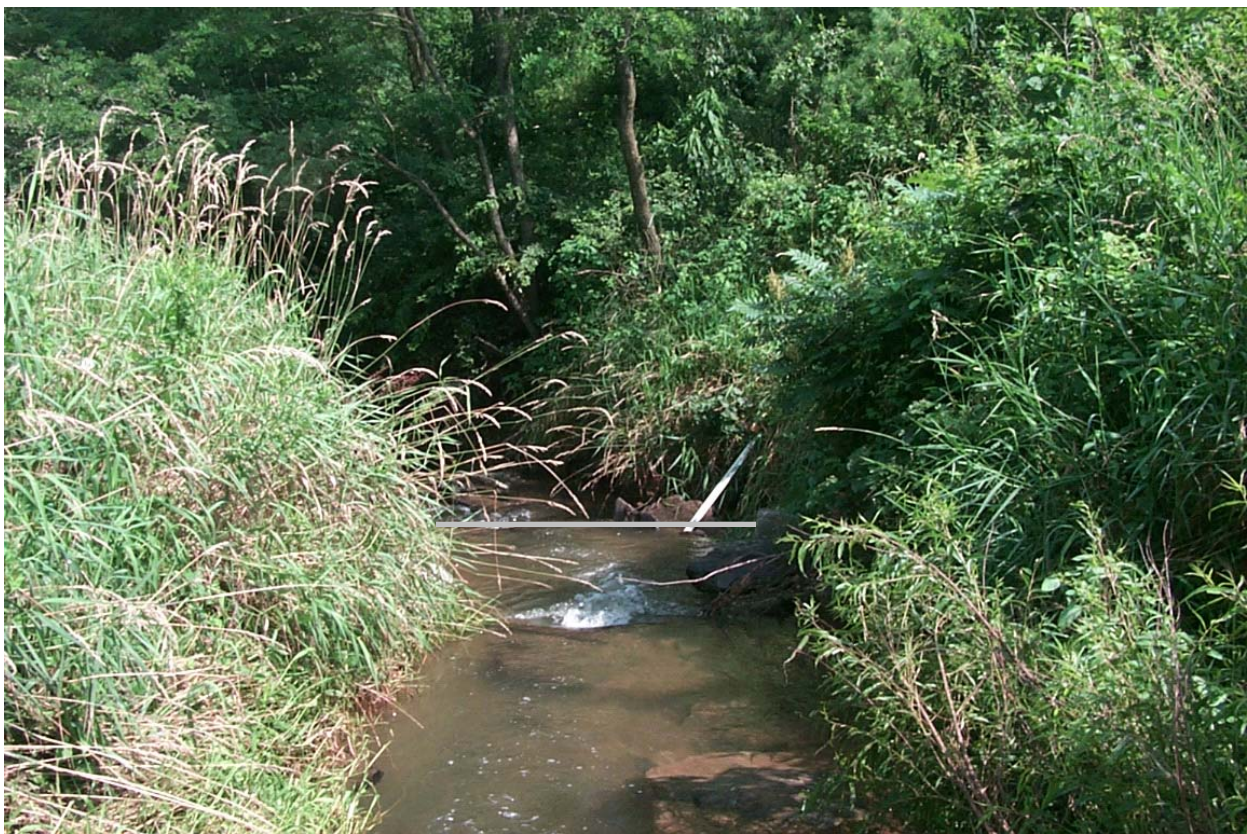
FIGURE 3.3. Cross-section 7+13, step pool.

CROSS-SECTION 7+13 – step pool (Figure 3.3): The thalweg has deepened and the channel has widened considerably, probably due to storm events and the failure of a beaver dam located above the cross-section. However, the streambanks are stable and well vegetated. While the banks are stable, the steep right bank should be visually monitored for potential bank erosion problems during the yearly conservation easement inspection.

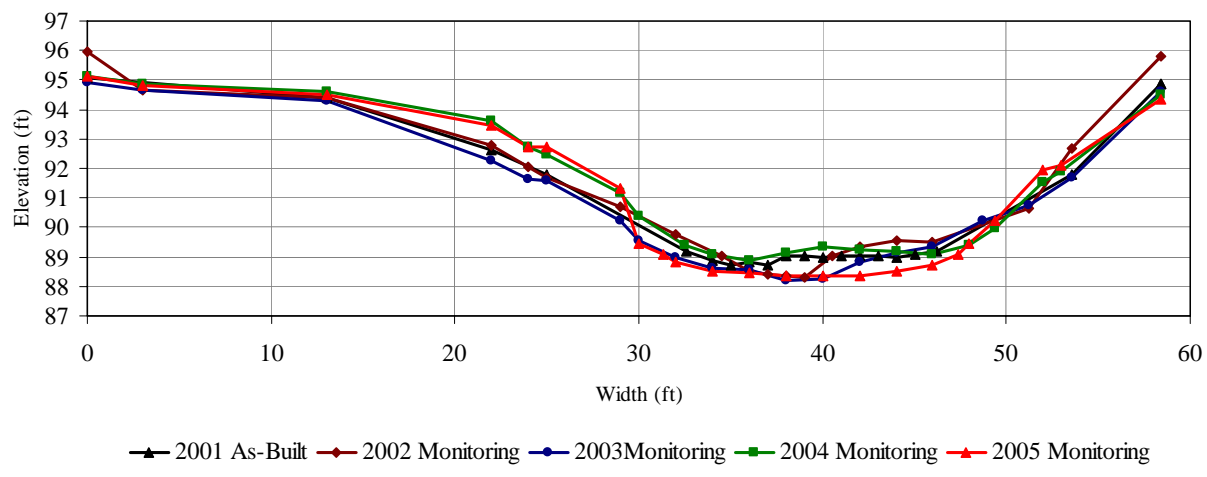
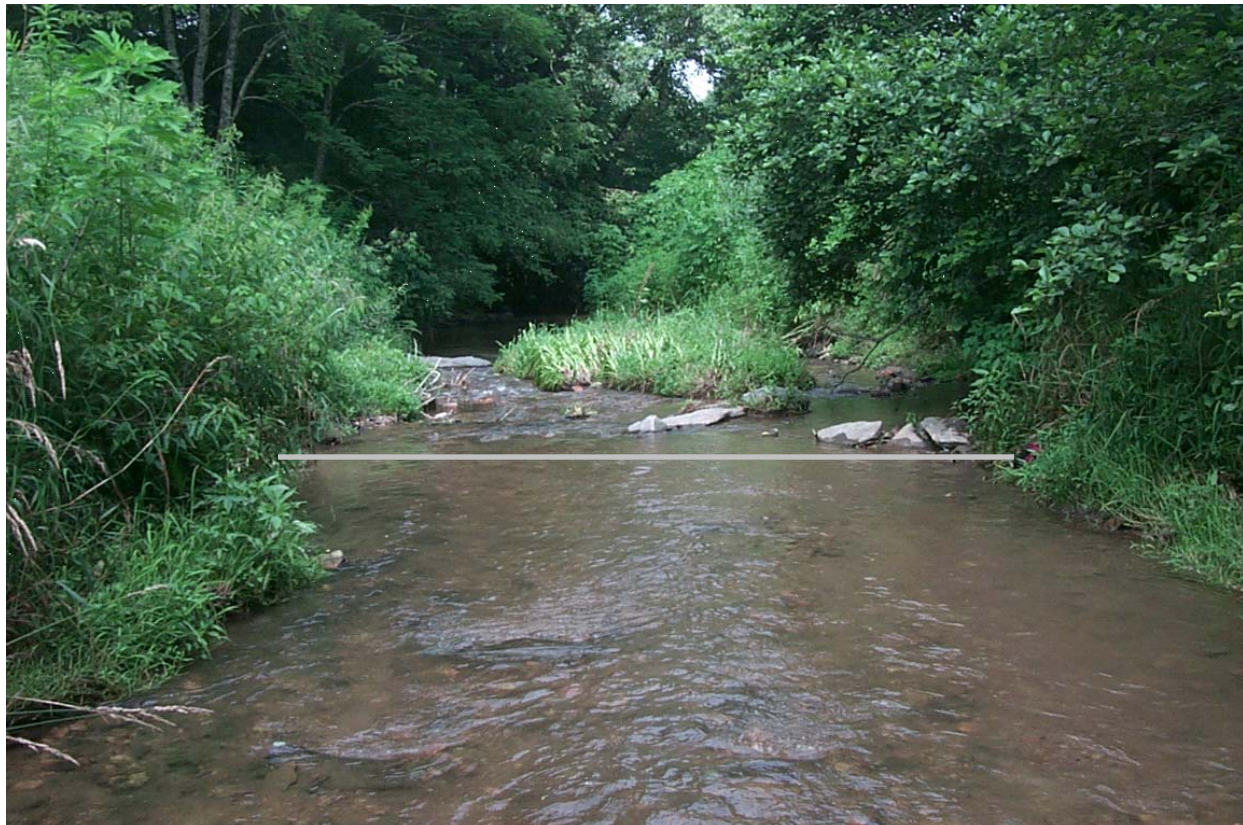
FIGURE 3.4. Cross-section 8+40, run.

CROSS-SECTION 8+40 – run (Figure 3.4): The thalweg has deepened to the level found in 2003. Immediately below the transect, the left bank has migrated slightly and a central bar has developed creating a separate channel along the right bank. These channel adjustments are the direct result of beaver activity during 2003 - 2004. Both banks are well vegetated and stable. If the central bar becomes larger, there is the potential risk of bank erosion developing along the right bank. This location should be monitored for potential bank erosion problems during the yearly conservation easement inspection.

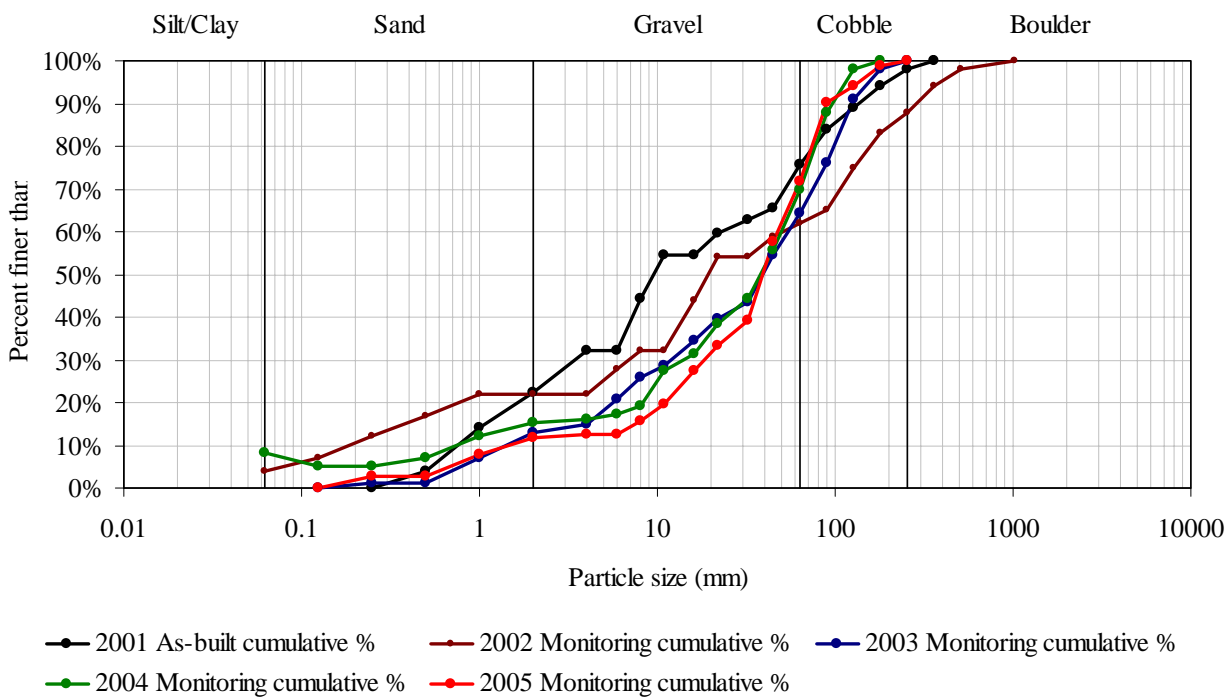
FIGURE 4.—Pebble count data comparisons, Racey mitigation site, Laxon Creek, Watauga County, 2001-2005.

Bed material was collected from a riffle at cross-section 18+42 (Figure 4). Substrate analyses show a slight increase in most particle sizes, except for the D_{95} cumulative distribution. Since 2001 the D_{50} cumulative distribution has coarsened from medium, to coarse, to very coarse gravel. The increase in particle size, especially the D_{50} and D_{84} cumulative distribution, is probably a result of the channel becoming narrower. This has occurred as a result of improved bank profiles and in-stream structures following site construction, an improved riparian corridor that has narrowed the stream to improve sediment transport, and the three September 2004 hurricanes that flushed out a lot of silt and sand from the watershed (visual observations immediately following these hurricane events).

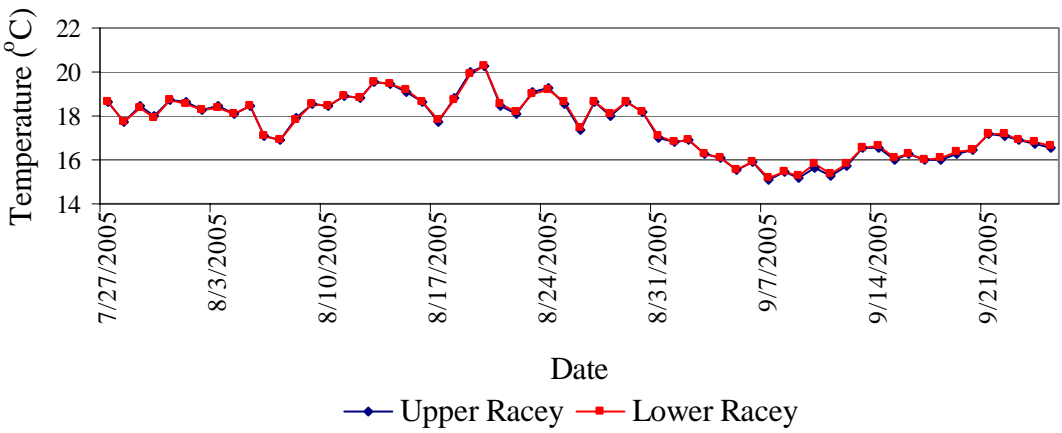
FIGURE 5.—Comparisons of daily average water temperatures at the upper and lower boundaries of the Racey mitigation site, Laxon Creek, Watauga County, July 28 – September 27, 2005.

Because Laxon Creek is classified by NCDWQ as trout water, the WRC wanted to determine if water temperatures would decrease as riparian vegetation began providing shade along the 1,160 ft site. Stream water temperature was recorded hourly at the upper and lower site boundaries from July 28 to September 27, 2005 (Figure 5) and compared with temperature data collected during approximately the same time period in 2001, 2002, and 2003 (Mickey and Hining 2004). The average daily water temperatures at the upper station were 17.7°C, 18.1°C, 16.5°C, and 17.5°C in 2001, 2002, 2003, and 2005, whereas at the lower station water temperatures were 17.4°C, 18.5°C, 16.5°C, and 17.5°C in 2001, 2002, 2003, and 2005. It was hoped from 2001 to 2005, as the density of the riparian vegetation improved, that the average daily water temperature would be cooler at the lower end of the project. Unfortunately, the upper and lower daily average water temperatures were nearly identical (Figure 5). This could be attributed to the study reach being too short (1,160 ft) to document any change in the temperature regime or the riparian vegetation has not matured enough to provide stream shading and cooler water temperatures.

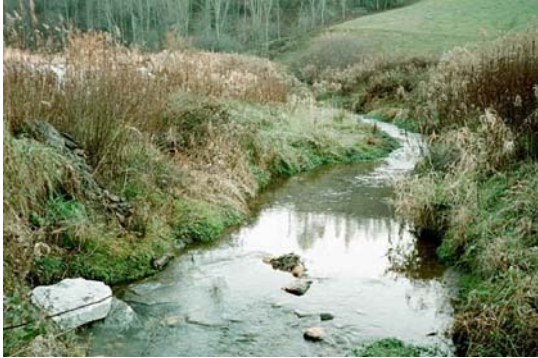
October 30, 2000 before construction.

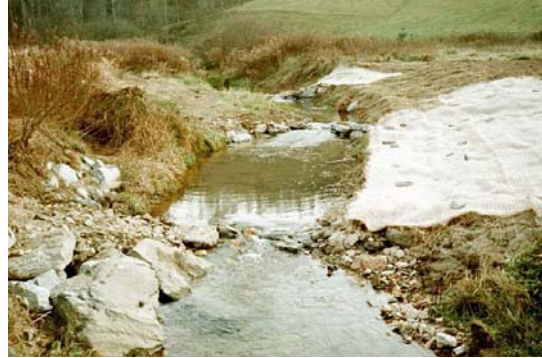
November 3, 2000 after construction.

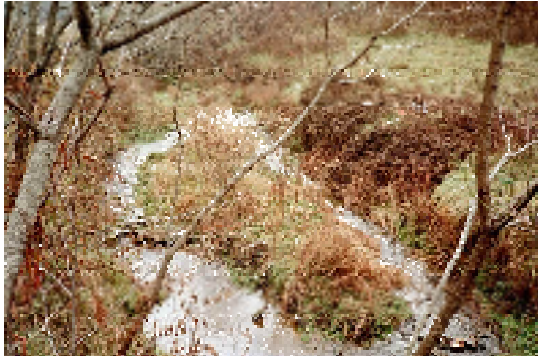
October 30, 2000 before construction.

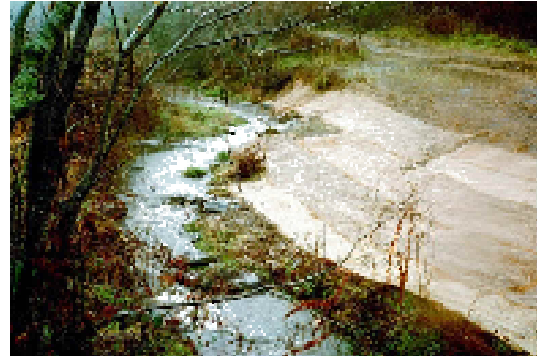
November 3, 2000 after construction.

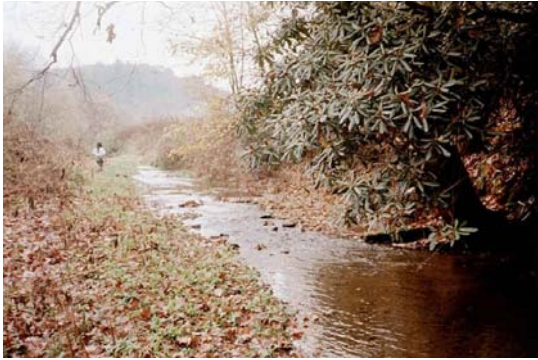
October 30, 2000 before construction.

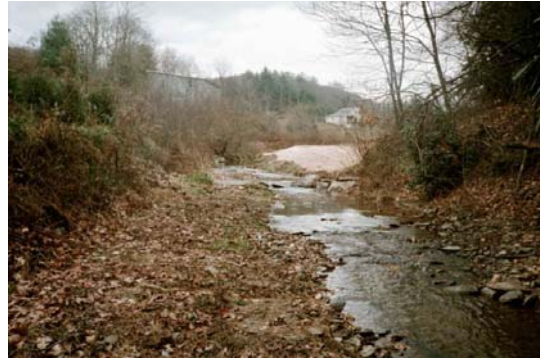
November 2, 2000 after construction.

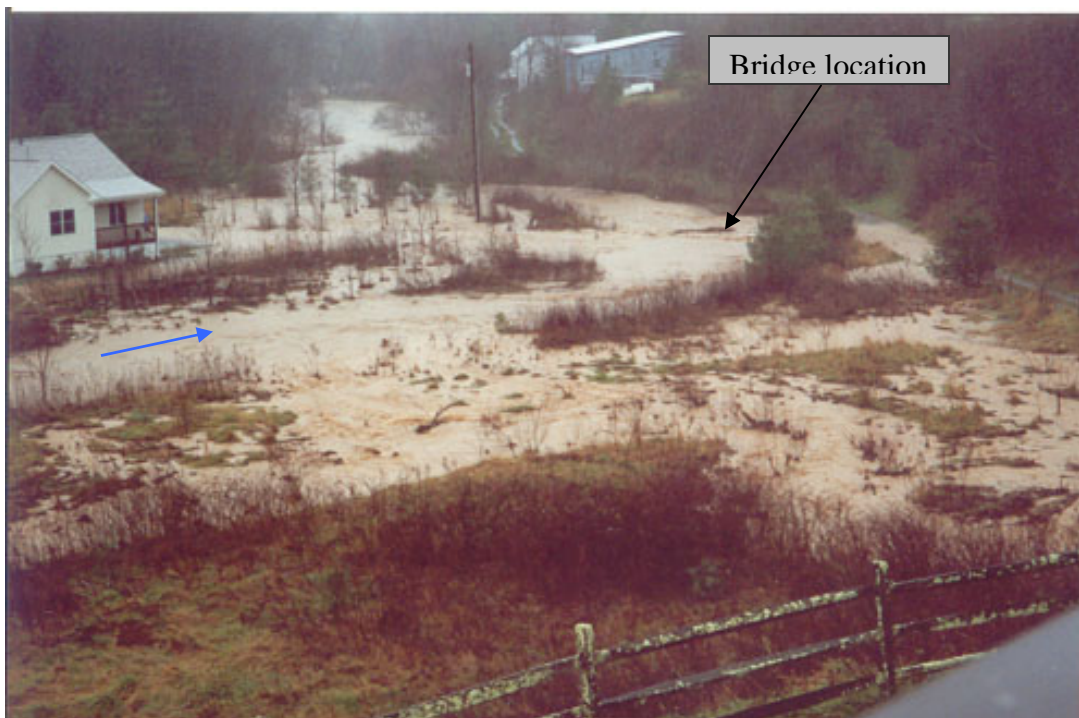
A major flood event occurred on November 19, 2003 that resulted in some minor damage to a rock cross-weir at longitudinal profile station 3+57 (Appendix 4). Damage to the structure occurred after a ford crossing was replaced by the landowner with a bridge in 2002 (construction of a bridge at this location was permitted in the conservation easement). Flood waters crested the bridge and lateral movement of flood waters were constricted by the bridge abutments. This constriction resulted in the flood waters creating an upward current under the cross-weir boulders, causing the structure to fail. Under normal flood conditions, flood waters would have flowed over the structure, holding it in place. This structure, along with some minor bank damage immediately downstream from the site, was repaired on February 25, 2004. These repairs have been the only ones required at this site since construction was completed on November 3, 2000 (Mickey and Scott 2001).

APPENDIX 4. Overview photograph showing the location of the bridge at longitudinal profile station 3+57 during the November 19, 2003 flood event on Laxon Creek, Watauga County. The rock cross-weir at this location was damaged during the flood and had to be repaired. Photograph courtesy of Dr. Jana Carp.
