REEDY BRANCH
STREAM RESTORATION
MONITORING YEAR 1 REPORT
AUGUST 2005

MY1 (2005) Reedy Branch Monitoring Report

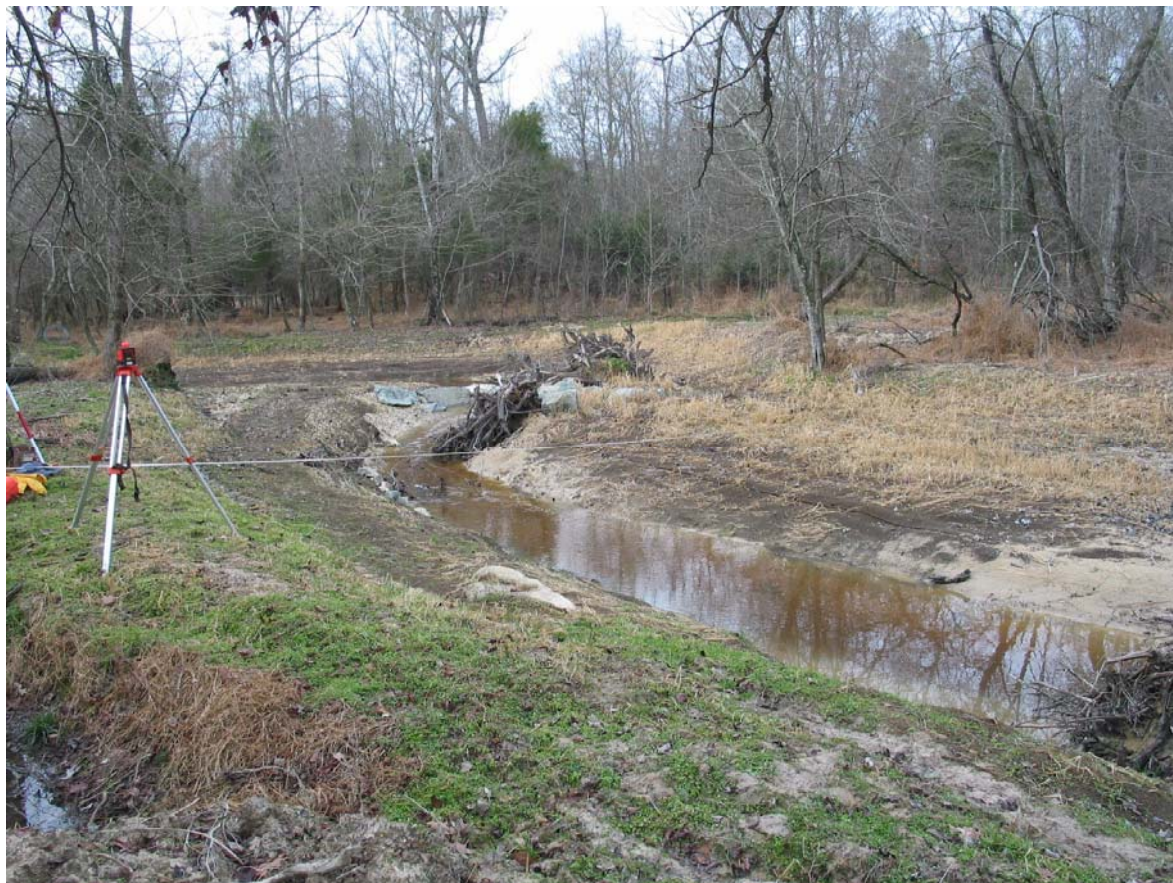
Photo 1. This is the reference riffle cross section (Station 1+05).

The low flow channel has good depth and width throughout the reach with patches of gravel starting to occur on the riffles. Good pool depth but much of the channel bottom is covered in fine silt that causes a milky cloud when disturbed. At medium flows the channel runs white like milk. At low flows the water is tannic brown.

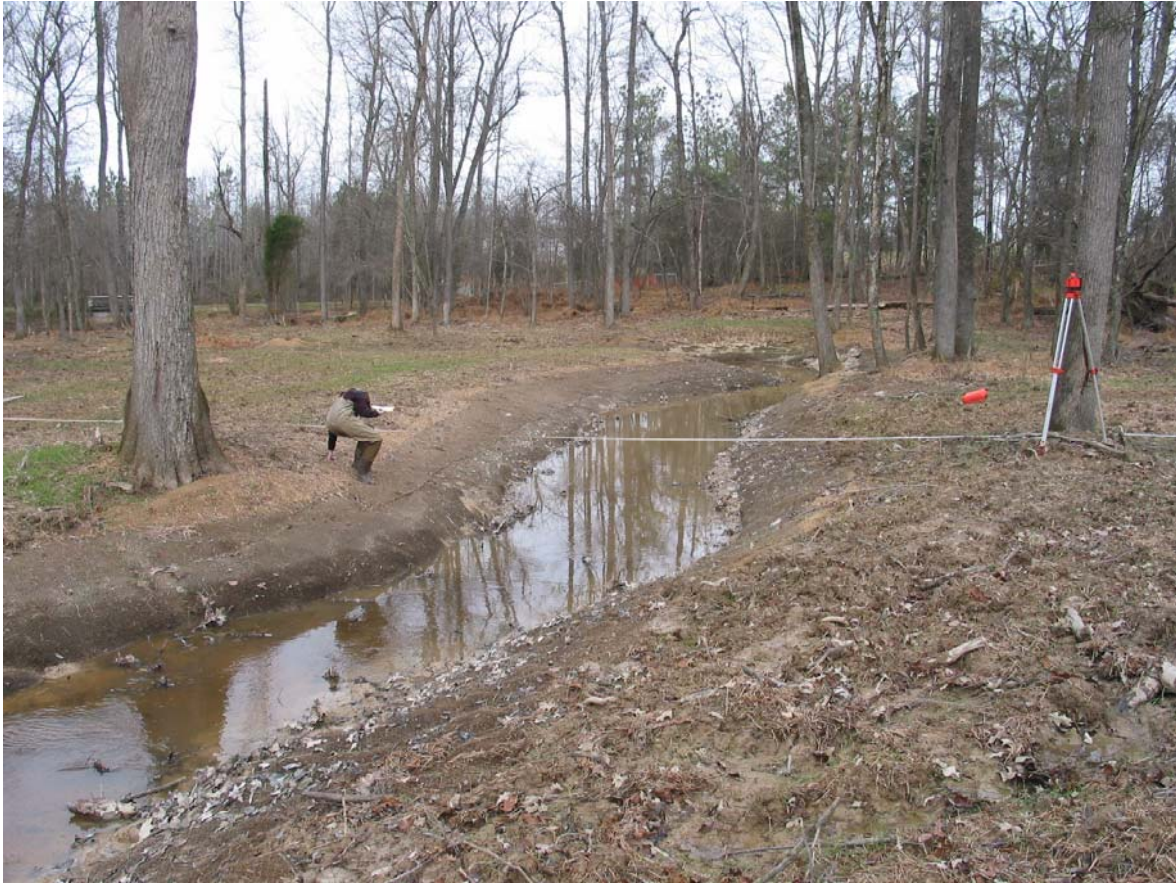
Photo 2. Pool cross section (Station 26+80).

The outside of this bend is where one of the most stable pools occurs, other than the plunge pool below each cross vane. The low flow depth is over 1.5 feet, just off the coir matting in the bank; bankfull depth is consistent with the design d_{\max} of 3.5 feet.

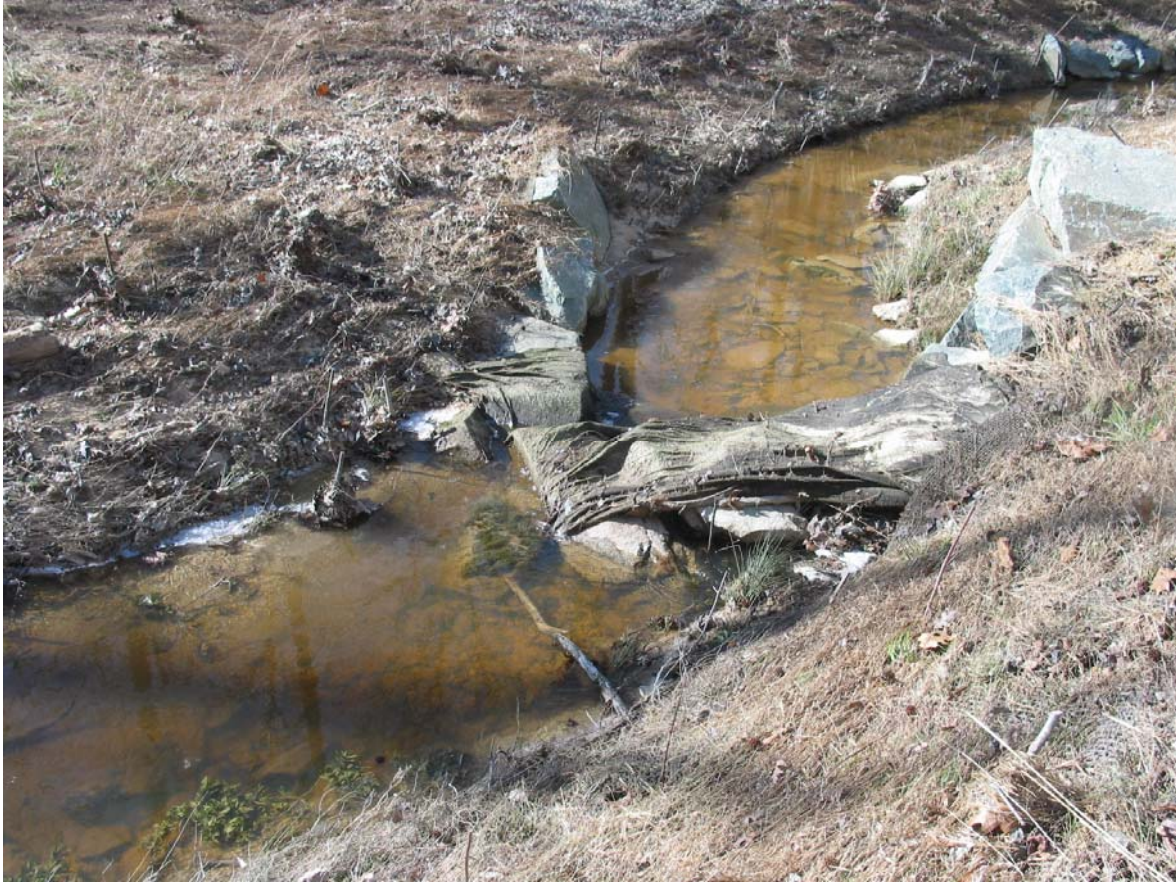
Photo 3. Cross vane with center section shifted and piping at several locations.

At high flows the arms of the cross vane accumulate sediment and protect the banks. This was corrected as a warranty repair.

There were three problem areas that needed warranty repairs, which were made in May 2005. One was a small area of run-on erosion down-slope from one of the construction access areas. Another was a cross vane which was leaking, and the third was some storm flow damage to the cattle crossing fences. Two of the repairs were made by Phillips and Jordan, and the cattle crossing was repaired by the landowner.

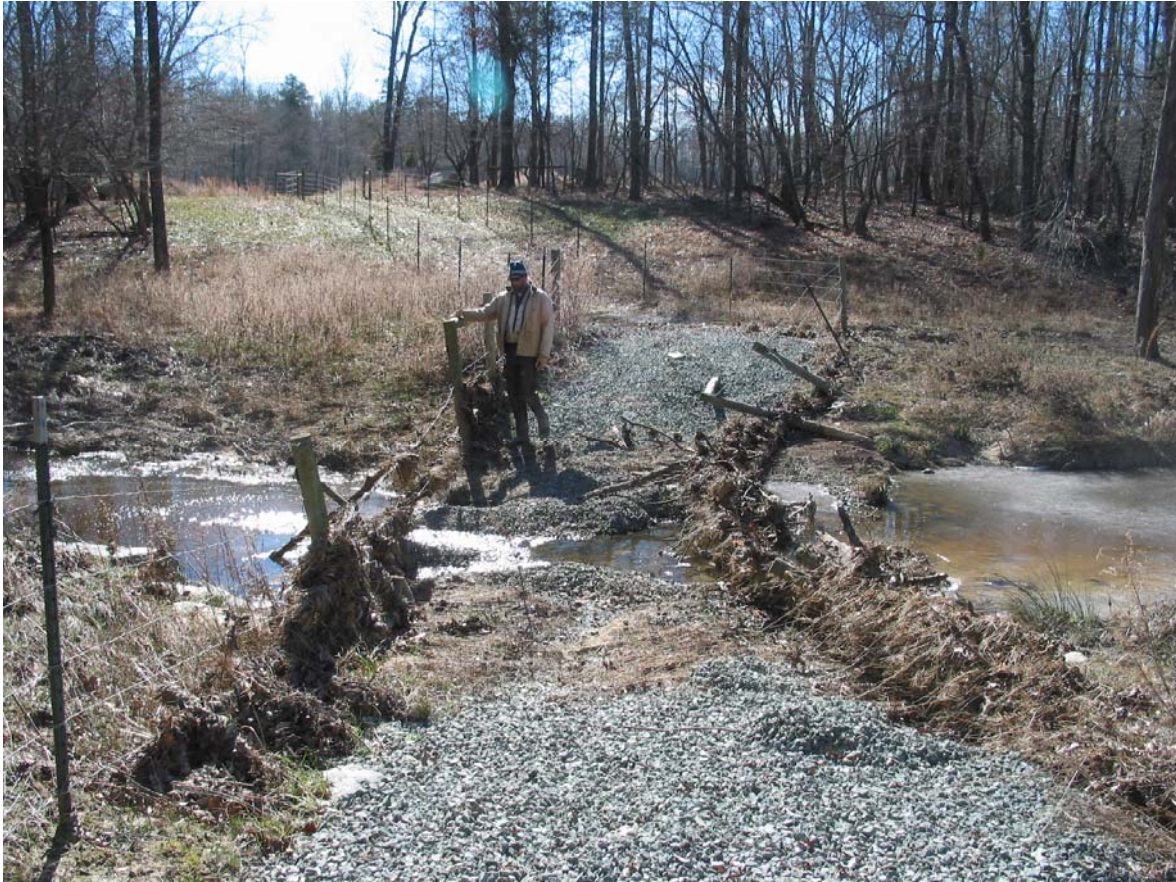
Photo 4. Storm damage to cattle crossing fence.

significant damage during a flood when the fencing on the upstream crossing accumulated heavy amounts of drift material and the force of the water pushed over the fence and pulled out the fence posts on either side of the crossing. After consulting with the landowner and the Alamance County NRCS office, it was decided to repair this problem by removing the fencing and hanging cattle panels from a cable stretched across the creek. These panels should offer sufficient resistance to the cattle to keep them in the crossing but swing up during storms to allow the drift and water to pass.

The other area of concern is the cattle crossing fencing. There are two cattle crossings, each bounded by an upstream and downstream fence. The upper crossing suffered significant damage from storm flows, while the lower crossing was undamaged. The high storm flows of last winter caused lots of drift to accumulate on the wires and the force of the water and weight of the accumulation caused the upstream fence to fail. The failure, shown in photo 4, resulted when the storm flow and ground saturation caused the fence posts to fall. The fence wire stayed intact and remained attached to the posts. Since the movement of cattle is an almost daily requirement, the landowner could not wait until the state approved a repair plan, so he fixed it himself after consulting with the designer and Alamance County Cooperative extension.

The landowner fixed this, at his own expense, by resetting and bracing the posts and replacing most of the horizontal wire with swinging cattle panel.

The agreed fix was to reinstall the fence posts and remove the horizontal wires crossing the channel. In place of the wires, a single cable was stretched from the top of the creekside posts and a heavy wire cattle panel was hung from the cable. The plan is that the panel will deter cattle from accessing the stream, but will swing up during high flows. On a visit to the site after the repairs were made, it was noted that the landowner did not remove all the horizontal wire from the original installation when he hung the cattle panels. When asked about this, he said he was concerned that there needed to be some resistance if the cattle pushed on the panel and he therefore left some wires in place. It will take more storm events to determine if this is a suitable and permanent fix.

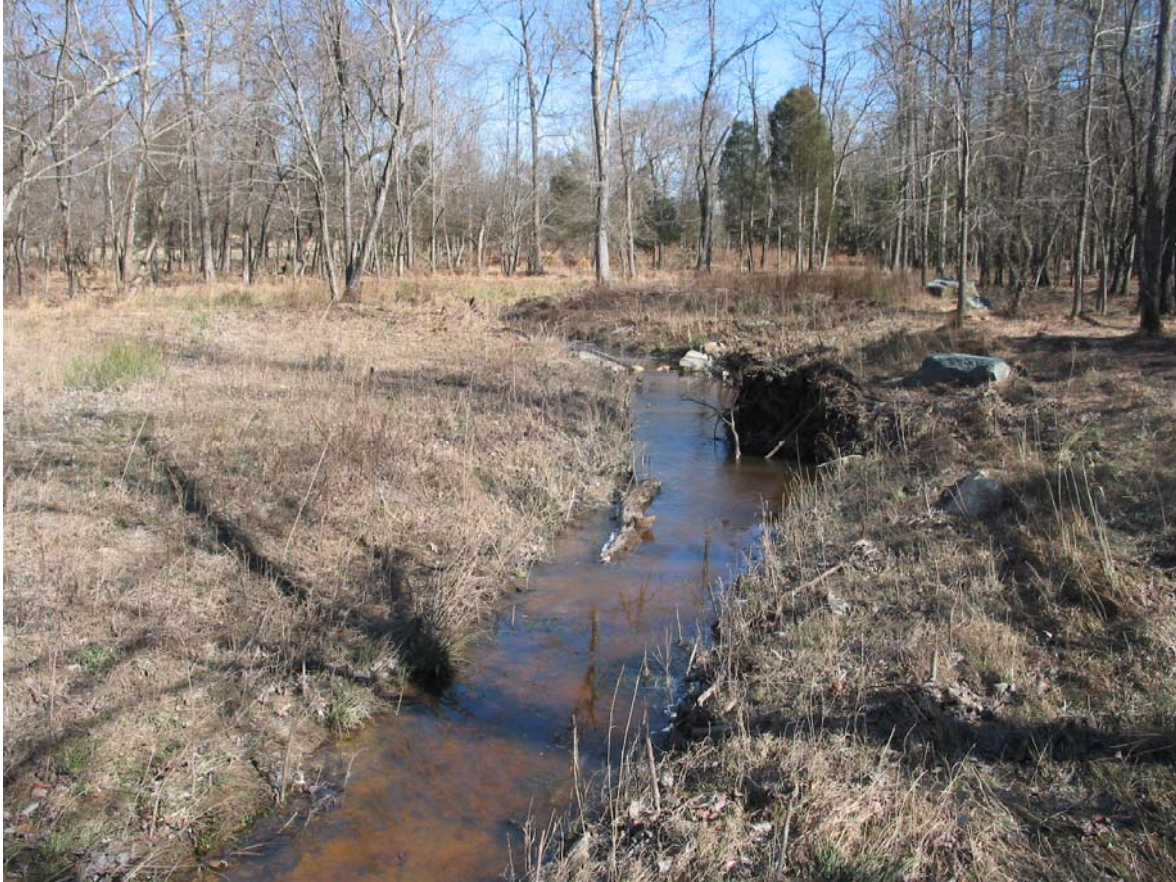
Photo 5 Reedy Branch in winter.

Note the good, thick, herbaceous riparian vegetation and general wooded valley.

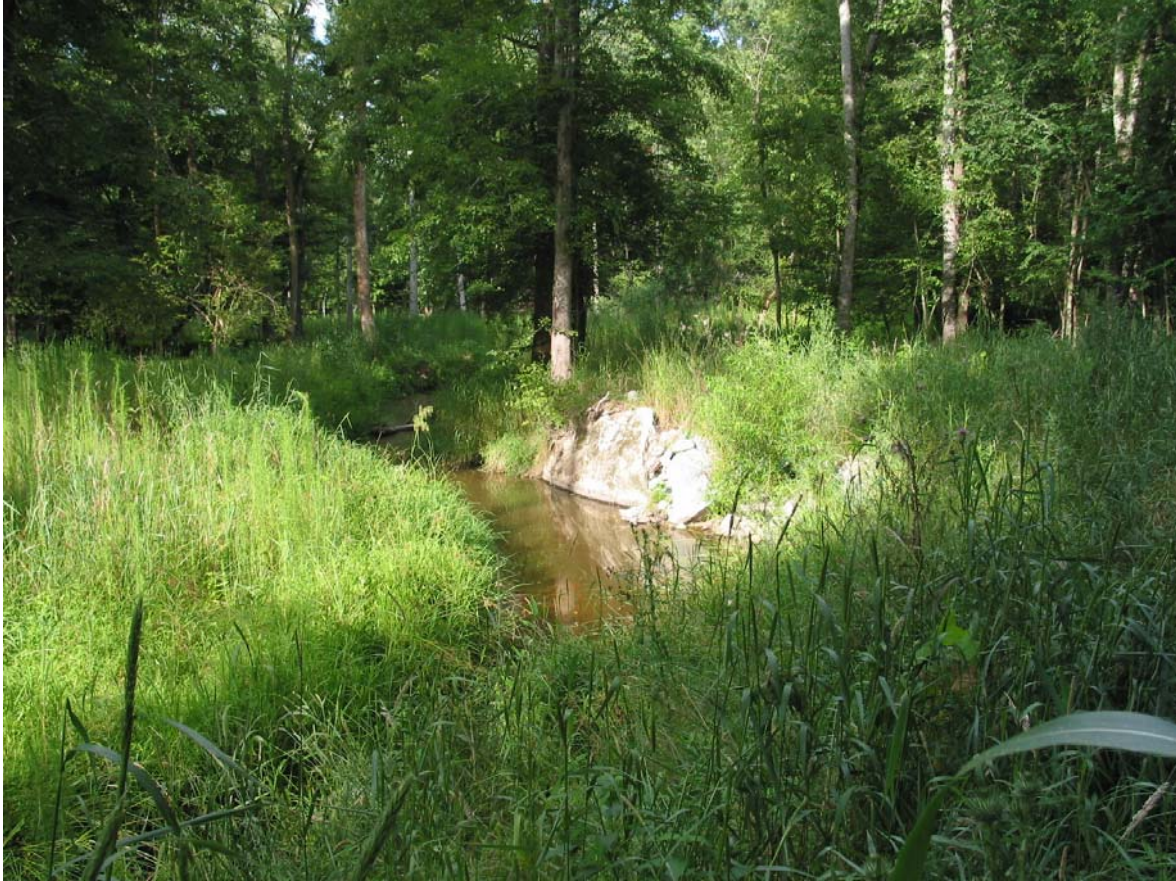
Photo 6 Reedy Branch in summer.

Note the lush herbaceous vegetation that averages 1 meter tall and the frequently closed canopy of mature trees left in place during the restoration.
