**REEDY BRANCH
FINAL MONITORING REPORT
YEAR 2 OF 5
2006**

EEP Project # 301
Alamance County, North Carolina

This report documents the data collected for Year 2 monitoring. The data includes geomorphic and vegetative components. The geomorphic data collected includes: longitudinal profiles, cross-sections, pebble counts, and photo points along the segment of restored stream. The vegetation data collected includes: stem count species and numbers for all of the vegetative plots throughout the project. The geomorphic data collected for Year 2 was compared to previous data collected in Year 1 by overlays of graphs for the longitudinal and cross-section surveys.

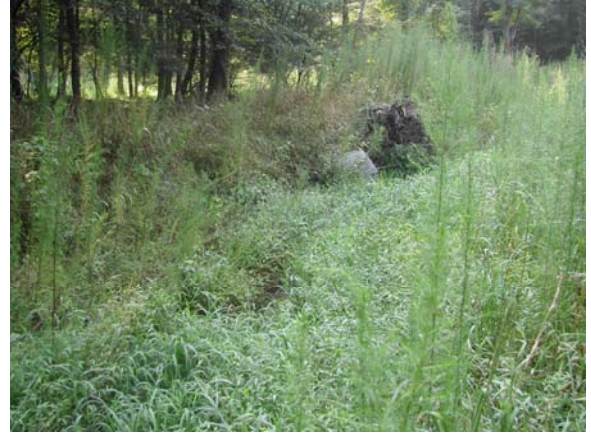
Photo 1: Japanese grass along both banks near Vegetation Plot 10

Photo 4: Japanese grass

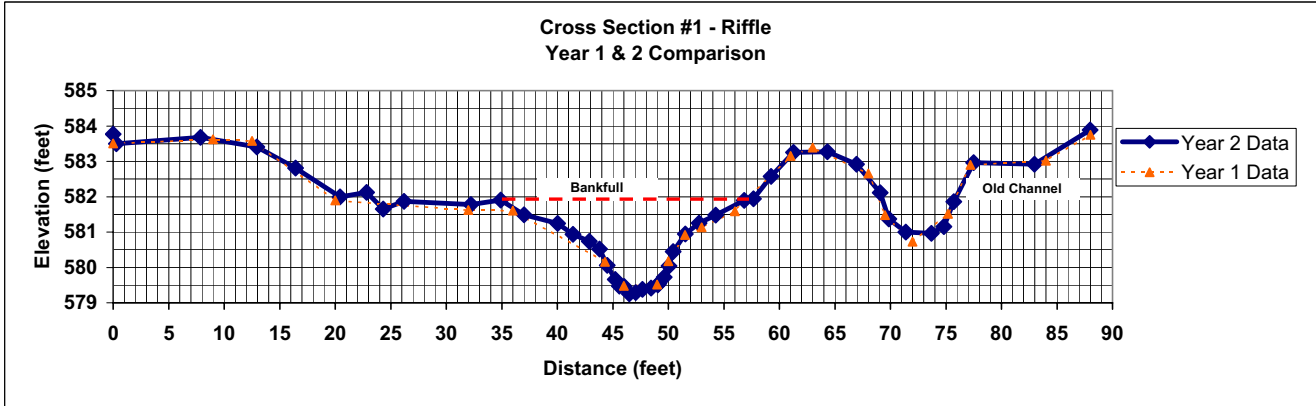
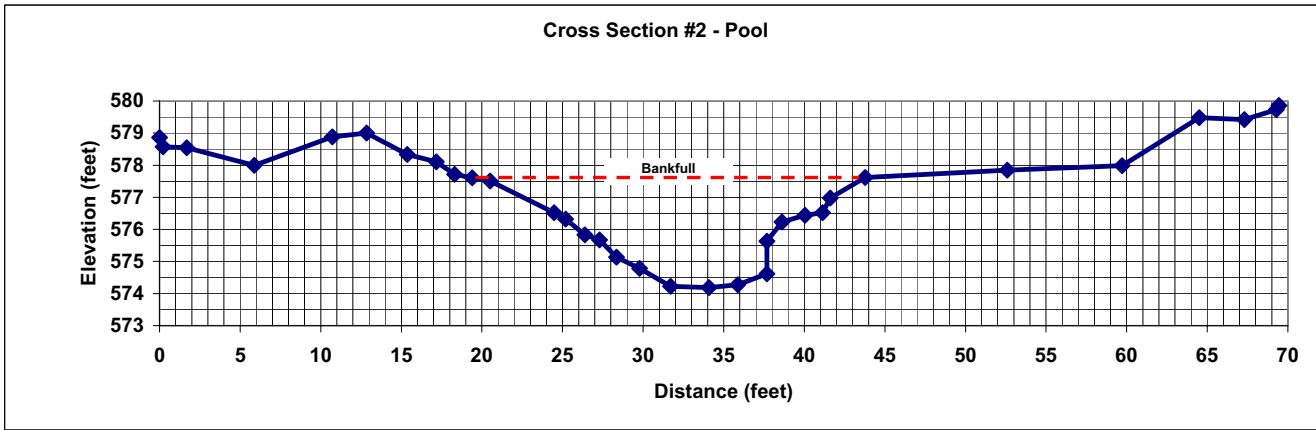
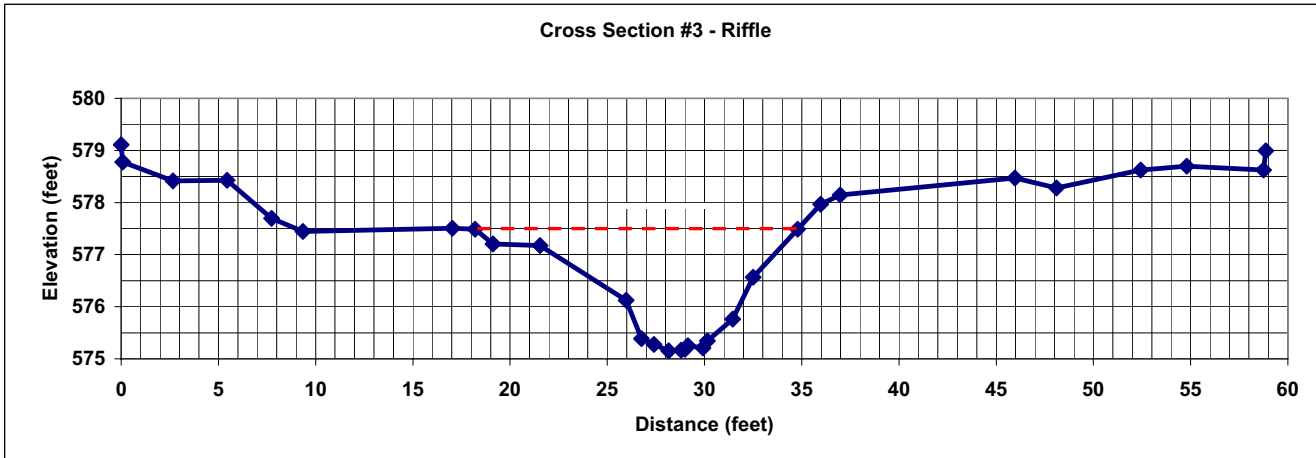
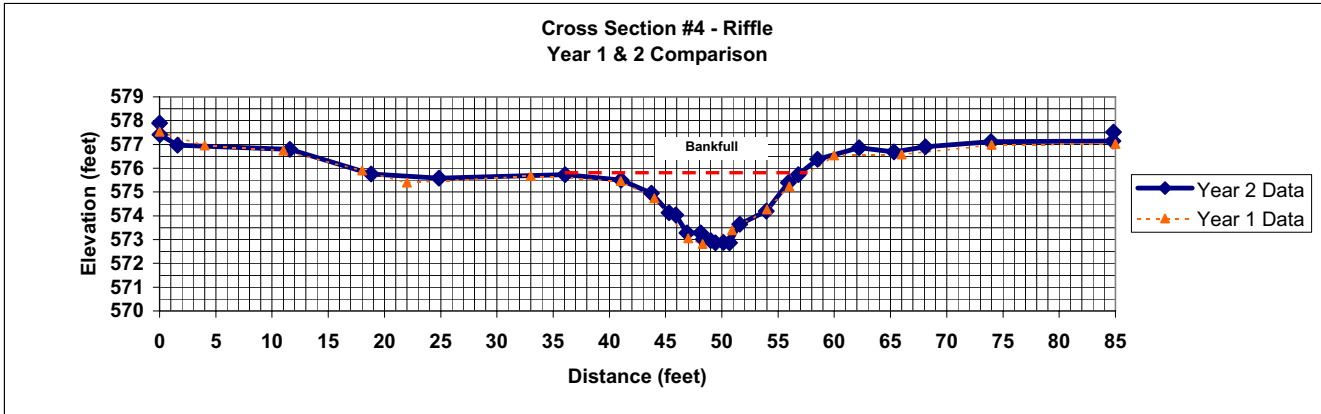
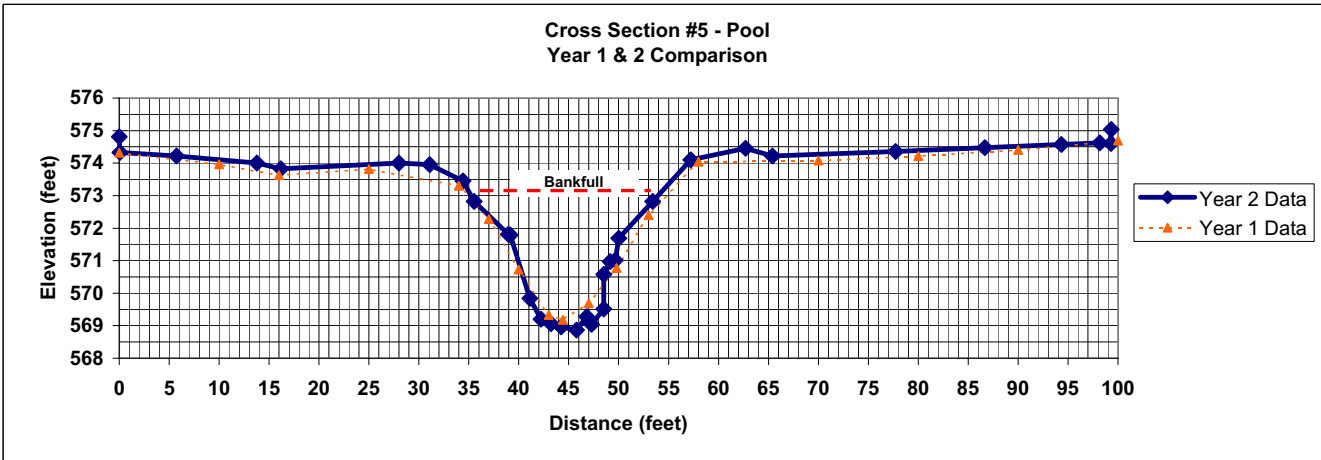
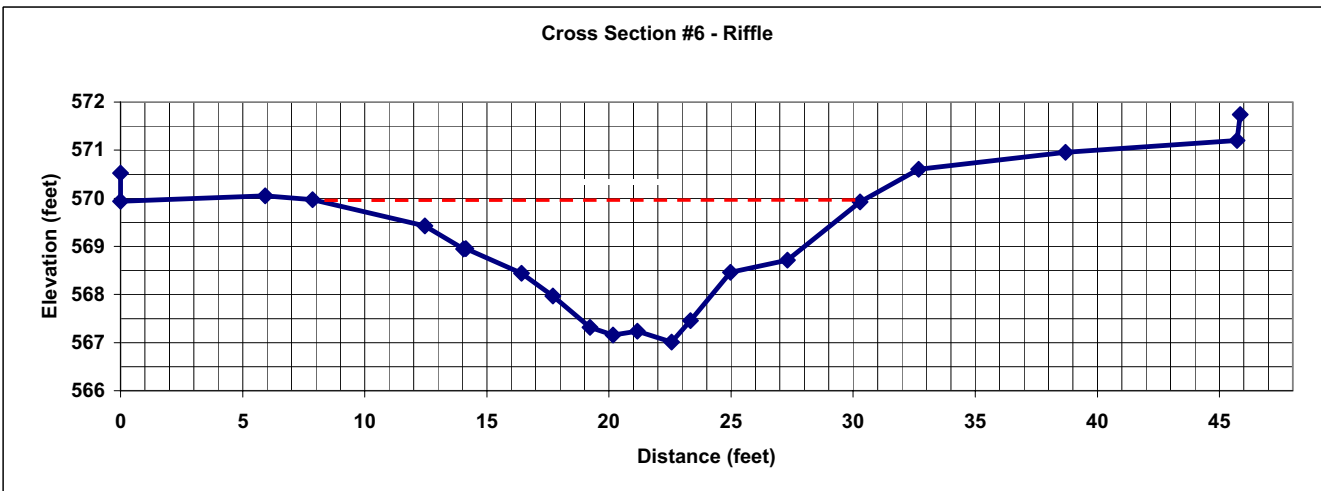
STREAM CROSS-SECTIONS

Three new cross section locations were established in Year 2 monitoring adding to the three existing cross sections from Year 1. The three cross-sections overlaid between the two years showed no major changes in dimensions. The longitudinal profiles between the two years were inconclusive. No conclusions were made due to discrepancies in stationing between years. This uncertainty in the location of some monitoring features and benchmarks has now been eliminated and therefore subsequent annual comparisons will be fully consistent with the data collection in this report. Some of the structures, as noted in the report, need to be monitored closely over the next year and may need to be repaired.

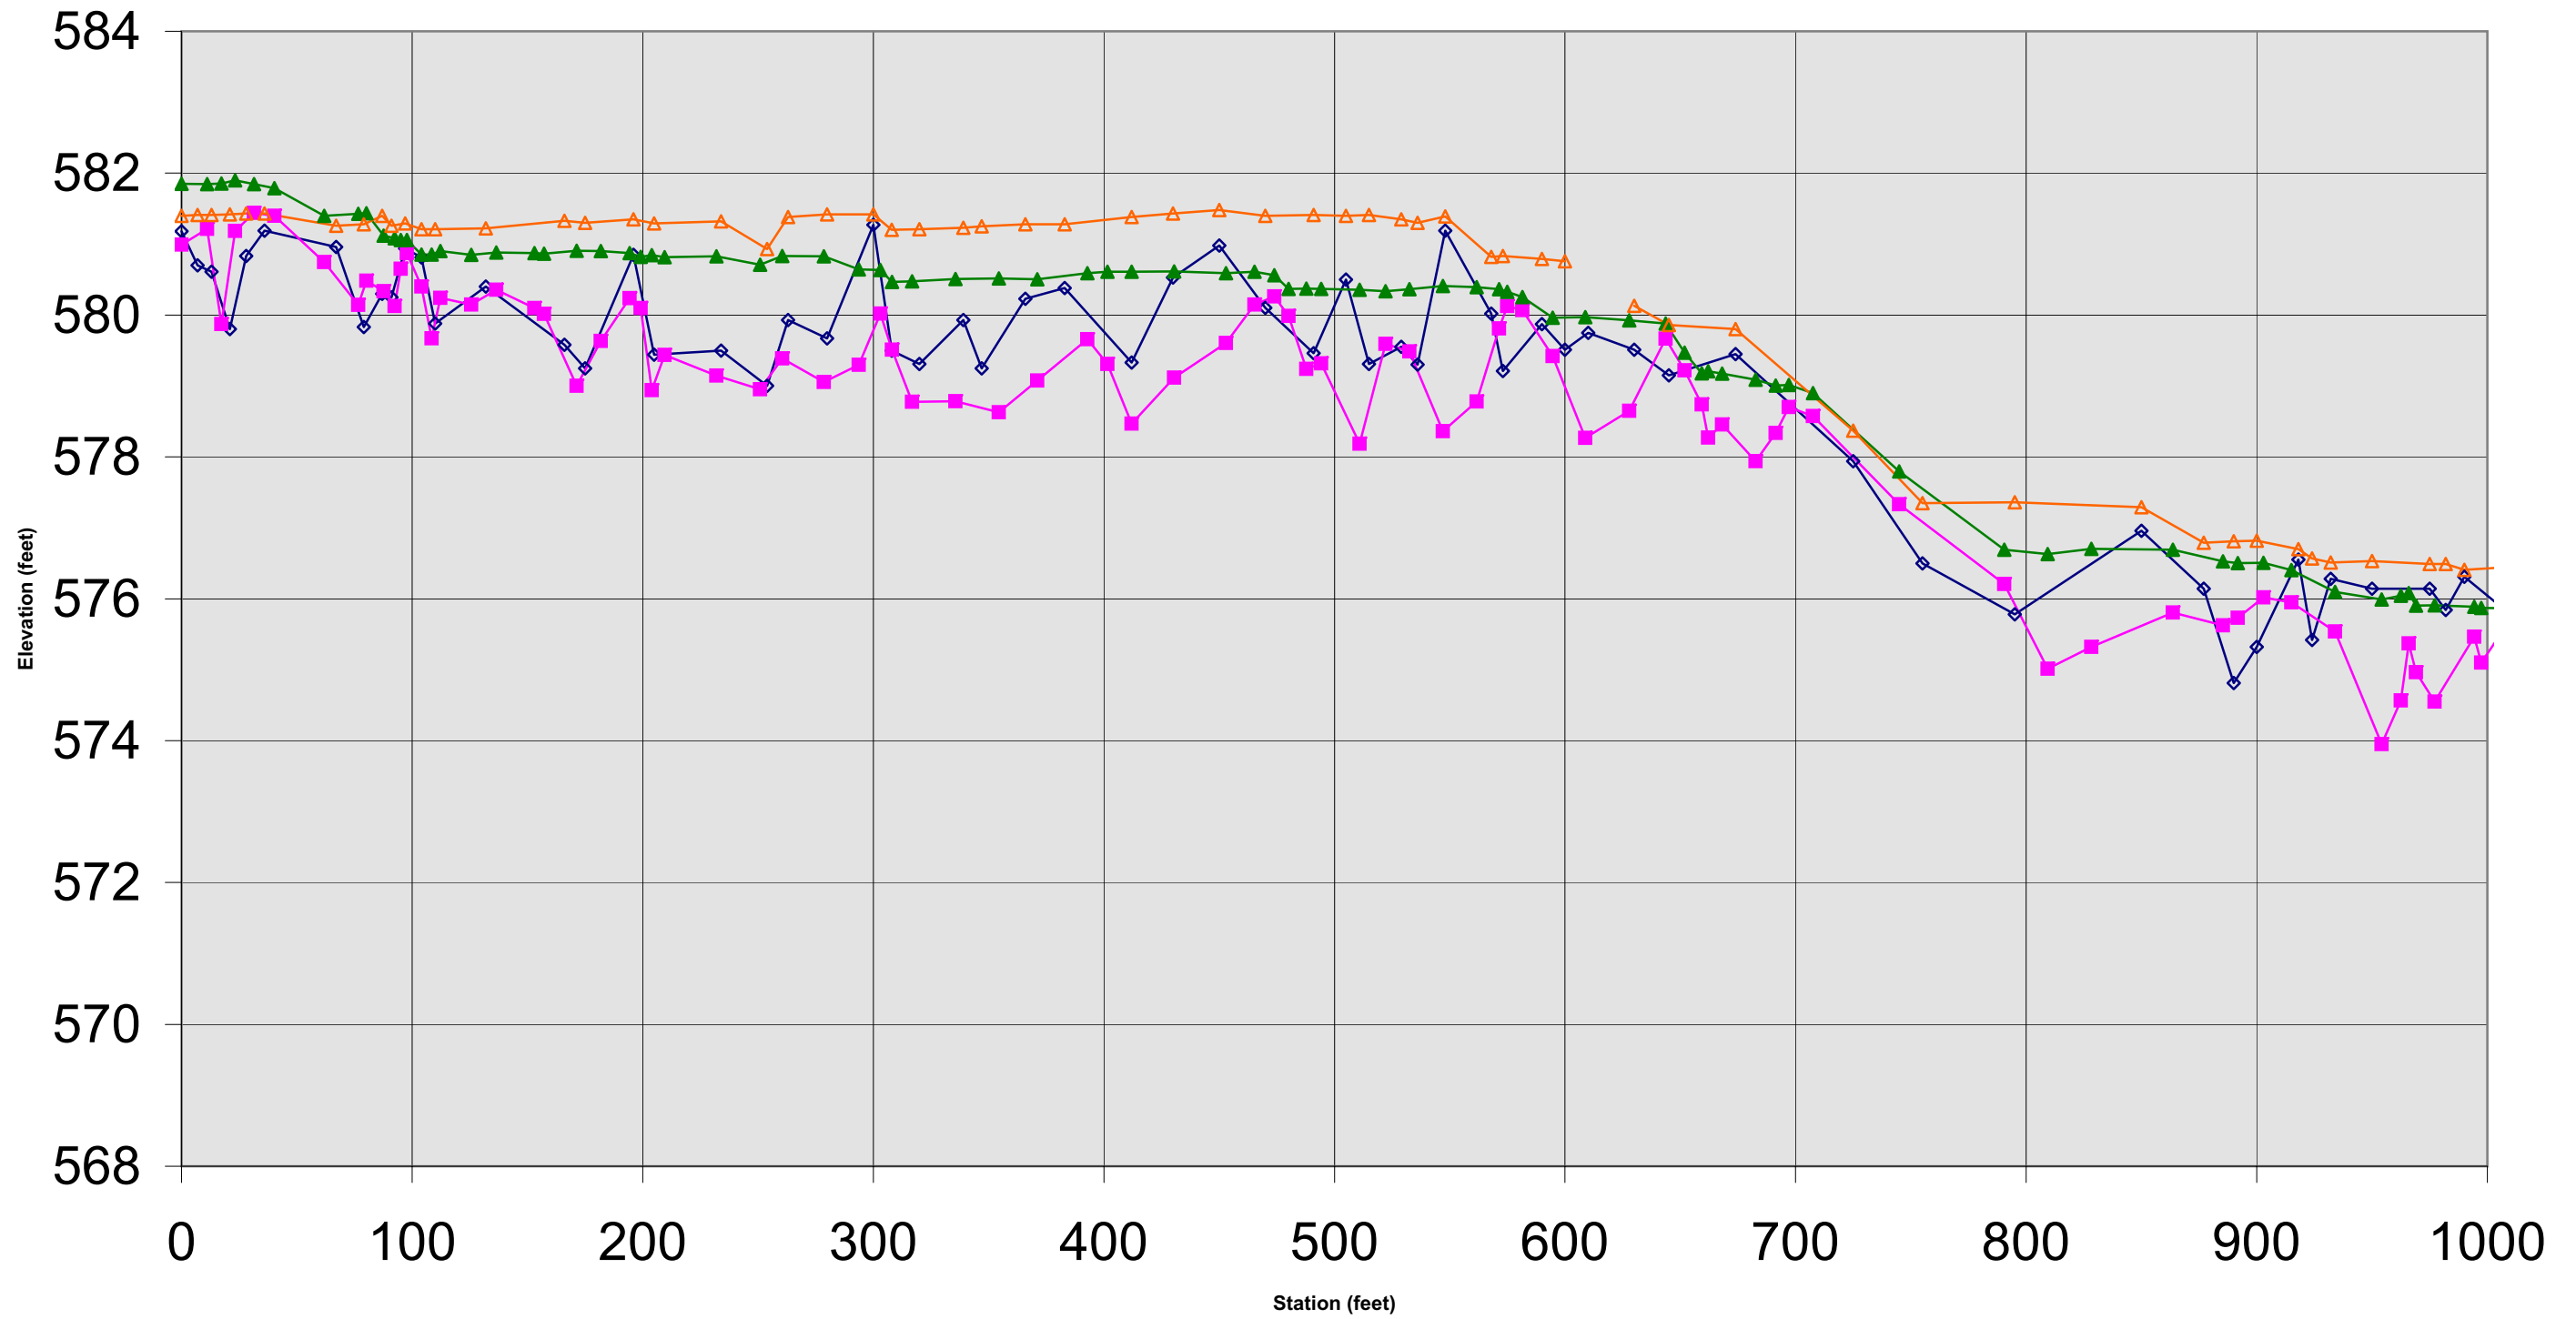
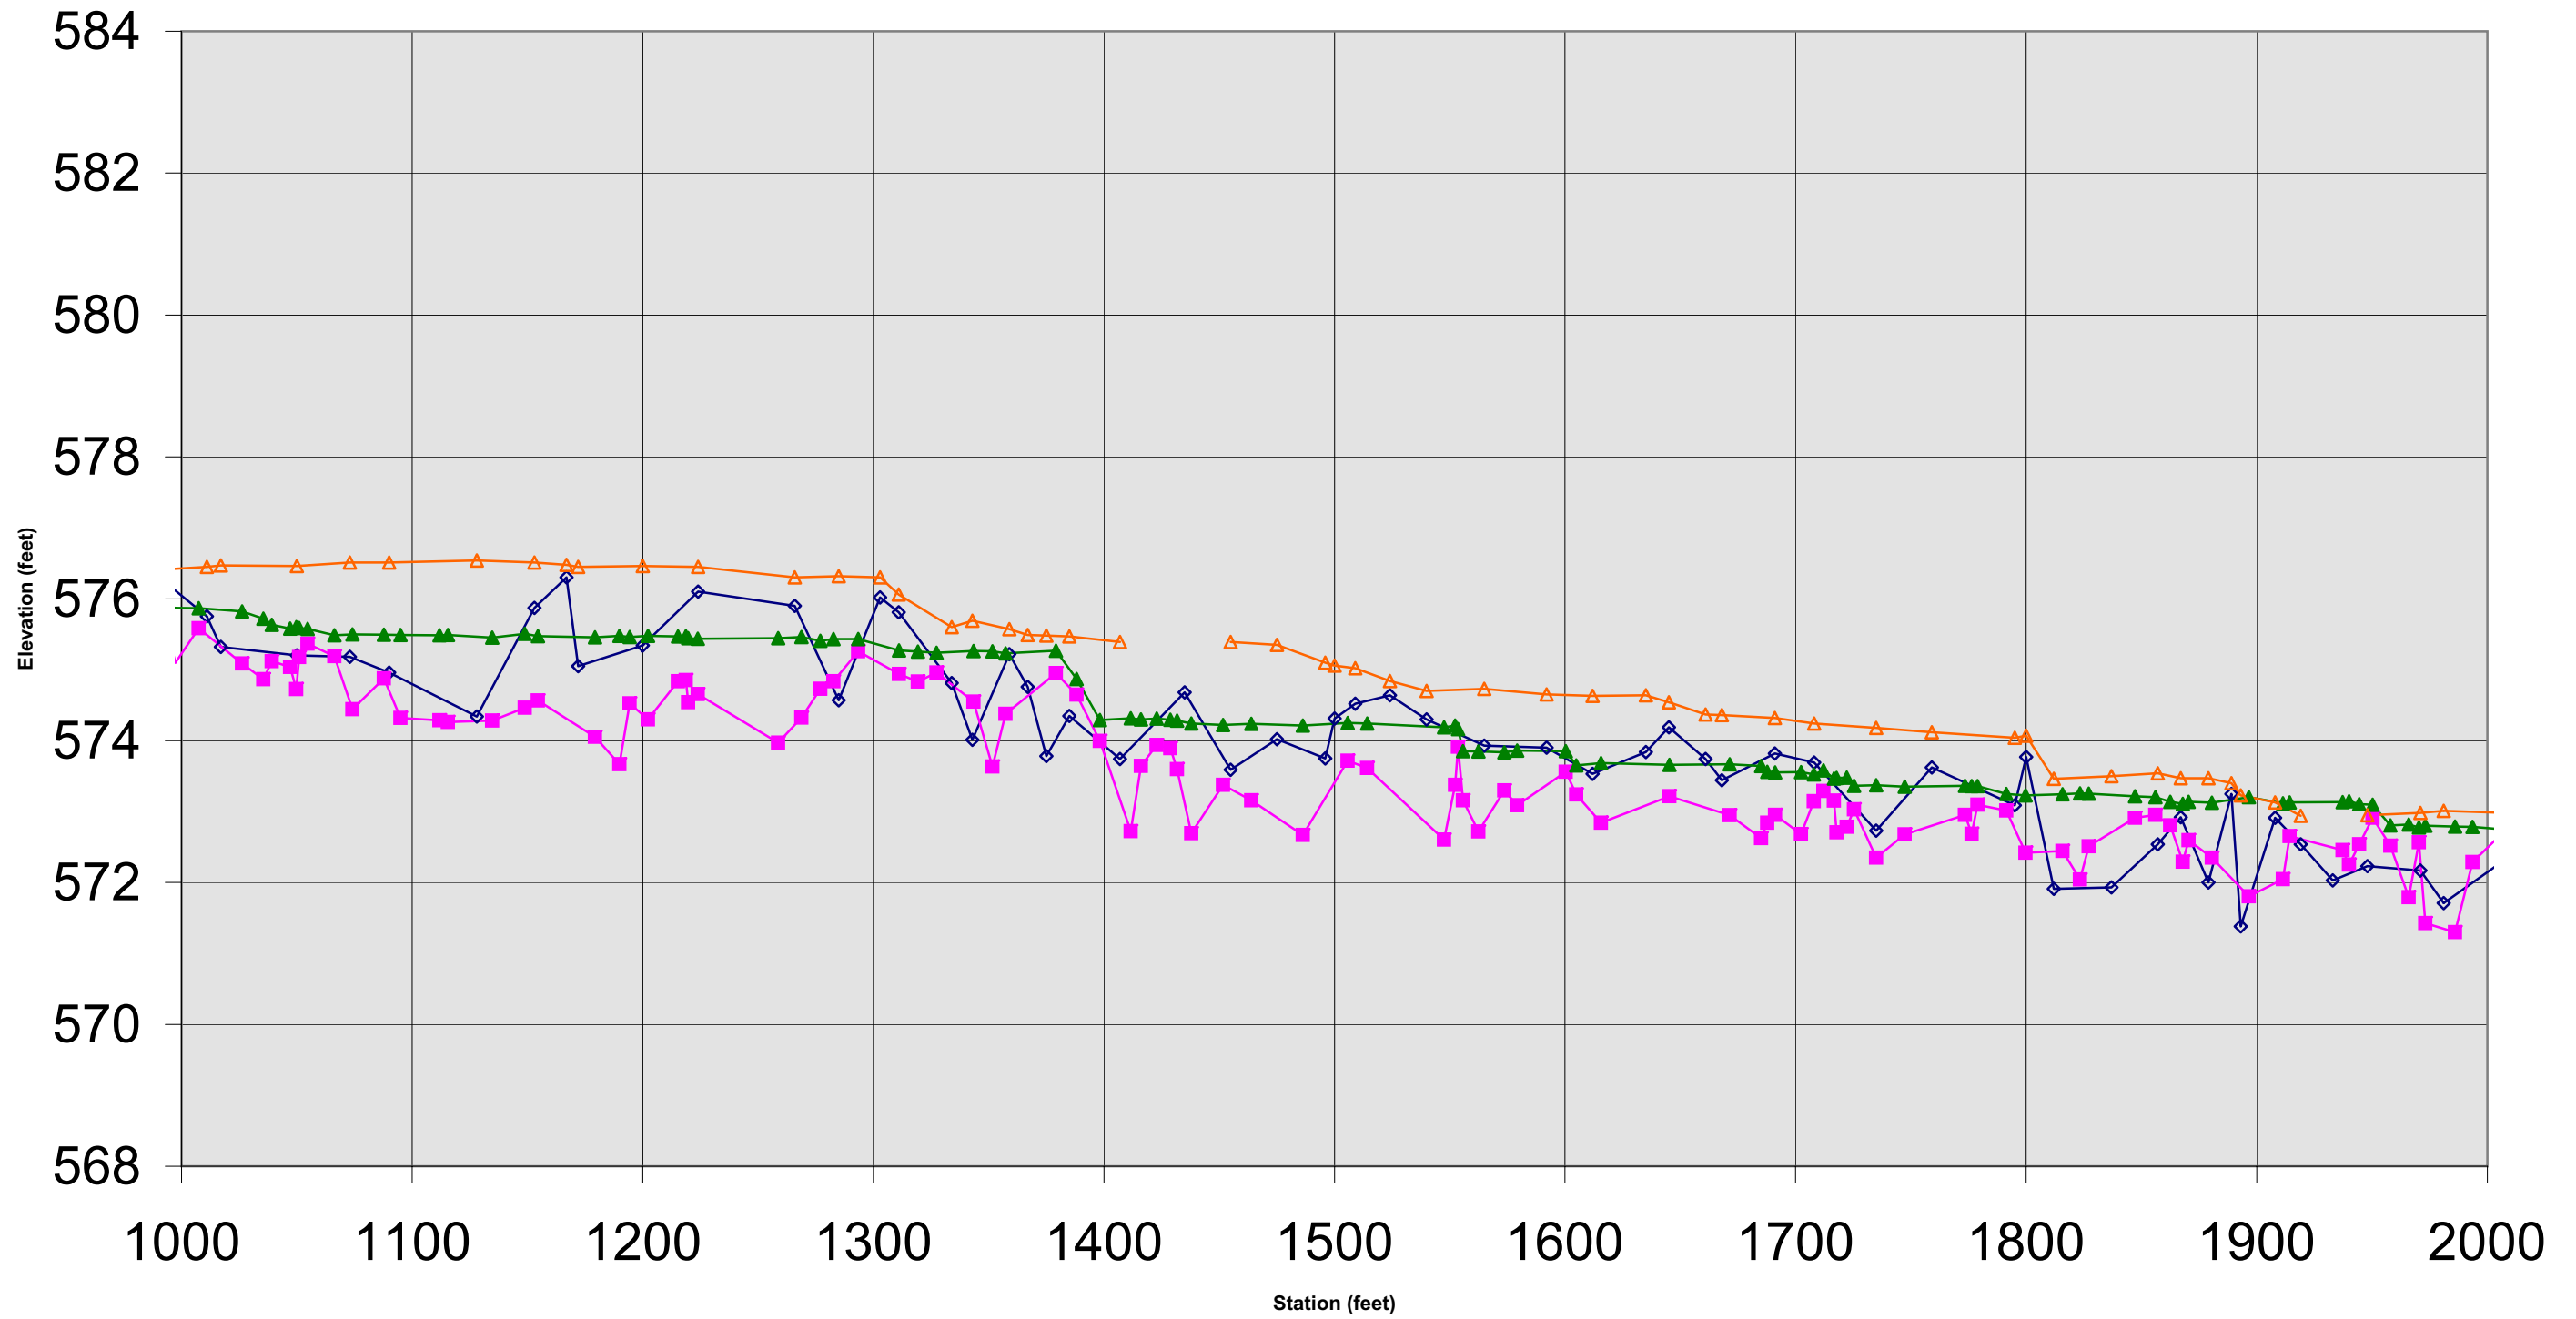
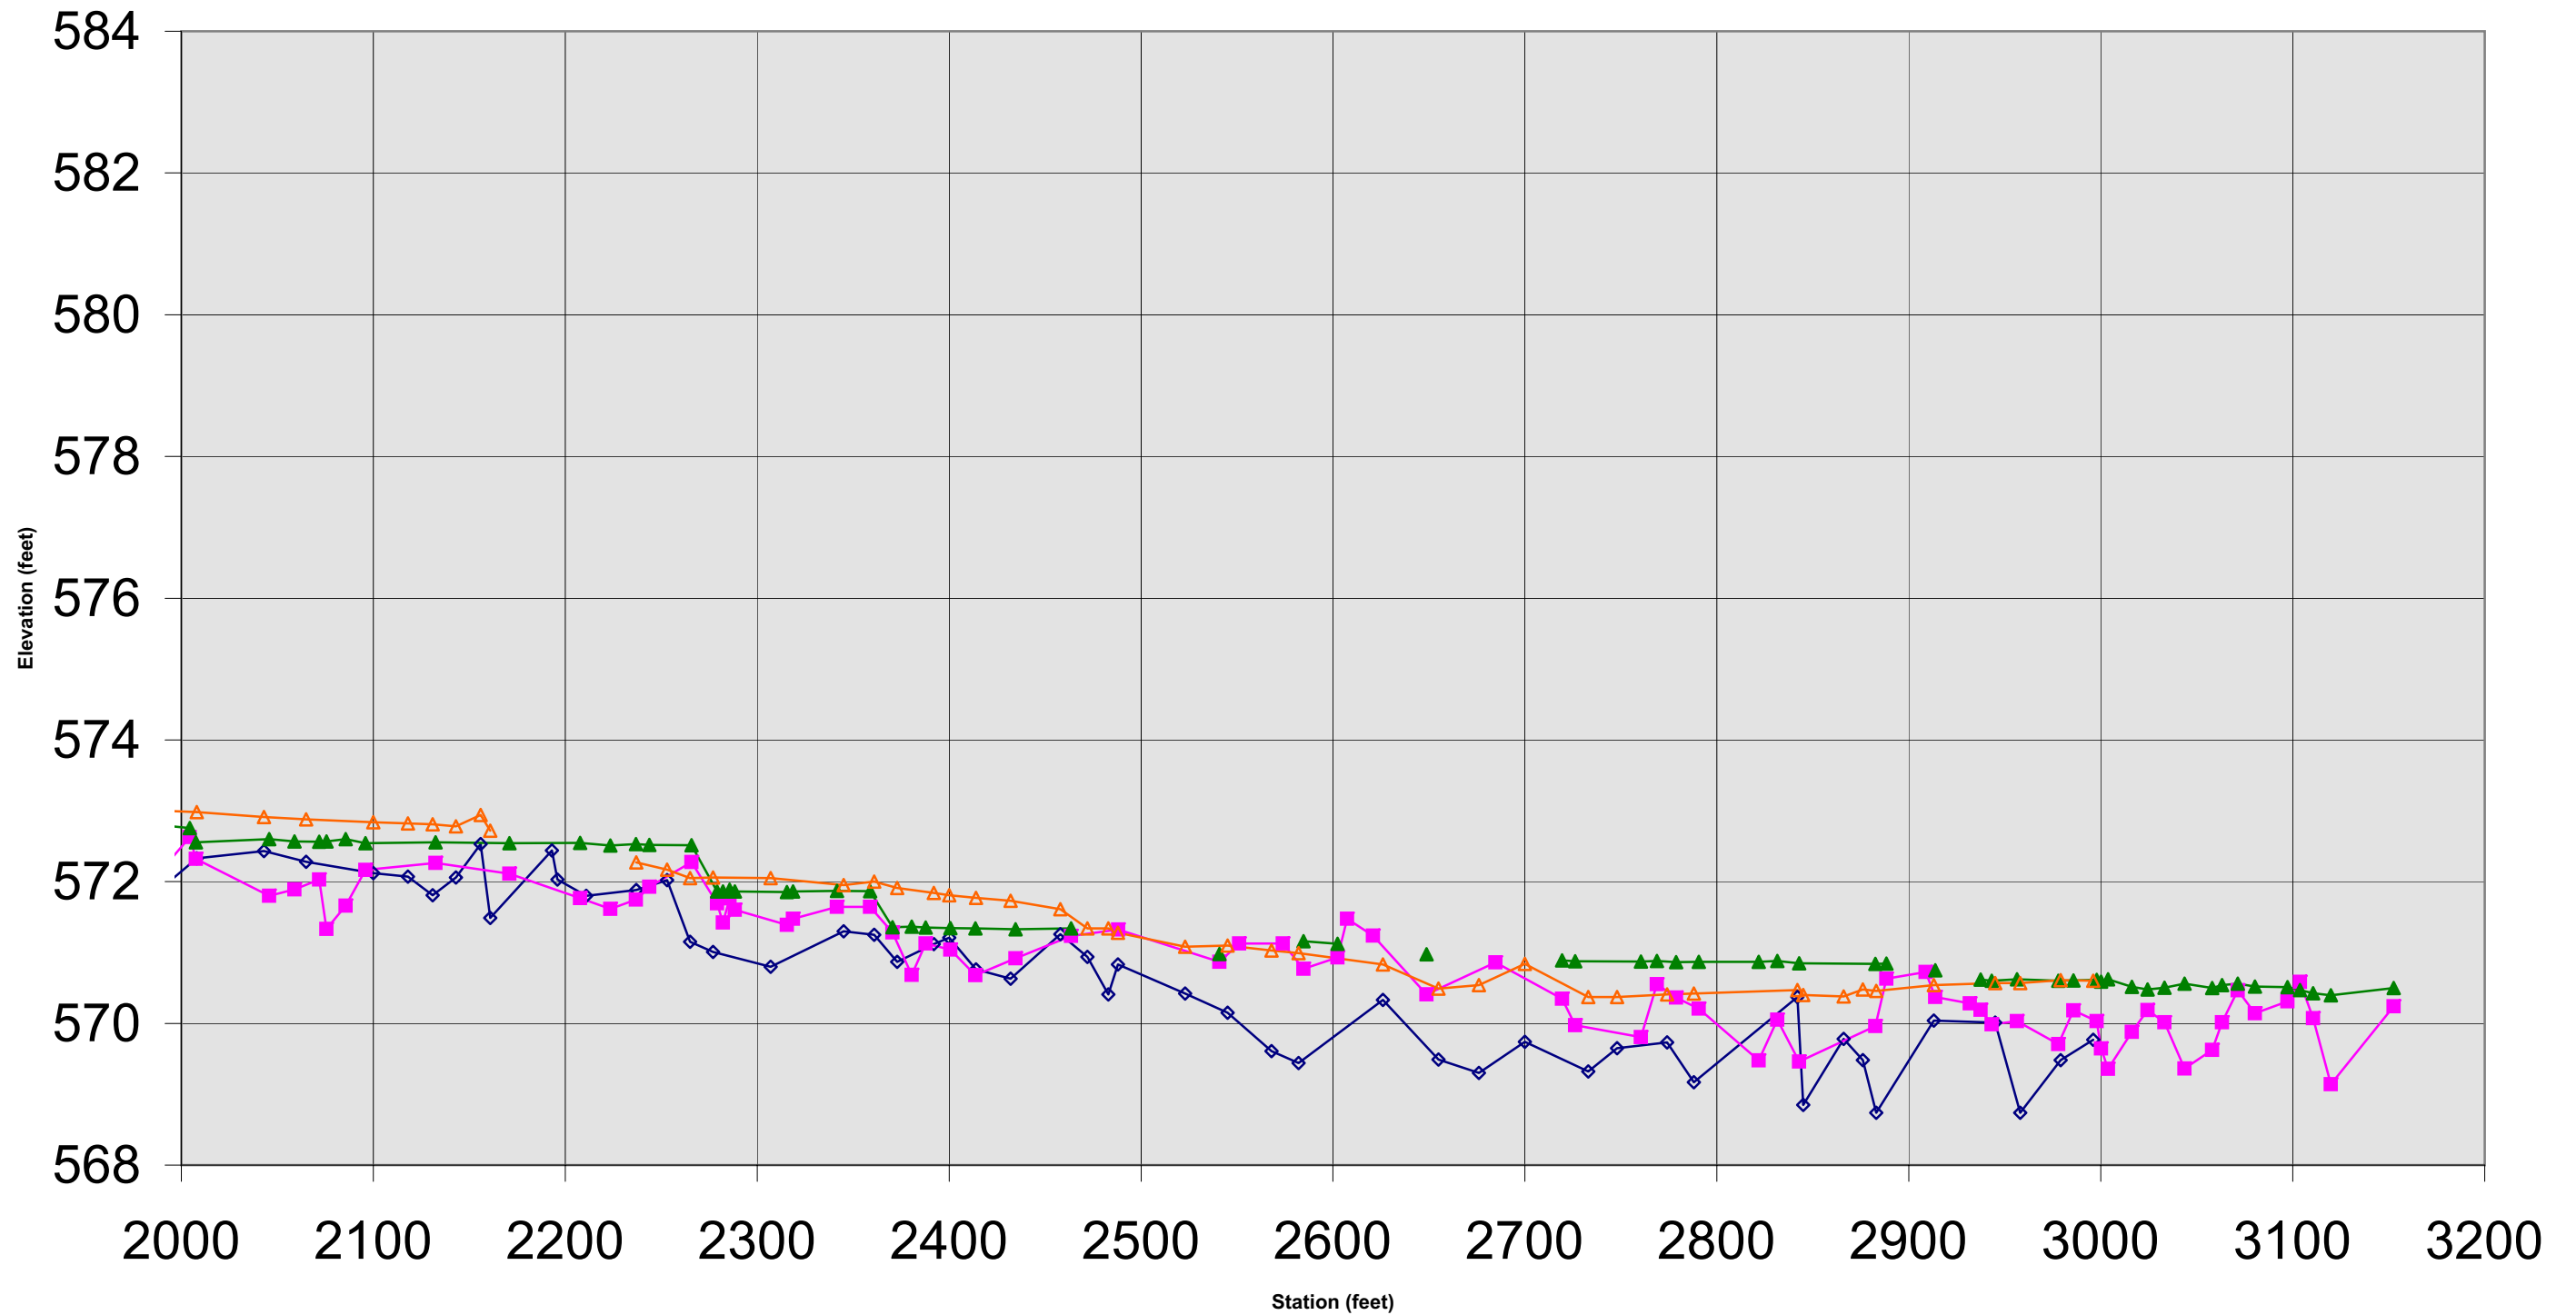
Year 1 & 2 Comparison

There is one significant aspect to note about the longitudinal profile for Year 2. There is a large stream segment distinguished as a run (Station No. 26+05 to 32+66). This accounts for an exceptionally large maximum pool spacing noted in Table XIII of Appendix B3.
