**REEDY BRANCH
FINAL MONITORING REPORT
MONITORING YEAR 4**

EEP Project # 301
Alamance County, North Carolina

**REEDY BRANCH STREAM RESTORATION
MONITORING YEAR 4 REPORT**

CONDUCTED FOR:
NCDENR ECOSYSTEM ENHANCEMENT PROGRAM

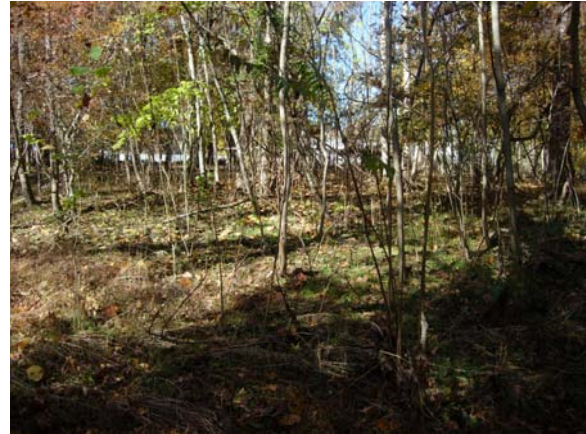
Photo 1. Representative Pickerelweed (*Pontederia cordata*) growing in the center portion of the picture (Station No. 11+88; view upstream; 11-6-2008).

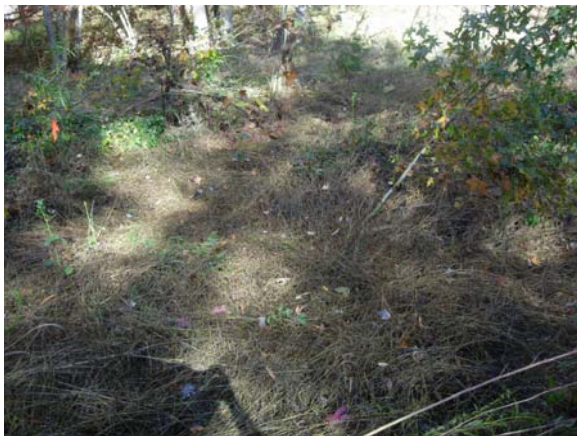
Photo 2. Representative Tree of Heaven (*Ailanthus altissima*) (Station No. 34+67; view upstream/left bank; 11-6-2008).

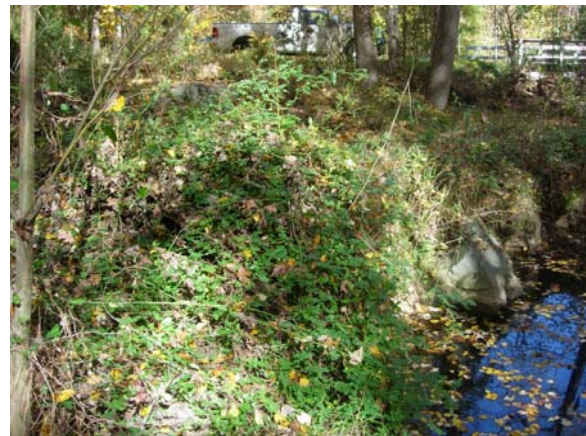
Photo 3. Representative Japanese grass (*Microstegium vimineum*) taking up most of photo (i.e., dormant brown grass) (Approximate Station No. 26+00; view downstream/left bank; 11-6-2008).

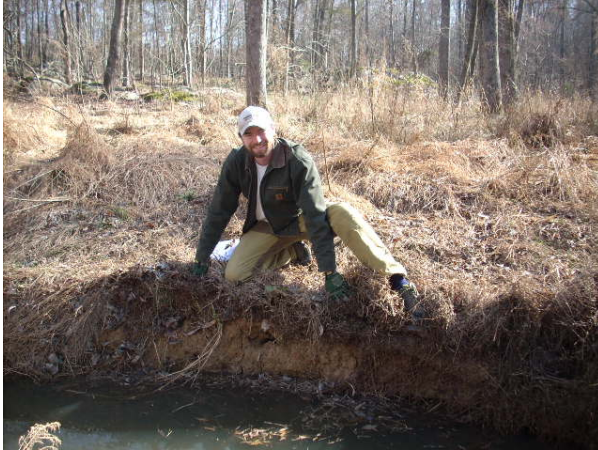
Photo 1: Representative bank erosion problem area (Station No. 24+29; view of right bank; 2-25-2008).

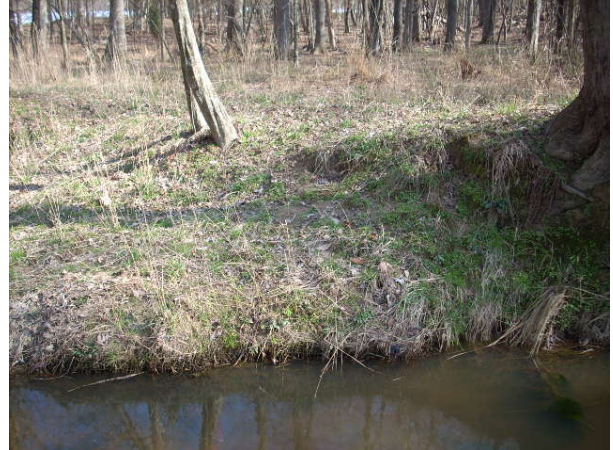
Photo 2: Representative undercut problem area (Station No. 23+41; view of right bank; 2-25-2008).

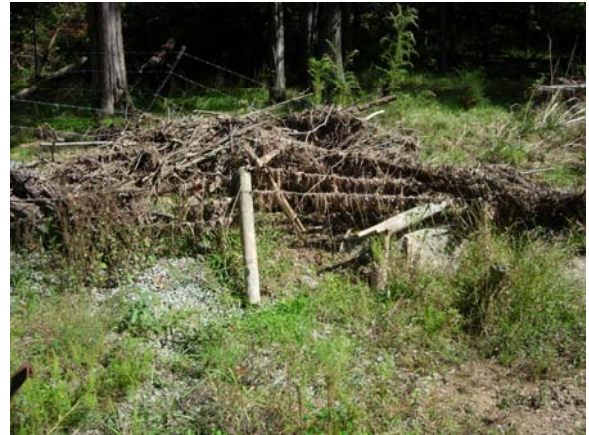
9/15/2008	8/27/2008 - 8/28/2008	6.58" of rain fell over this two day period according to NOAA NCDC Graham 2 ENE, NC substation (ID 313555); Prominent wrack lines observed with large amounts of debris caught in fencing well above bankfull elevation.	Photo 4 in SPA Photolog; note large amount of debris caught in fencing.
9/15/2008	9/6/2008 - 9/7/2008	2.35" of rain fell over this two day period according to NOAA NCDC Graham 2 ENE, NC substation (ID 313555); Prominent wrack lines observed with large amounts of debris caught in fencing well above bankfull elevation.	Photo 4 in SPA Photolog; note large amount of debris caught in fencing.

Photo 4: Representative cattle crossing fence damage problem area (Station No. 15+; view downstream on 10-13-2008). Note major damage to the fencing and debris caught in fencing above bankfull elevation (i.e. evidence of bankfull flow).

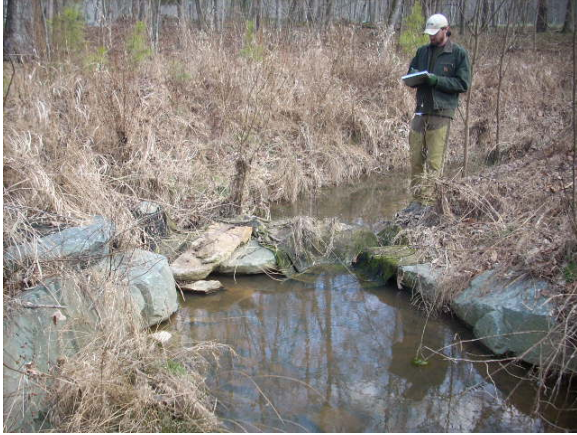
Photo 5: Representative problem crossvane (Station No. 32+86, view upstream on 2-25-2008).

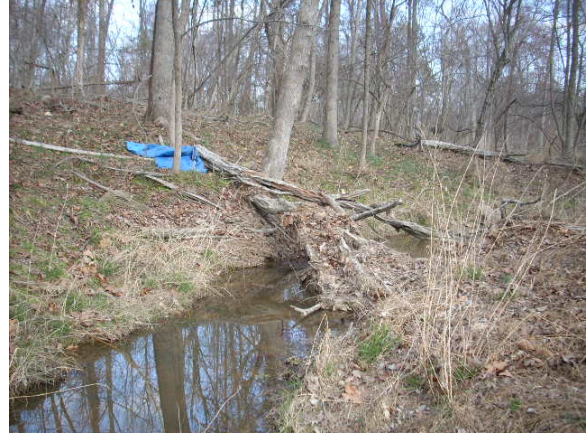
Photo 6: Representative debris jam (35+27, view downstream on 2-25-2008).

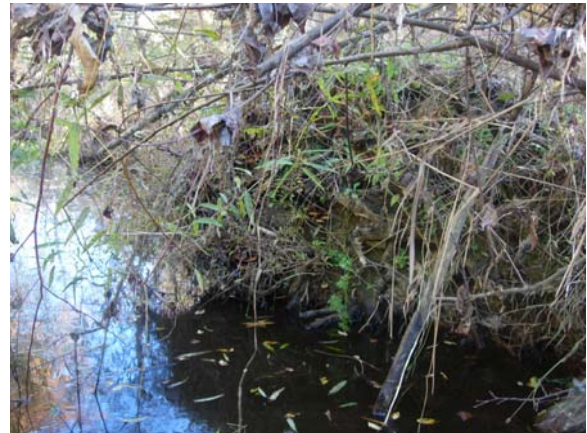
Photo 8: Representative problem rootwad (rootwad placed too high (11+64, view downstream on 11-6-2008).
