**REEDY BRANCH
FINAL MONITORING REPORT
MONITORING YEAR 5 OF 5
2009**

EEP Project # 301
Alamance County, North Carolina

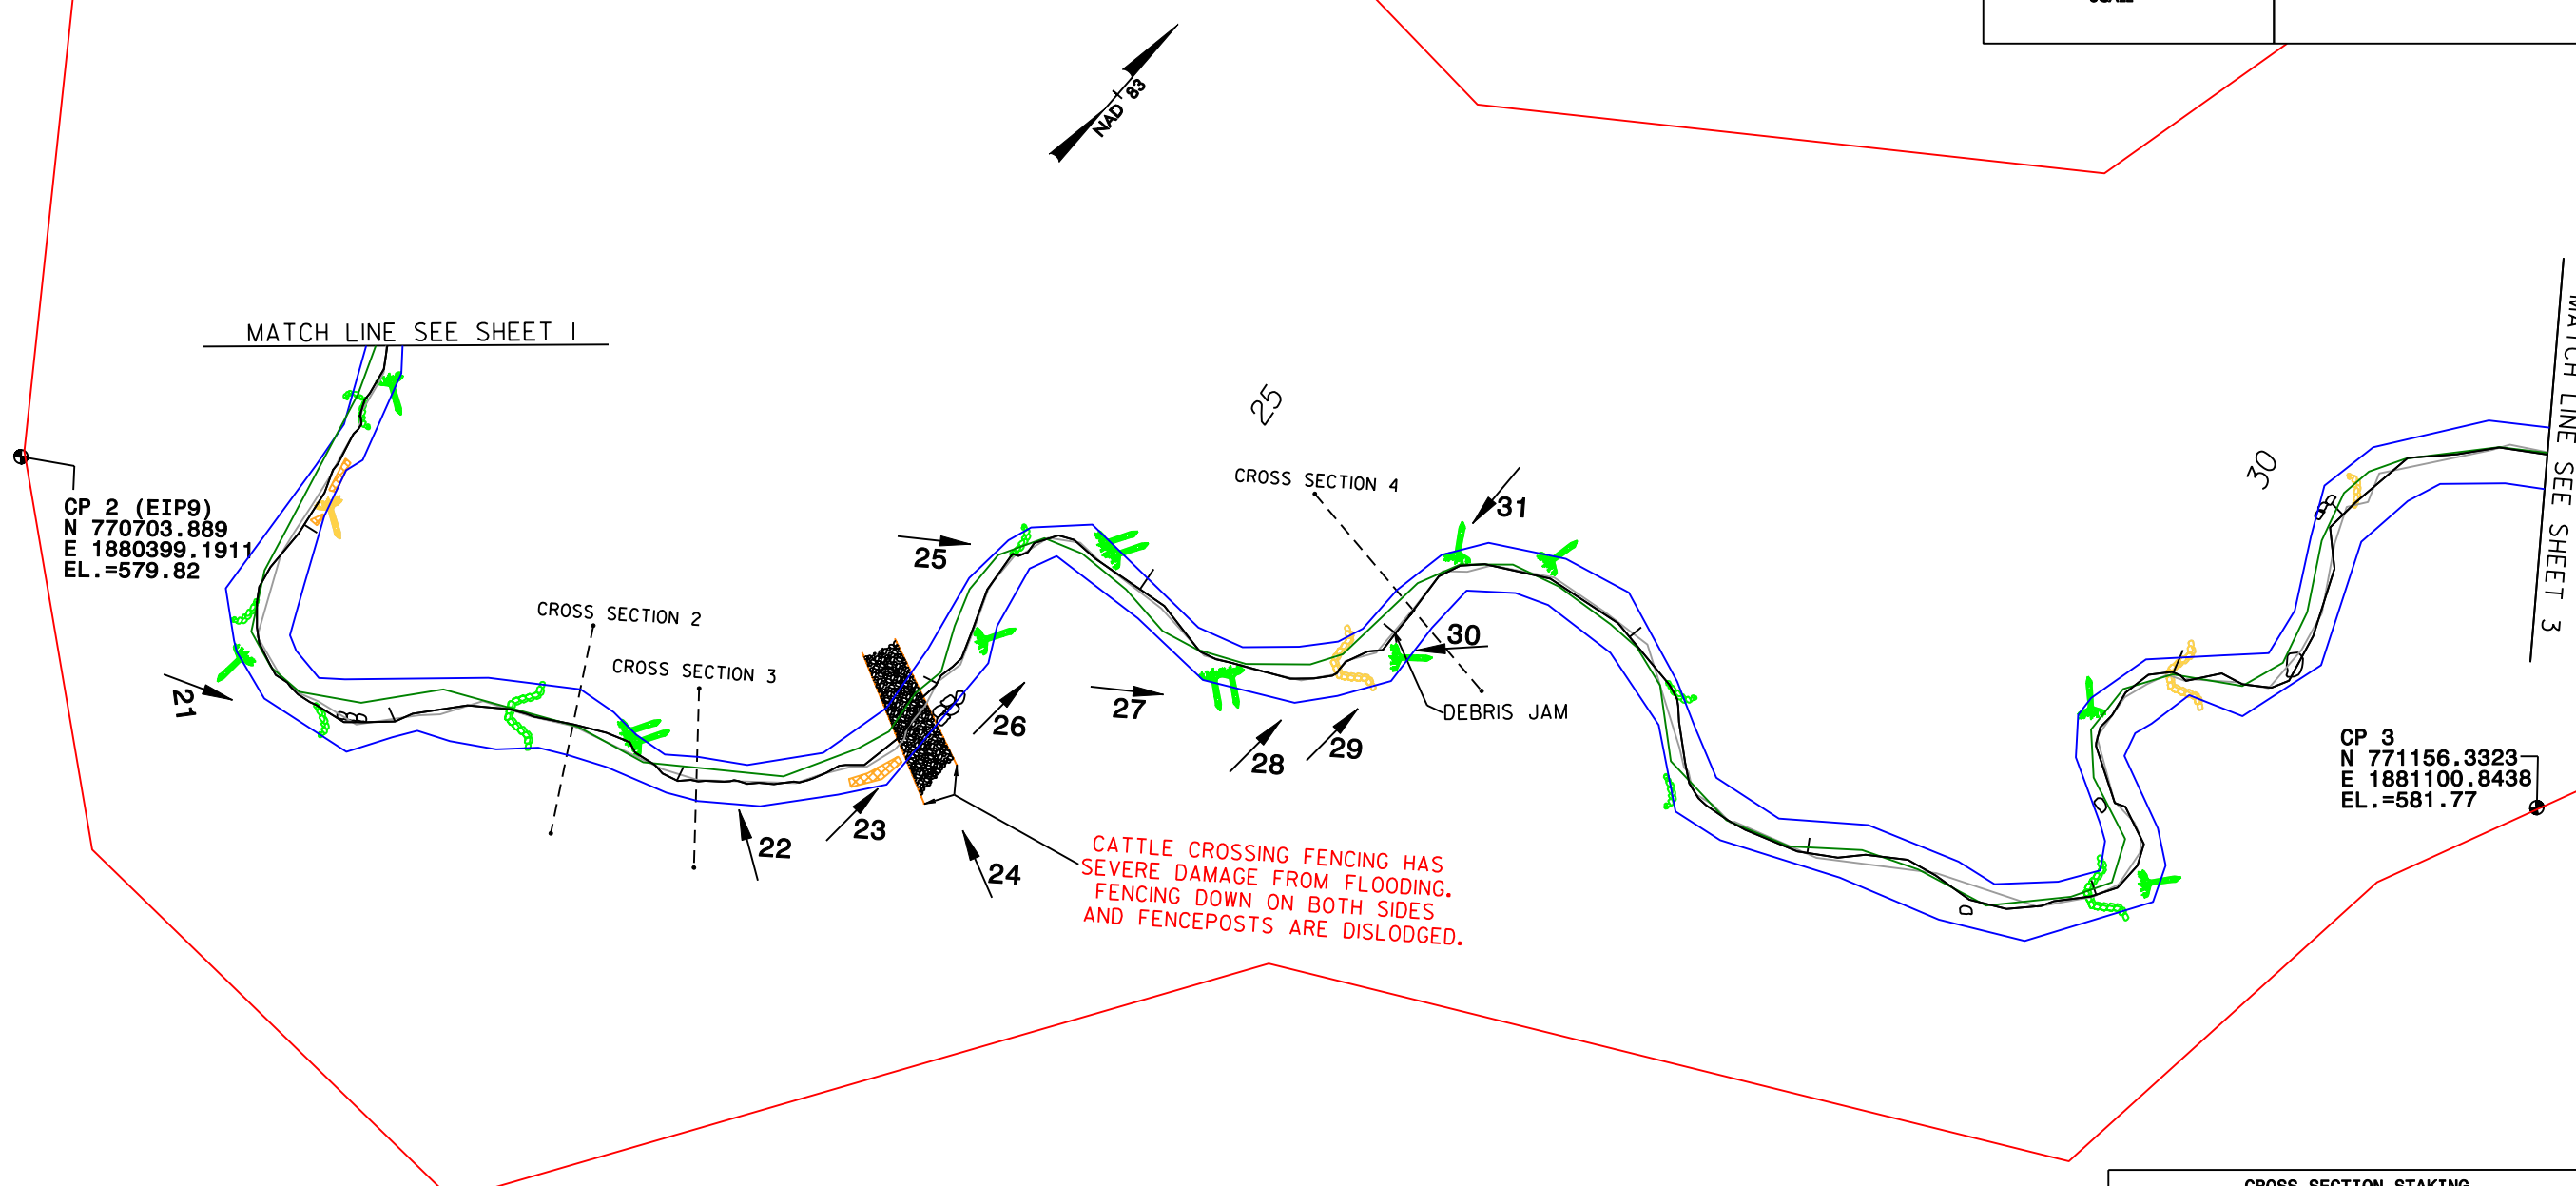
CATTLE CROSSING FENCING HAS SEVERE DAMAGE FROM FLOODING. FENCING DOWN ON BOTH SIDES AND FENCEPOSTS ARE DISLODGED.
