Year 1 Monitoring Report

Rhapsody Mitigation Project

Randolph County, North Carolina
Cape Fear River Basin
Randleman Lake Watershed
HUC 03030003

January 2021

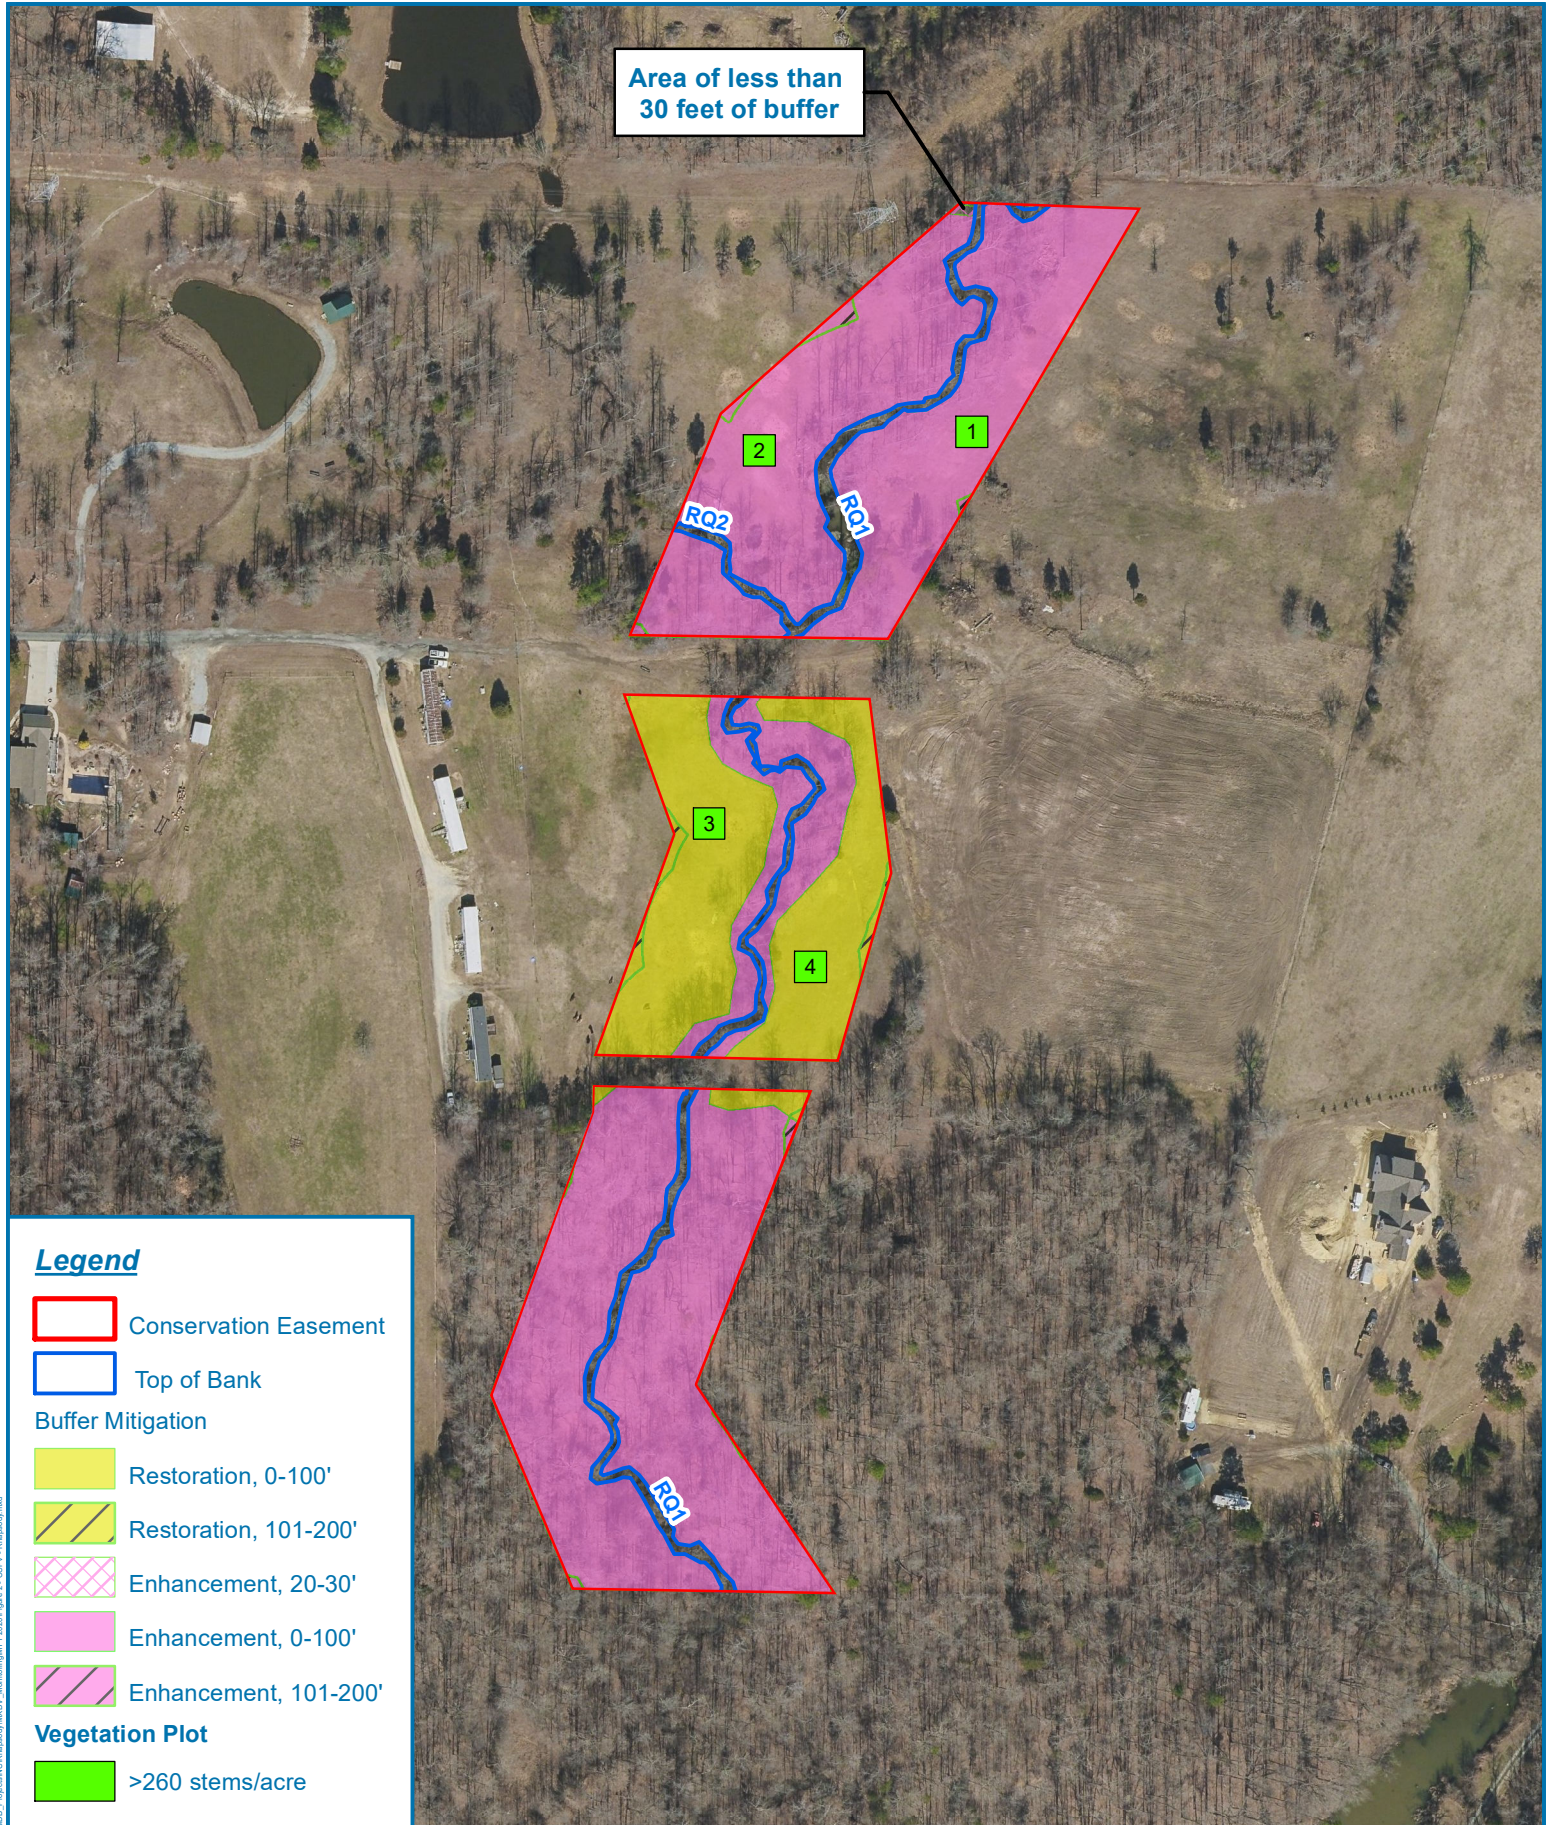
Figure 2 - Current Conditions Plan View
Rhapsody Mitigation Project
 Randolph County, North Carolina

Visual assessment of vegetation outside of the monitoring plots indicates that the herbaceous vegetation is becoming well established throughout the project and no invasive species were observed. The fence has been installed, is in good condition, and is maintaining cattle exclusion. Additionally, there were no signs of encroachment or concentrated flow in the easement area.
