Year 3 Monitoring Report
FINAL

Rhapsody Mitigation Project

DMS Project #: 100110 | Contract #: 7864 | DWR # 2019-1405 | RFP: 16-007703

Randolph County, North Carolina
Cape Fear River Basin
Randleman Lake Watershed
HUC 03030003

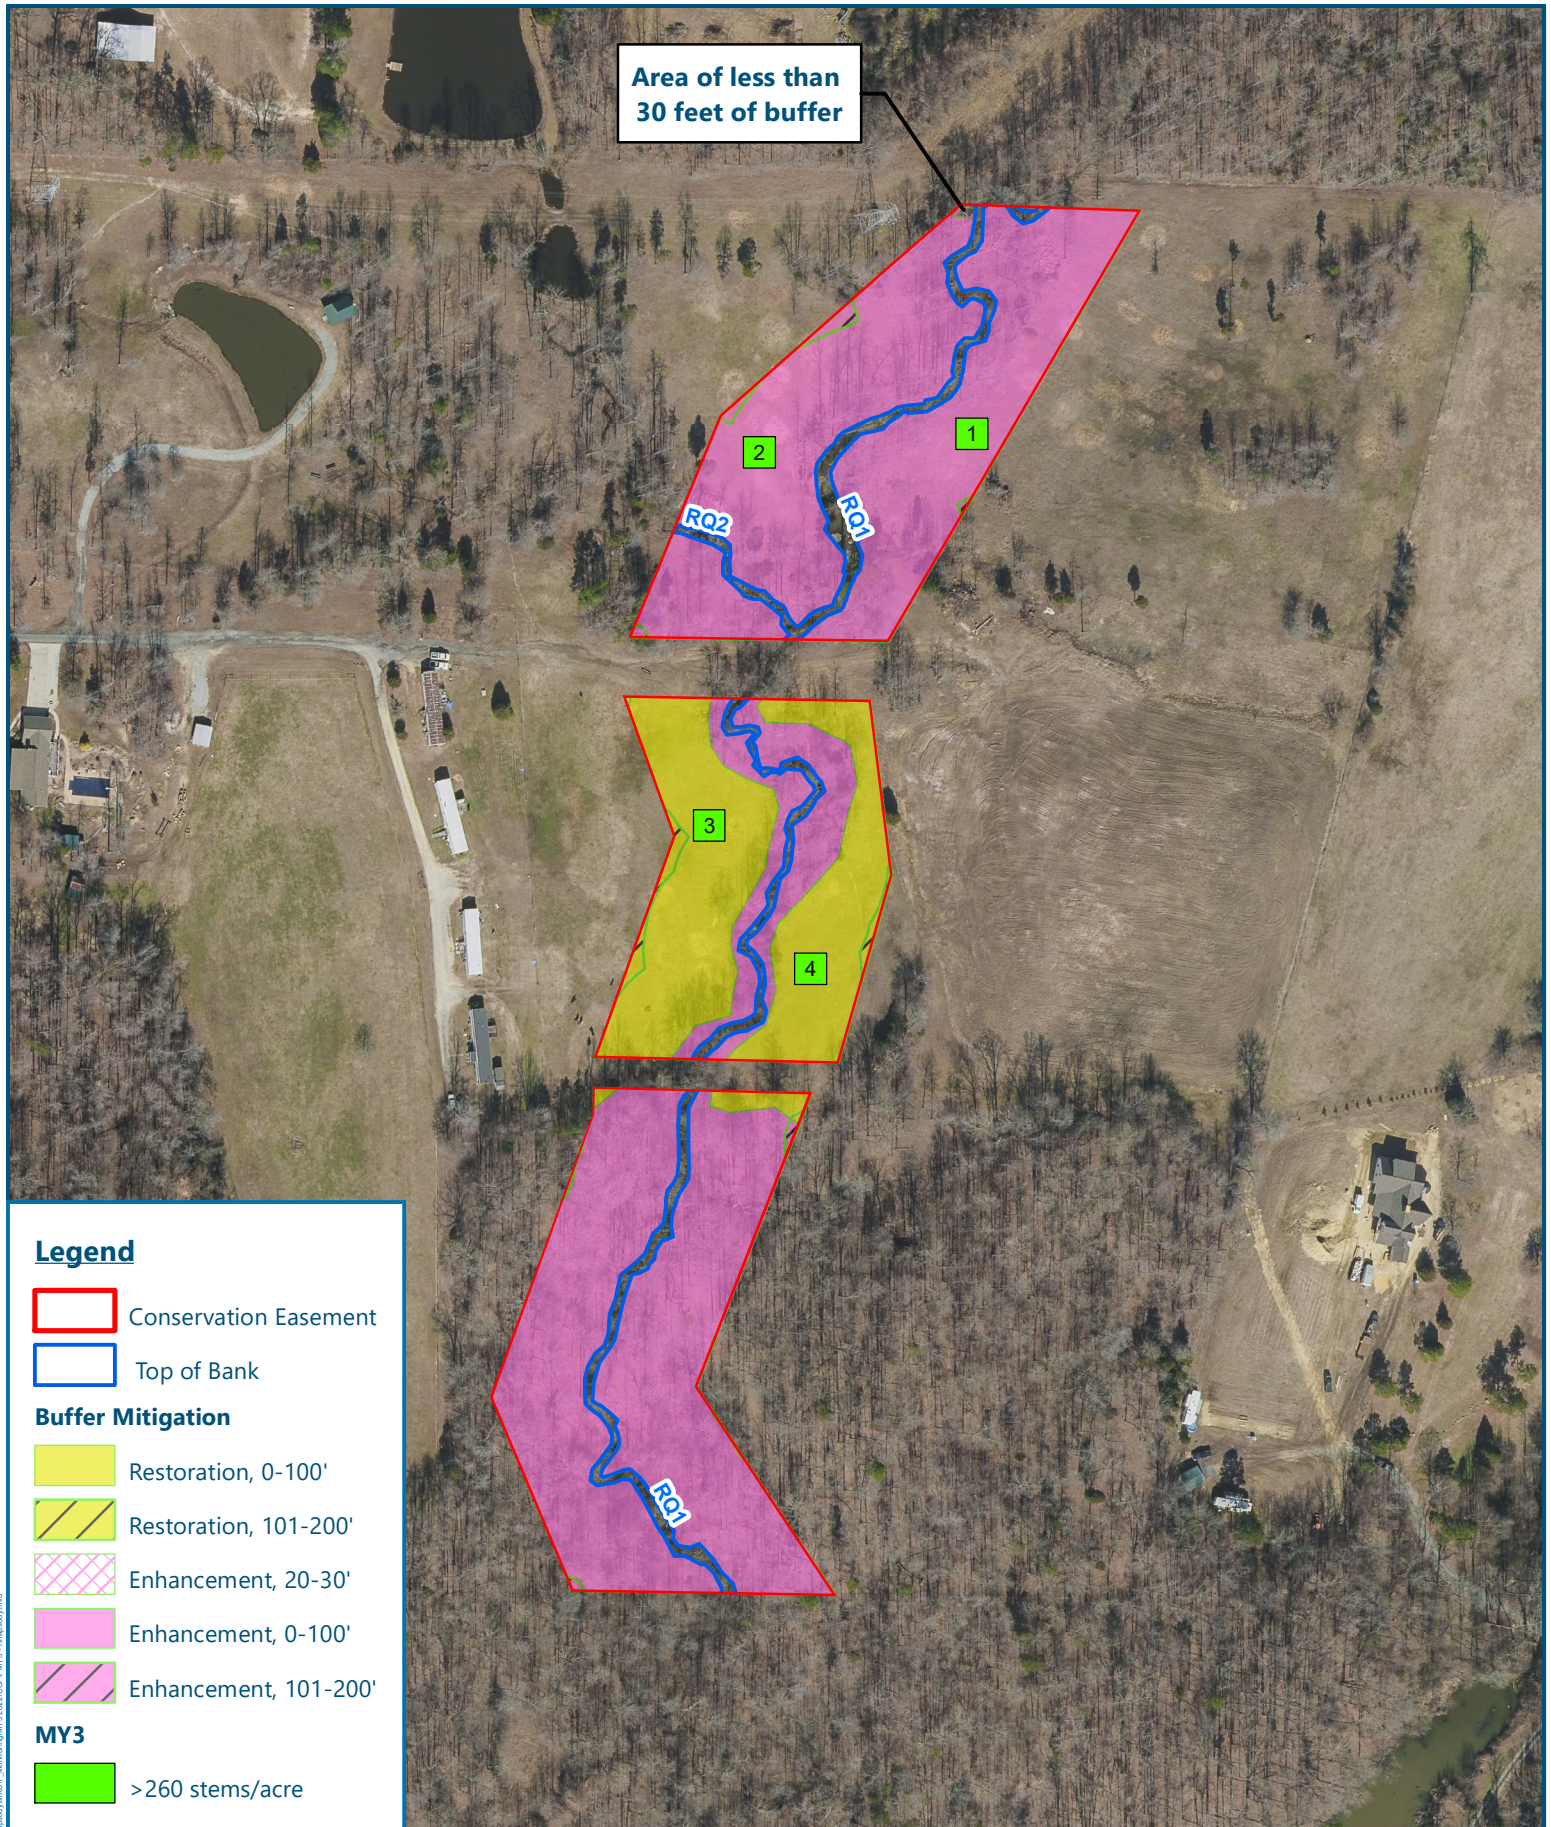
Figure 2 - Current Conditions Plan View

Visual assessment of vegetation outside of the monitoring plots indicates that the herbaceous vegetation is becoming well established throughout the project. A small amount of Tree of Heaven (*Ailanthus altissima*) was noticed in the easement and will be treated later this year. The fence is in good condition besides a tree falling on a small section of fence on the northern crossing of the site. The fence will be repaired later this year. The fence is still maintaining cattle exclusion and there were no signs of encroachment. Additionally, there were no signs of concentrated flow in the easement area.
