Year 4 Monitoring Report

Rhapsody Mitigation Project

DMS Project #: 100110 | Contract #: 7864
DWR # 2019-1405 | RFP: 16-007703

Randolph County, North Carolina
Cape Fear River Basin
Randleman Lake Watershed
HUC 03030003

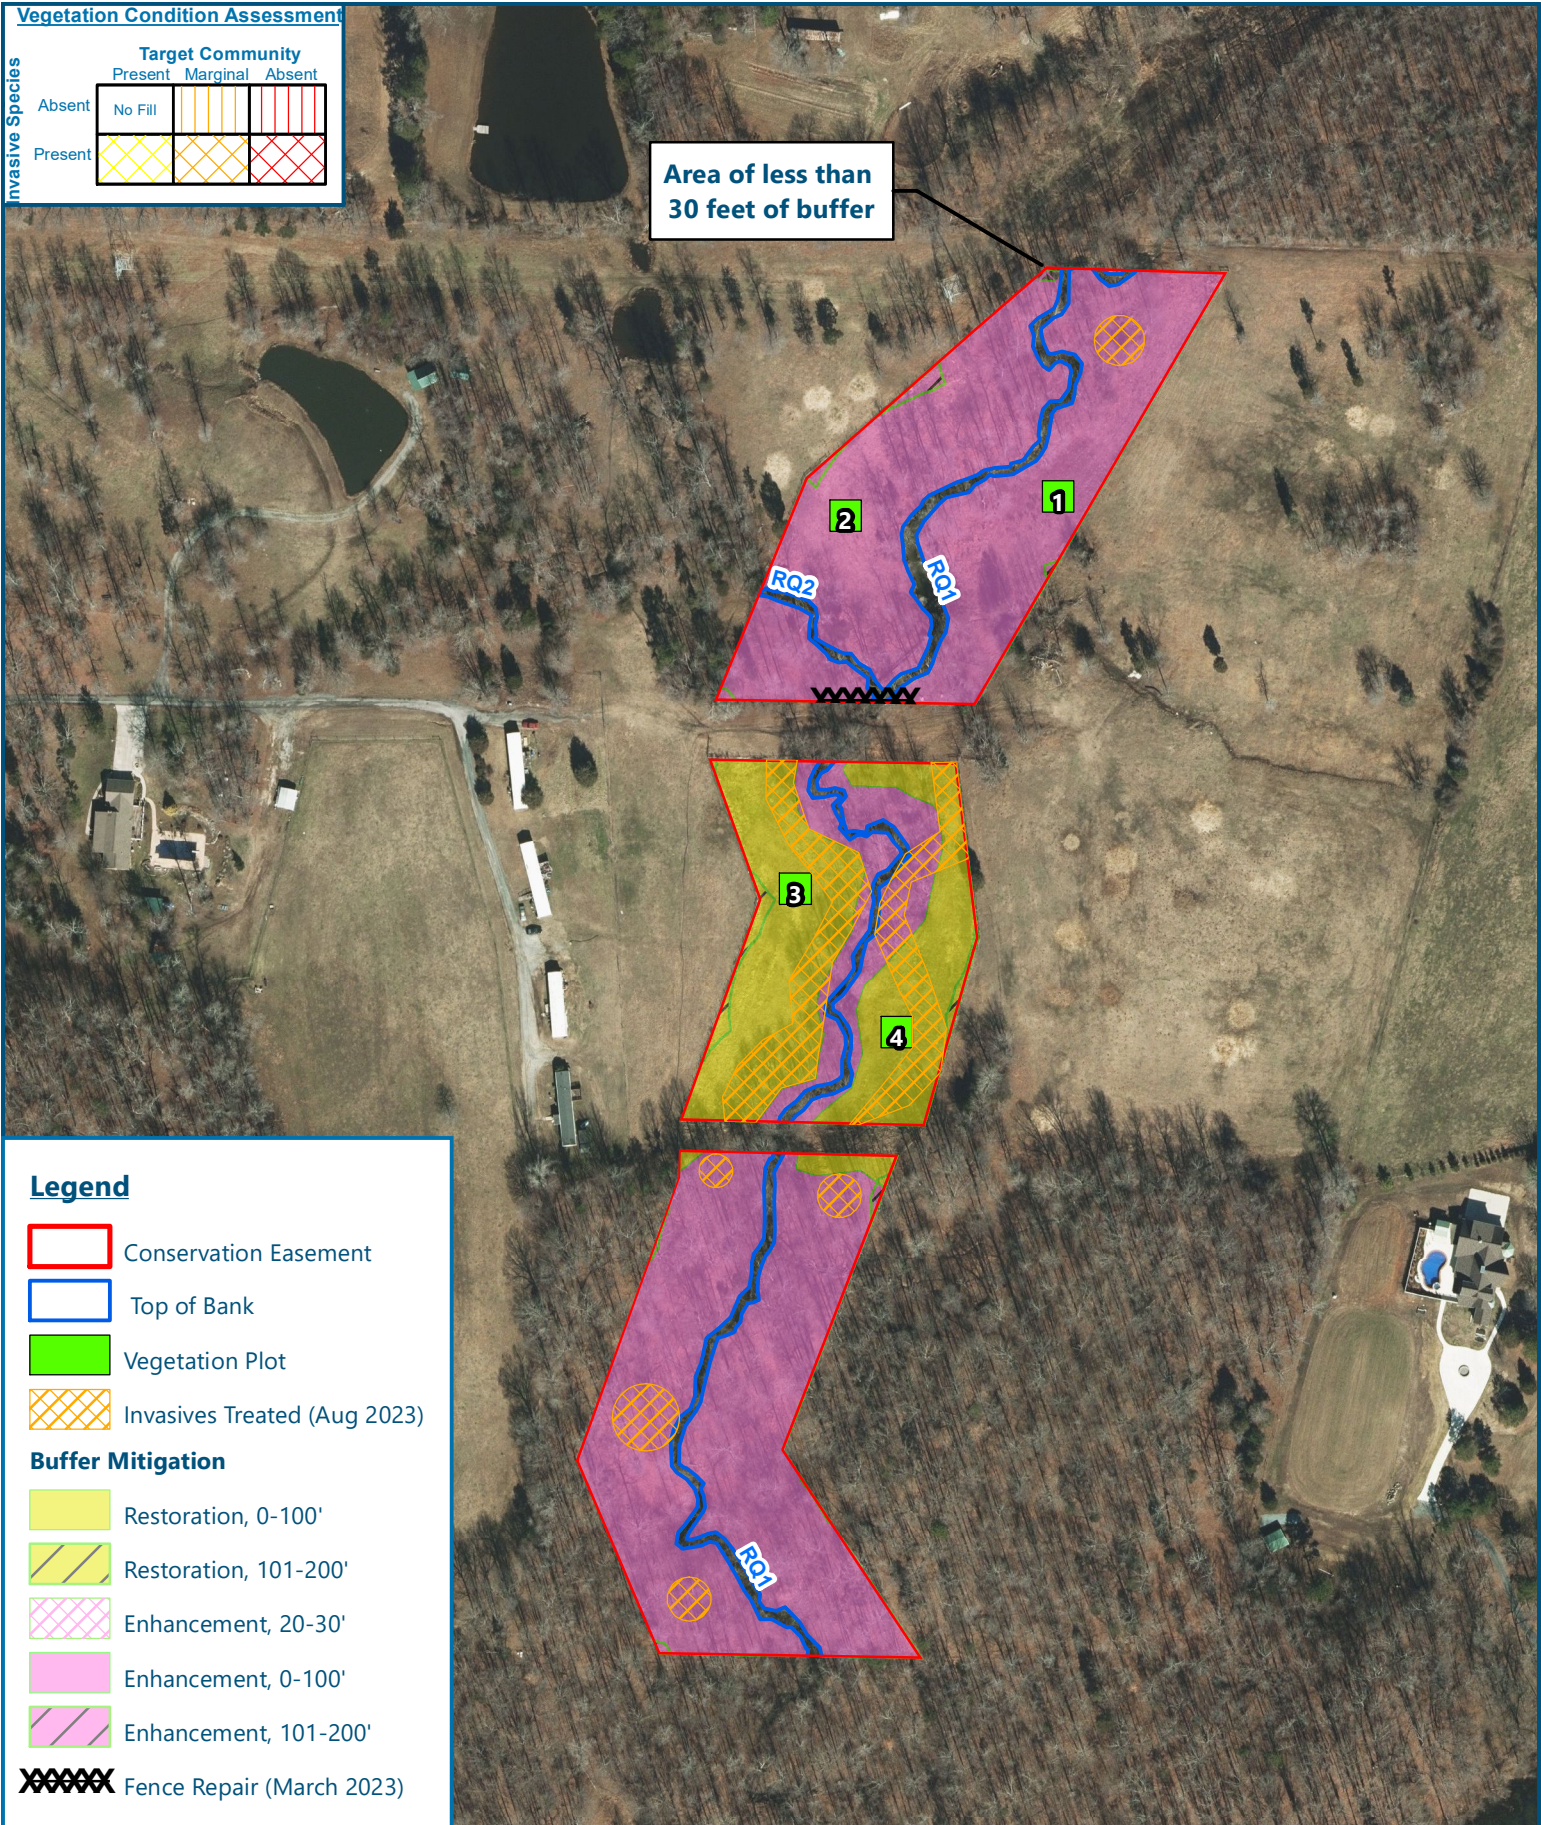
Figure 2 - Current Conditions Plan View

altissima), Chinese privet (*Ligustrum sinense*), and multiflora rose (*Rosa multiflora*) was treated within the easement on August 19, 2023. Invasives will continue to be monitored and will be treated again if necessary. A small section of the fence was repaired on March 9, 2023, from a fallen tree and now is in good condition. The fence is still maintaining cattle exclusion and there were no signs of encroachment. Additionally, there were no signs of concentrated flow in the easement area.

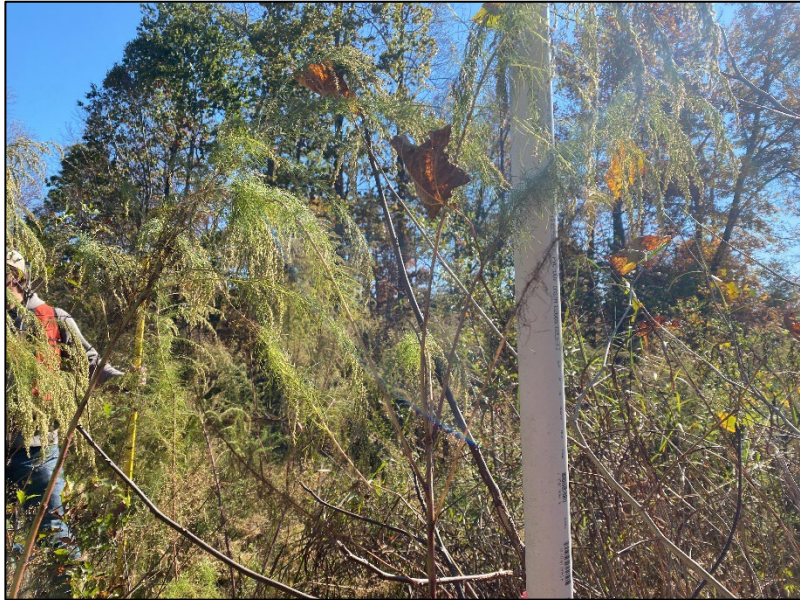
Vegetation Plot 1 (11/01/2023)

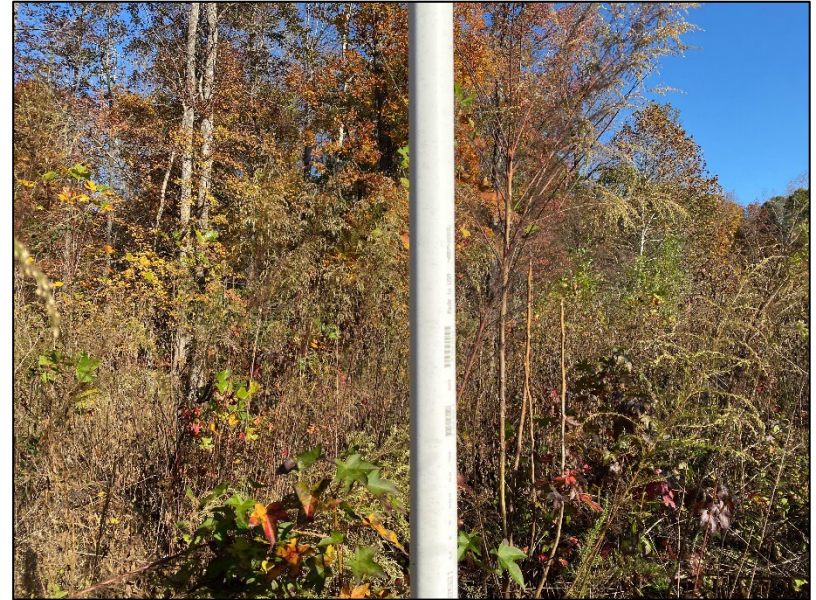
Vegetation Plot 2 (11/01/2023)

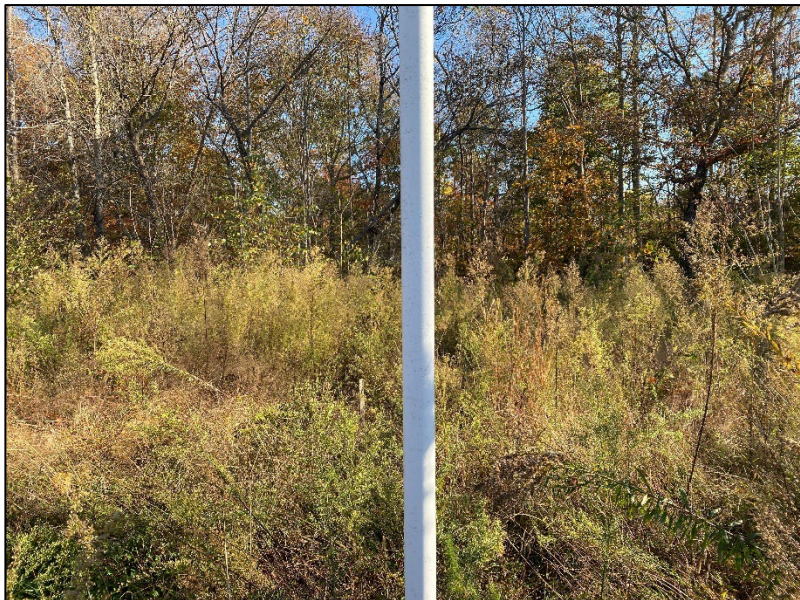
Vegetation Plot 3 (11/01/2023)

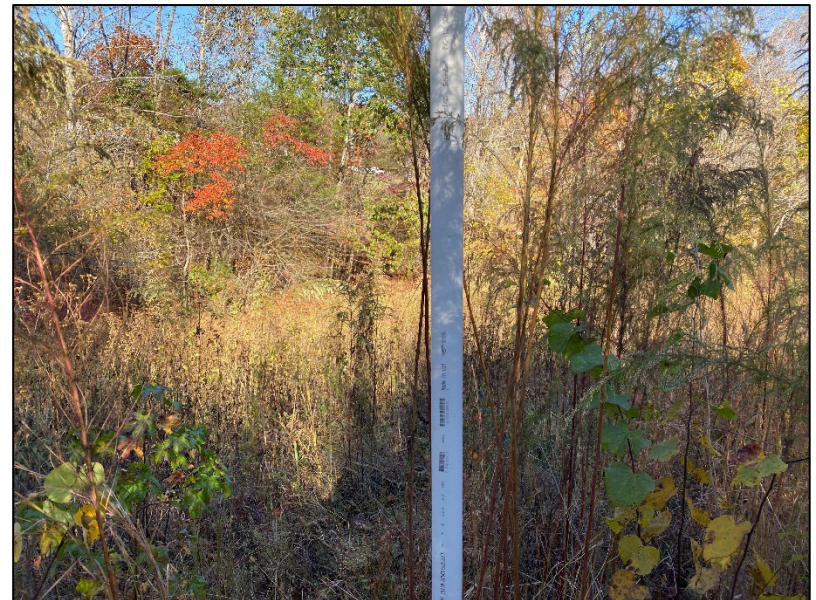
Vegetation Plot 4 (11/01/2023)

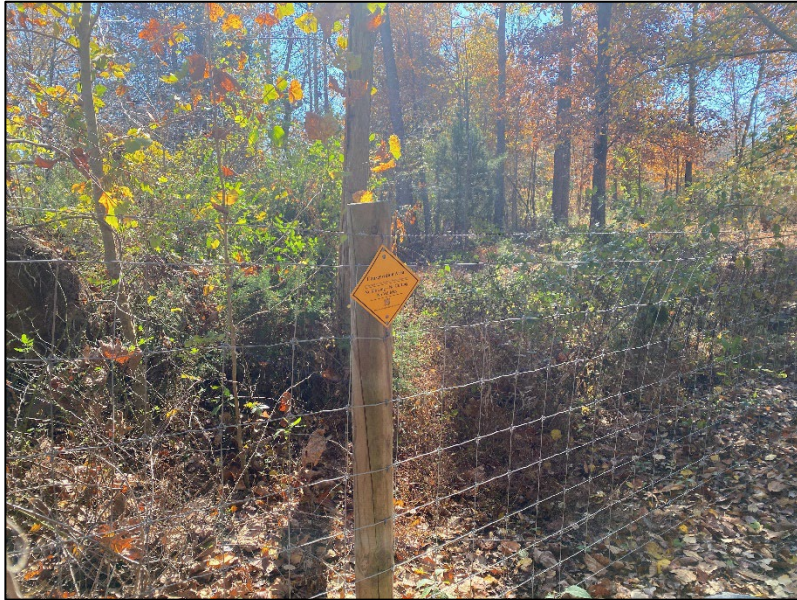
Easement signage (11/01/2023)

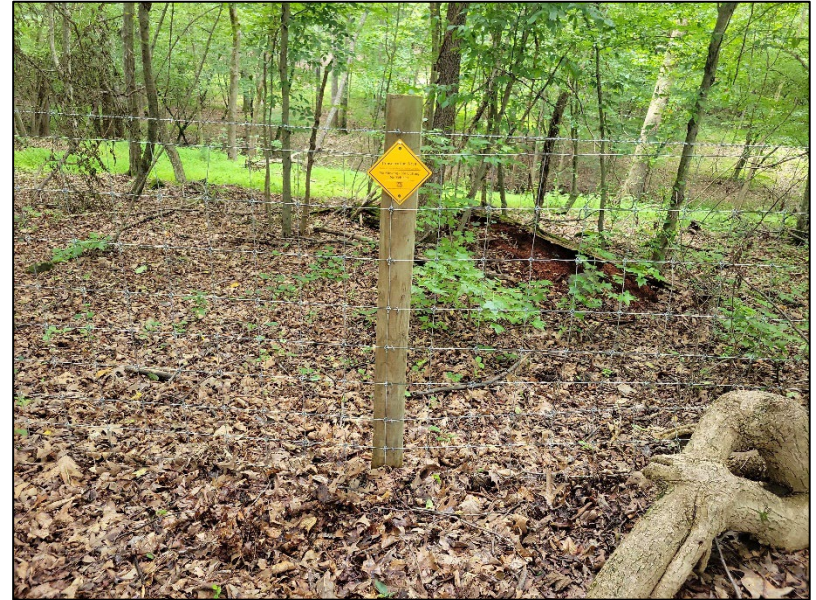
Easement Signage (7/10/2023)

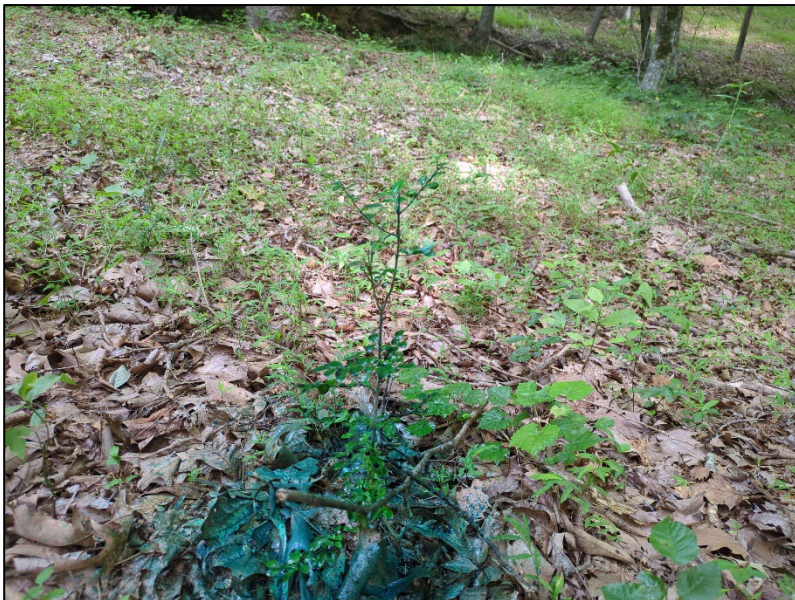
Foliar treatment of Chinese privet (07/19/2023)
