**Richland Creek Stream
Restoration Monitoring Report
EEP Project # 304
Monitoring Year – 01
2005**

EXECUTIVE SUMMARY

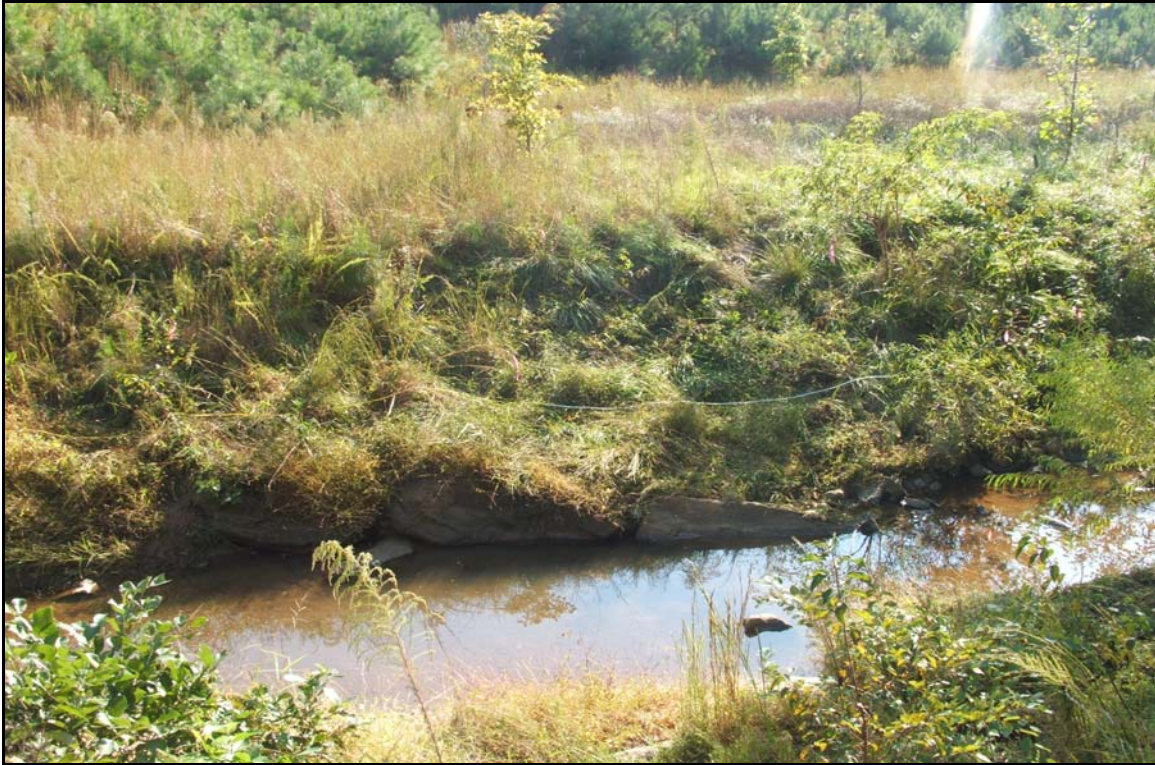
Plot 1 Photo – Taken from photo station 3 looking to center of vegetation plot across stream.
Note rock cross vane in foreground. 10/19/05 - MY 01.

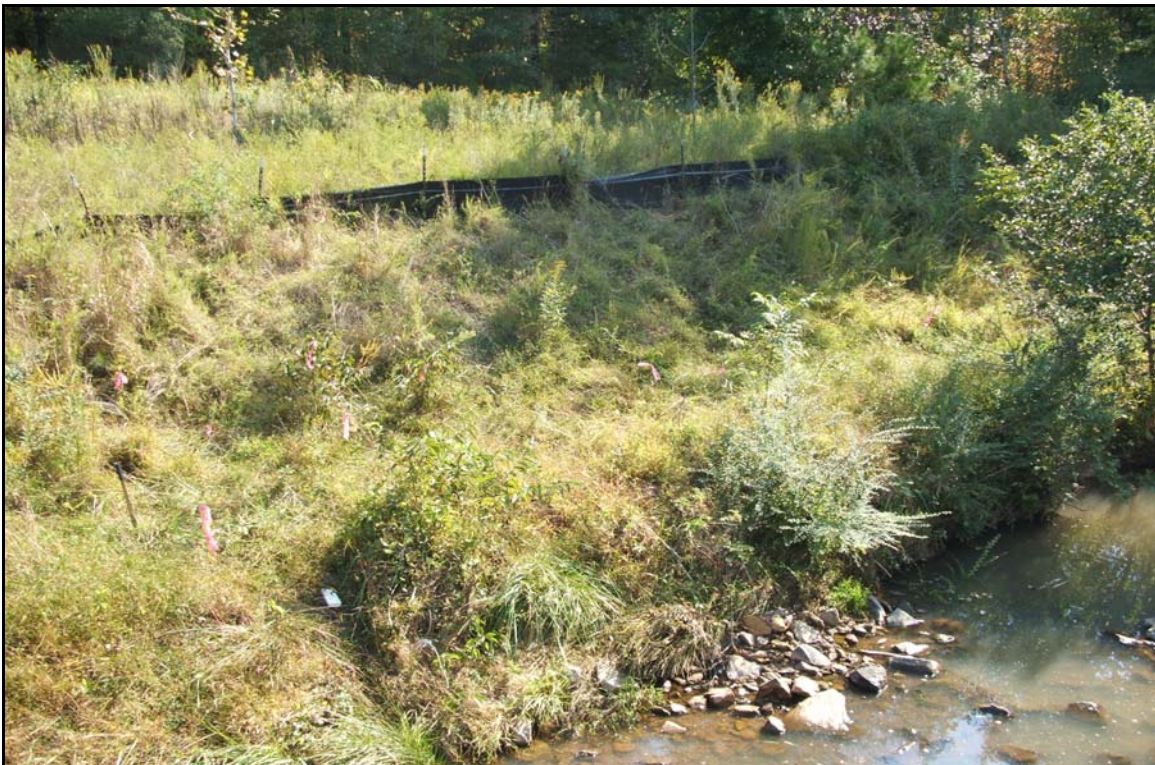
Plot 2 Photo – Taken from photo station 14 looking to center of vegetation plot across stream.
10/19/05 - MY 01.

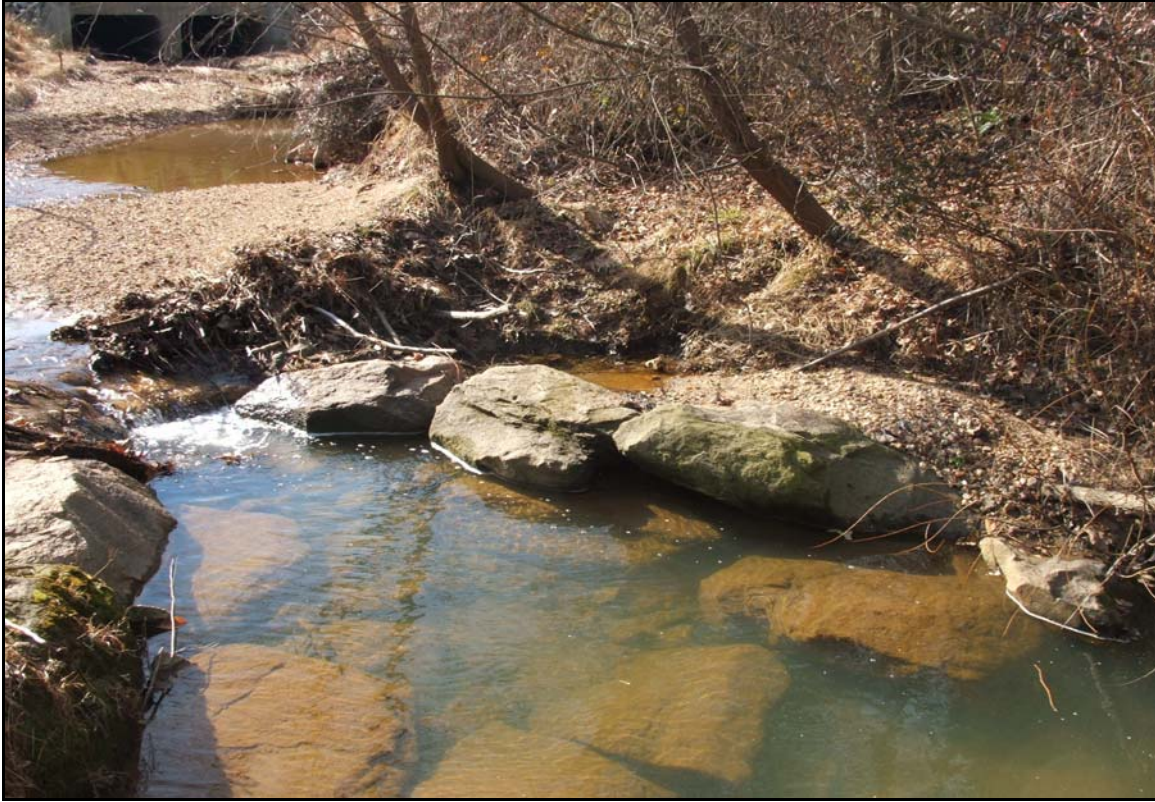
A visual inspection of the stream reaches found them to be functioning well. The cross vanes appeared to be working as designed, although the cross vane in reach 2 had some bank scour around the vane. The conditions of the stream can be evaluated by comparing the yearly monitoring photos from the established photo stations and the tables within the report. These photo stations were not surveyed, but their approximate locations are depicted in the monitoring plan view.

Table 9b. Stream Problem Areas Project Number and Name: 304 – Richland Creek Segment/Reach: Reach 2			
Feature Issue	Station numbers	Suspected Cause	Photo #
Cross Vane – back or arm scour	20+85	unknown	SP1

Table 10b. Categorical Stream Feature Visual Stability Assessment						
Project Number and Name: 304 – Richland Creek						
Segment/Reach: Reach 2						
Feature	Initial	MY - 01	MY - 02	MY - 03	MY - 04	MY - 05
A. Riffles	100%	100%				
B. Pools	100%	100%				
C. Thalweg	100%	100%				
D. Meanders	100%	100%				
E. Bed General	100%	100%				
F. Vanes	100%	75%

SP 1 (Reach 2) – Back arm scour on left arm of cross vane.

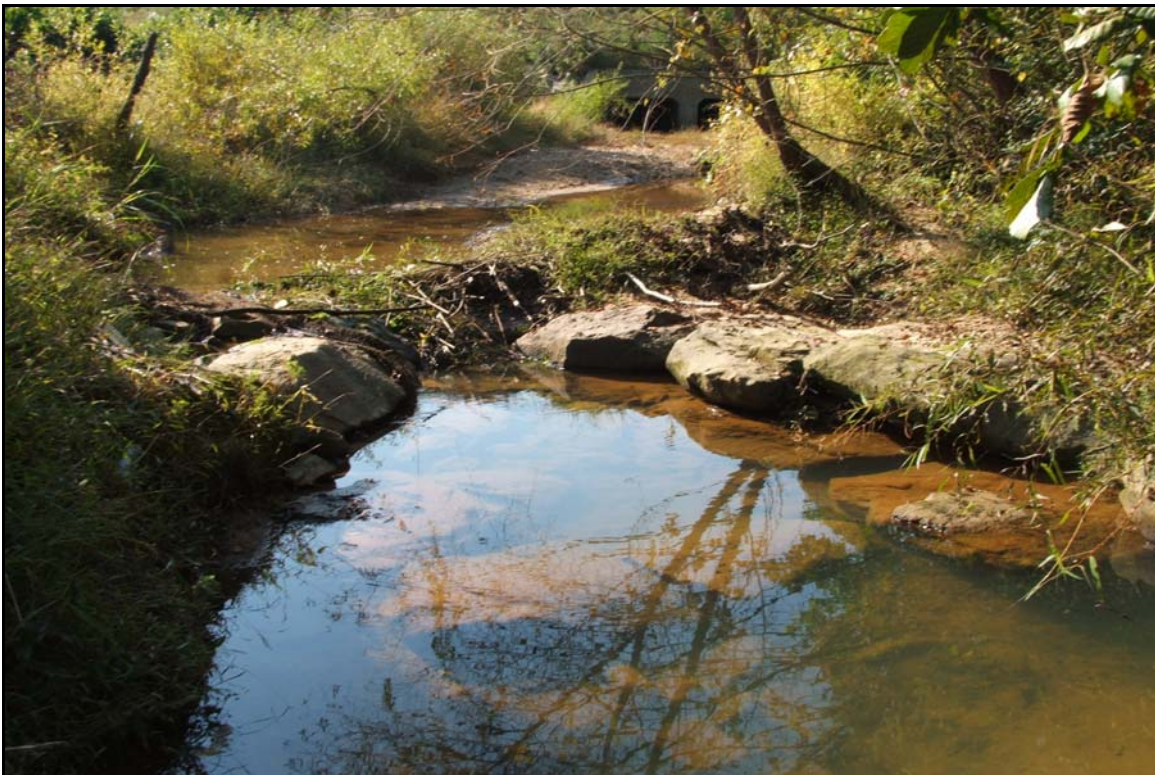
Photo Station 8 (Reach 2) – View looking upstream at rock cross vane, note loss of back fill material in front of cross vane arm on right side of photo.
