**Richland Creek Stream
Restoration Monitoring Report
EEP Project # 304
Monitoring Year – 02
2006**

January 2007

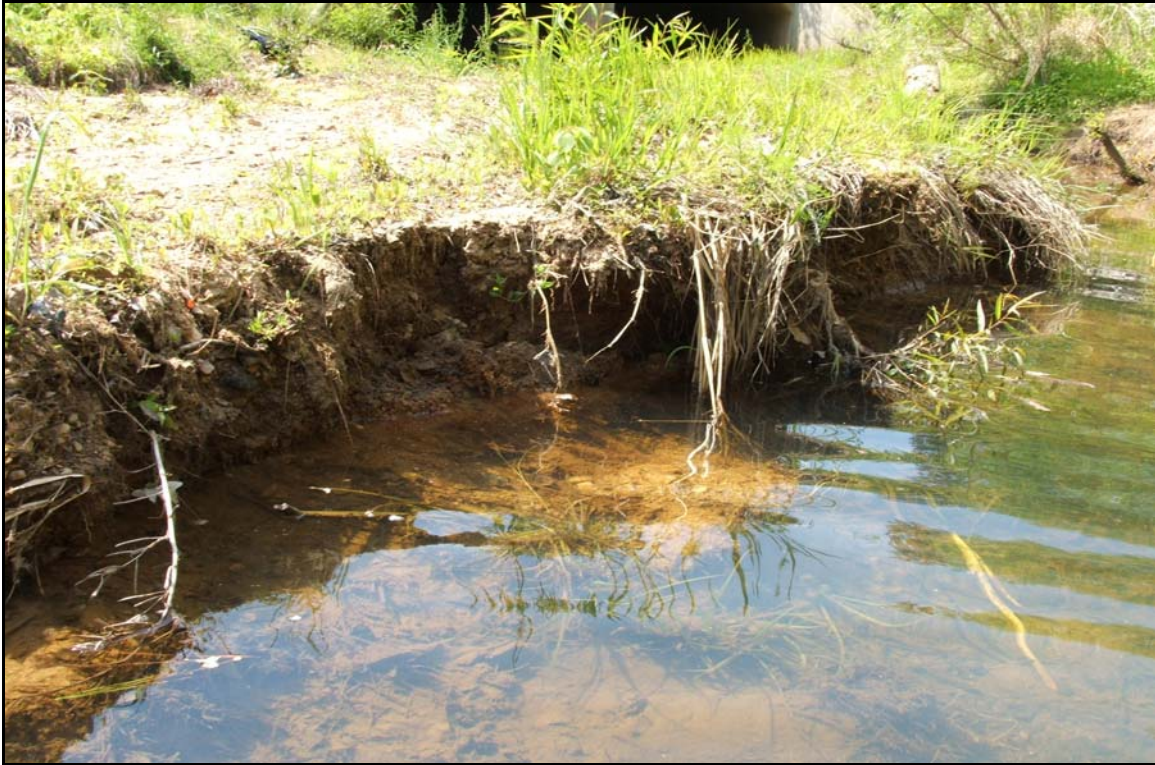
A visual inspection of the stream reaches found them to be functioning well. The cross vanes appeared to be working as designed, although the cross vane in reach 2 had some bank scour around the vane. Reach 2 also had an isolated section of bank erosion. The conditions of the stream can be evaluated by comparing the yearly monitoring photos from the established photo stations and the tables within the report. These photo stations were not surveyed, but their approximate locations are depicted in the monitoring plan view.

Table B1b. Stream Problem Areas			
Project Number and Name: 304 – Richland Creek			
Segment/Reach: Reach 2			
Feature Issue	Station numbers	Suspected Cause	Photo #
Bank erosion	20+50 – 20+65	unknown	SP1
Cross Vane – back or arm scour	20+85	unknown	SP2

SP 1 (Reach 2) – Stream bank erosion on inside of upstream meander.

F. Bank	1. Actively eroding, wasting, or slumping bank	N/A	N/A	1/15	98	98
F. Vanes	1. Free of back or arm scour?	4	5	N/A	80	
	2. Height appropriate?	5	5	N/A	100

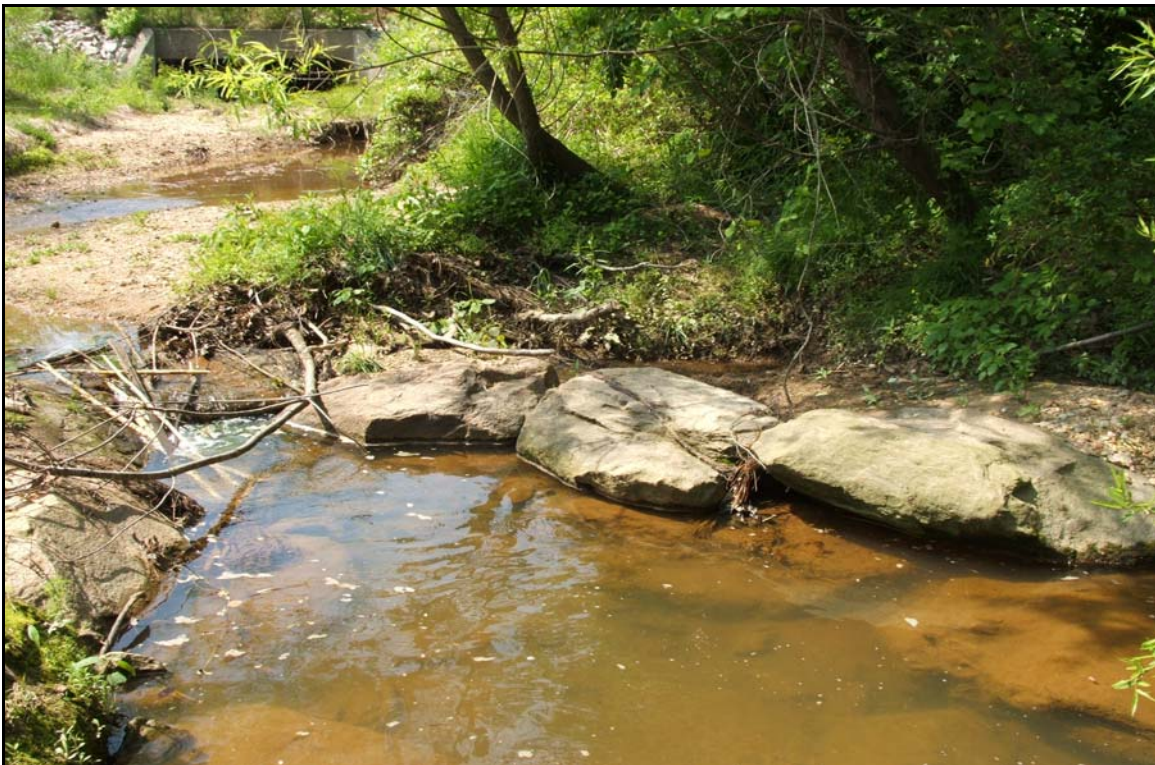
SP 2 (Reach 2) – Back arm scour on left arm of cross vane.

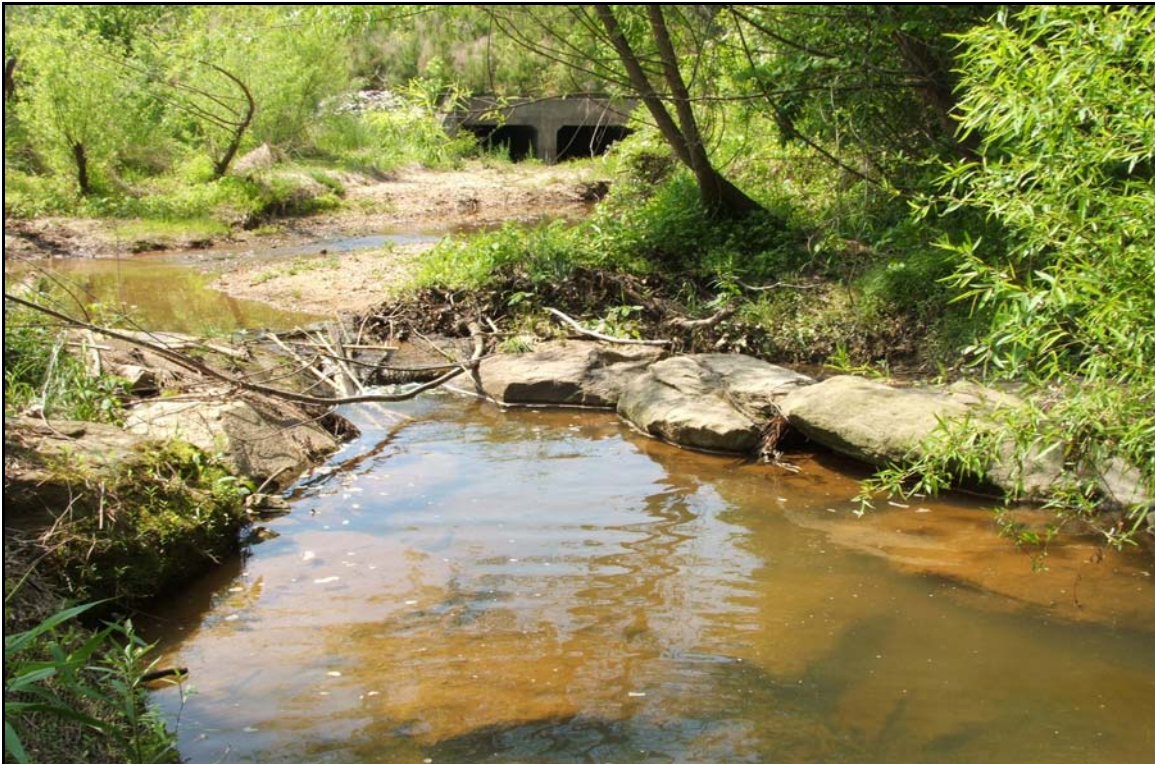
Photo Station 8 (Reach 2) – View looking upstream at rock cross vane, note loss of back fill material in front of cross vane arm on right side of photo.
