**Baseline Monitoring Document and As-Built Report
Final
Paschal Golf Course (Richland Creek) Stream Restoration
EEP Project #276
2010**

December 2010

Monitoring Firm

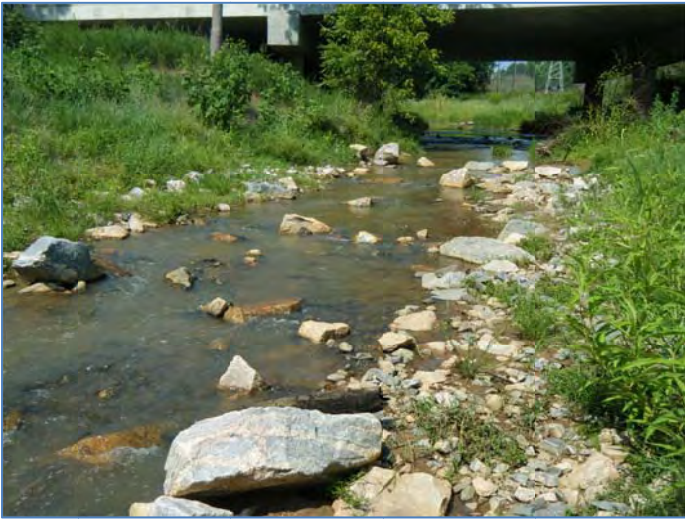
Photo Point #1 – Looking upstream at fish ramp 8/6/2010

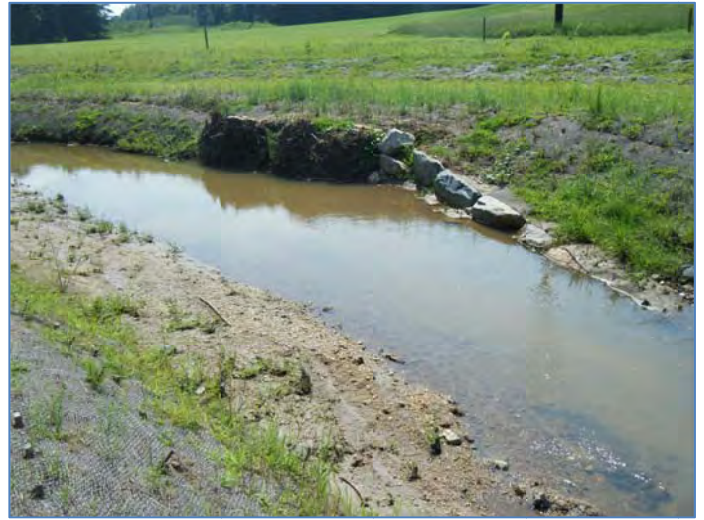
Photo Point #3 – Looking downstream 8/6/2010

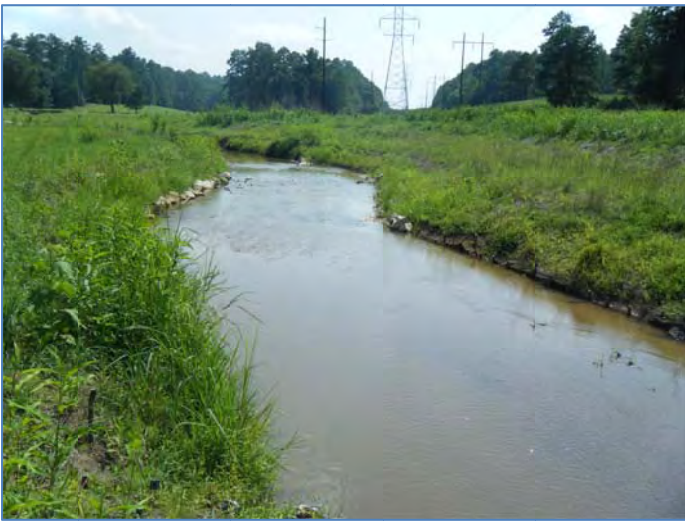
Photo Point #2 – Looking downstream 8/6/2010

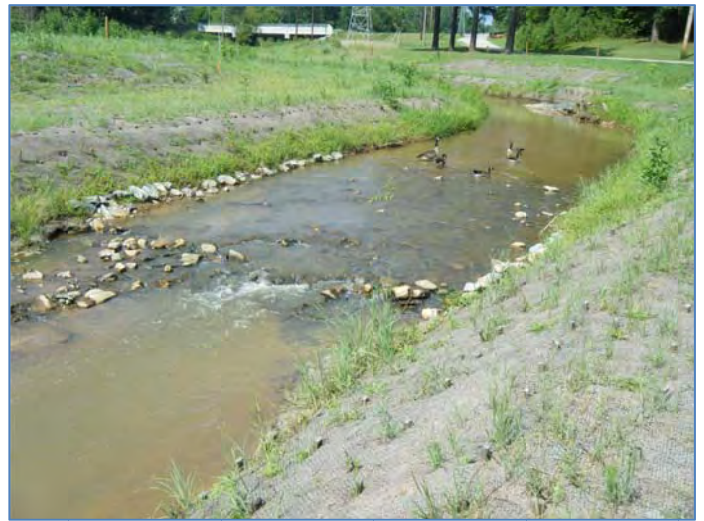
Photo Point #3 – Looking upstream 8/6/2010

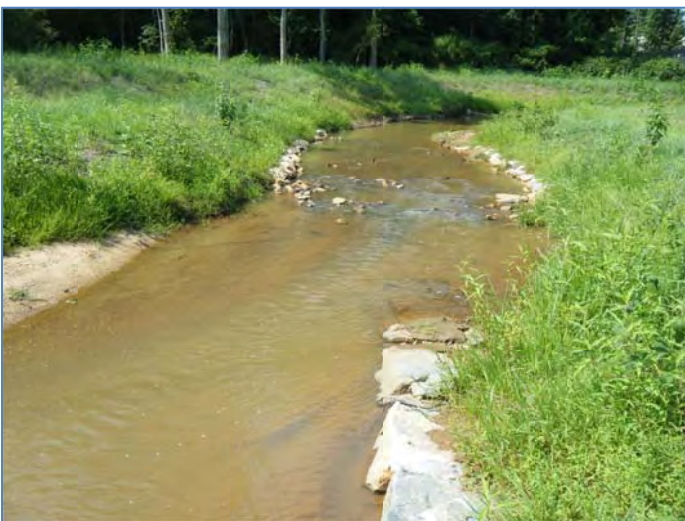
Photo Point #2 – Looking upstream 8/6/2010

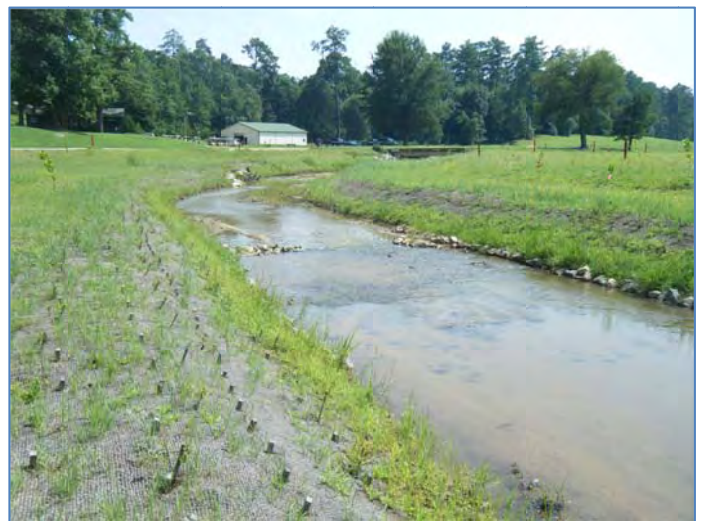
Photo Point #4 – Looking downstream 8/6/2010

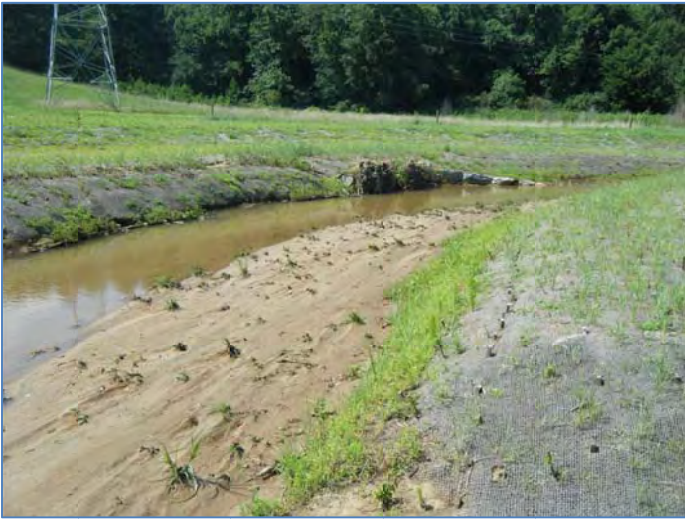
Photo Point #4 – Looking upstream 8/6/2010

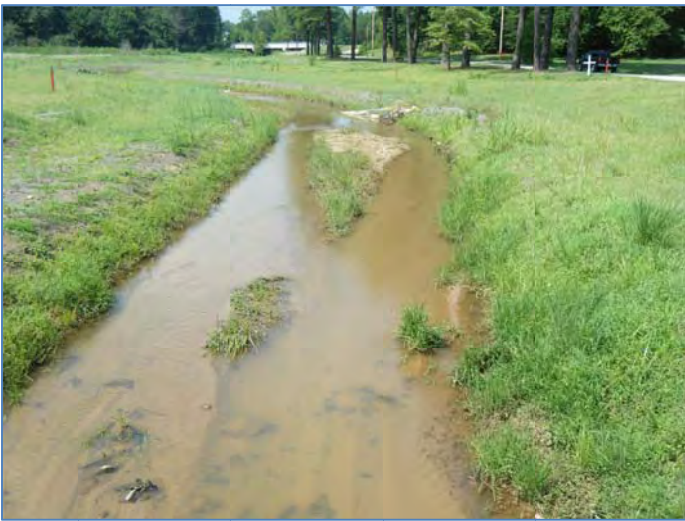
Photo Point #5 – Looking upstream from bridge 8/6/2010
