**Paschal Golf Course (Richland Creek)
Stream Restoration Monitoring Report
EEP Project #276
Monitoring Year 01**

**Construction Completed: May 2010
Data Collection: July 2011
Submitted: December 2011**

PASCHAL GOLF COURSE (RICHLAND CREEK)
 PROJECT #276 - MONITORING YEAR 1
 WAKE FOREST, WAKE COUNTY, NORTH CAROLINA

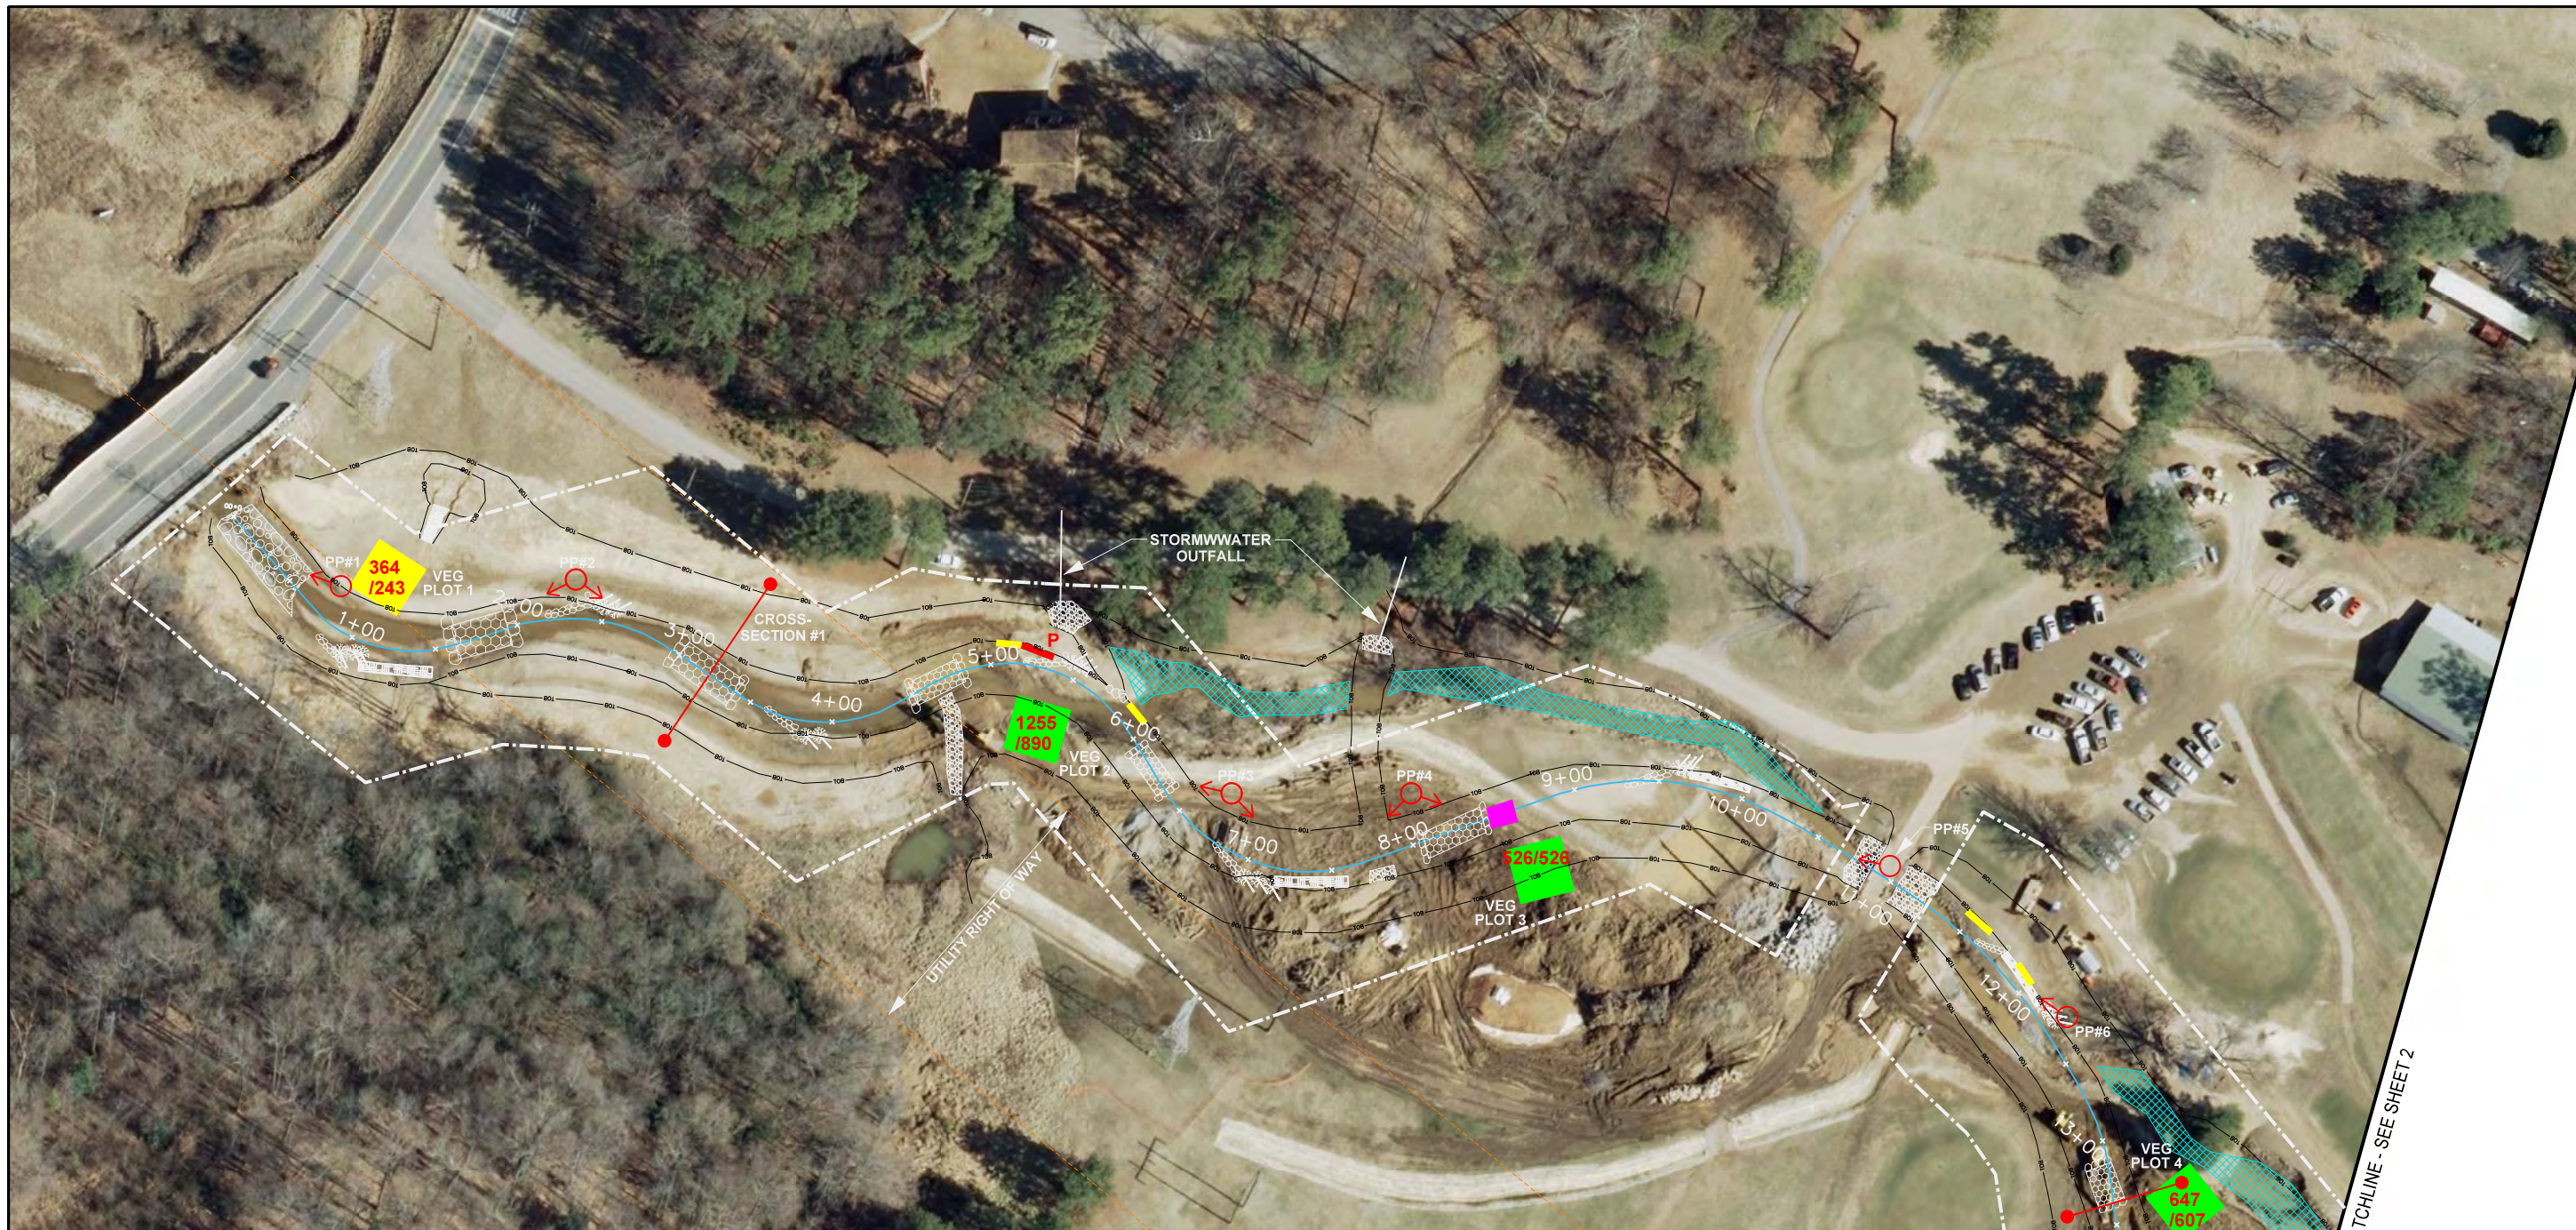
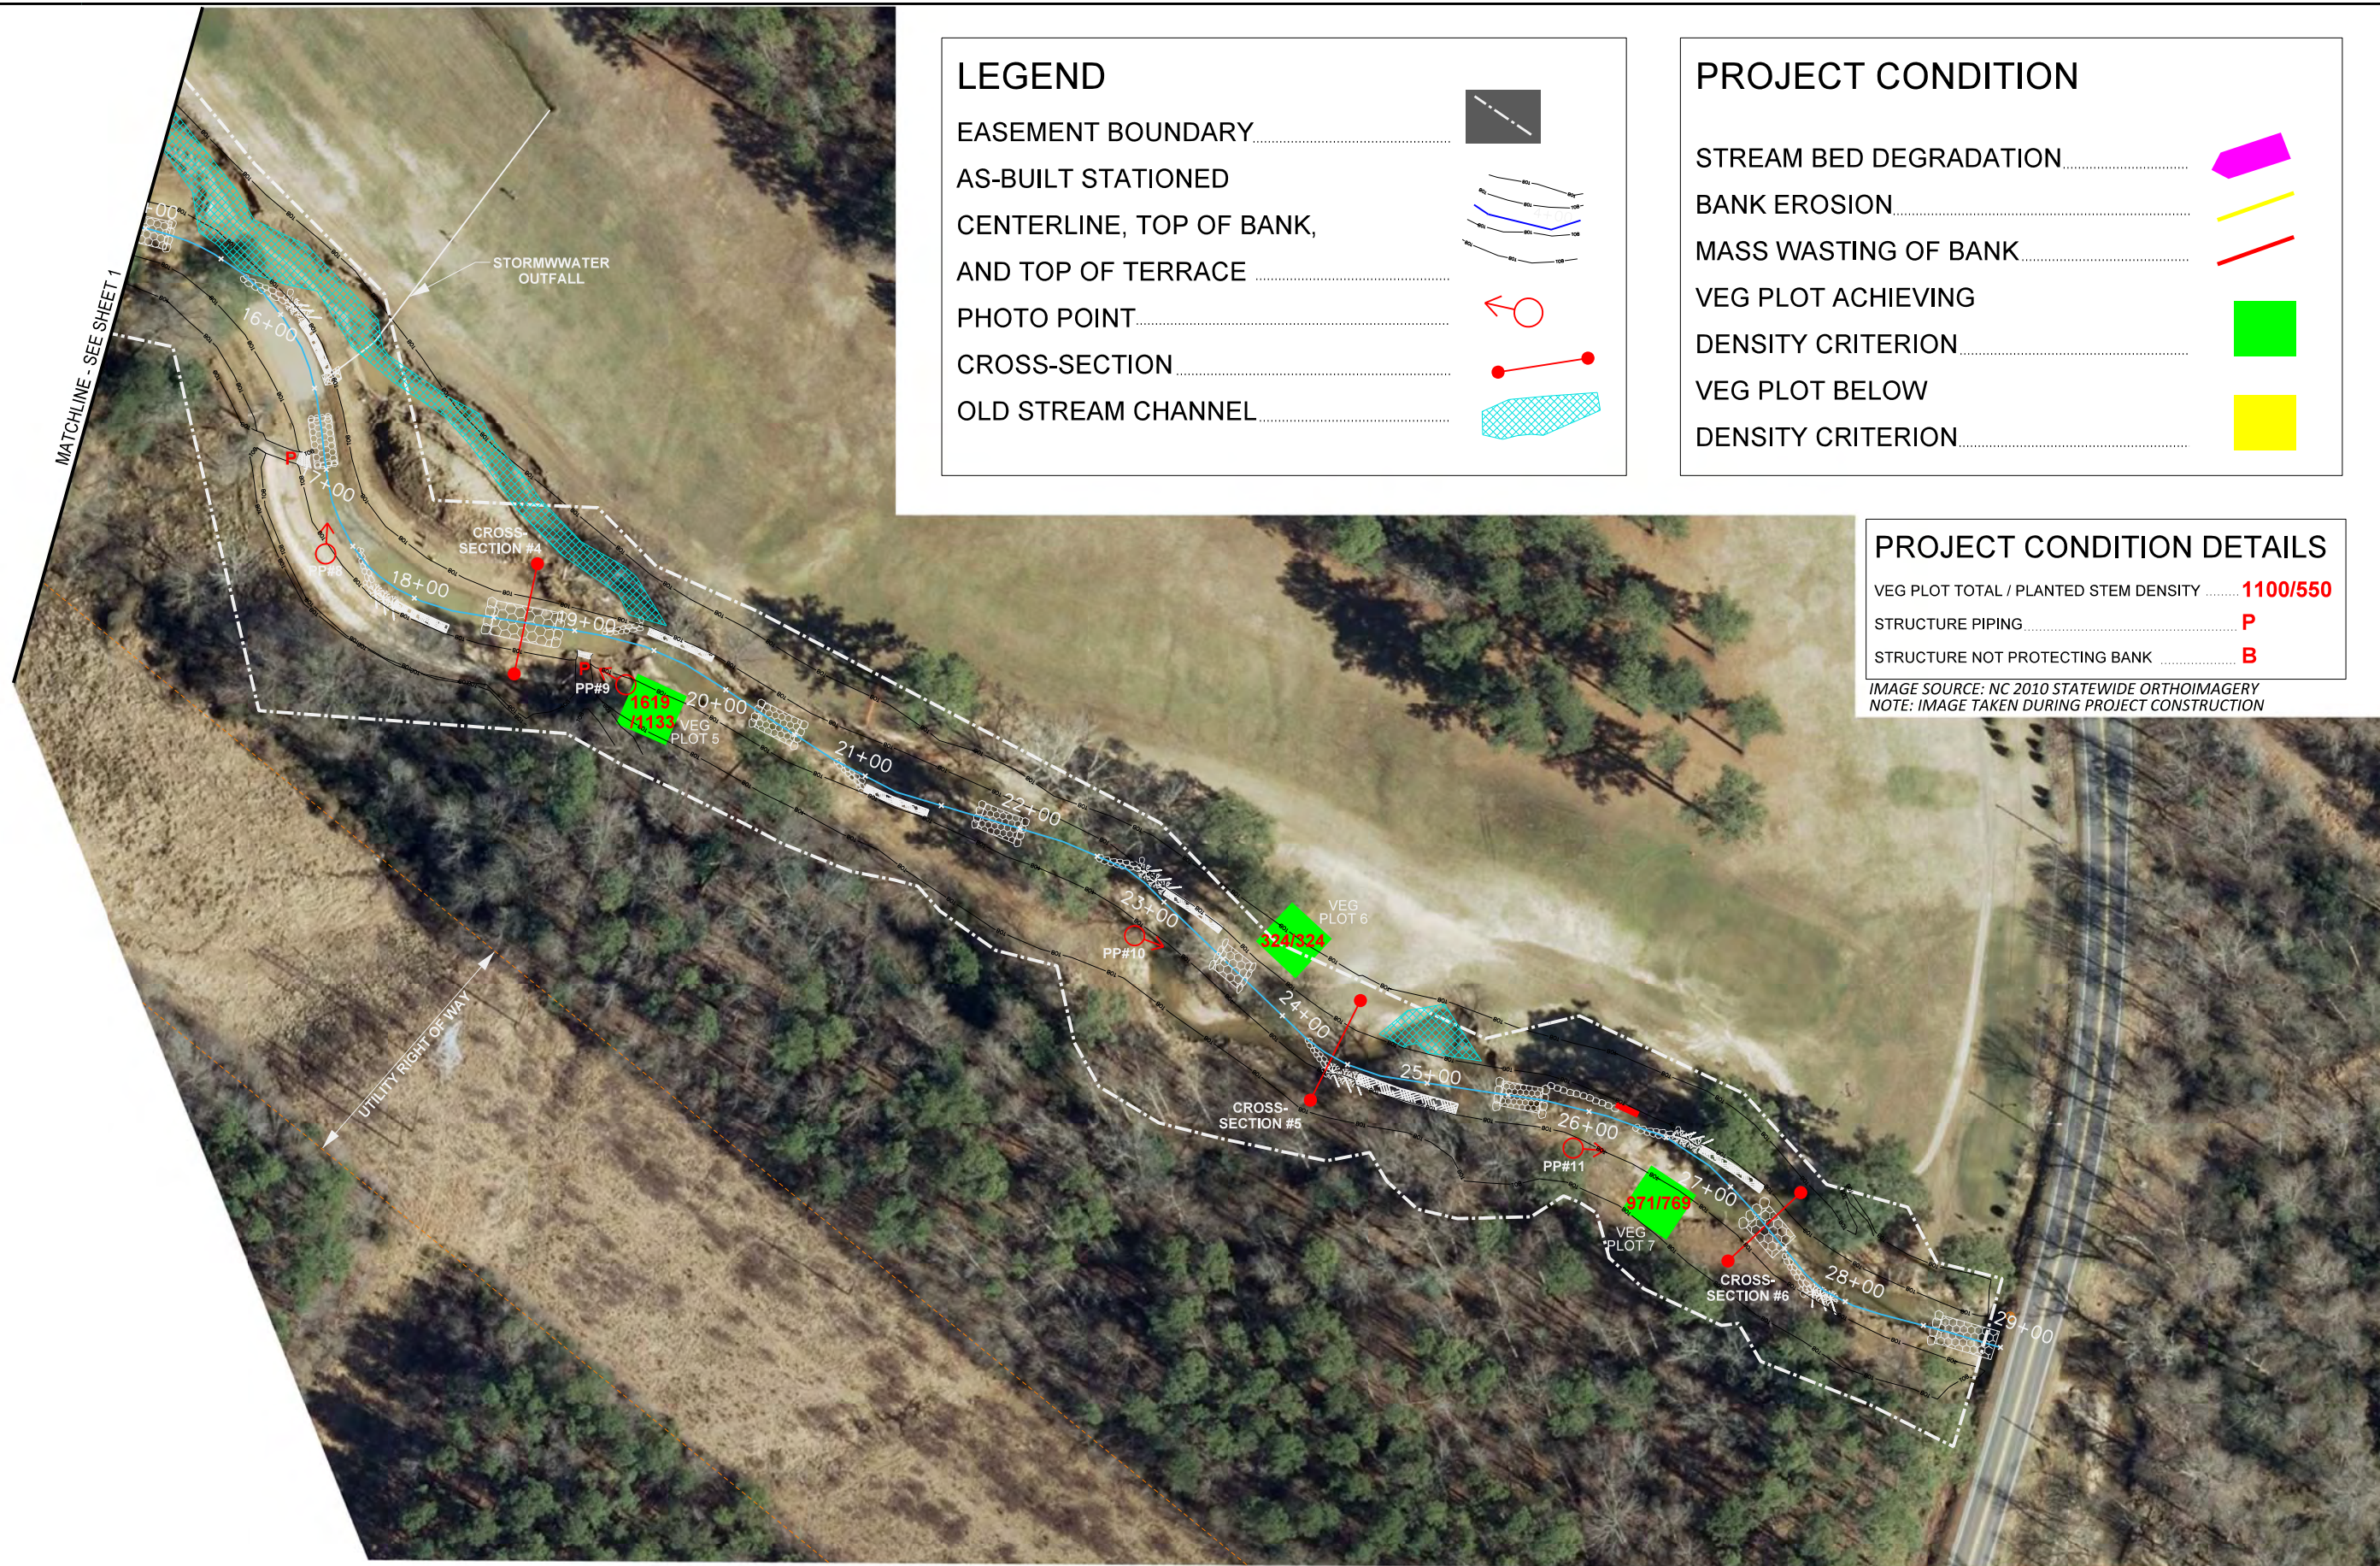
DATE: NOV 2011
 SCALE: 1" = 100'
 FIGURE 3
 CURRENT CONDITION PLAN VIEW
 SHEET 1 OF 2

First-year monitoring found Richland Creek to be mostly stable, with only minor changes from the baseline conditions. The stream has had areas of localized bank erosion since construction (1% of all banks), with one section (Station 5+05) displaying signs of mass wasting (1% of all banks). These areas will continue to be watched closely in Monitoring Year Two. The longitudinal and cross-sectional data also reflect the overall stability in the project streams. As a part of the stream success criterion, the stream must experience at least two bankfull events, each in separate monitoring years. The site has experienced multiple bankfull events since construction.

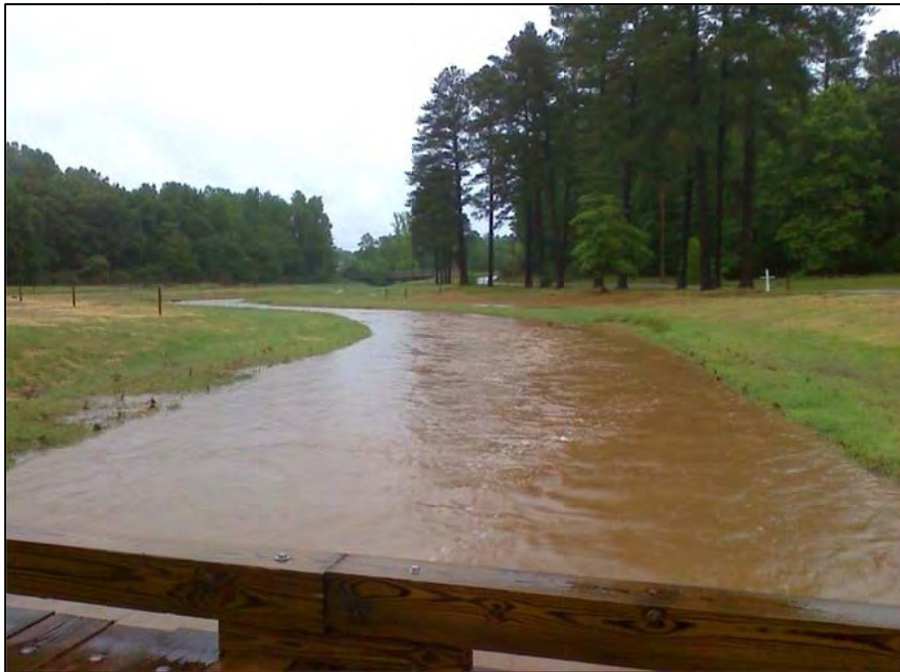
Photo #1 - Bankfull Event, 5/17/2010
