**Paschal Golf Course (Richland Creek)
Stream Restoration Monitoring Report**

**EEP Project # 276
EEP Contract # D080285
Monitoring Year 02**

**Construction Completed: May 2010
Data Collection: August 2012
Submitted: January 2013**

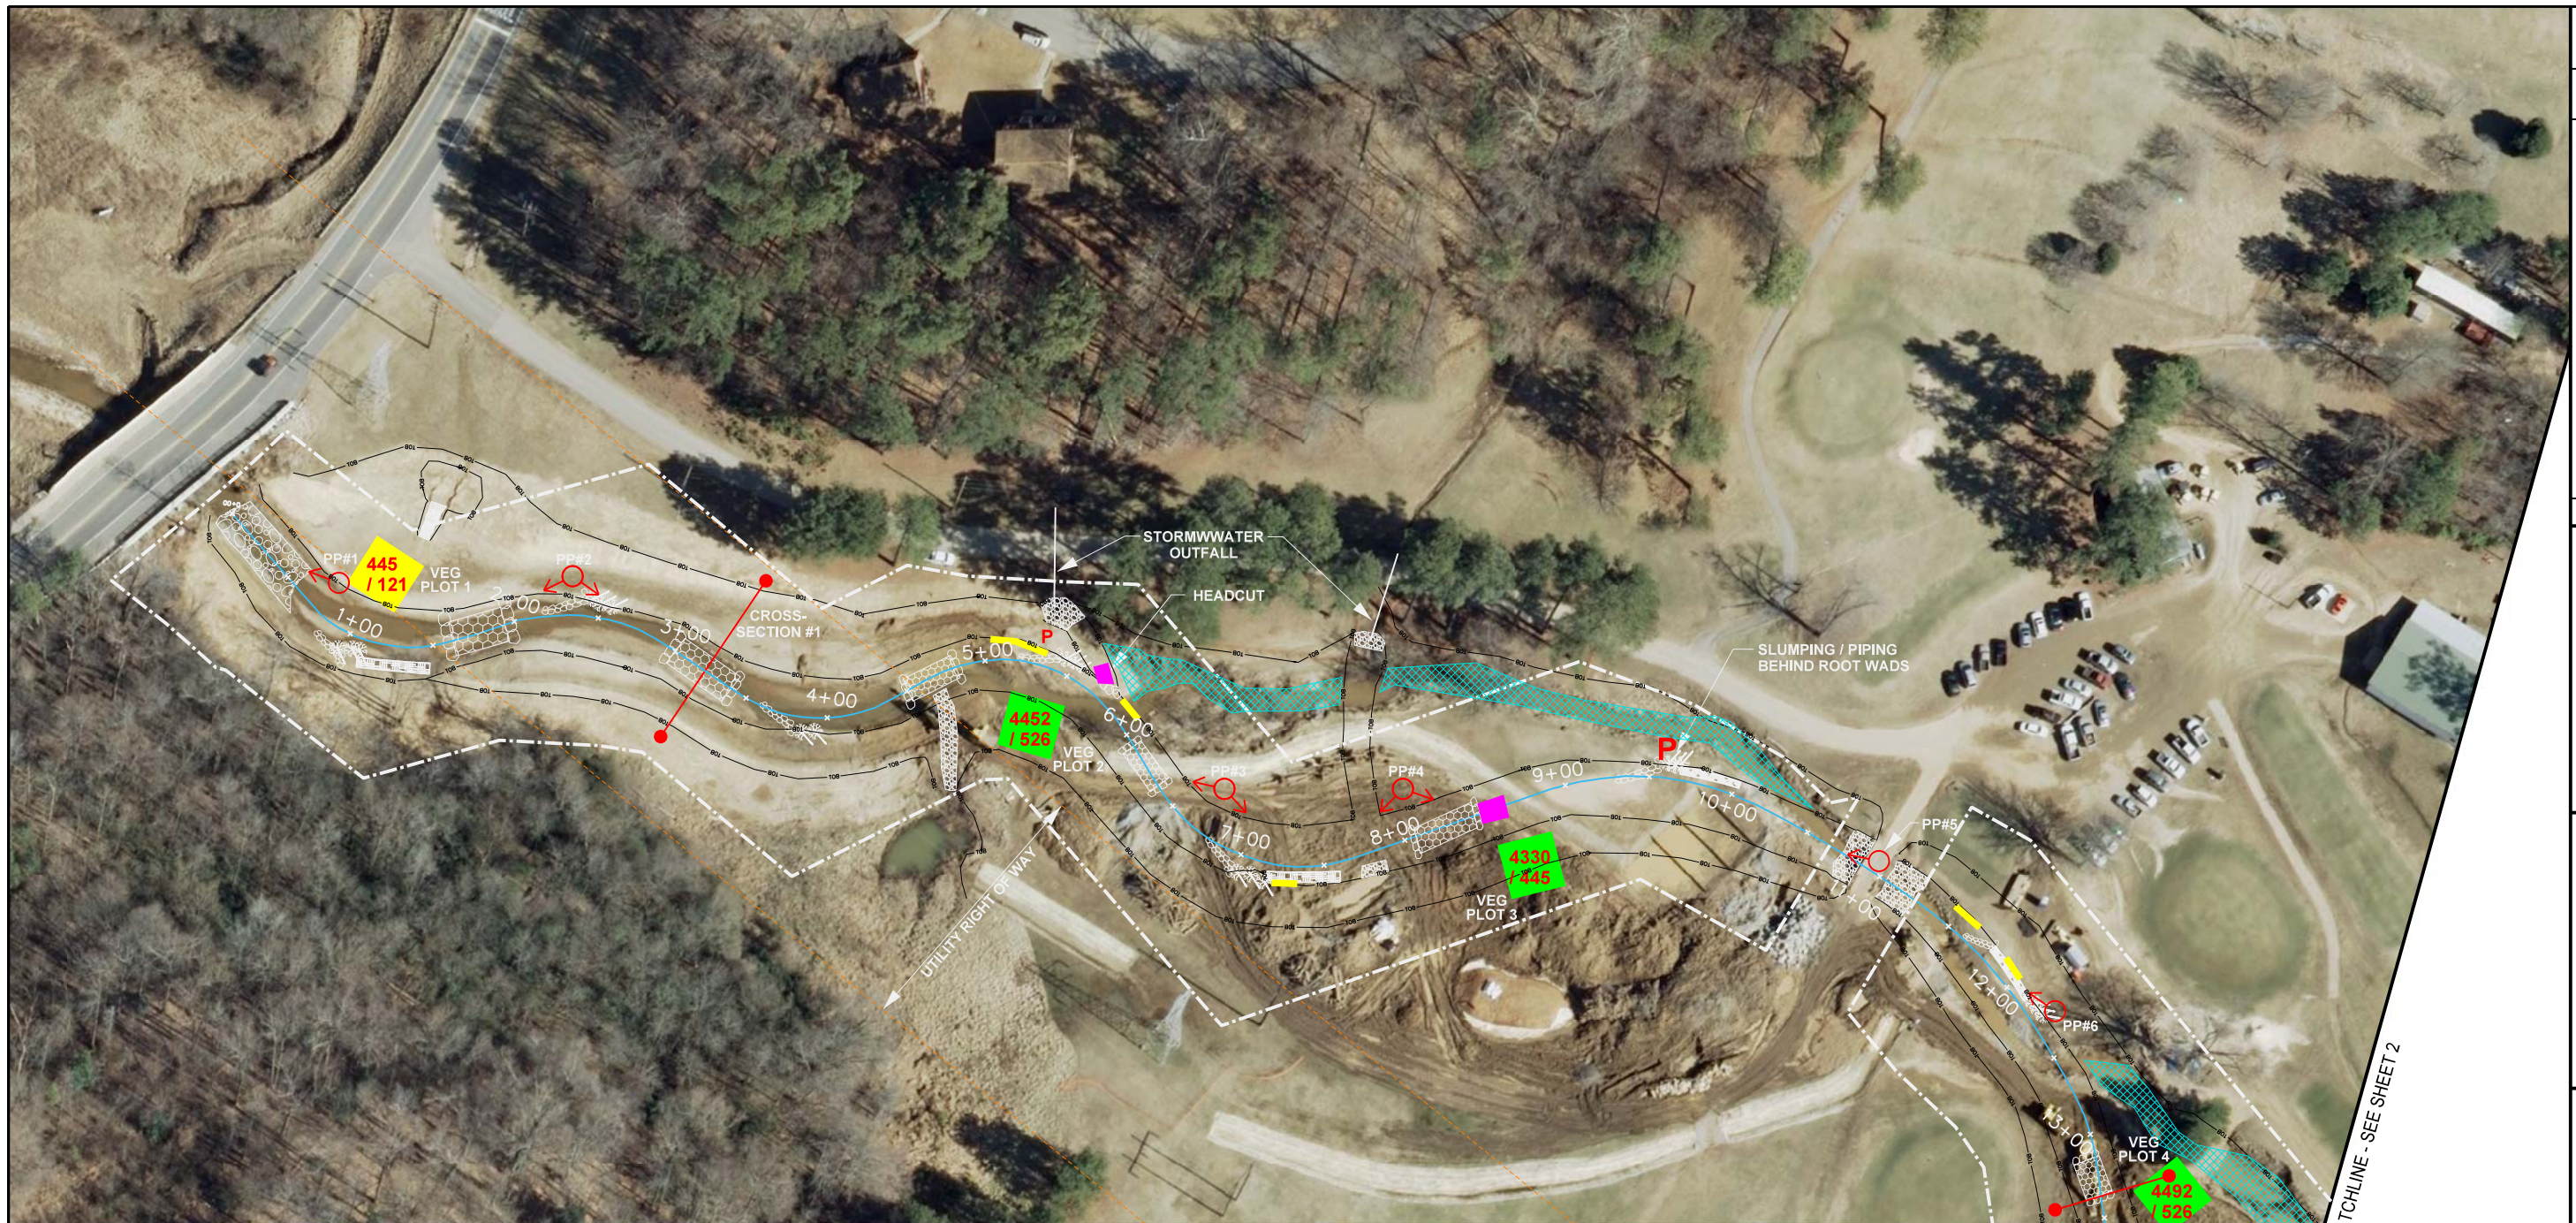
DATE: NOV 2012
SCALE: 1" = 100'
FIGURE 3
CURRENT CONDITION PLAN VIEW
SHEET 1 OF 2

Second-year monitoring found Richland Creek to be mostly stable, with only minor changes from the baseline conditions. The stream has had areas of localized bank erosion since construction (2% of all banks), with six areas along the stream, only one area (Station 26+25) displaying signs of mass wasting (1% of all banks). One area along the stream is experiencing bed degradation along with one area experiencing deposition. These areas will continue to be watched closely in Monitoring Year Three. The longitudinal and cross-sectional data also reflect the overall stability in the project streams. As a part of the stream success criterion, the stream must experience at least two bankfull events, each in separate monitoring years. The site has experienced multiple bankfull events since construction.

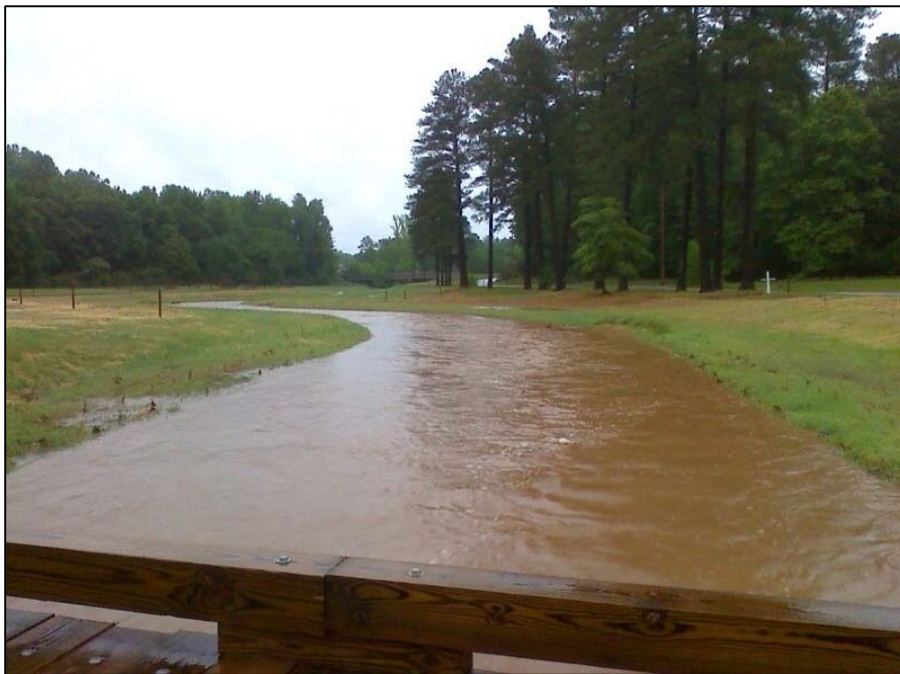
Photo #1 - Bankfull Event, 5/17/2010
