**Paschal Golf Course (Richland Creek)
Stream Restoration Monitoring Report**

**EEP Project # 276
EEP Contract # D080285
Monitoring Year 03**

**Construction Completed: May 2010
Data Collection: June 2013
Submitted: December 2013**

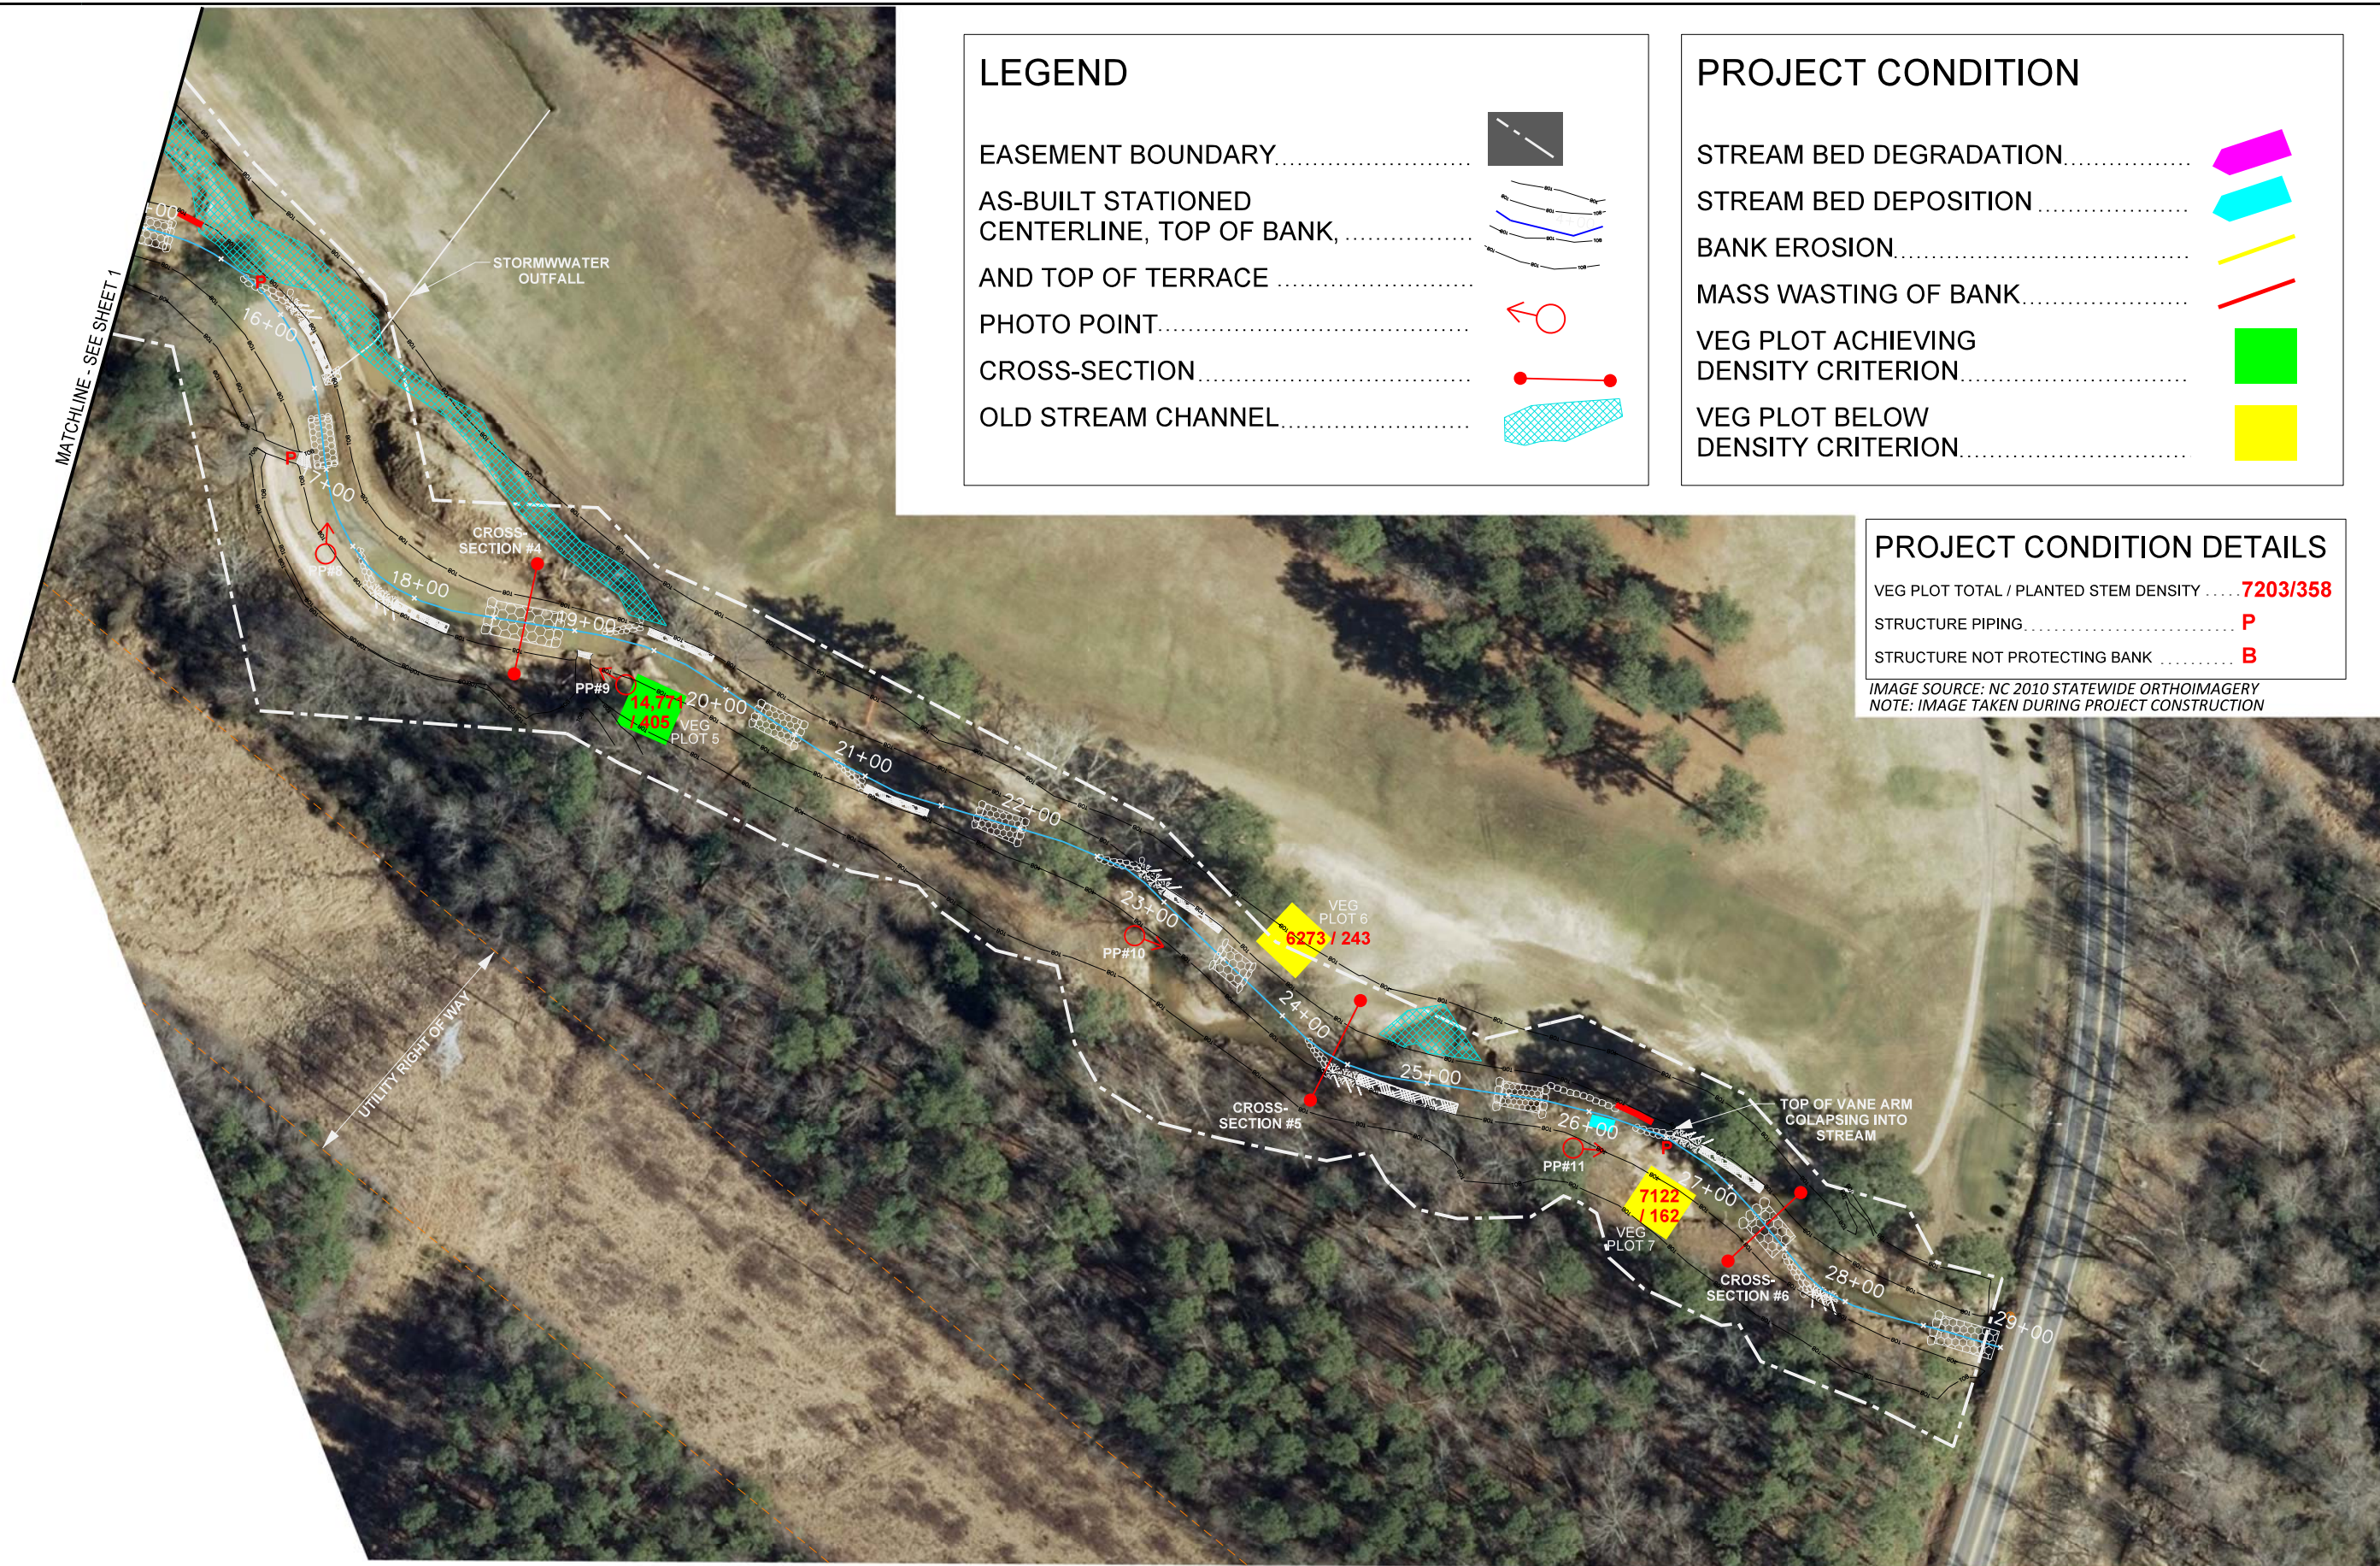
DATE: NOV 2013
 SCALE: 1" = 100'
 FIGURE 3
 CURRENT
 CONDITION
 PLAN VIEW
 SHEET 2 OF 2

Third-year monitoring found Richland Creek to be mostly stable, with only minor changes from the baseline conditions. The stream has four areas of localized bank erosion since construction (2% of all banks), and five areas displaying signs of mass wasting (1% of all banks). There is currently one headcut located approximately at Station 5+75, with two areas along the stream experiencing bed deposition. Please see Appendix B Problem Area Photos. These areas will continue to be watched closely in Monitoring Year Four. The longitudinal and cross-sectional data also reflect the overall stability in the project streams. As a part of the stream success criterion, the stream must experience at least two bankfull events, each in separate monitoring years. The site has experienced multiple bankfull events since construction.

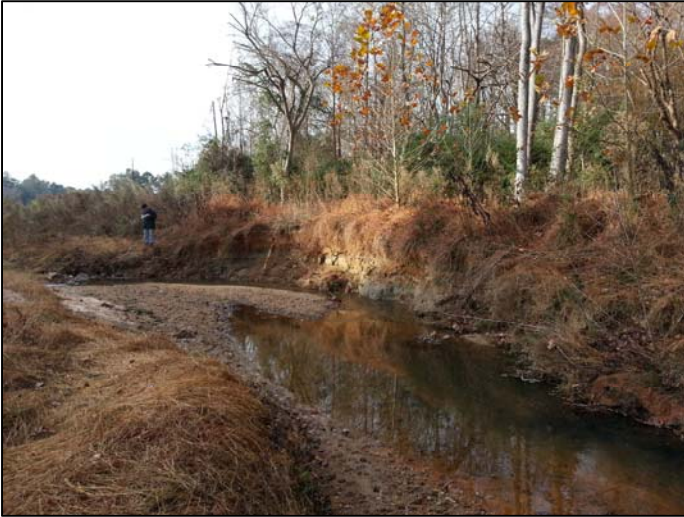
Station 1+00 Right Bank – 11/15/2013

2. Bank	1. Scoured/Eroding	Bank lacking vegetative cover resulting simply from poor growth and/or scour and erosion			4	80	99%
	2. Undercut	Banks undercut/overhanging to the extent that mass wasting appears likely. Does <u>NOT</u> include undercuts that are modest, appear sustainable and are providing habitat.			0	0	100%

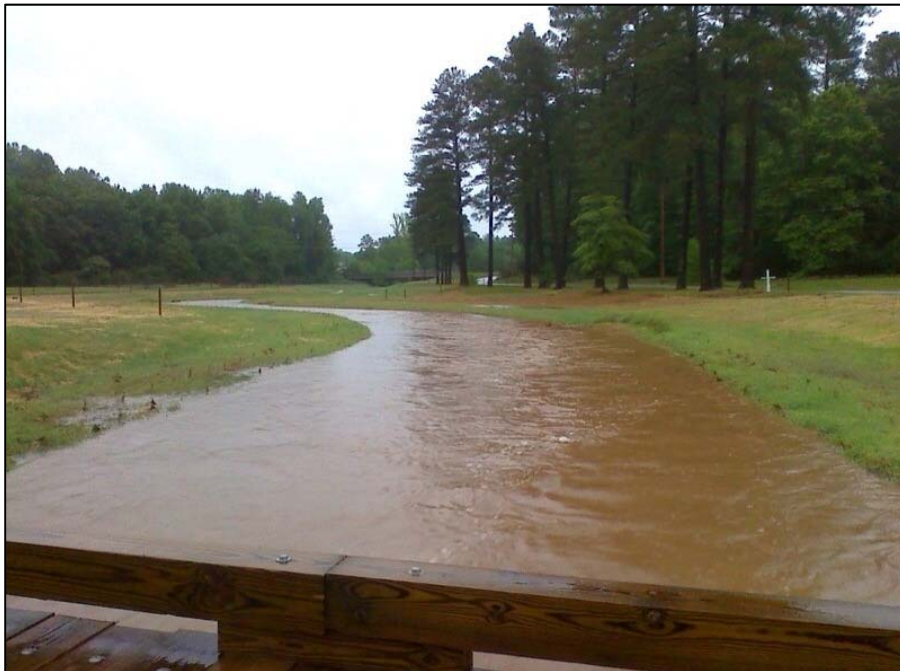
Photo #1 - Bankfull Event, 5/17/2010

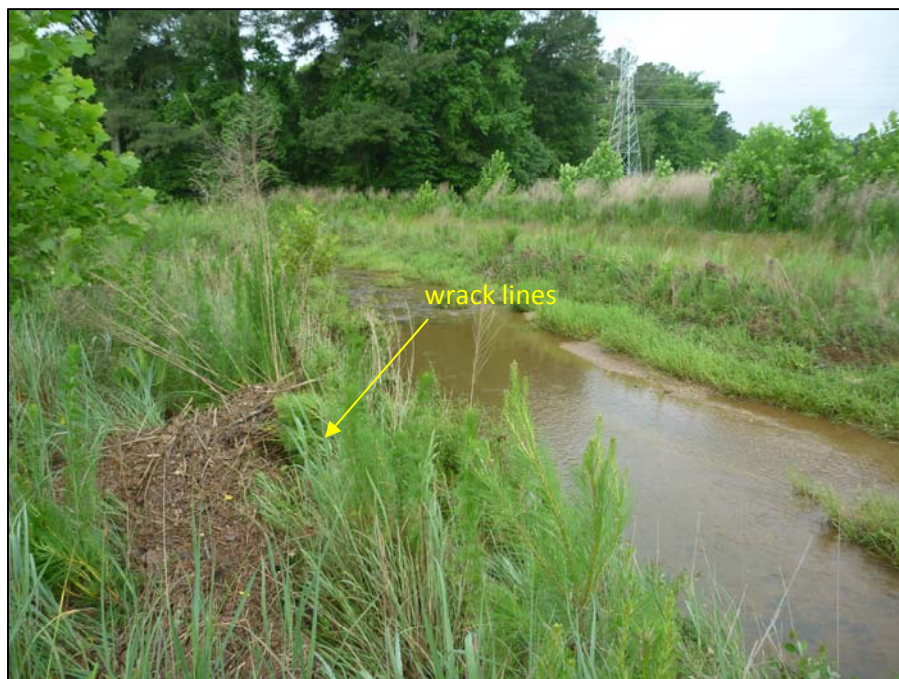
Photo #2 – Bankfull Evidence (wrack lines), 6/10/2013

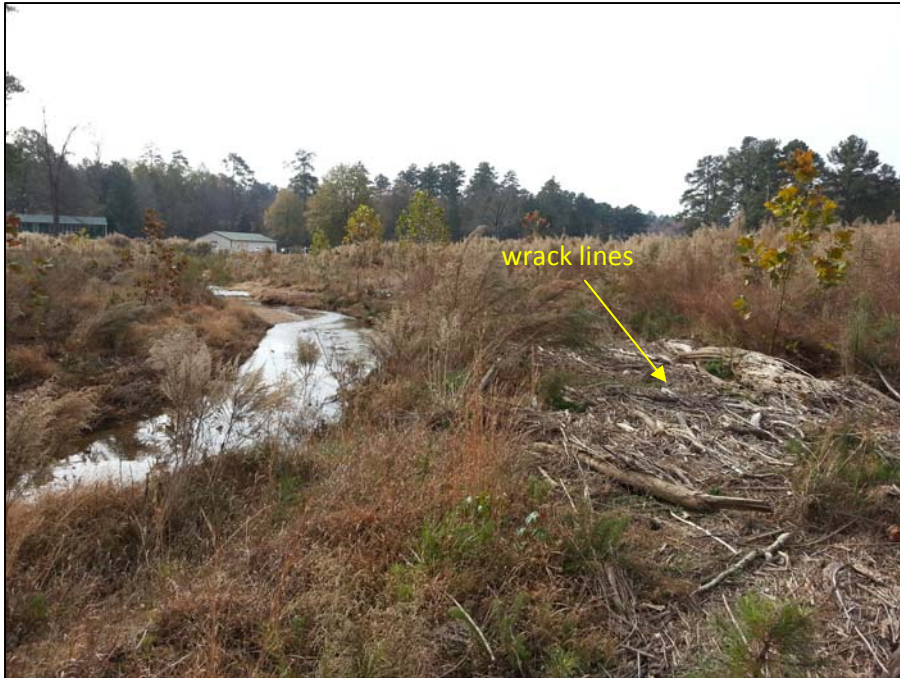
Photo #3 – Bankfull Evidence (wrack lines), 11/15/2013
