**Paschal Golf Course (Richland Creek)  
Stream Restoration Monitoring Report**

**EEP Project # 276  
EEP Contract # 004927  
Monitoring Year 04**

**Construction Completed: May 2010  
Data Collection: June 2014  
Submitted: January 2015**

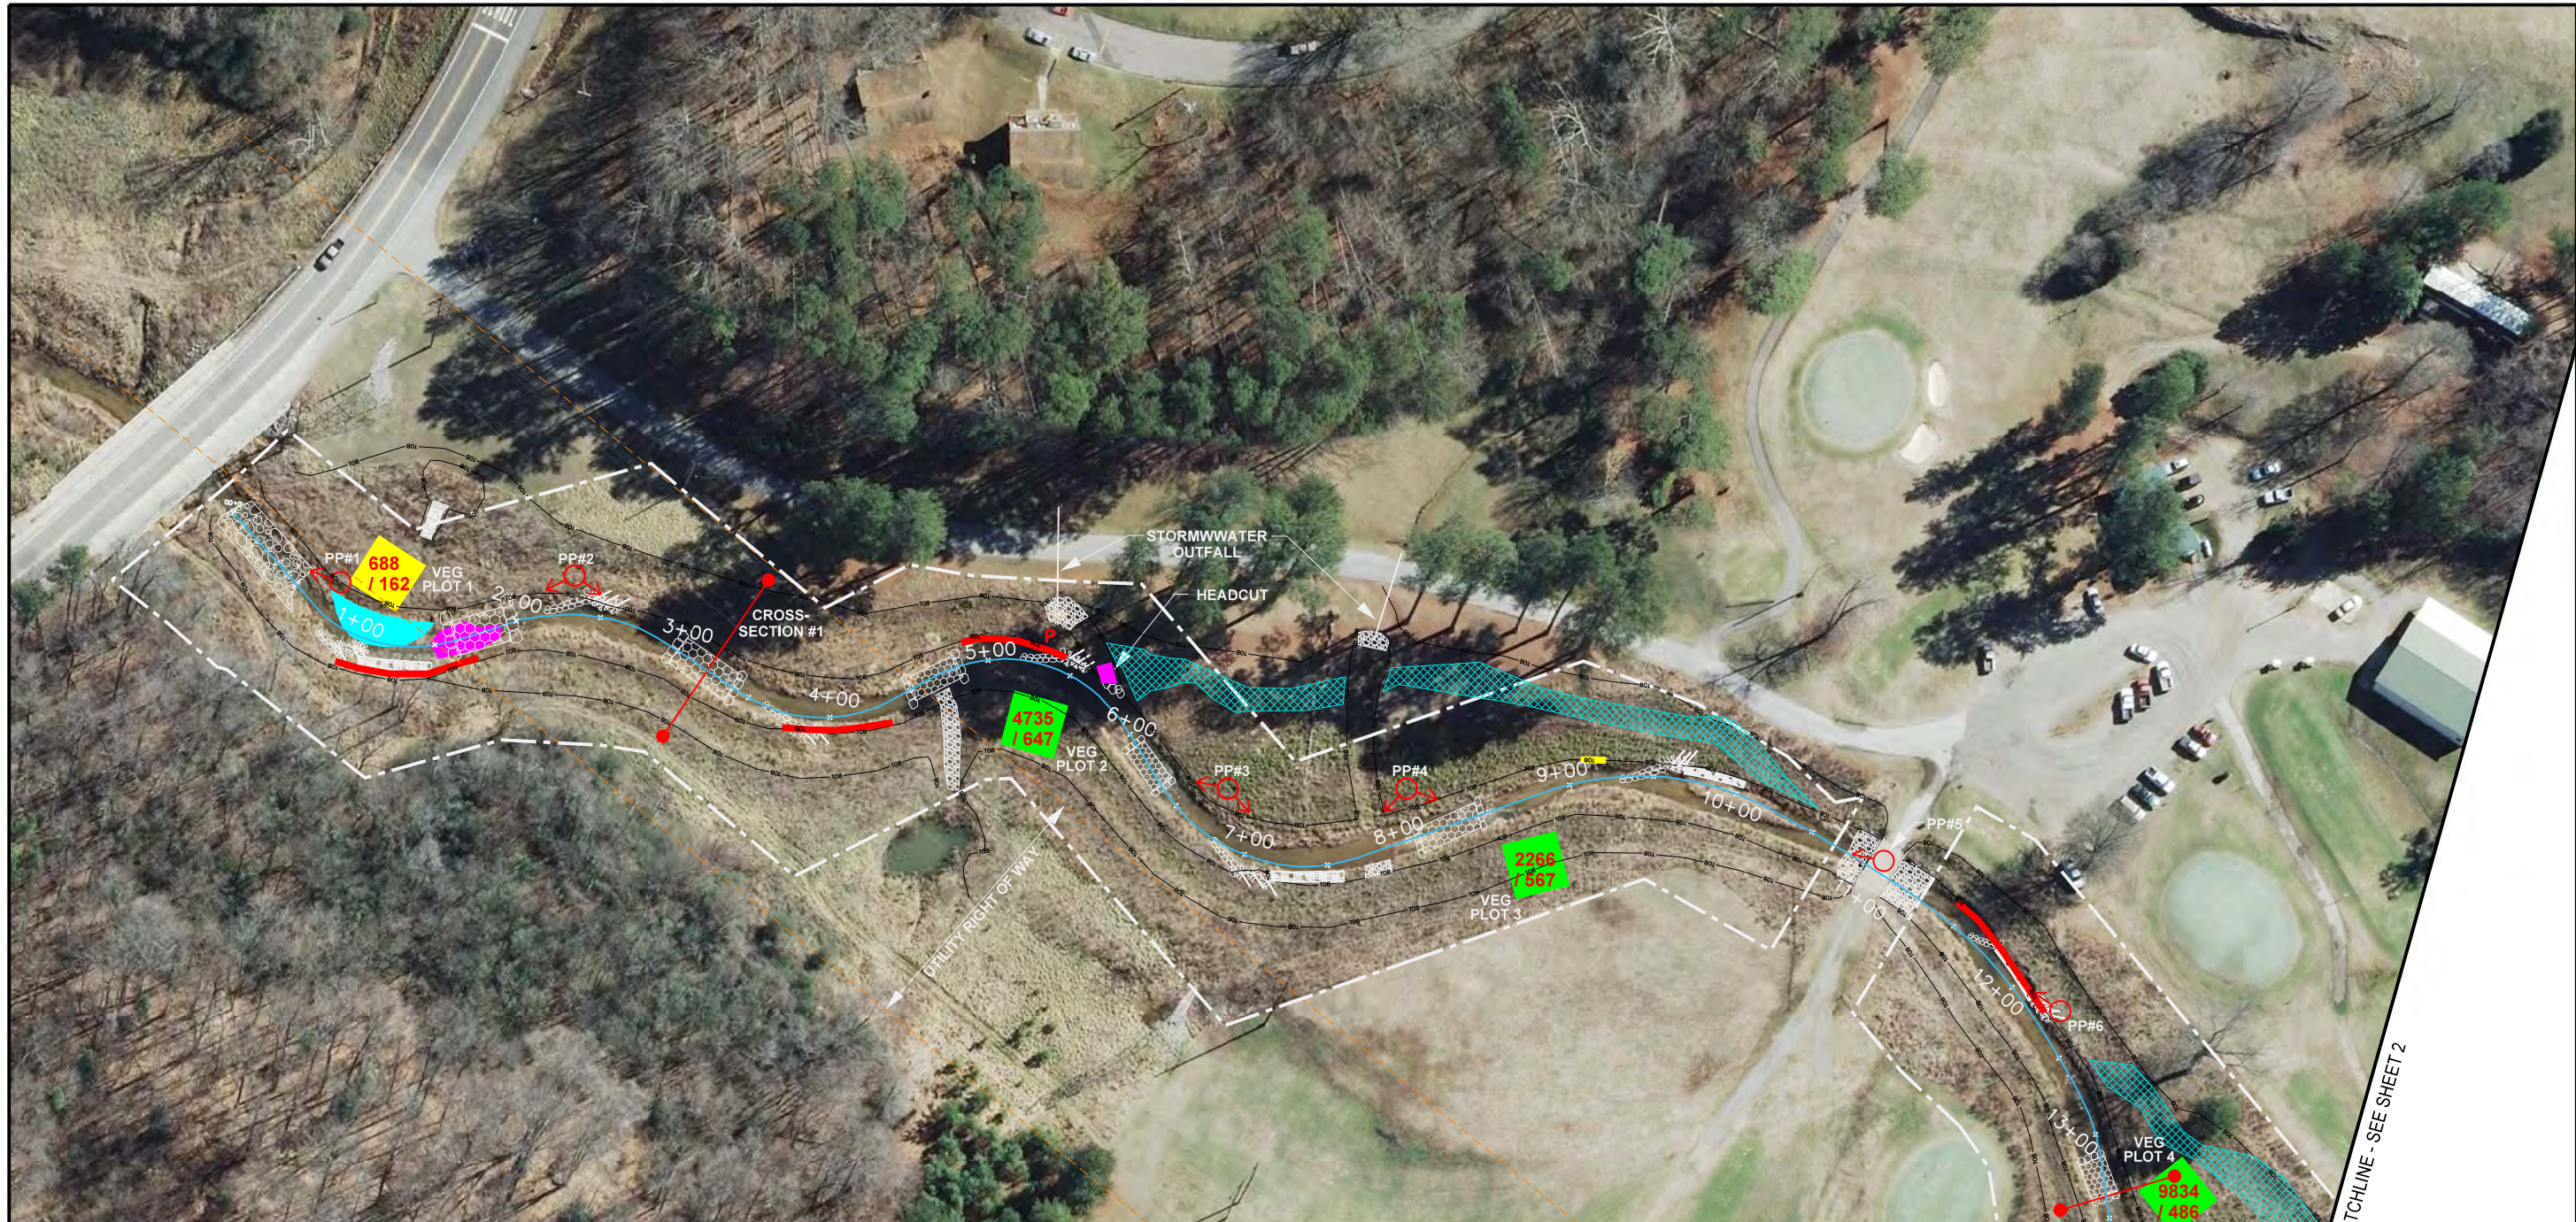
DATE: NOV 2014
SCALE: 1" = 100'
FIGURE 3
CURRENT CONDITION PLAN VIEW
SHEET 1 OF 2

Fourth-year monitoring found Richland Creek to be mostly stable, with only minor changes from the baseline conditions. The stream has three areas of localized bank erosion since construction (2% of all banks), and five areas displaying signs of mass wasting (1% of all banks). There is currently one headcut located approximately at Station 5+75, with one area along the stream experiencing bed deposition. Please see Appendix B Problem Area Photos. A repair plan for these isolated areas of instability is being prepared for implementation in 2015. The longitudinal and cross-sectional data also reflect the overall stability in the project streams. As a part of the stream success criterion, the stream must experience at least two bankfull events, each in separate monitoring years. The site has experienced multiple bankfull events since construction.

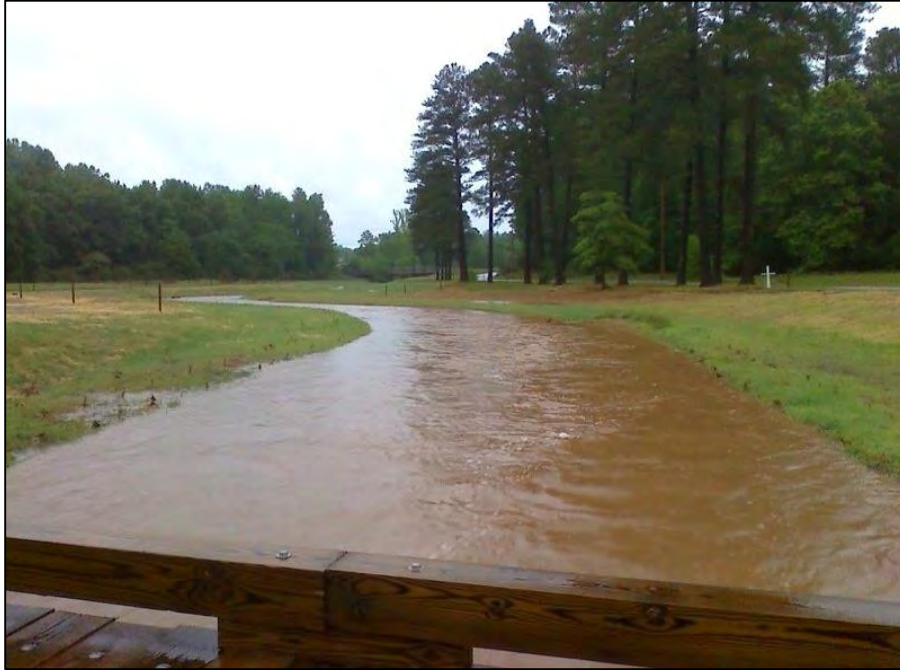
Photo #1 - Bankfull Event, 5/17/2010

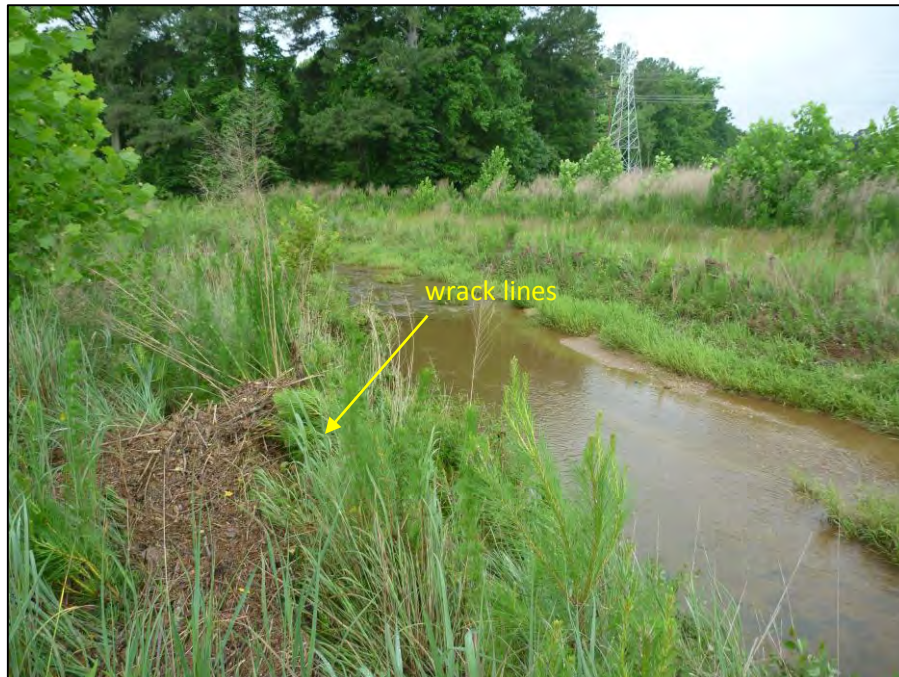
Photo #2 – Bankfull Evidence (wrack lines), 6/10/2013

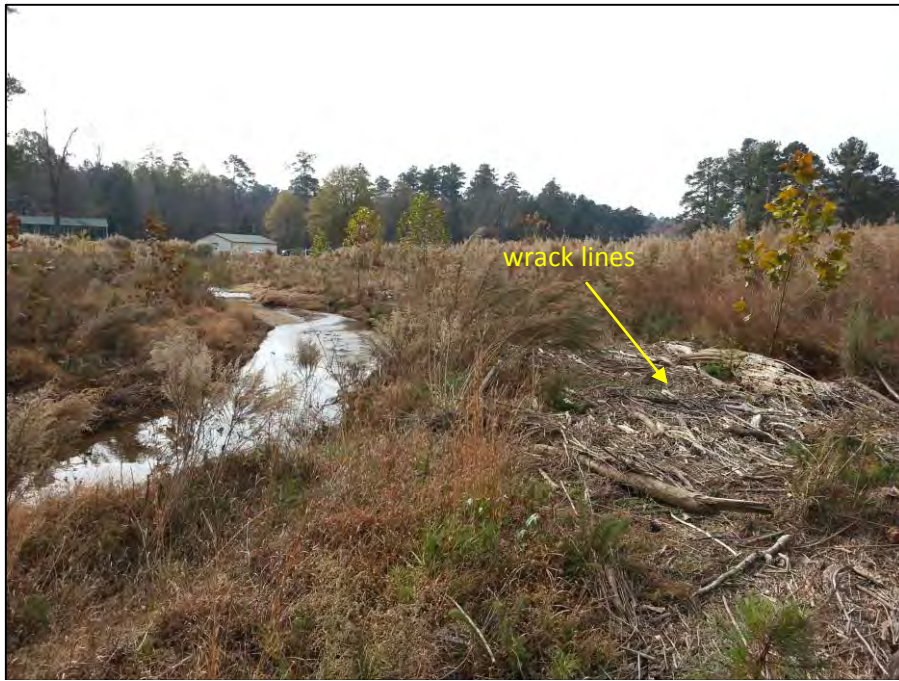
Photo #3 – Bankfull Evidence (wrack lines), 11/15/2013

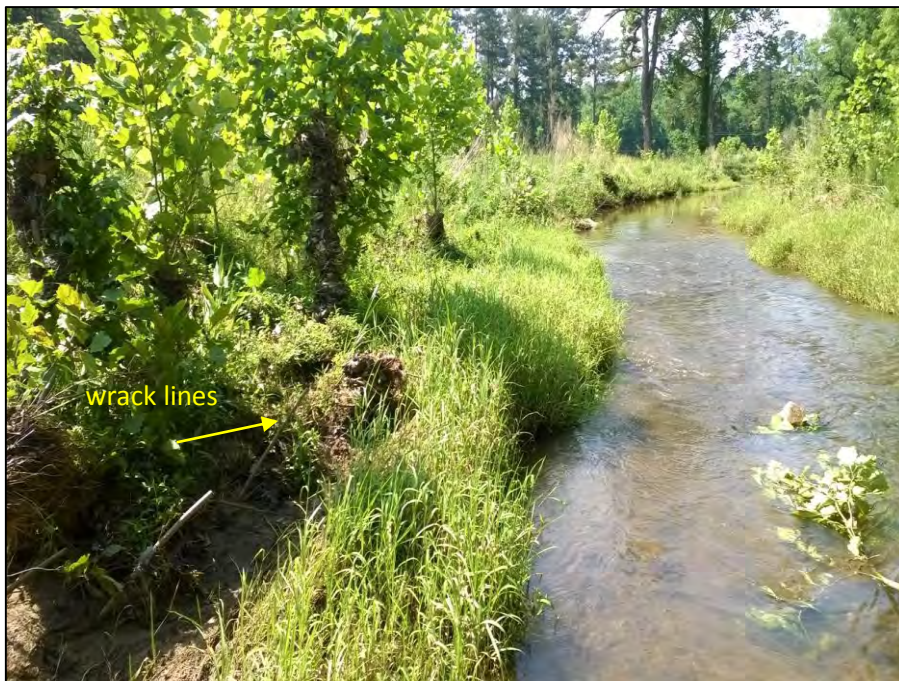
Photo #4 – Bankfull Evidence (wrack lines), 5/28/2014

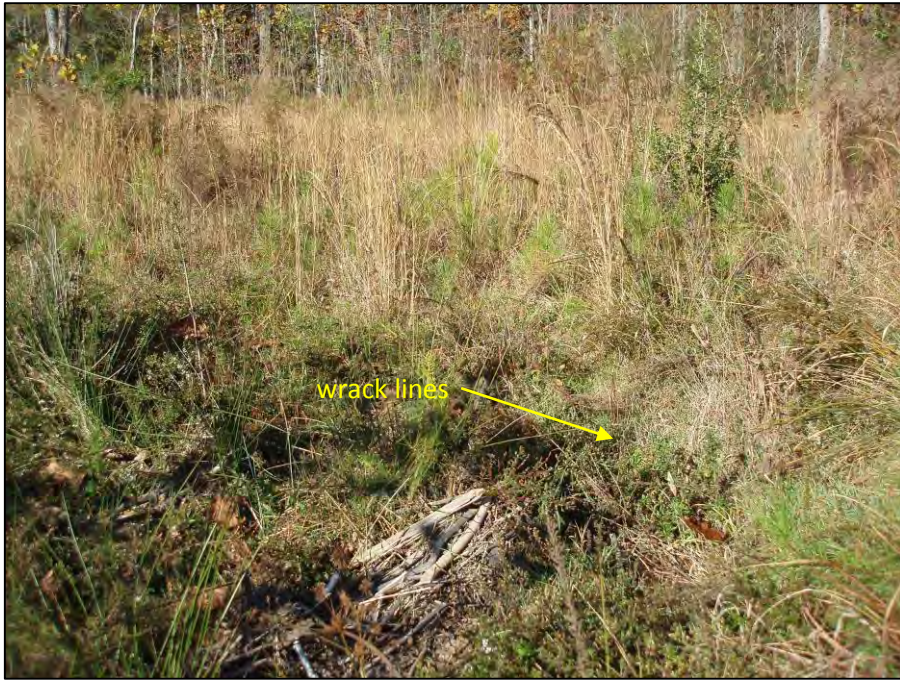
Photo #5 – Bankfull Evidence (wrack lines), 11/10/2014
