As-Built Mitigation Plan

ROCKY BRANCH STREAM RESTORATION

Yadkin County, North Carolina

February 20, 2008

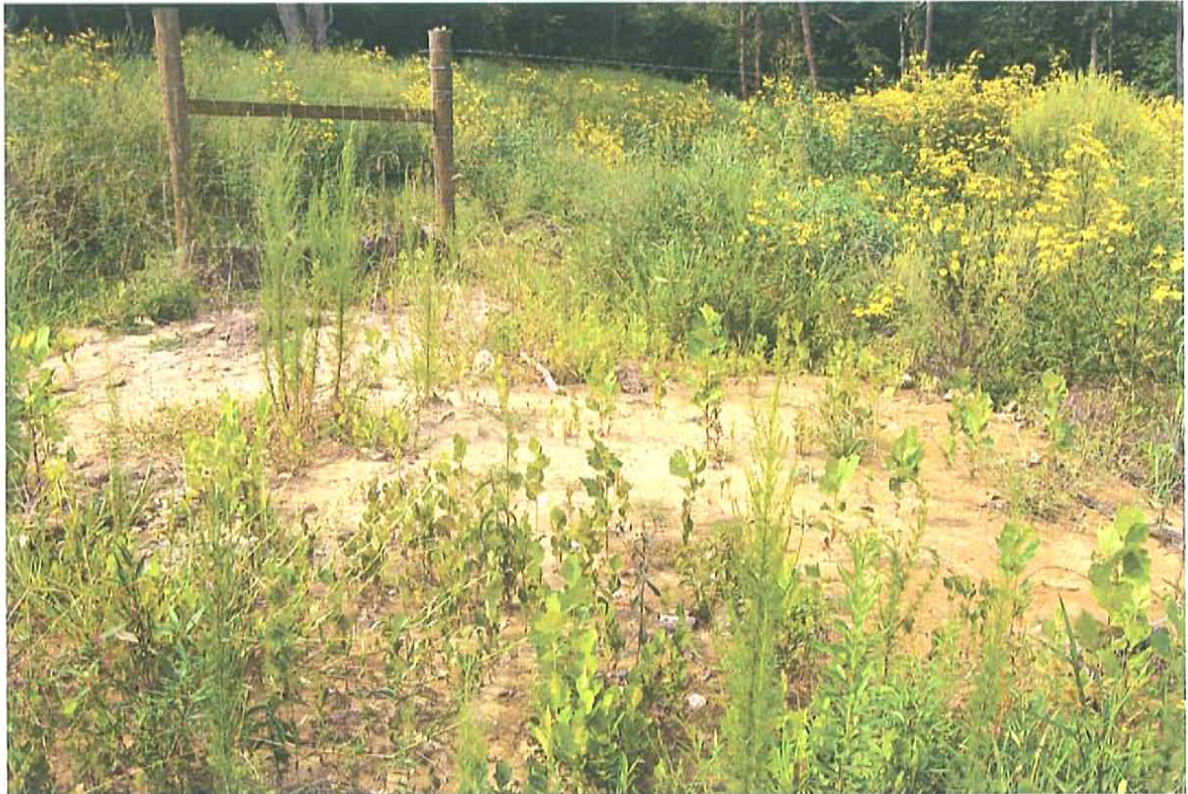
Rocky Branch (Station 1+77) View near I-77 right-of-way fence of eroded area caused by a debris jam. Area is currently vegetated with natural sycamore seedlings.

During the walk-through conducted on June 15, 2007, specific areas were noted as "Areas of Concern". At that time, Mulkey recommended that vegetation should be allowed to grow for one season before any actions were taken. This recommendation was developed to reduce or to minimize damage that may occur from reentering the site with heavy equipment. During the As-built surveys, the site had become well vegetated, but specific areas of concern were still present, that should be mentioned in this baseline document. These areas were photographed and documented in Appendix H. Large quantities of invasive species previously covering the site have been significantly reduced following construction and the alteration of the hydrologic regime.

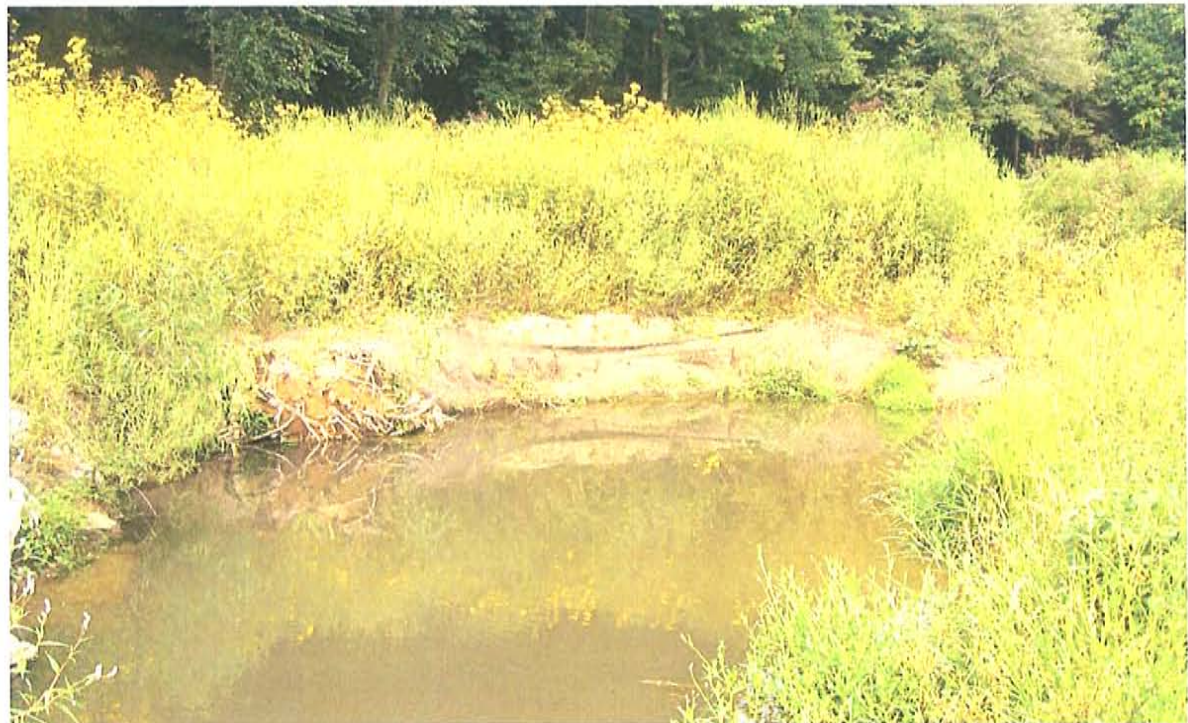
Rocky Branch (Stations 4+10 – 4+20) Pool with sloughed banks upstream of cross section 4. View looking downstream.

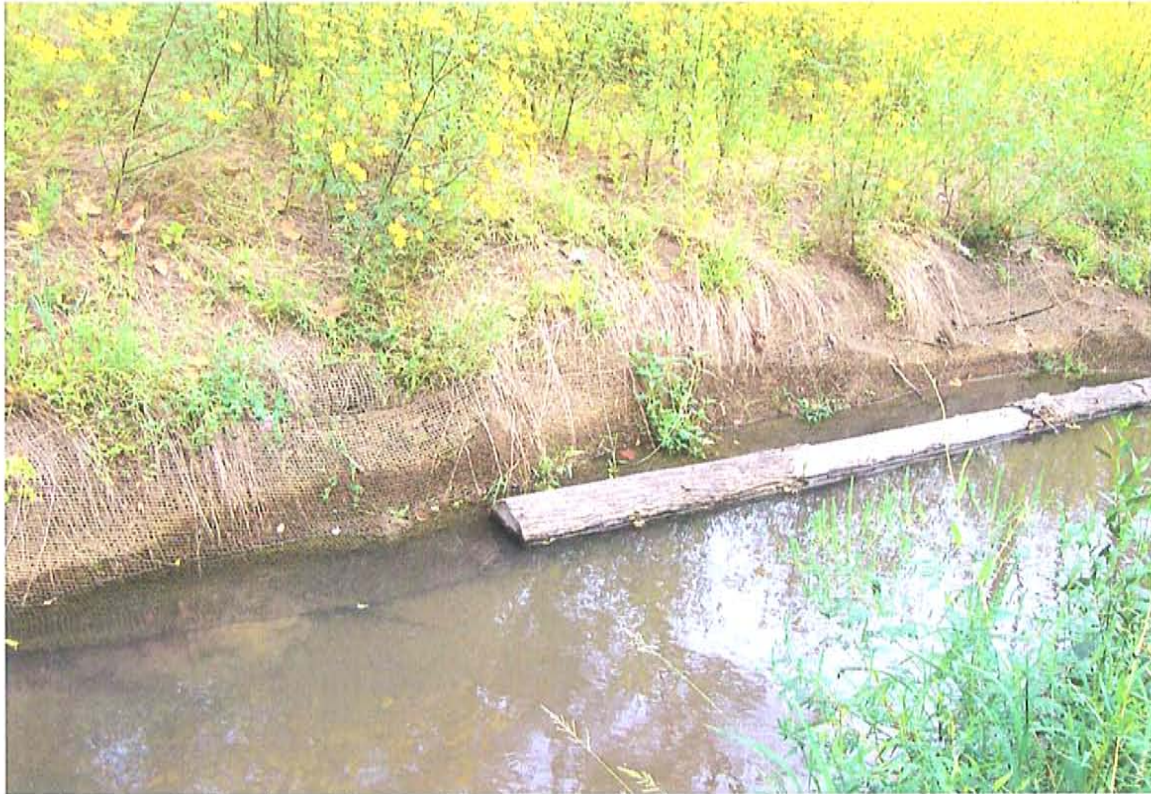
Rocky Branch, (Stations 23+70 – 23+90) Stretch of channel with sloughed banks. View looking across channel from right to left.

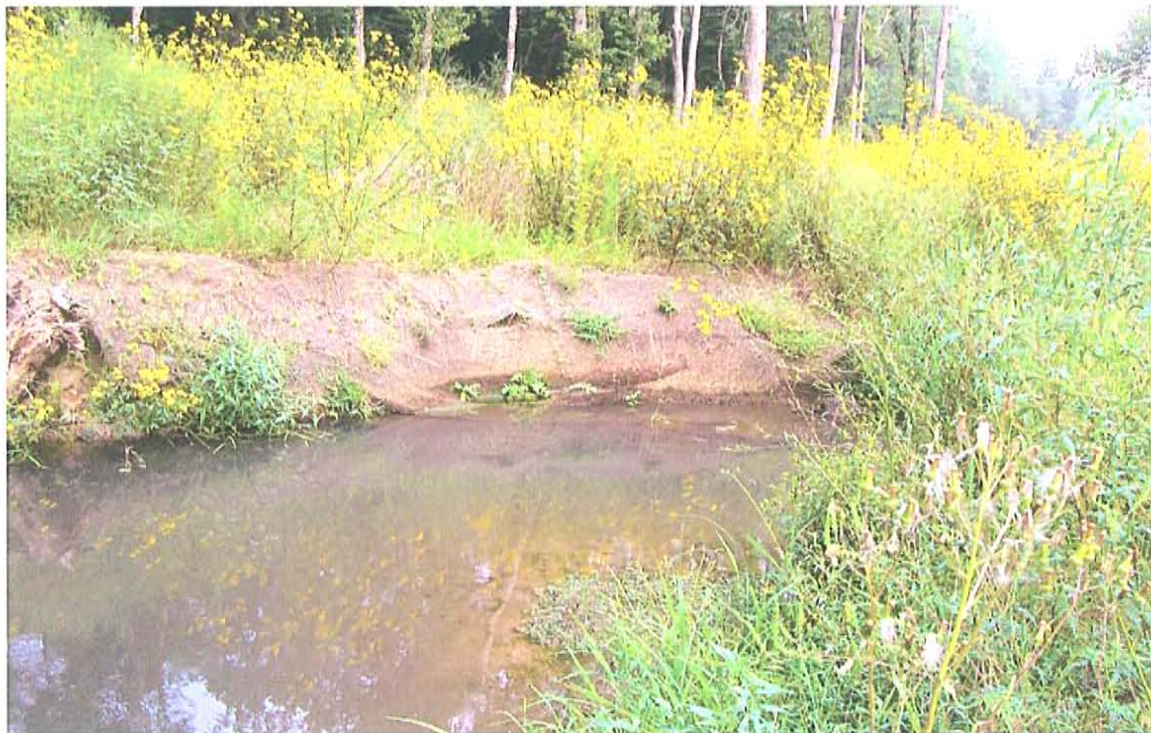
Rocky Branch, (Stations 25+70 – 25+80) Stretch of channel with sloughed banks. View looking across channel from right to left.

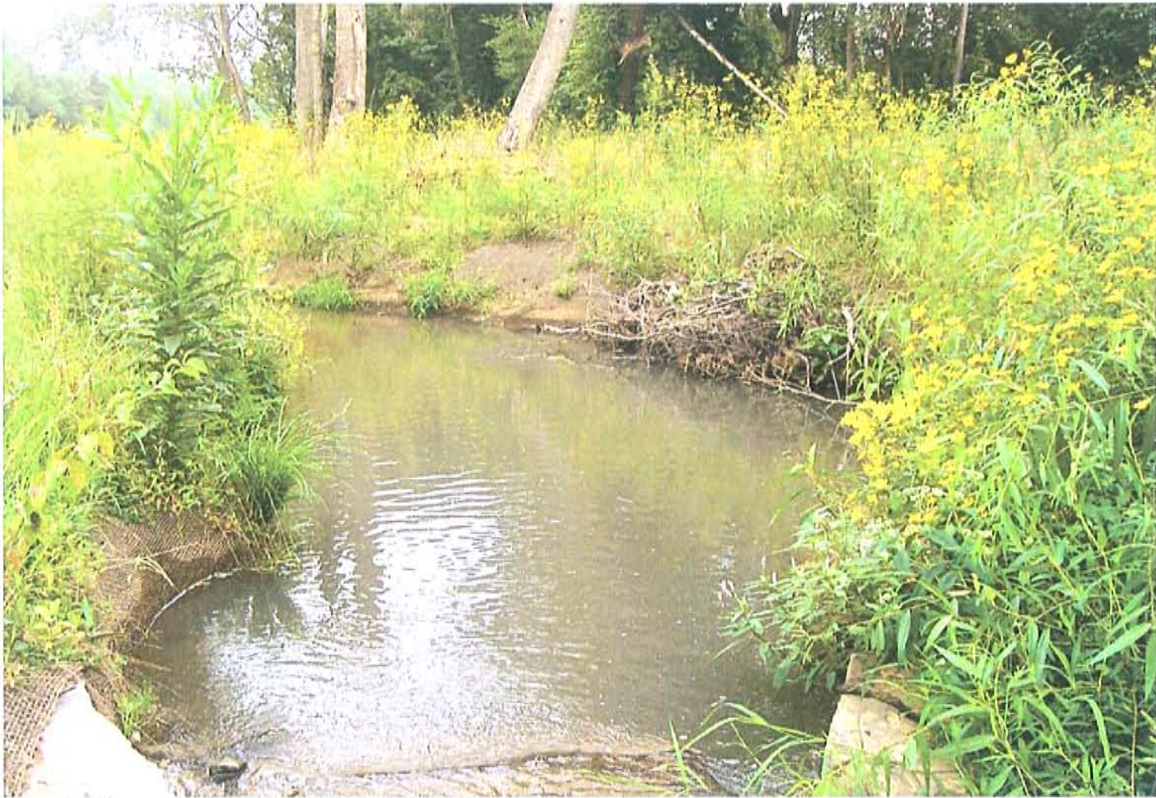
Rocky Branch (Station 22+32) Cross Section 6 – Pool. Large cross sectional area compared with proposed design.

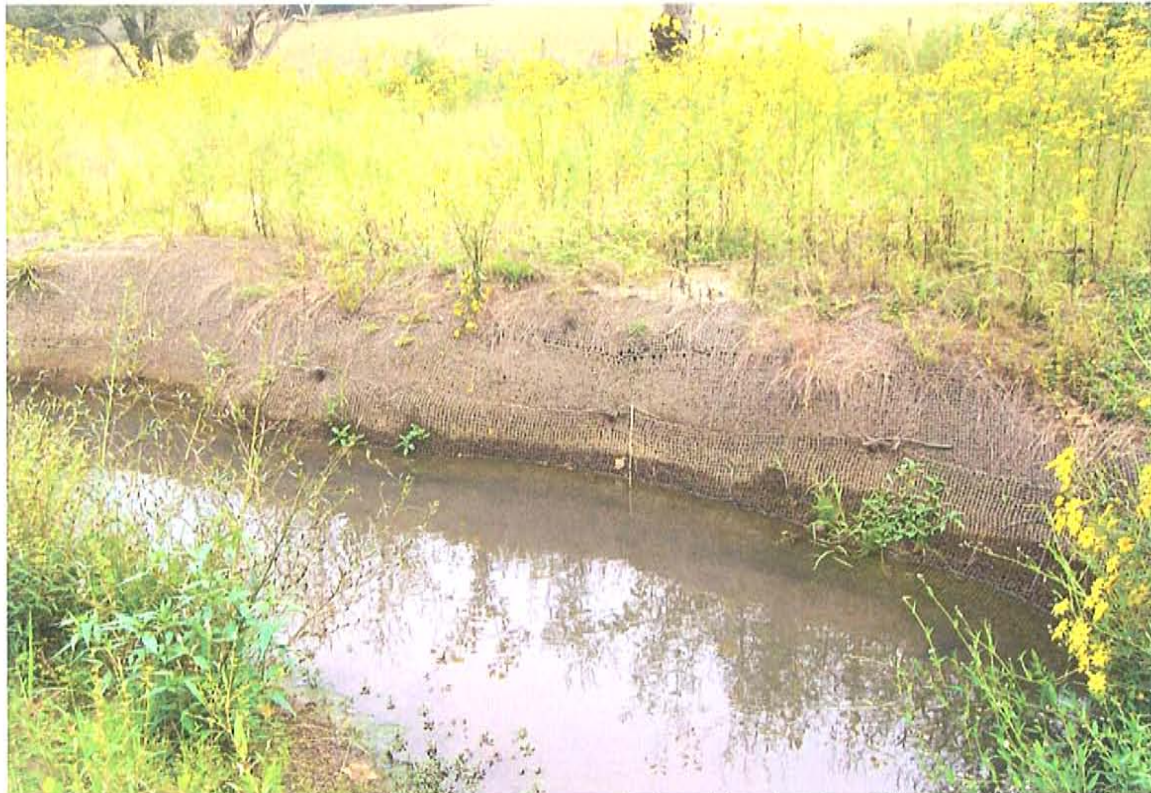
Rocky Branch (Stations 34+00 – 34+30) Area of sloughing banks. View looking across channel from left to right.
