Rocky Branch Stream Restoration

Yadkin County, North Carolina

2008 Year 1 Monitoring Report

EEP Project Number: 308

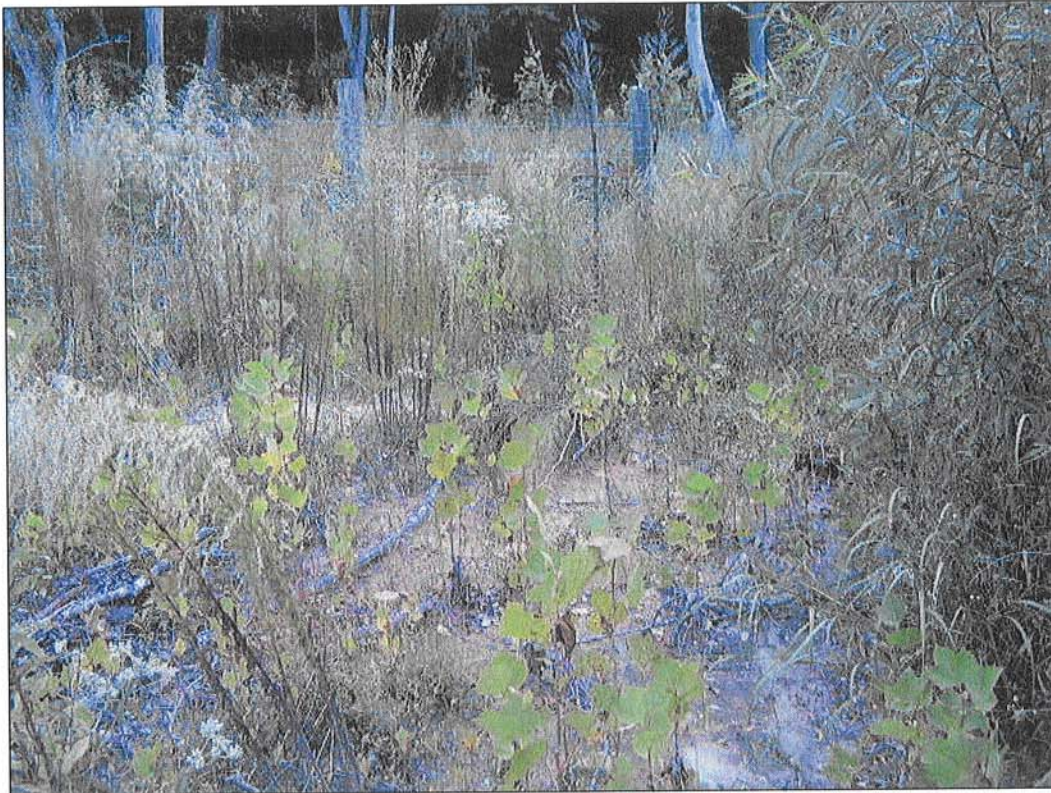
One area, located at Station 1+77, was noted in the As-Built Mitigation Rocky Branch Stream Restoration report as a bare floodplain. This is an eroded area caused by a debris jam. The As-Built Mitigation Rocky Branch Stream Restoration report noted the area was naturally vegetated with sycamore (*Plantanus occidentalis*) seedlings. At the time of the field investigations for the First Year Monitoring, exposed soil persists at the bare floodplain area;

VEGETATION PROBLEM AREA 1: ROCKY BRANCH (STATION I+77) VIEW NEAR I-77 RIGHT-OF-WAY FENCE OF ERODED AREA CAUSED BY A DEBRIS JAM. AREA IS CURRENTLY VEGETATED WITH NATURAL PLATANUS OCCIDENTALIS SEEDLINGS.

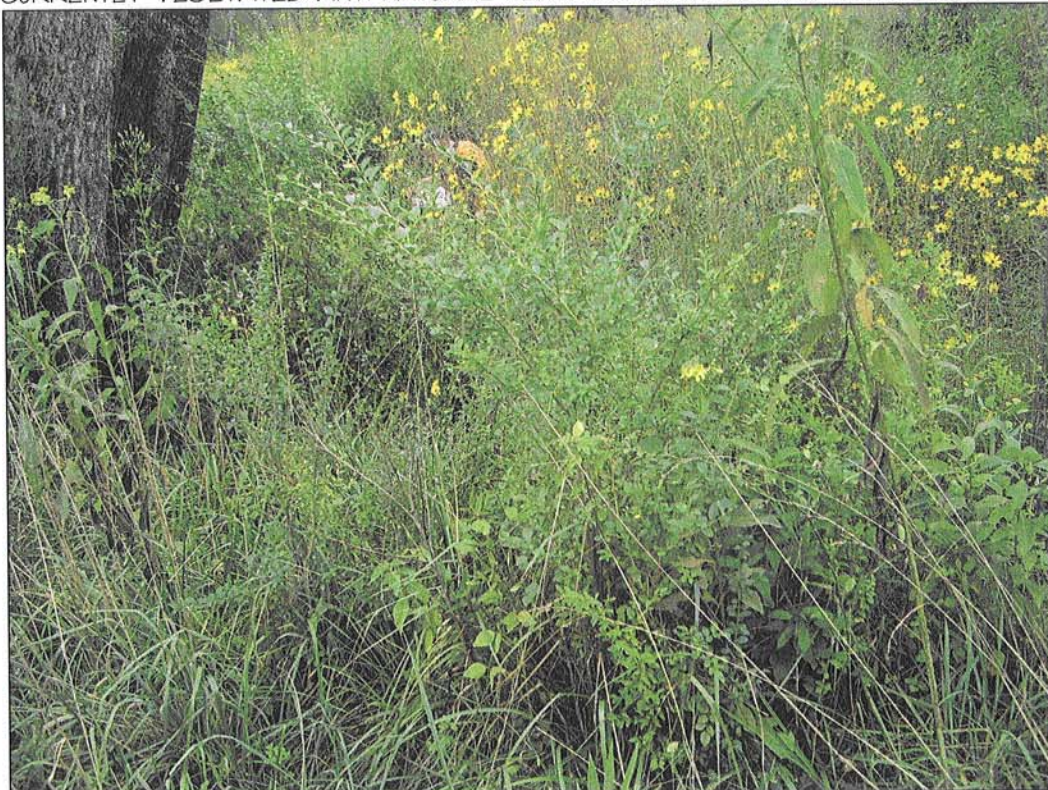
There are areas in which invasive populations have encroached into Rocky Branch Stream Restoration Site. Patches of Chinese privet (*Ligustrum sinense*), Chinese lespedeza (*Lespedeza cuneata*), multiflora rose (*Rosa multiflora*), and Japanese honeysuckle (*Lonicera japonica*) were noted.

VEGETATION PROBLEM AREA 2: LIGUSTRUM SINENSE ENCROACHMENT.

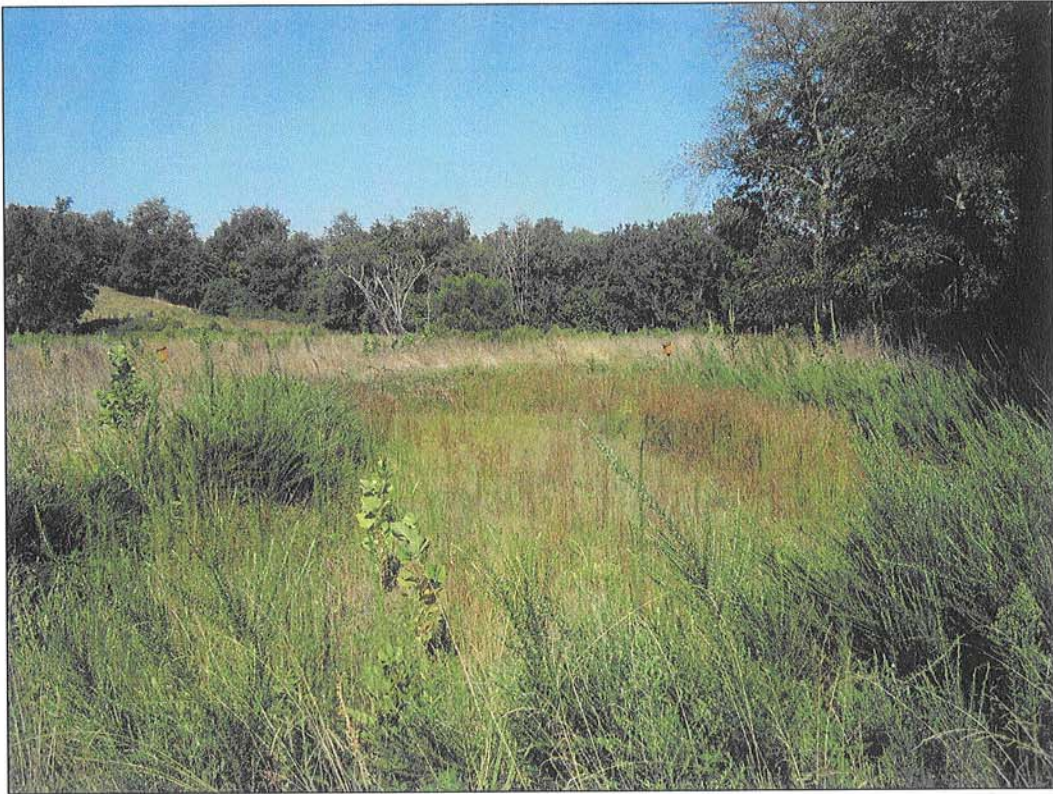
VEGETATION PROBLEM AREA 3: LESPEDEZA CUNEATA ENCROACHMENT.

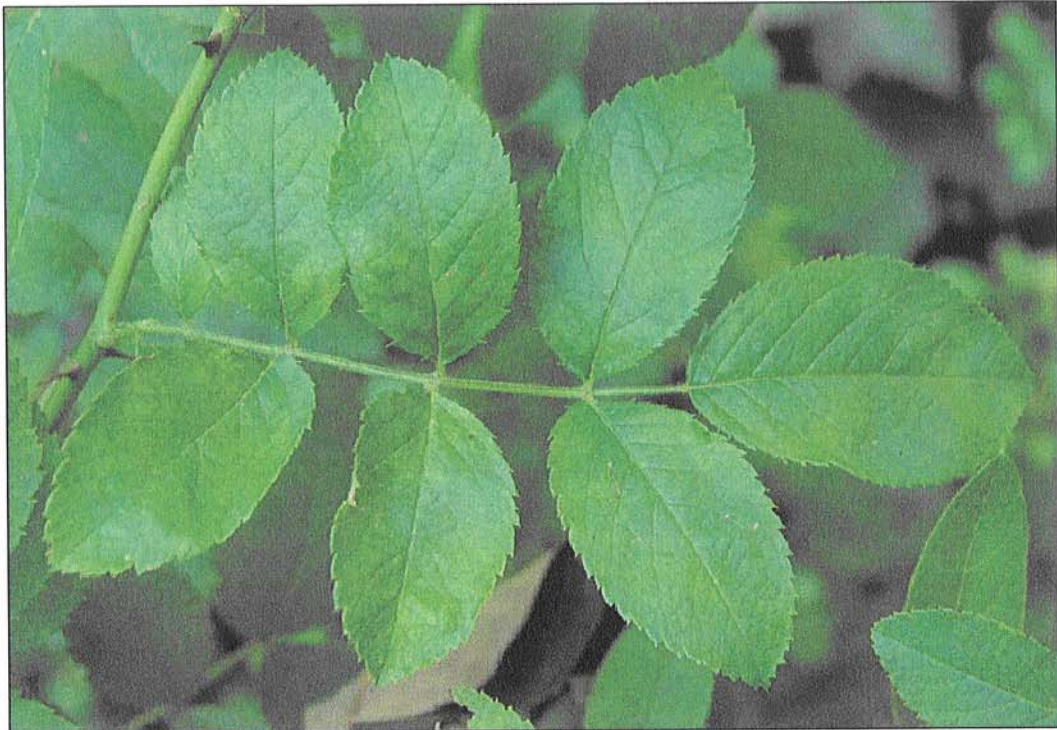
VEGETATION PROBLEM AREA 4: ROSA MULTIFLORA ENCROACHMENT.

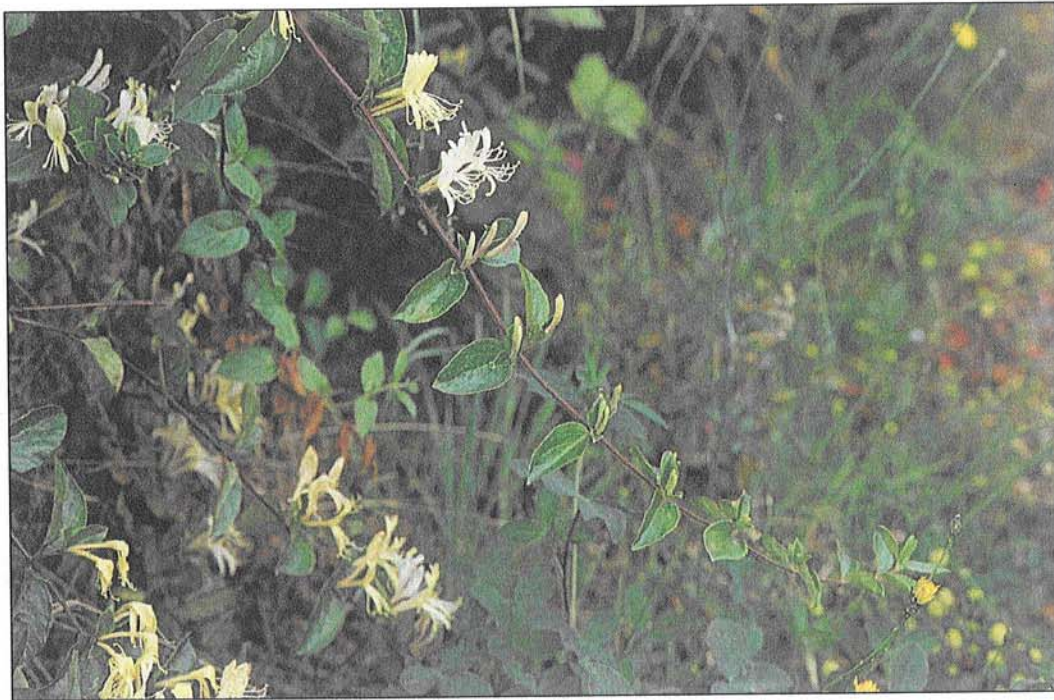
VEGETATION PROBLEM AREA 5: LONICERA JAPONICA ENCROACHMENT.

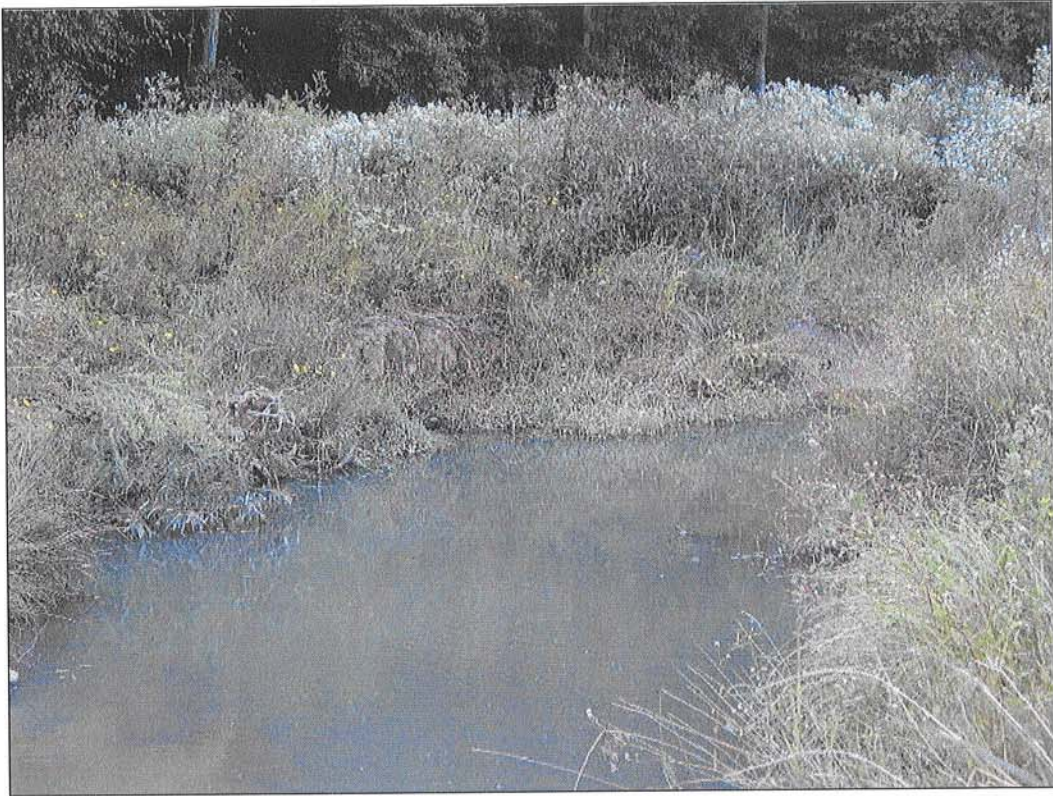
STREAM PROBLEM AREA 1: ROCKY BRANCH (STATIONS 4+10 - 4+20) POOL WITH SLOUGHED BANKS UPSTREAM OF CROSS SECTION 4. VIEW LOOKING DOWNSTREAM.

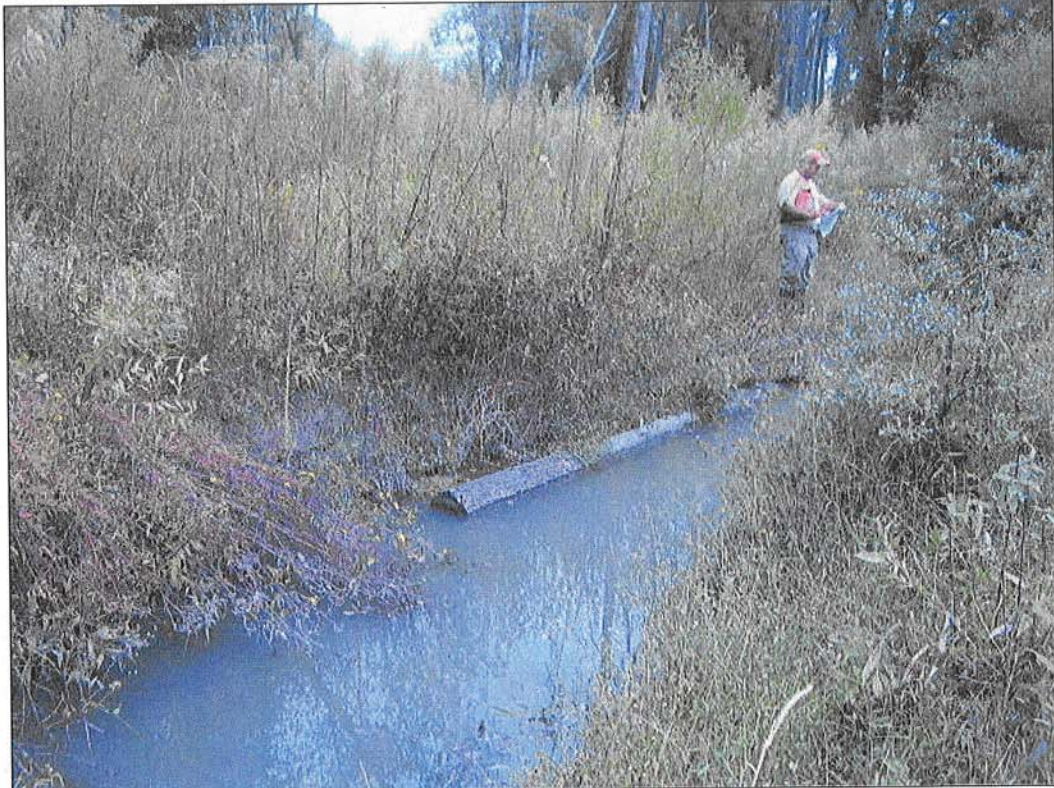
STREAM PROBLEM AREA 2: ROCKY BRANCH (STATIONS 23+70 - 23+90) STRETCH OF CHANNEL WITH SLOUGHED BANKS. VIEW LOOKING ACROSS CHANNEL FROM RIGHT TO LEFT.

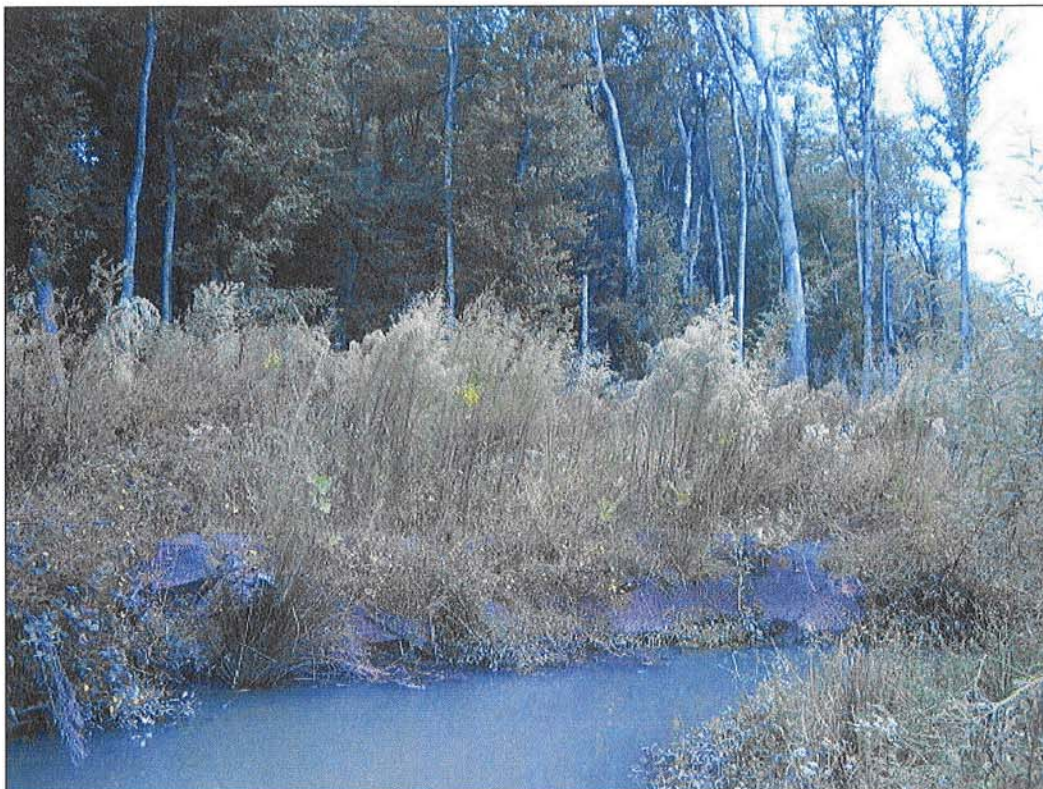
STREAM PROBLEM AREA 3: ROCKY BRANCH (STATIONS 25+70 - 25+80) STRETCH OF CHANNEL WITH SLOUGHED BANKS. VIEW LOOKING ACROSS CHANNEL FROM RIGHT TO LEFT.

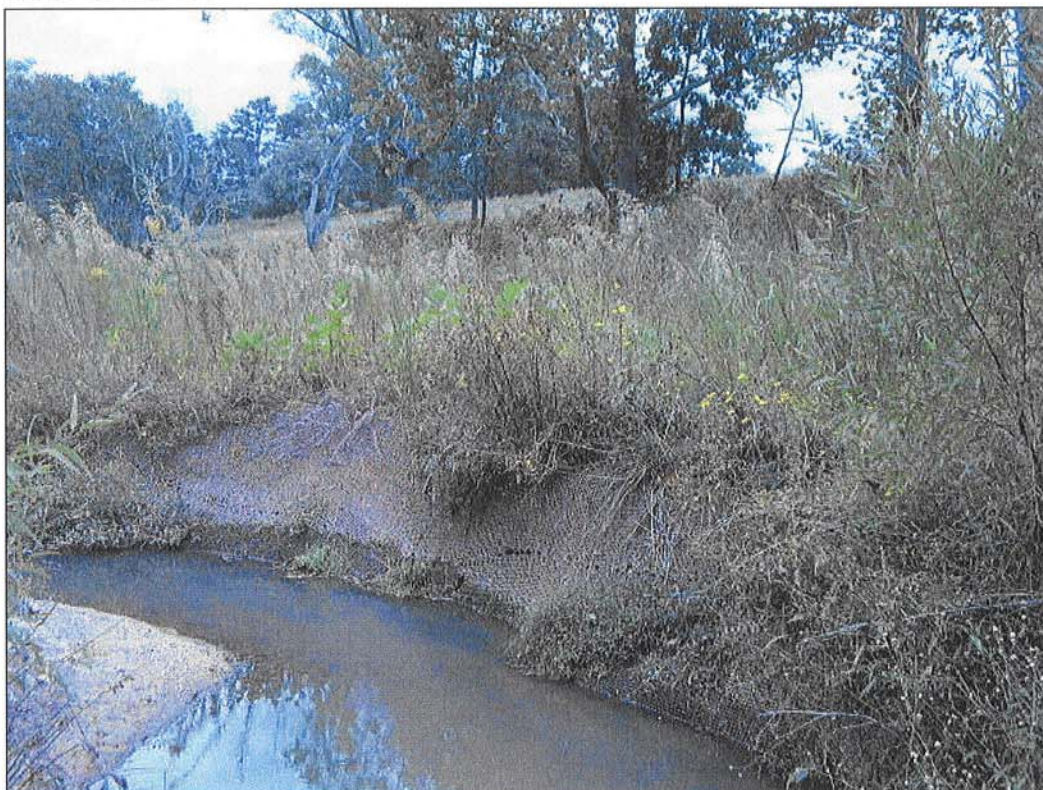
STREAM PROBLEM AREA 4: ROCKY BRANCH (STATIONS 32+80 - 33+00) AREA OF SLOUGHING BANKS. VIEW LOOKING ACROSS CHANNEL FROM LEFT TO RIGHT.

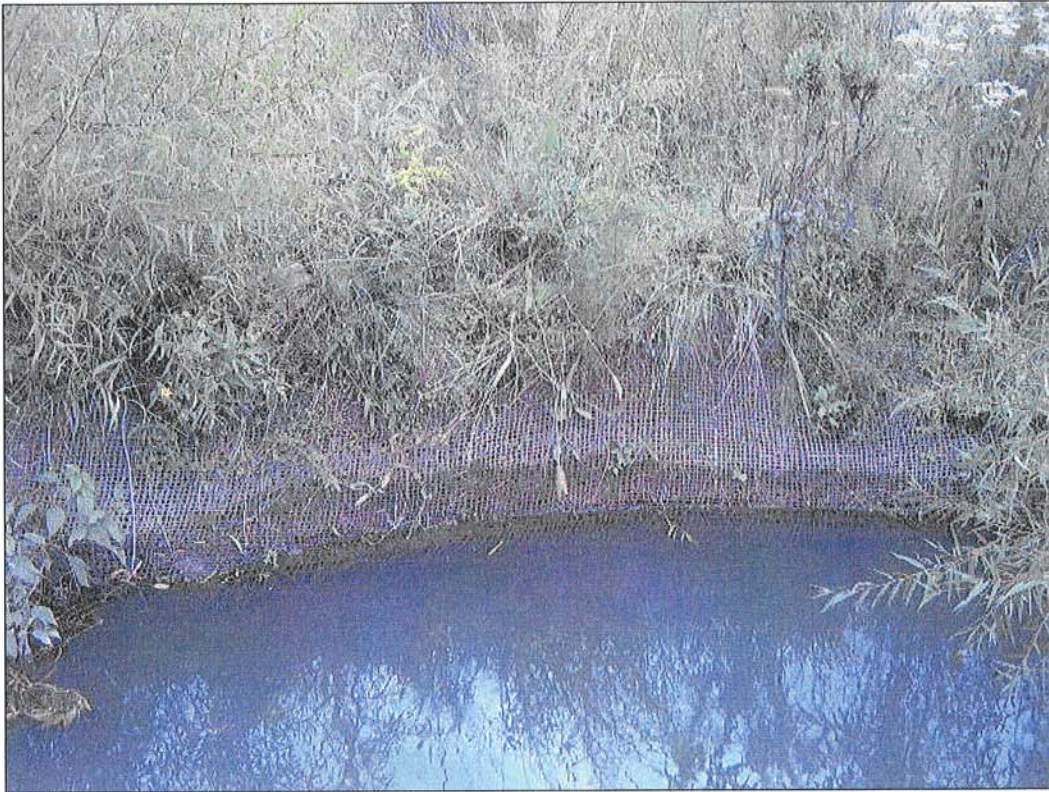
STREAM PROBLEM AREA 5: ROCKY BRANCH (STATIONS 34+00 - 34+30) AREA OF SLOUGHING BANKS. VIEW LOOKING ACROSS CHANNEL FROM LEFT TO RIGHT.
