YEAR 1 MONITORING REPORT

ROSES CREEK STREAM MITIGATION SITE
Burke County, North Carolina
NC DMS Project # 96309

Construction Completed: May 2016
Morphology Data Collected: November 22, 2016
Vegetation Data Collected: October 5, 2016
Submitted: December 2016

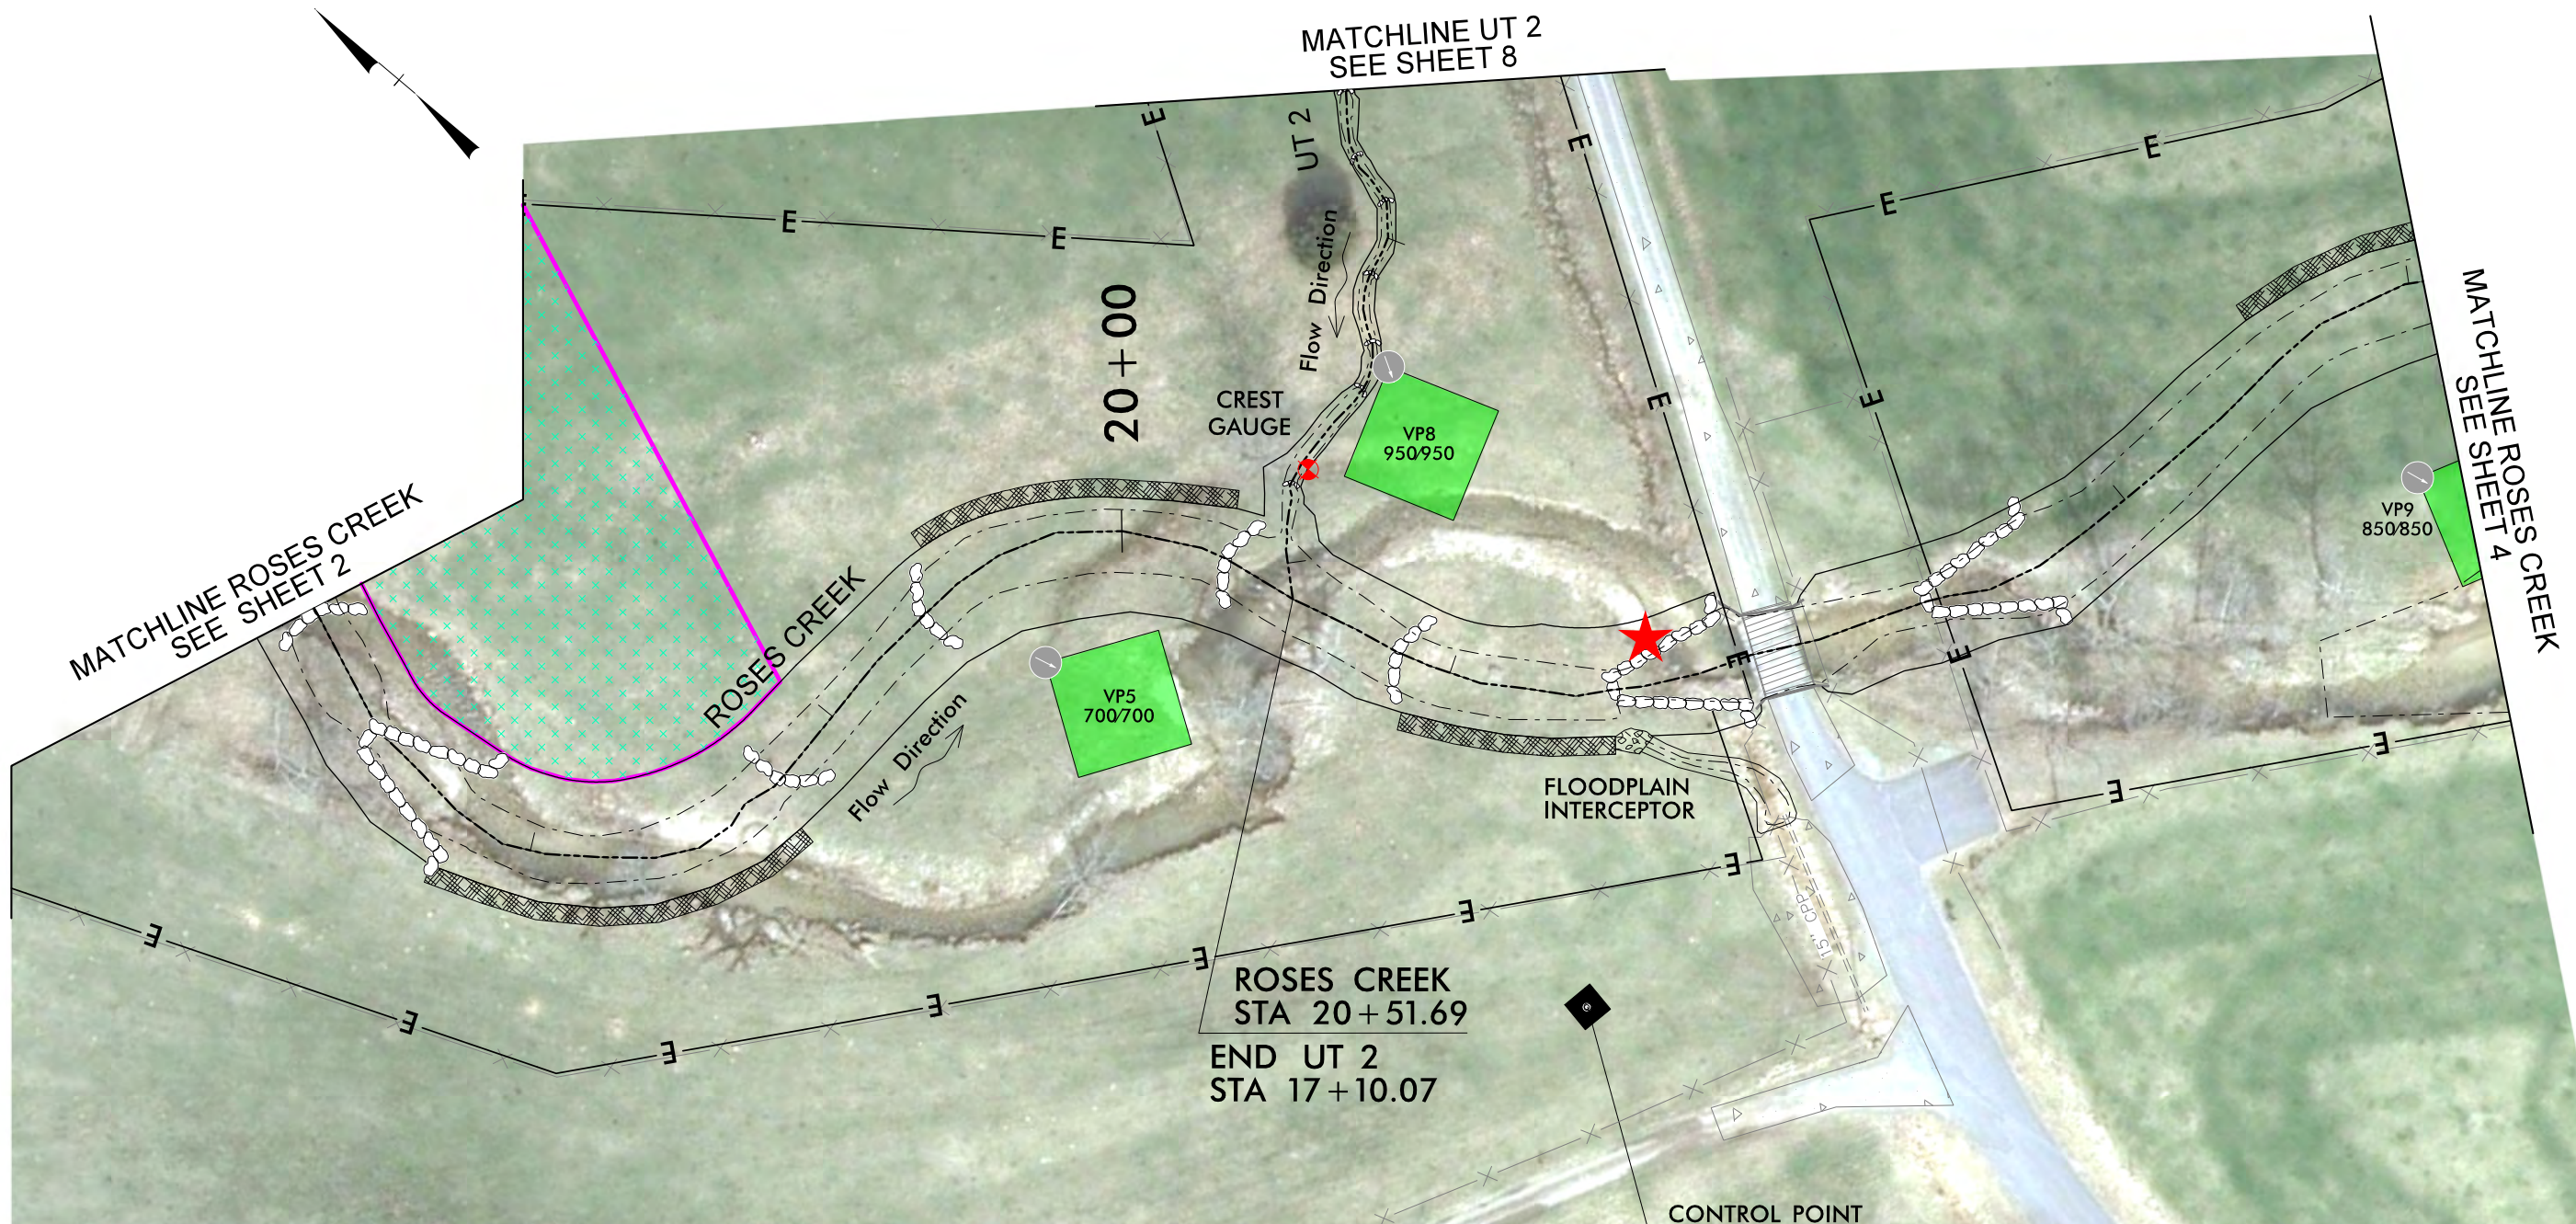
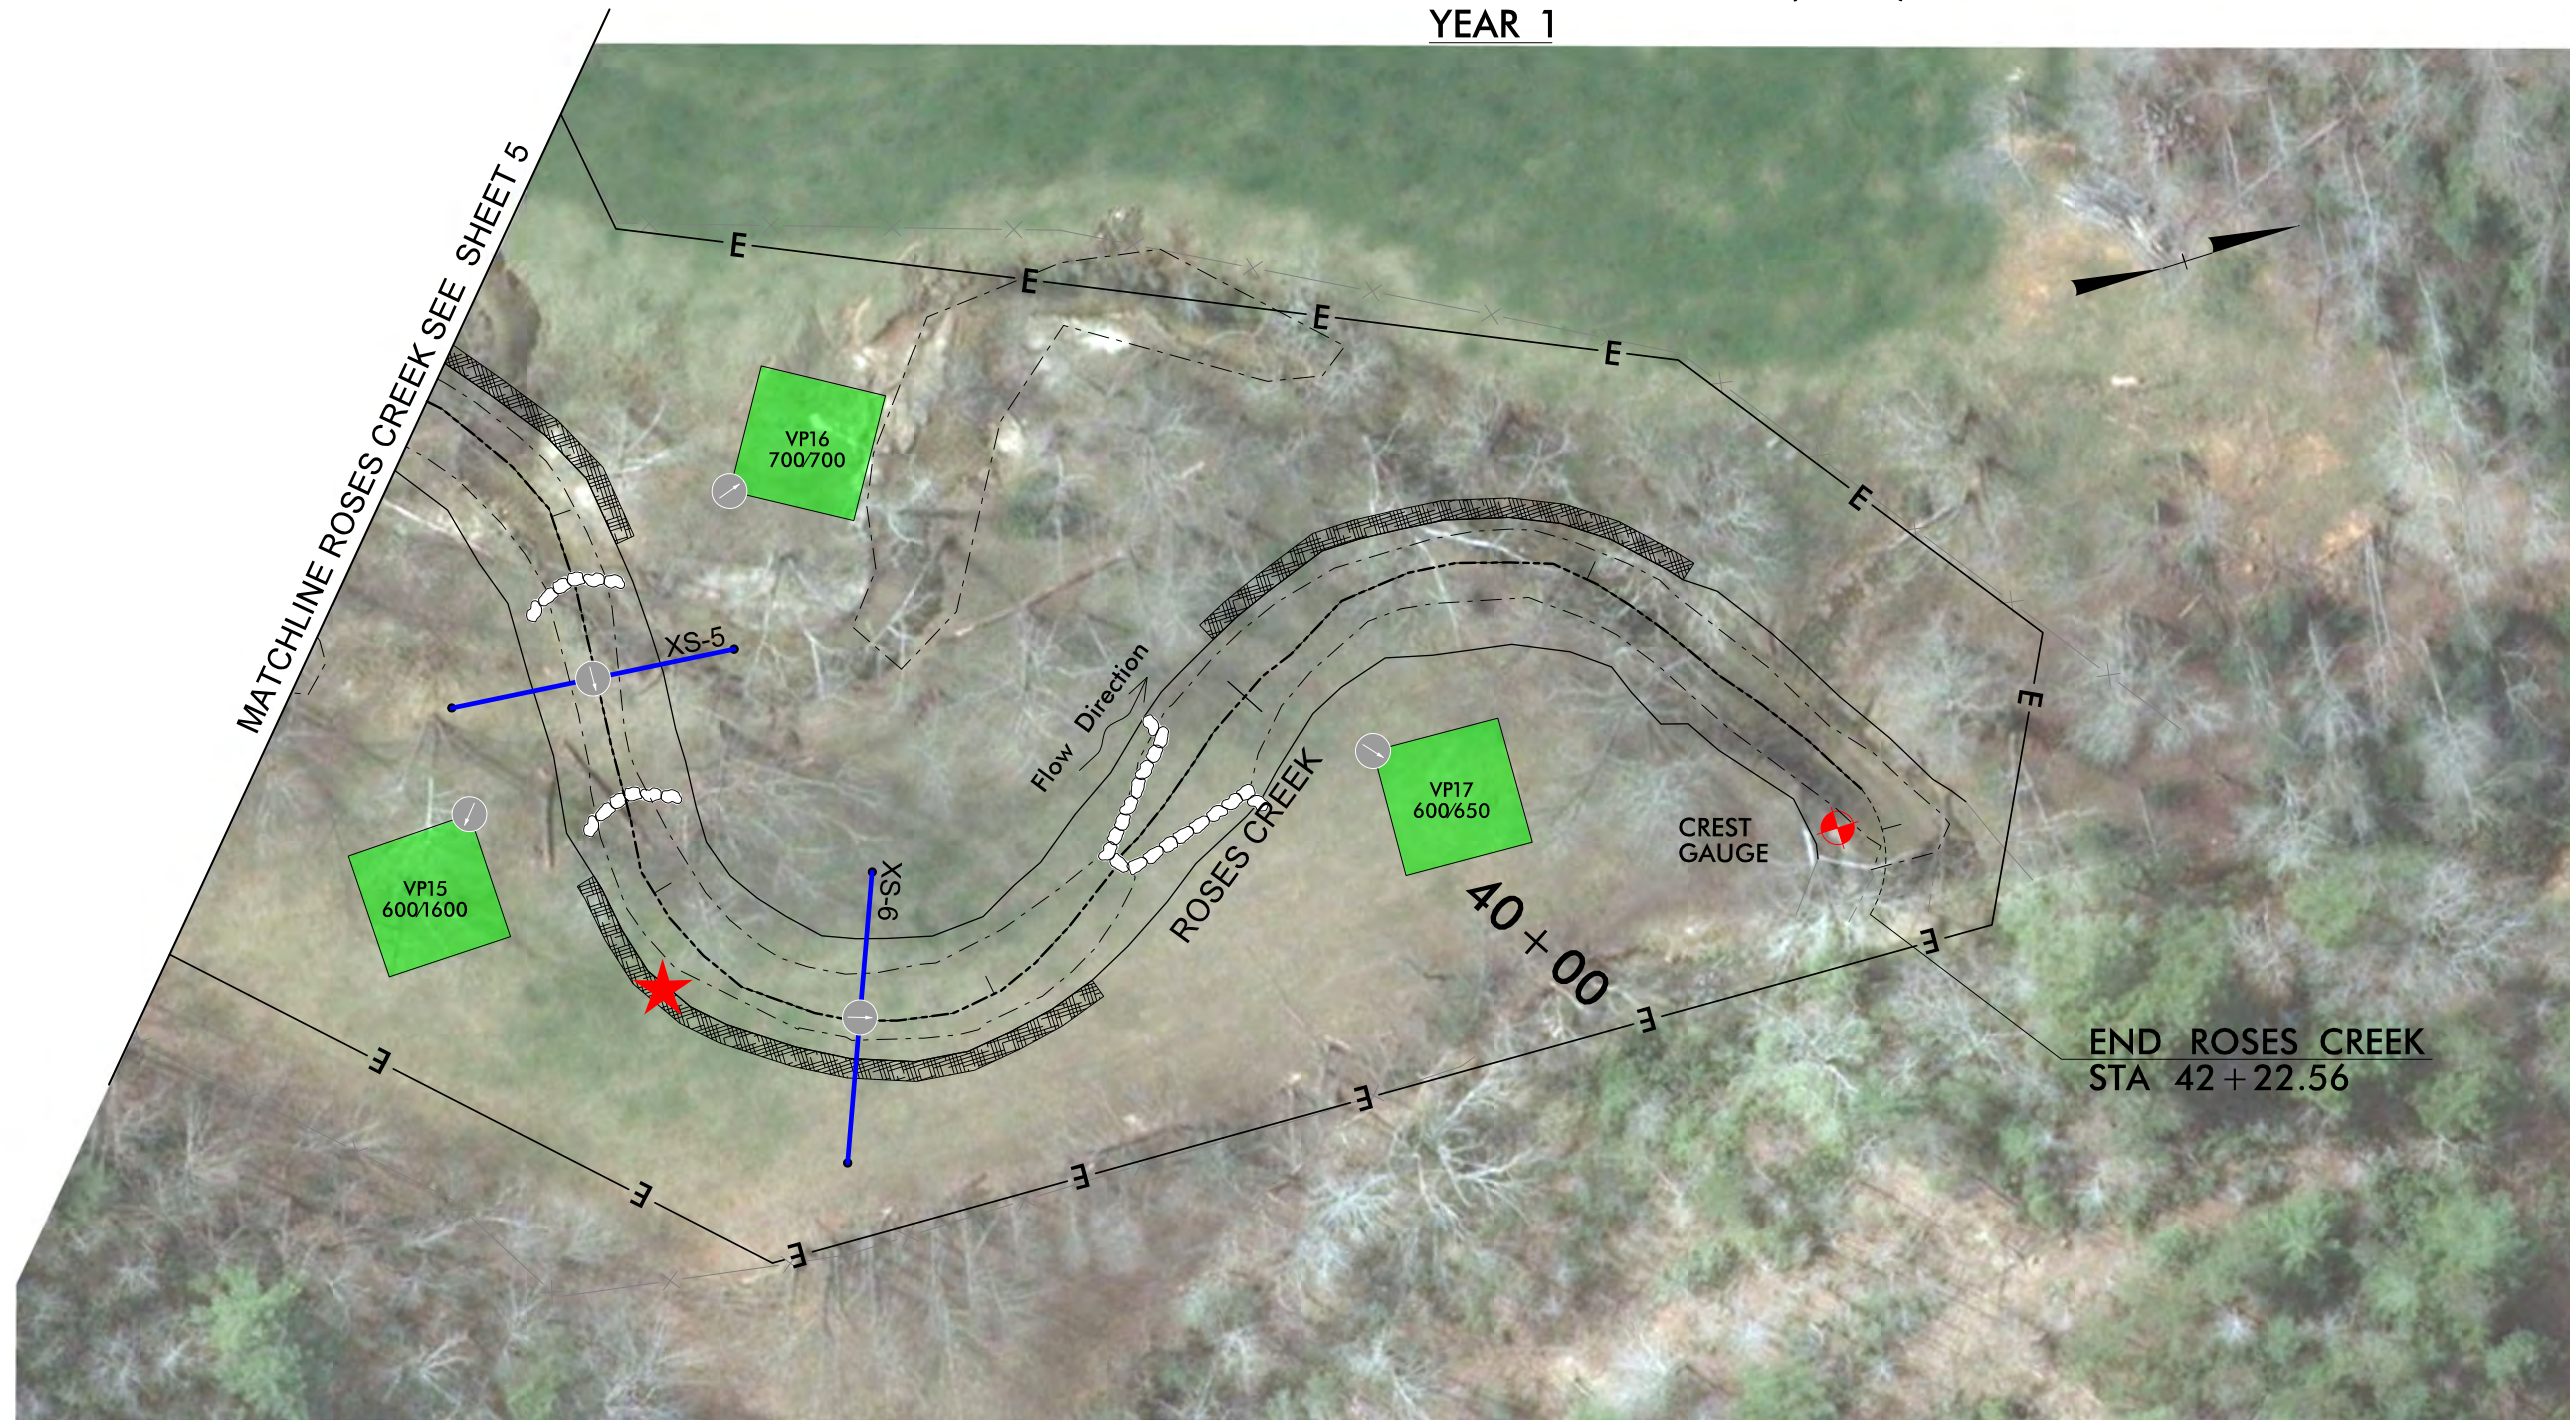
Two small holes were noted on-site where backfill from construction has settled. HDR|ICA will monitor these areas to ensure that they do not increase in size.
