YEAR 2 MONITORING REPORT

ROSES CREEK STREAM MITIGATION SITE
Burke County, North Carolina
NC DMS Project No. 96309

Construction Completed: May 2016
Morphology Data Collected: June 1, 2017
Vegetation Data Collected: August 14, 2017
Submitted: December 2017

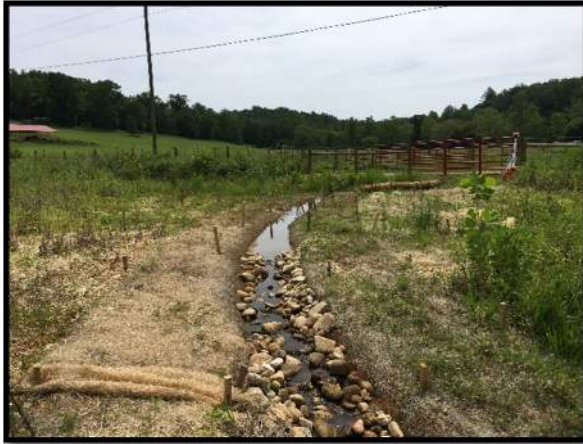
A large tree stump has washed downstream into the project area indicating that the site has experienced heavy flows over the past year. The stump has not caused any damage but its effect on the stream will continue to be monitored by HDR | ICA. Wrack lines were noted along the top of bank on the main channel. The crest gauge at the downstream end of the main channel indicates that Roses Creek overtopped its banks at least one time during the first half of the monitoring year. A second bankfull event was also documented by the landowner in October 2017. Crest gauge records are provided in Appendix E.

**3.18 Stump washed into project area
STA 13+40 (Roses Creek)**

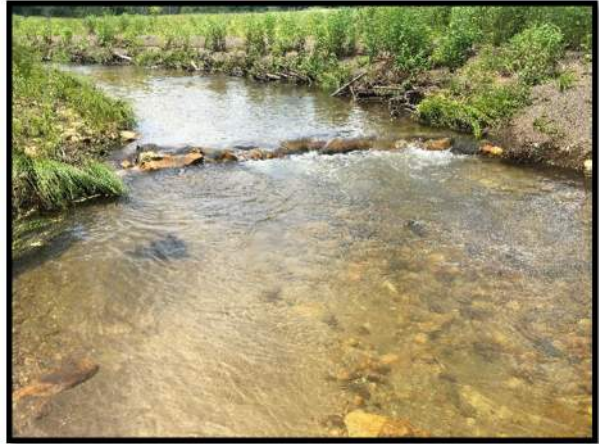
Near the confluence of UT 2 and Roses Creek, a small conveyance was created to drain standing water in the floodplain that was encroaching upon the land owner's driveway. This conveyance was lined with rock along the bottom and common rush (*Juncus effusus*) was planted at the outlet to prevent any erosion to the bank of Roses Creek. Coir fiber matting, straw, and a native seed mixture was applied to the surrounding area to stabilize of any bare soil.

**3.19 Conveyance created at
STA 20+75 (Roses Creek)**

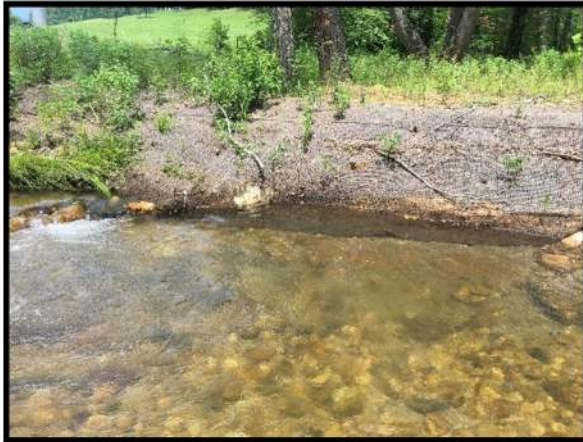
Two holes along the bank of Roses Creek were repaired at the downstream end of the project. One of the holes was converted into a floodplain interceptor lined with rock and common rush to prevent further erosion to the bank. Two areas of minor bank erosion are present along the banks of Roses Creek at stations 36+33 and 37+31. It is expected these areas will stabilize over time as herbaceous vegetation establishes along the banks. A small scour pool has developed

immediately downstream of a rock step structure at station 37+25. HDR | ICA will continue to monitor these areas closely over the next monitoring year.

**3.20 Scour below rock step structure
STA 37+25 (Roses Creek)**

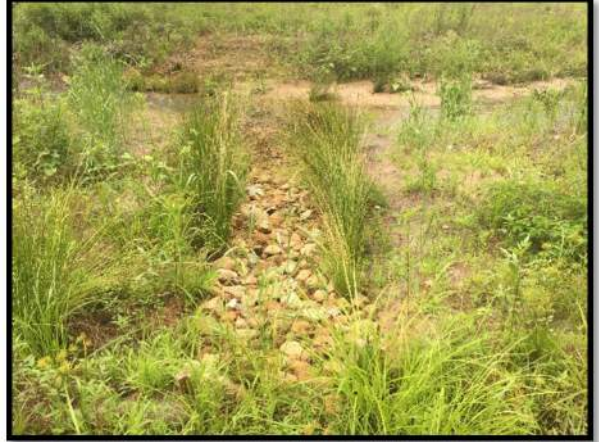
**3.21 Minor erosion at rock step structure
STA 37+27 (Roses Creek)**

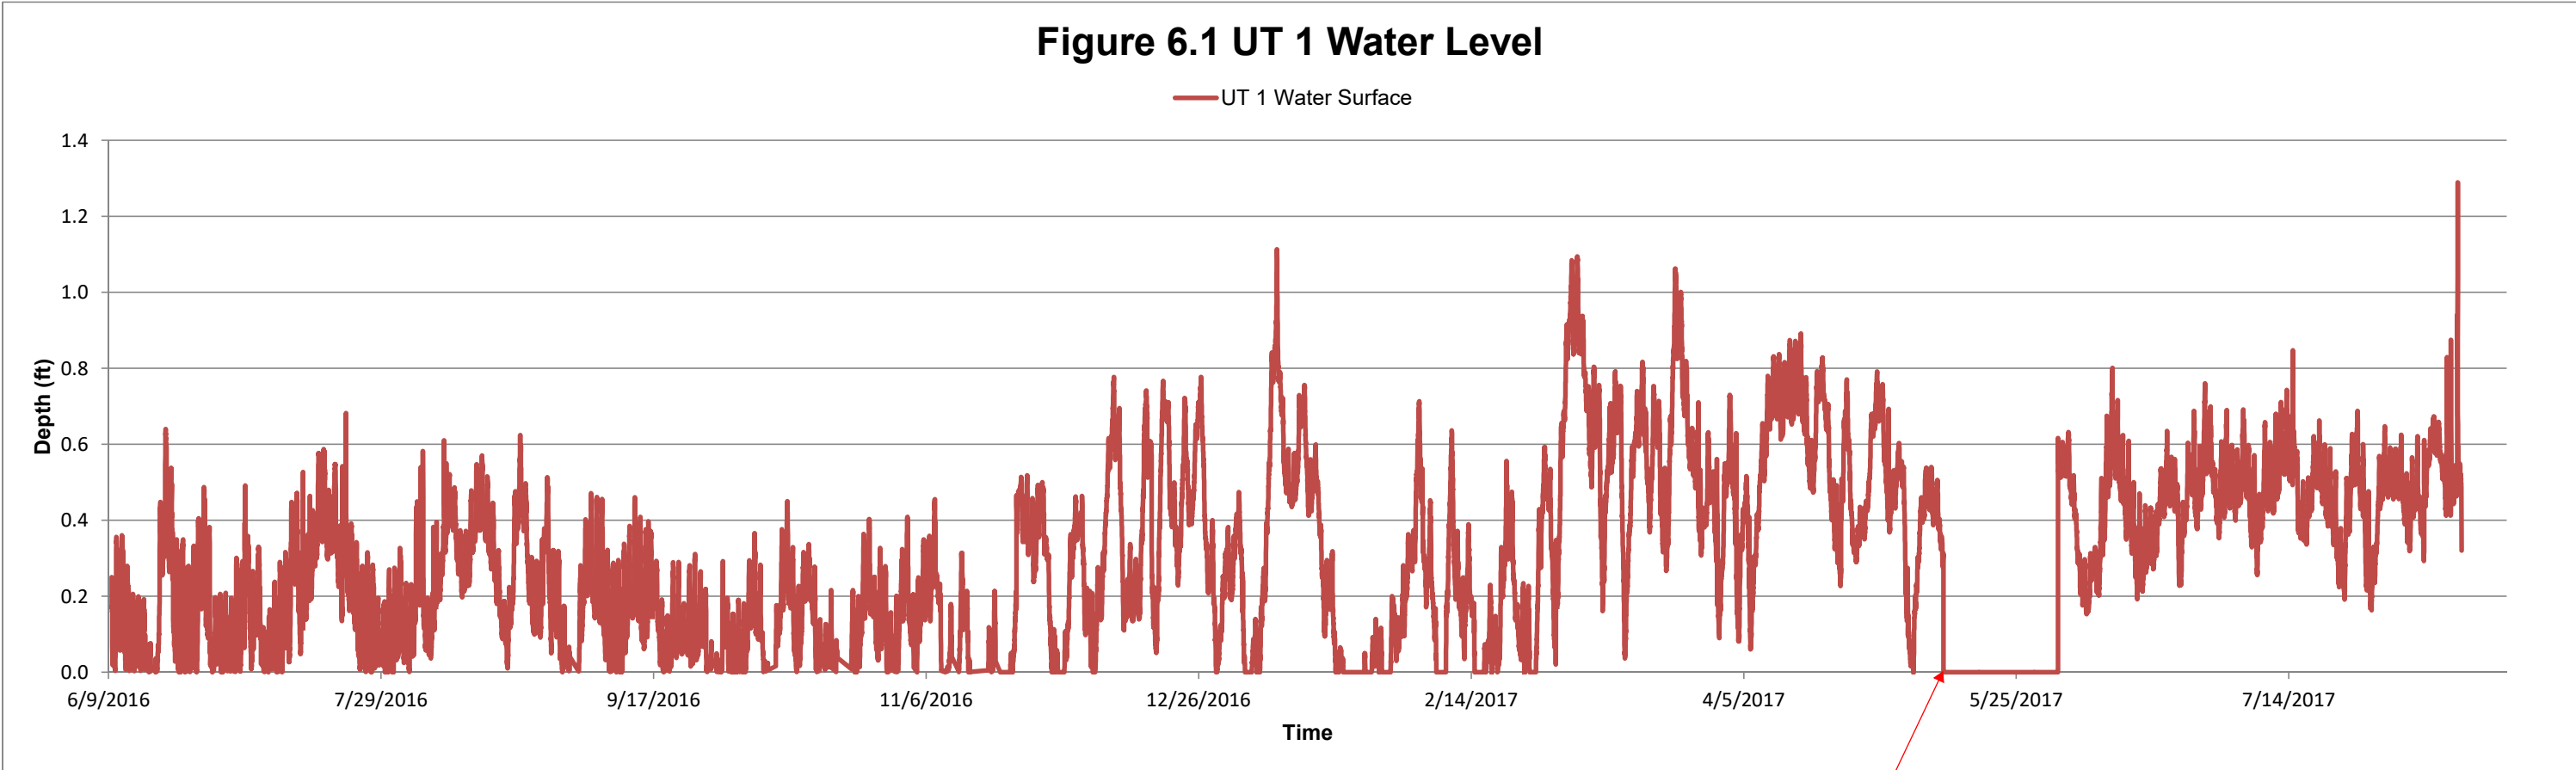
Figure 6.1 UT 1 Water Level

Based on water level data obtained using the Hobo U20 pressure transducers installed in the bottom of each tributary, all three have indicated consistent flow throughout the past monitoring year. It is worth noting that there is a brief period of data missing during the month of May 2017 due to a computer software malfunction. Water level data is provided in Appendix E as well.

Water level data missing
5/11/2017 - 6/1/2017

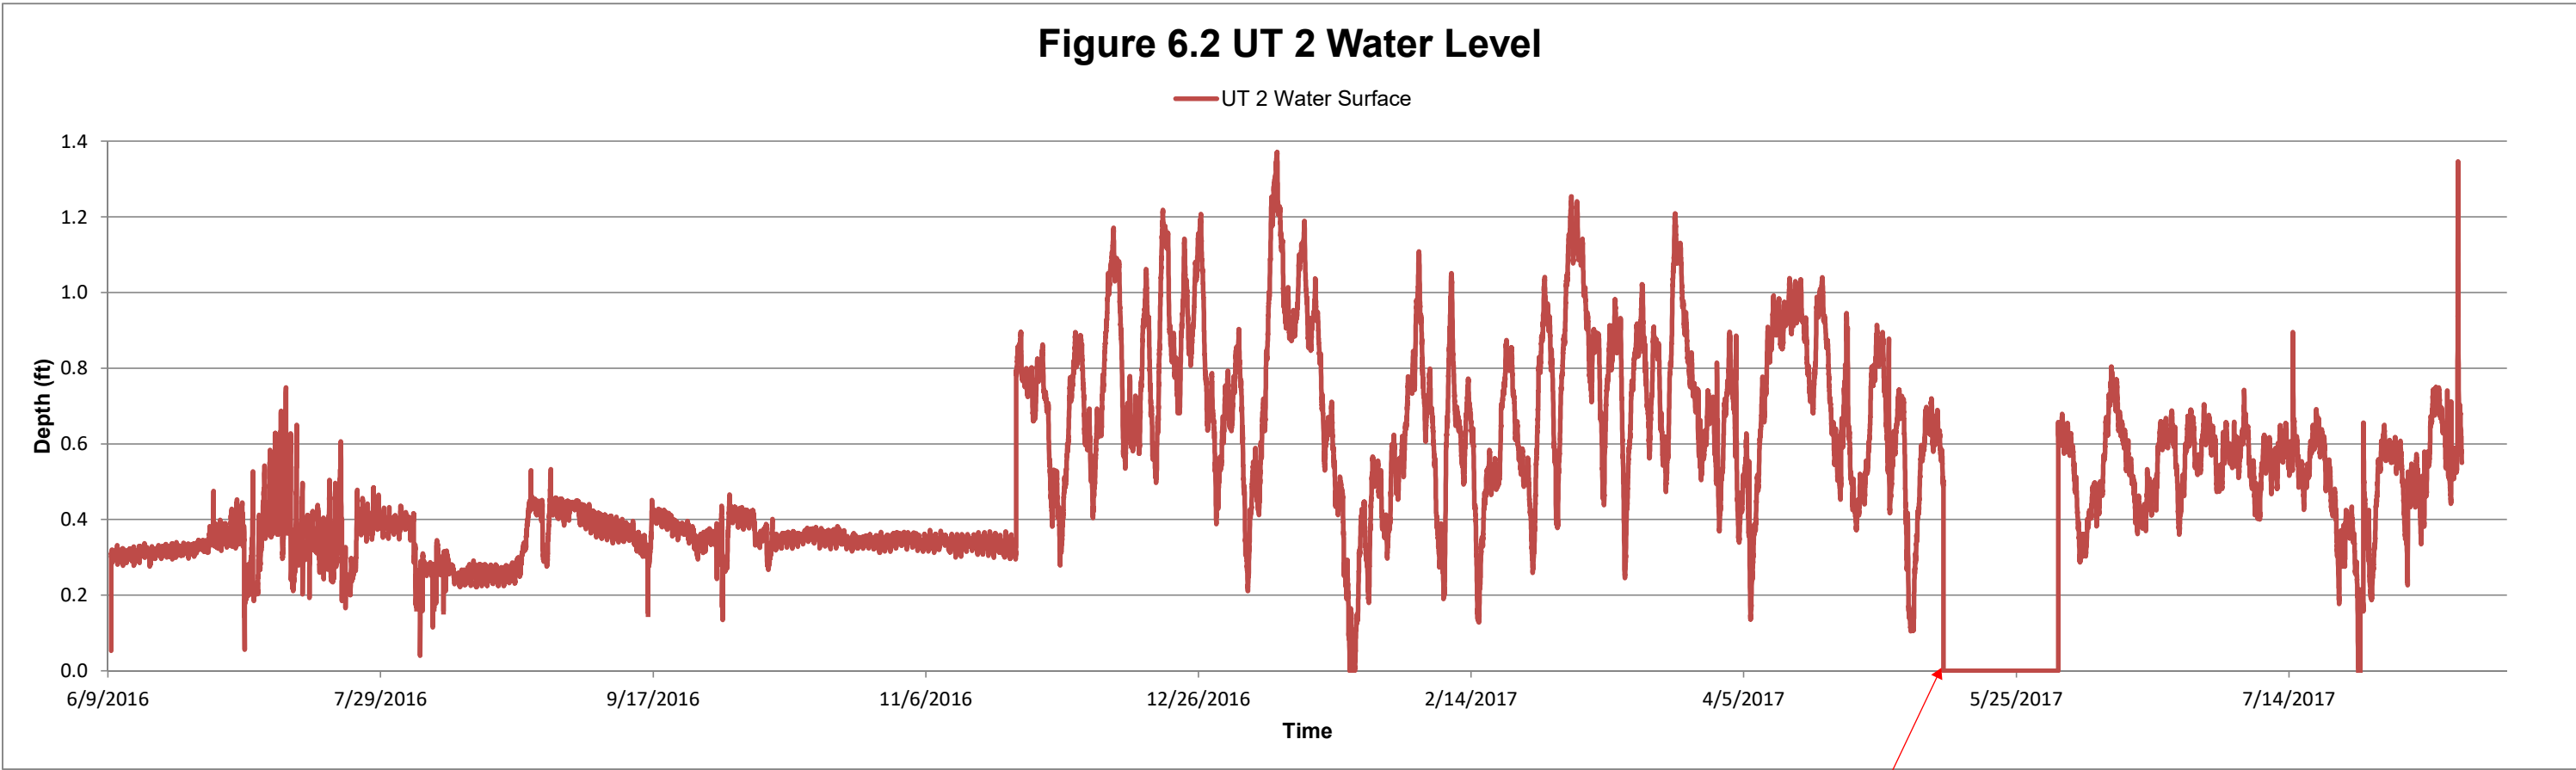
Figure 6.2 UT 2 Water Level

Water level data missing
5/11/2017 - 6/1/2017

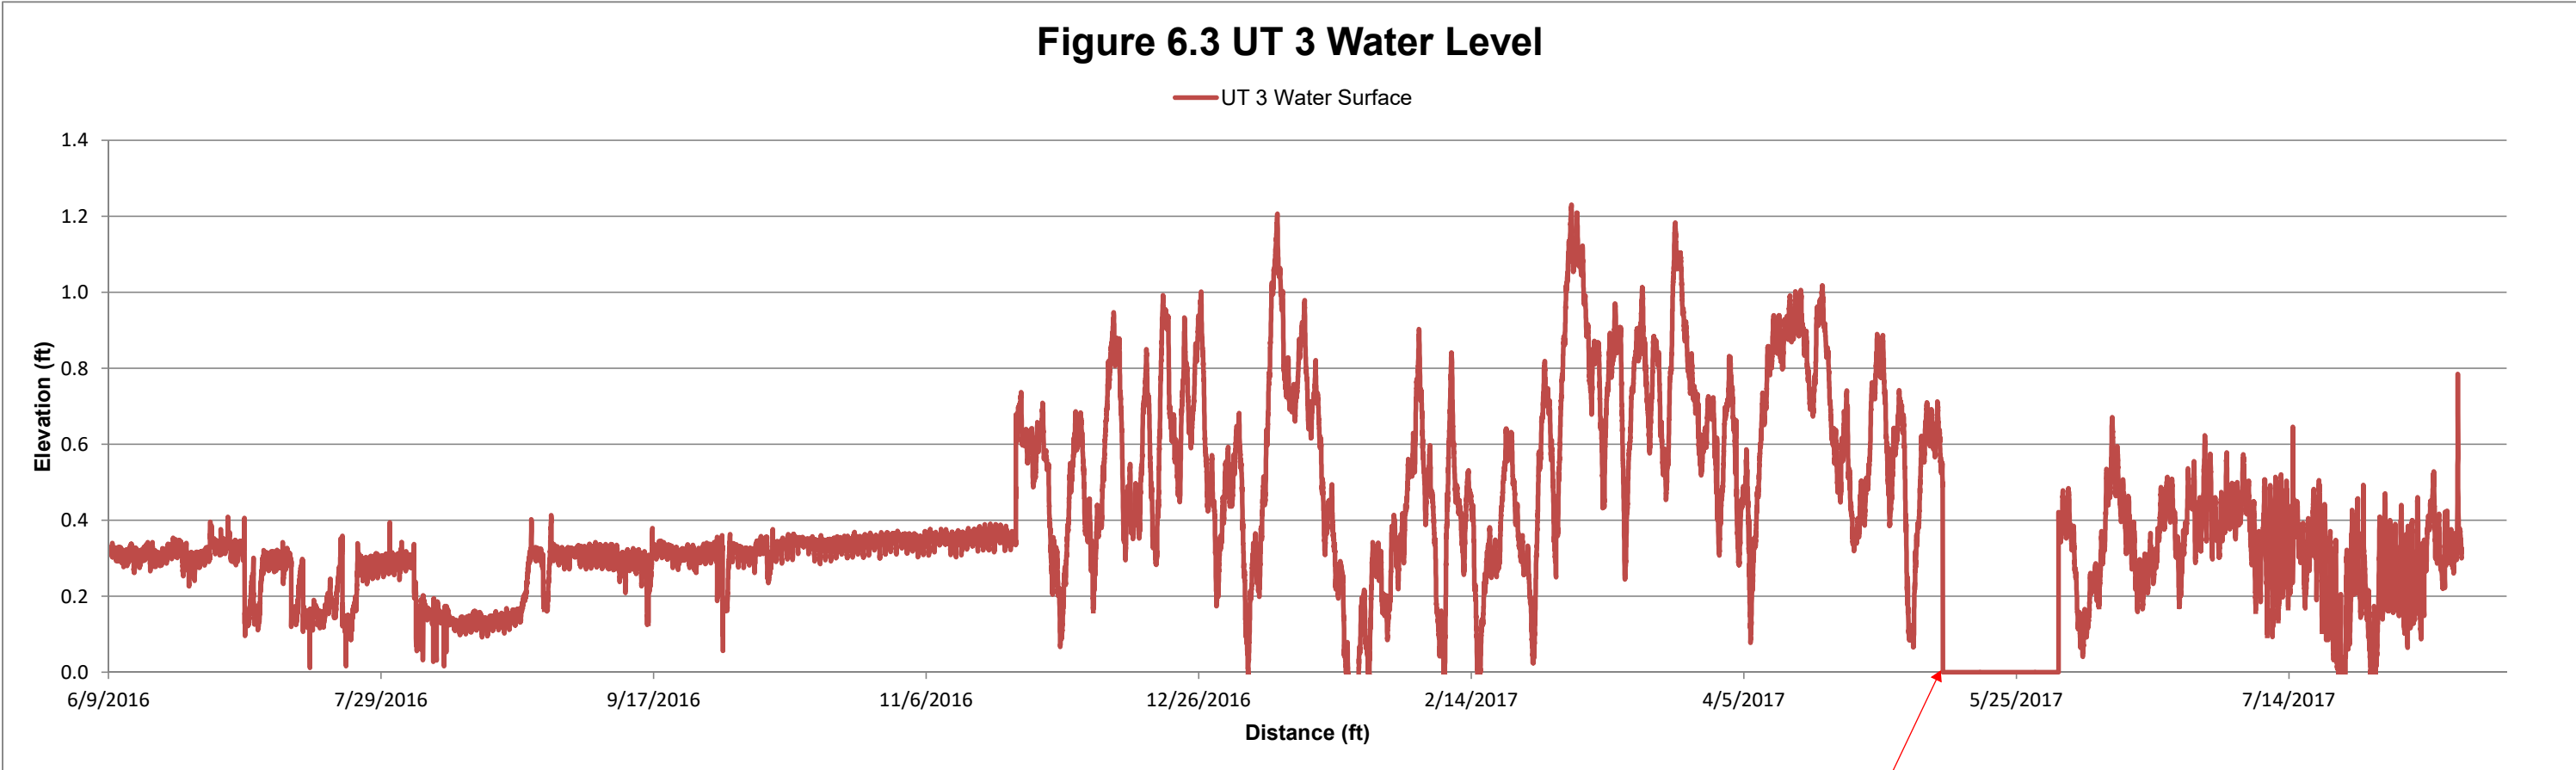
Figure 6.3 UT 3 Water Level

Water level data missing
5/11/2017 - 6/1/2017

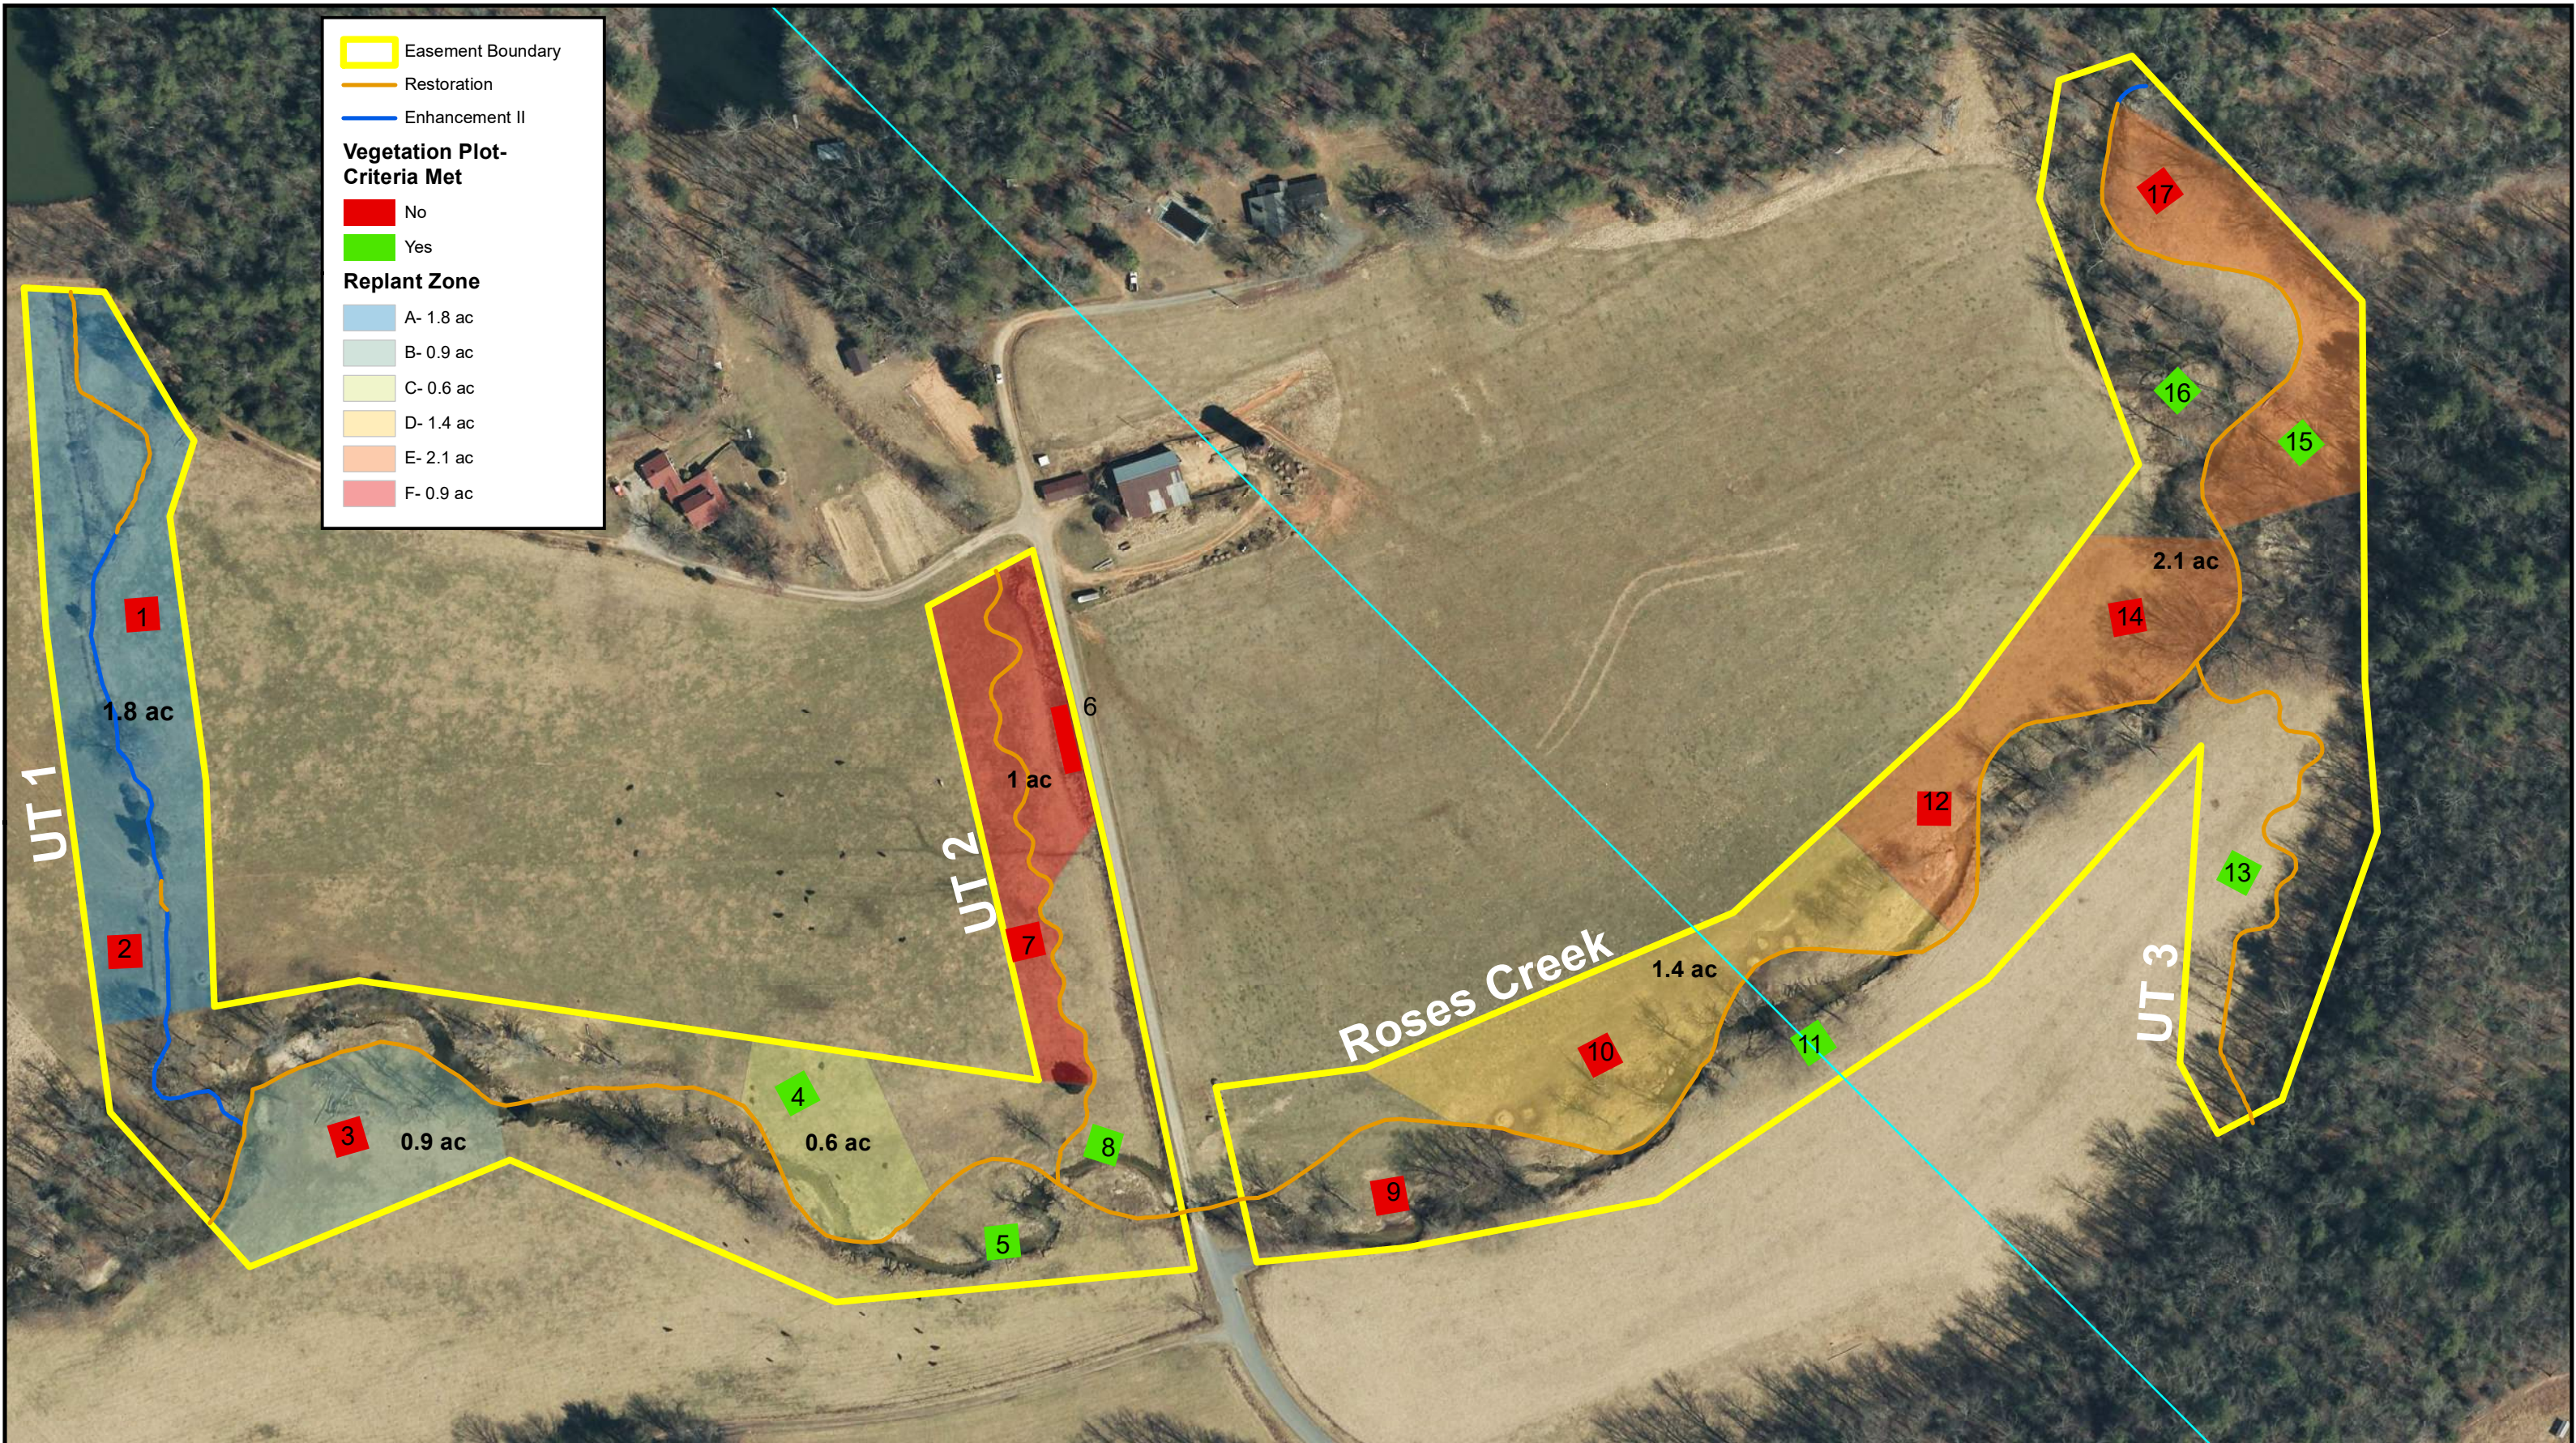
Roses Creek Replanting Map- 2017

Planted stems along UT 1 and UT 2 have been heavily browsed upon by deer. Deer trails were noted through Plot 1 and while all the planted stems in this plot were either dead or missing, stems in the surrounding area showed signs of browsing. A large deer bed was discovered at the center of Plot 2 and only one stem has survived after supplemental planting.

Supplemental planting for the Site is scheduled for Winter of 2018 as part of the corrective action plan developed to address planted stem mortality. Supplemental planting will include species that are less desirable to deer to increase the planted stem survivability. The corrective action plan separates the Site into 6 zones, to identify low stem density areas within the site. Figure 7.1 and Tables 13 and 13a depict each planting zone and corresponding species list and planting densities (Appendix F).
