YEAR 3 MONITORING REPORT

ROSES CREEK STREAM MITIGATION SITE

Burke County, North Carolina
NC DMS Project # 96309

Construction Completed: May 2016
Morphology Data Collected: March 28, 2018
Vegetation Data Collected: August 6, 2018
Submitted: December 18, 2018

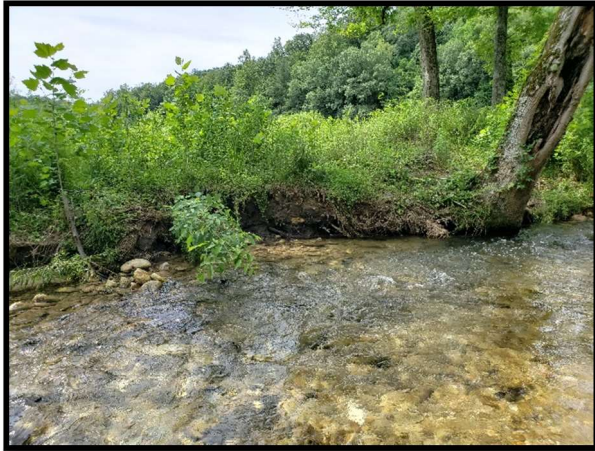
Roses Creek and its tributaries have remained in stable, functioning condition over the past monitoring year with the exception of bank/overbank erosion at stations: 10+91 -11+25, 12+69 - 12+91, 35+90 – 36+18, 37+18 – 37+30 and 39+26 - 39+44. These areas of erosion were repaired by Land Mechanic Design, Inc. between September 26, 2018 and October 2, 2018. Furthermore, the rock step structure originally installed at station 37+18 was relocated to station 37+30 due to severe erosion around the structure. A soil lift was installed immediately upstream of the relocated structure which extends 20 feet upstream. Repair work photos are included in Appendix B.

3.18 Erosion at station 10+91-11+25

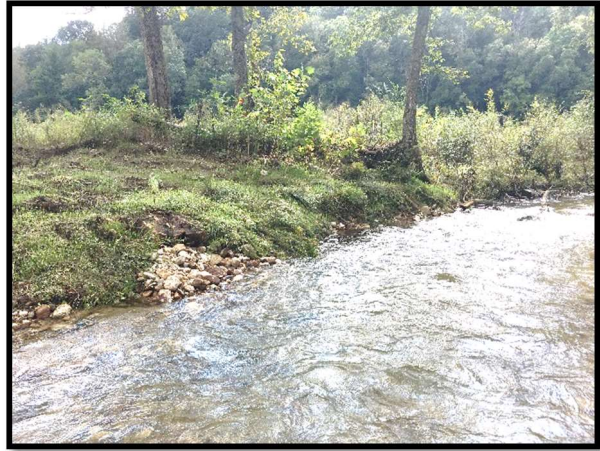
3.19 Repair at station 10+91-11+25

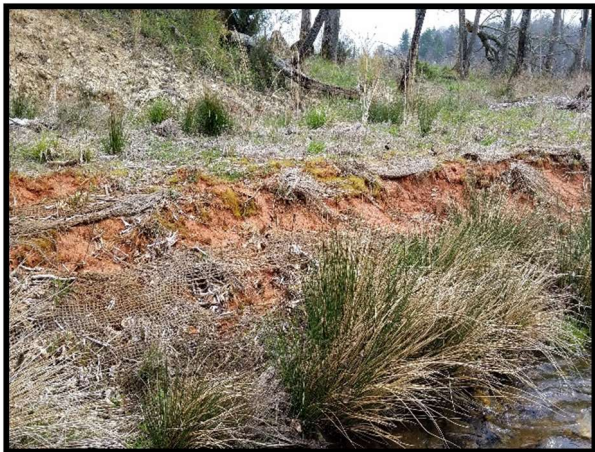
3.20 Erosion at station 12+69-12+91

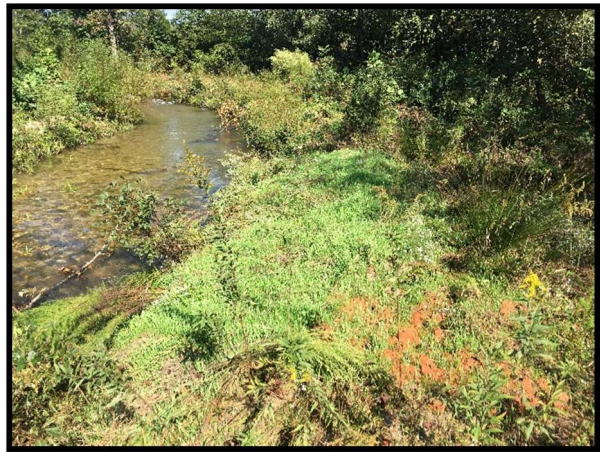
3.21 Repair at station 12+69-12+91

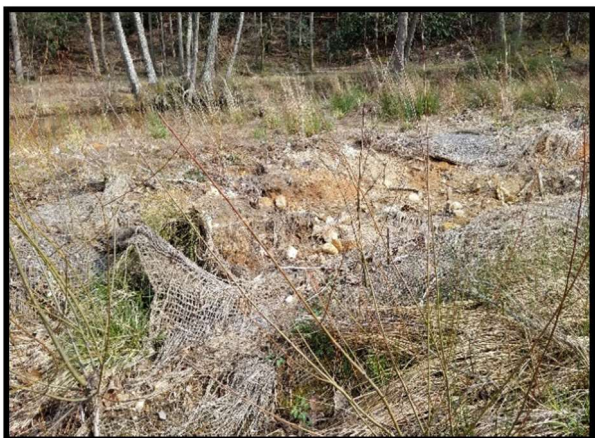
3.22 Erosion at station 35+90-36+18

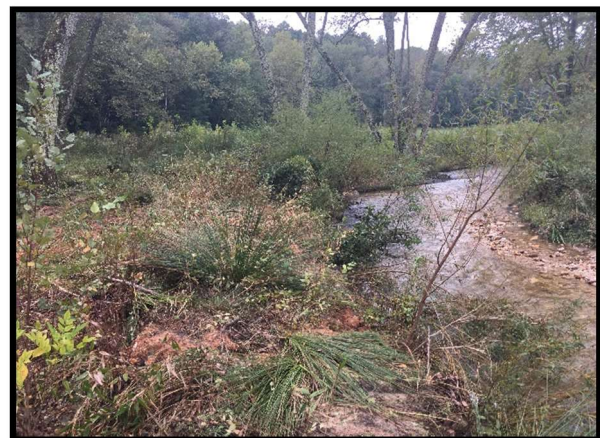
3.23 Repair at station 35+90-36+18

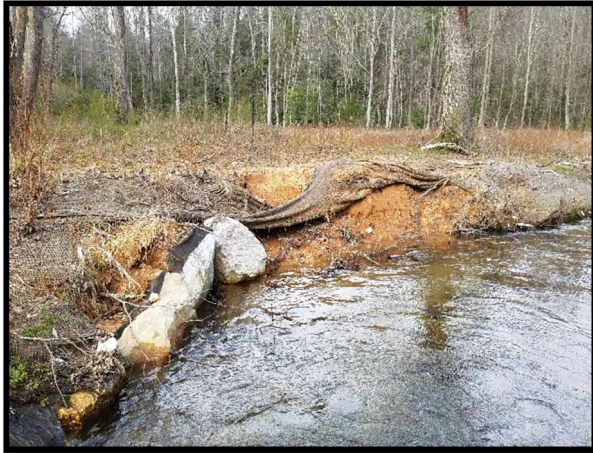
3.24 Severe Erosion and rock step at station 37+10-37+30

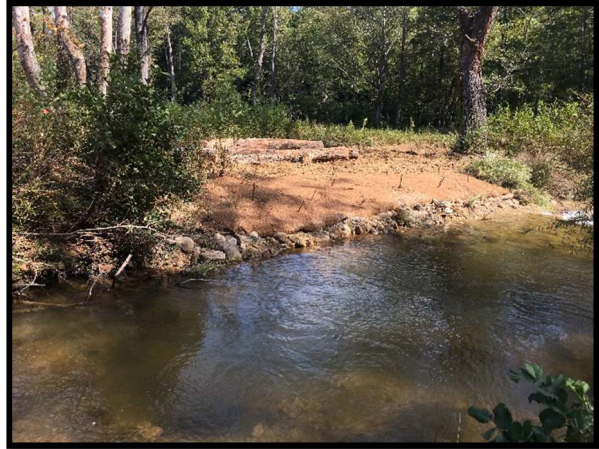
3.25 Repair of erosion at station 37+10-37+30 and relocation of rock step

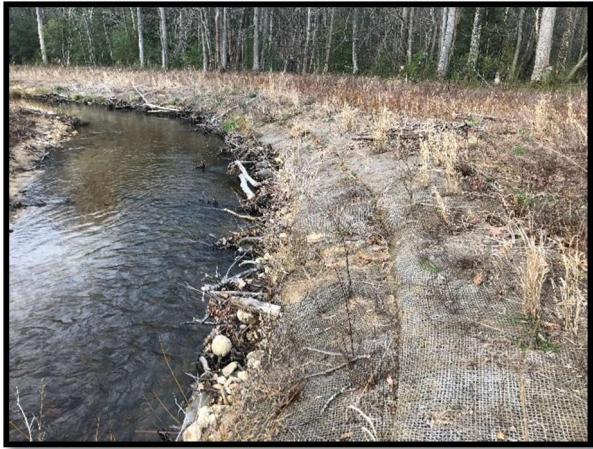
3.26 Erosion at station 39+26-39+44

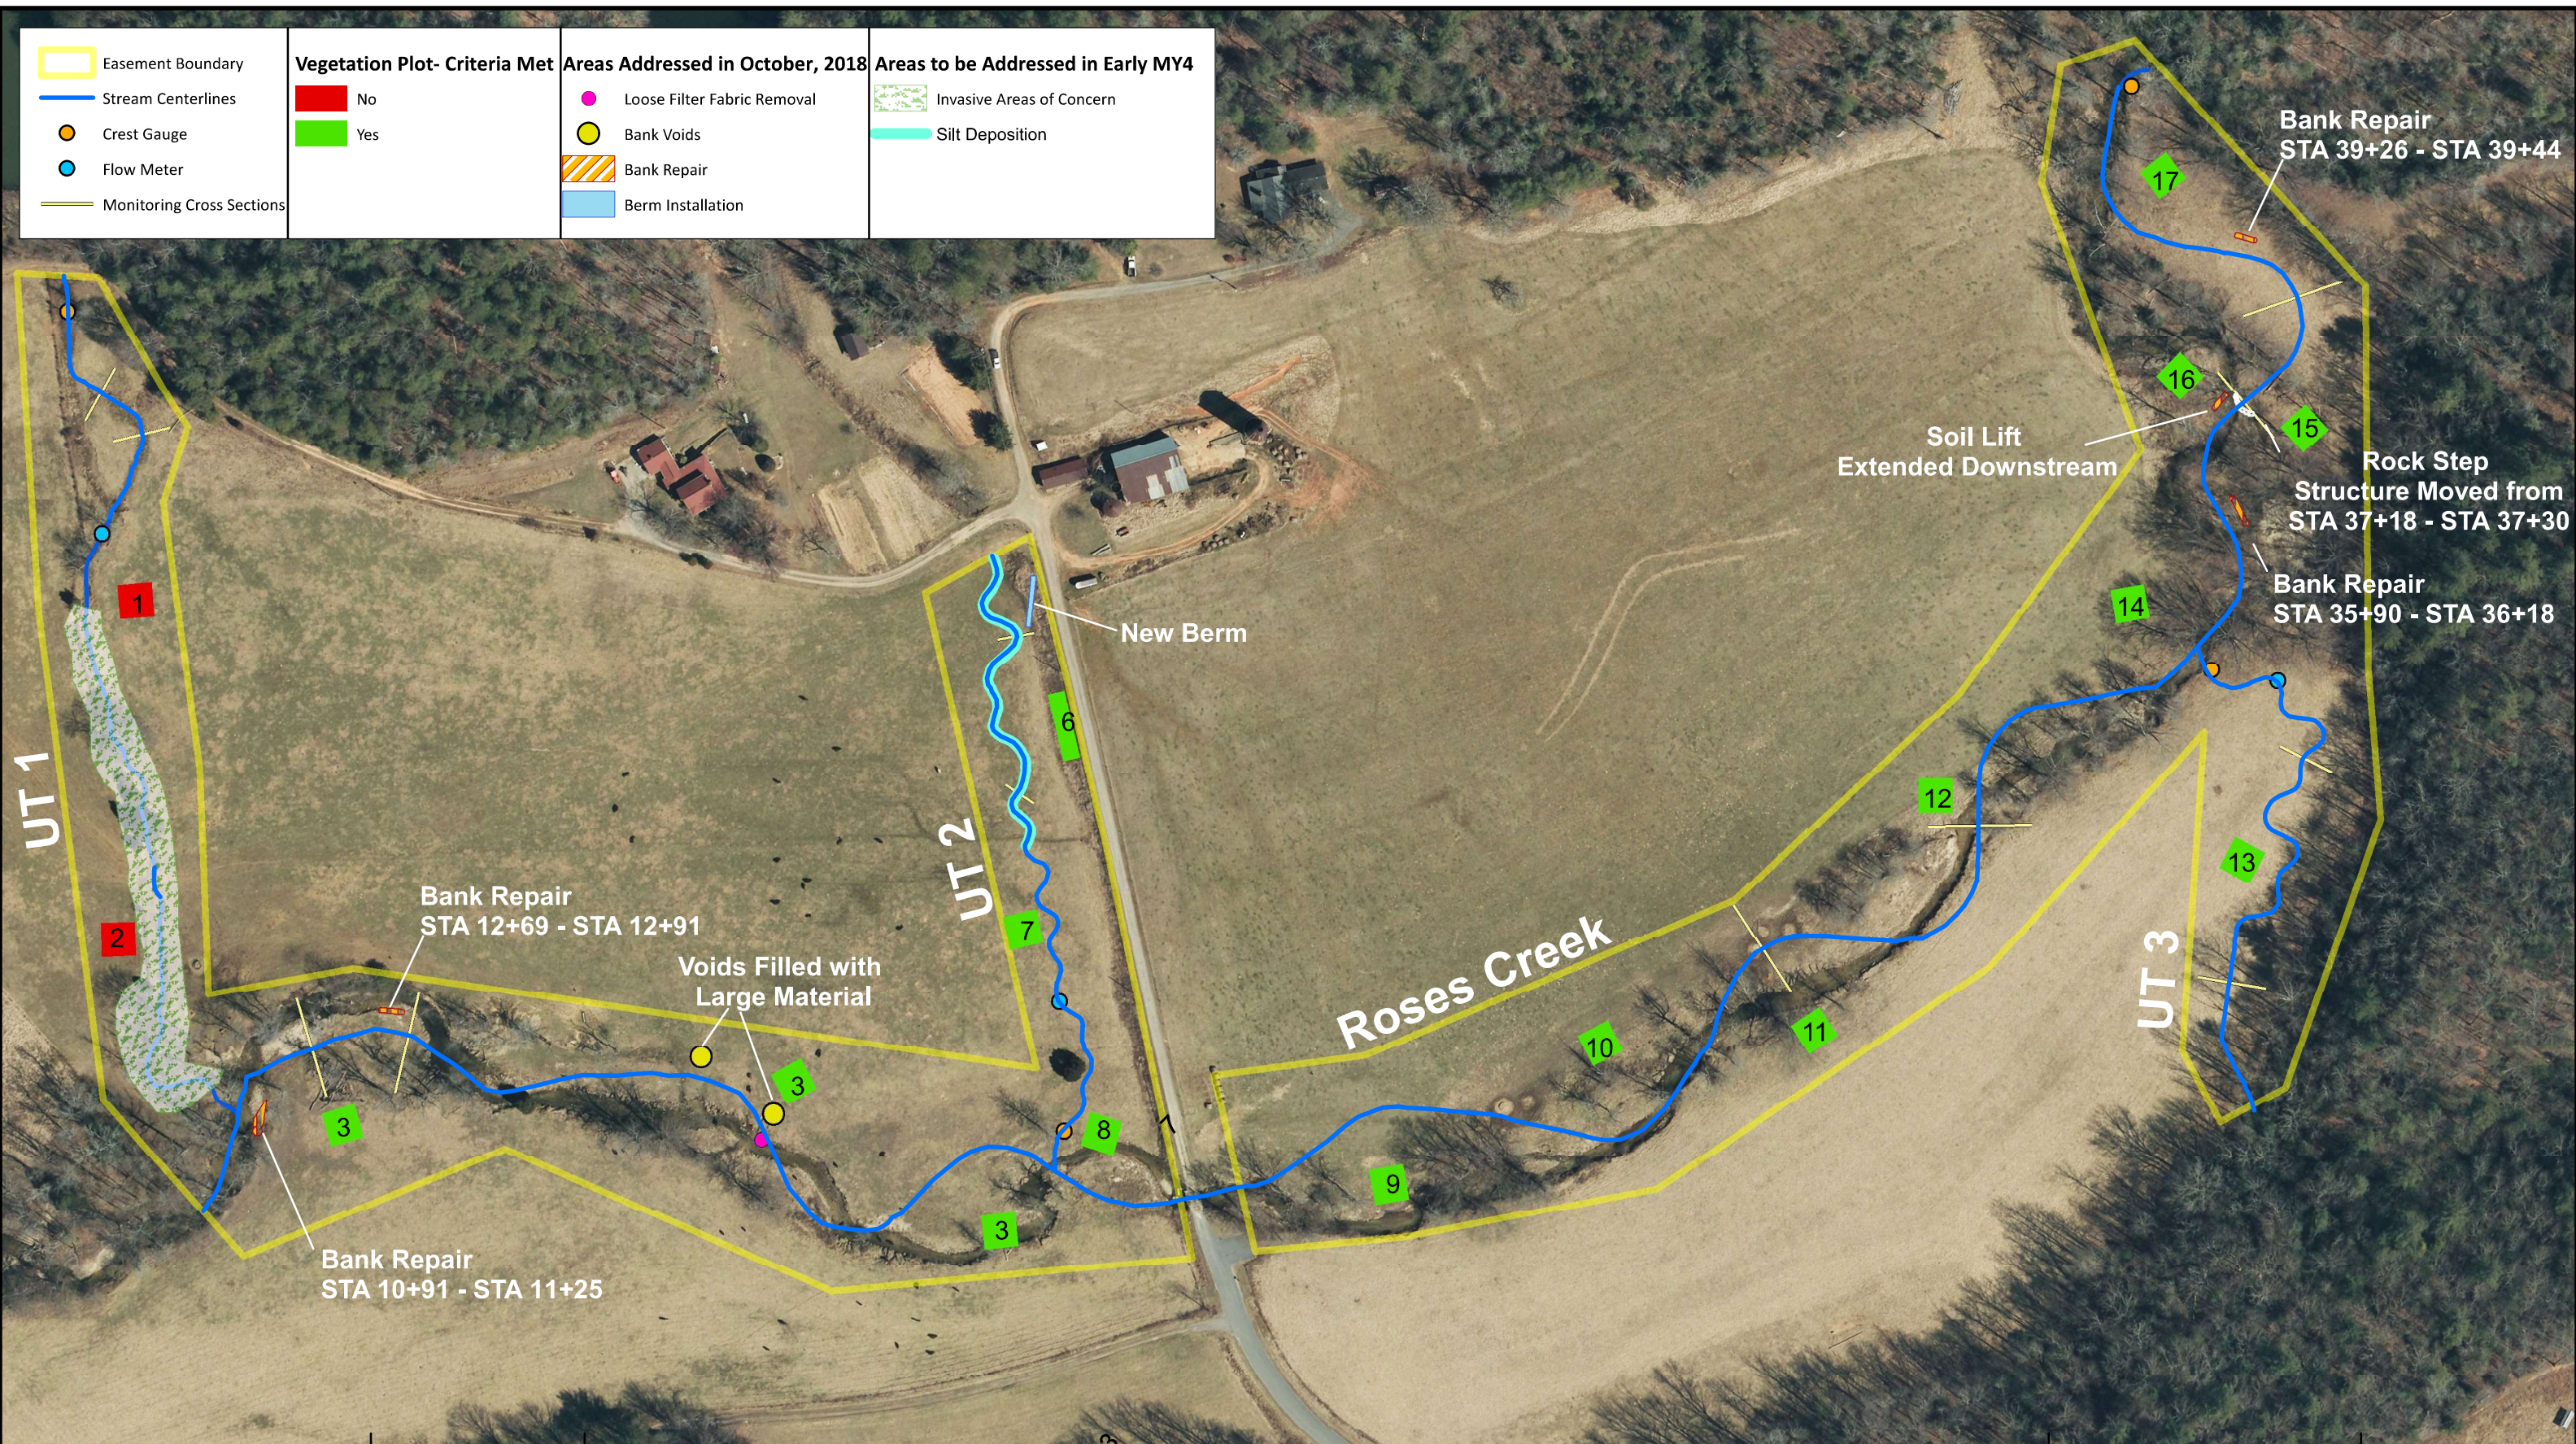
Figure 7. Roses Creek Adaptive Management Map- MY3

Response: The CCPV has been updated to show areas that are currently of concern. Many of the areas shown in 2017 were addressed during the repair work in October, 2018. A separate Adaptive Management Map has been included in the report in Appendix F. This figure shows areas that were repaired during 2018 and areas to be addressed in the near future.

Response: We plan to address the areas of privet and invasives along UT1 and the lower main stem as soon as practicable, likely during the winter of 2019.
