**YEAR 4 MONITORING REPORT**

**ROSES CREEK STREAM MITIGATION SITE**  
Burke County, North Carolina  
NC DMS Project # 96309

Construction Completed: May 2016  
Visual Assessment Data Collected: Jan 2019, May 2019, Aug 2019, Sept 2019, Nov 2019  
Submitted: February, 2020

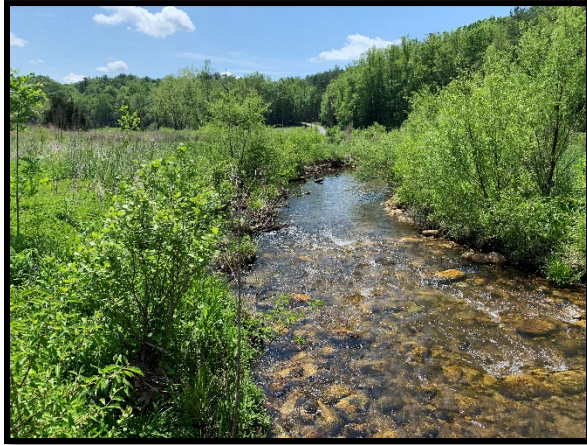
**3.1 Minor erosion at 19+50**

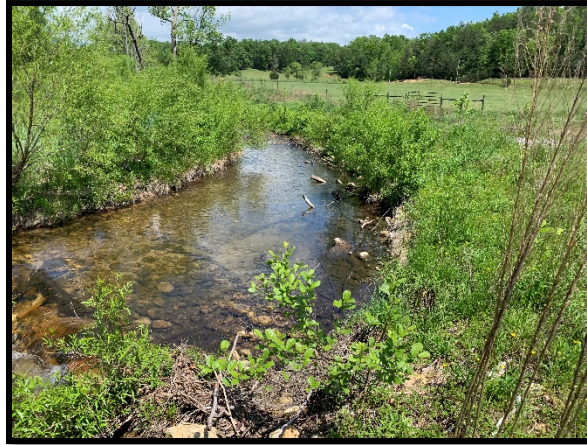
**3.2 Minor erosion at 20+10**

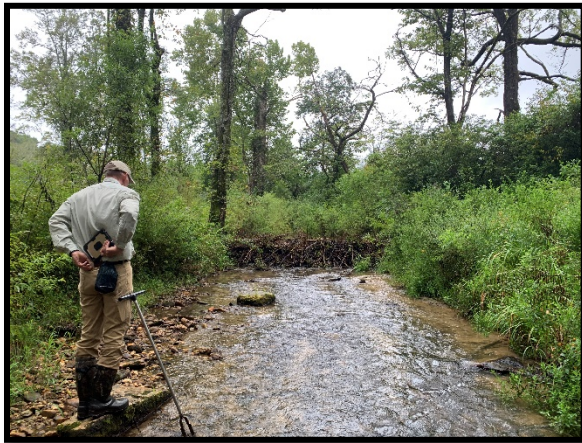
stabilize these areas over time. HDR will monitor areas of erosion closely over the next year. A beaver dam was discovered near STA 41+80 in August 2019, and backwater effects extended to approximately STA 38+00. The dam was removed in September 2019 and the stream is currently stable at this location. Photos of the dam before and after removal are presented in figures 3.1-3.6. The beavers were removed from the Site to discourage construction of future dams; however, an additional beaver dam was observed near STA 31+50 in December 2019. HDR will coordinate with APHIS to trap beaver and remove the dam at this location in 2020.

**3.3 Beaver dam near STA 41+25**

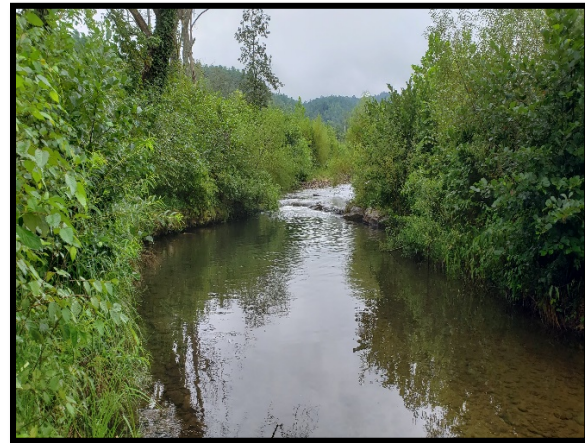
**3.4 Backwater effects from dam STA 38+00**

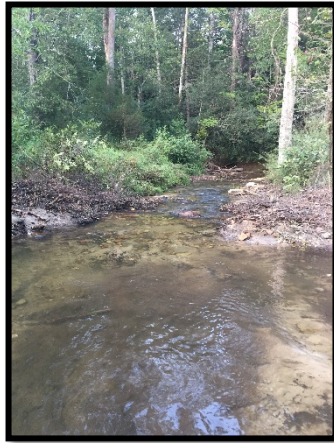
**3.5 Beaver dam removal near STA 41+25**

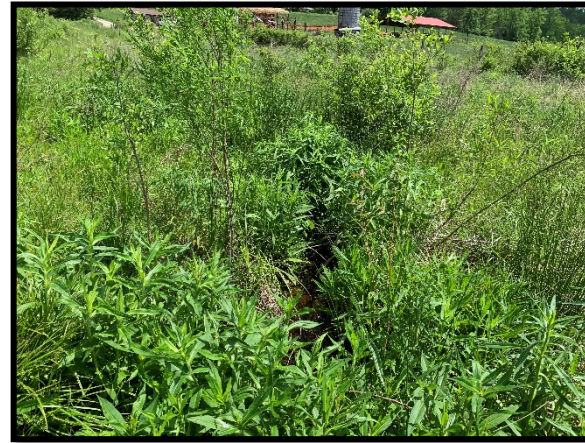
**3.6 UT 2 dense bank vegetation STA 10+75**

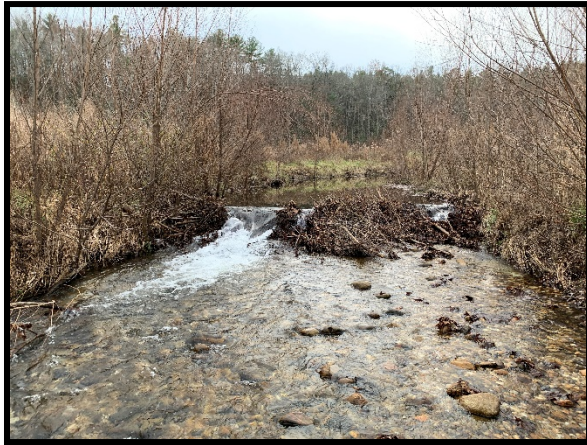
**3.7 Beaver dam at 31+50**

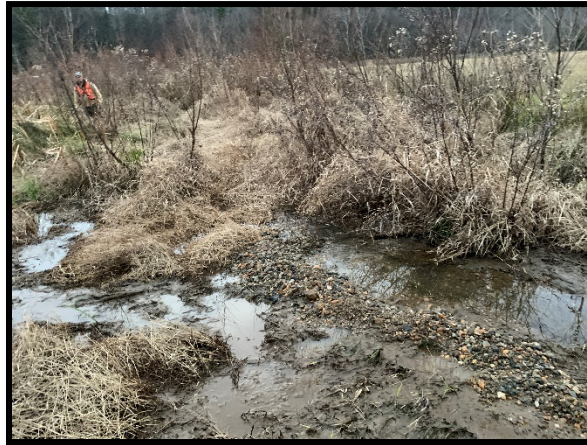
**3.8 Recent sediment deposits at head of UT 2**

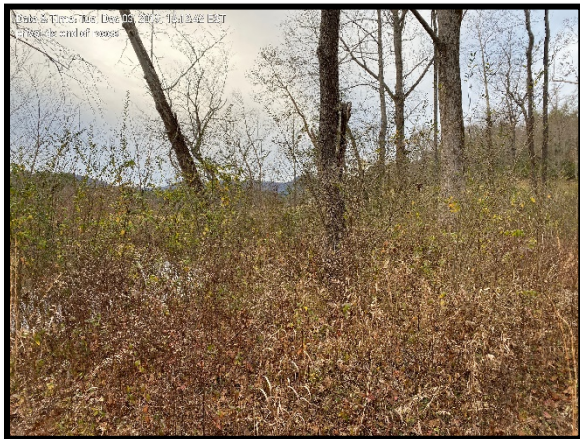
Chinese privet and multiflora rose were observed and treated downstream of STA 14+75 along UT 1. Invasive stems were mechanically removed, and the stumps were treated with herbicide twice in 2019 (January and September, 2019). In addition, privet was observed downstream of STA 37+00 in the left floodplain of Roses Creek. HDR plans to conduct additional treatments in 2020 to control the spread of invasive species on-site. HDR will continue to monitor these areas closely.

**3.9 Privet downstream of 37+00**

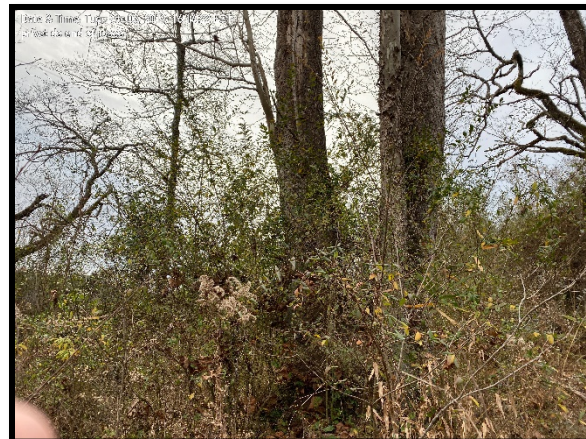
**3.10 Privet downstream of 37+00**

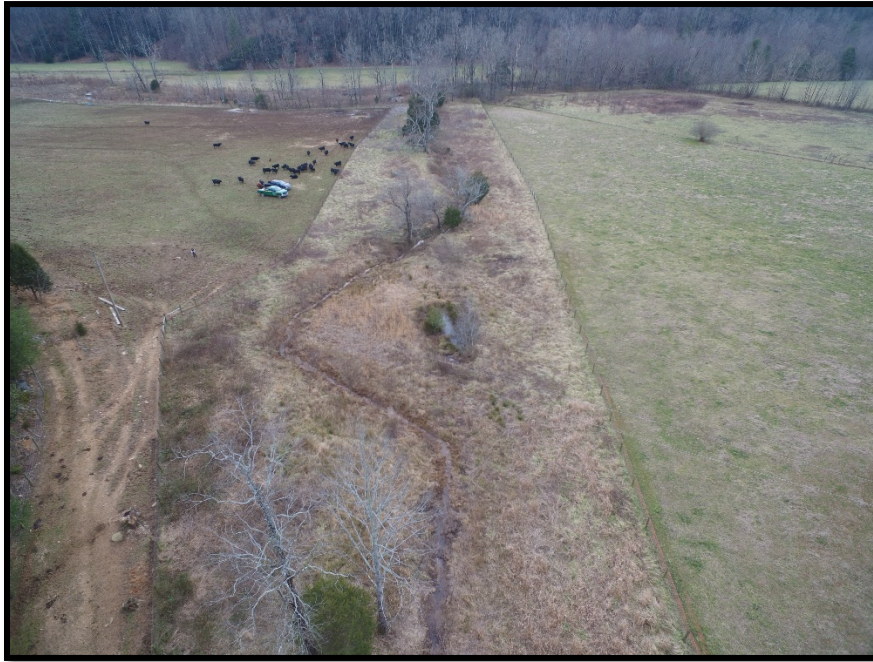
**3.11 UT 1 aerial evidence of single channel flow**

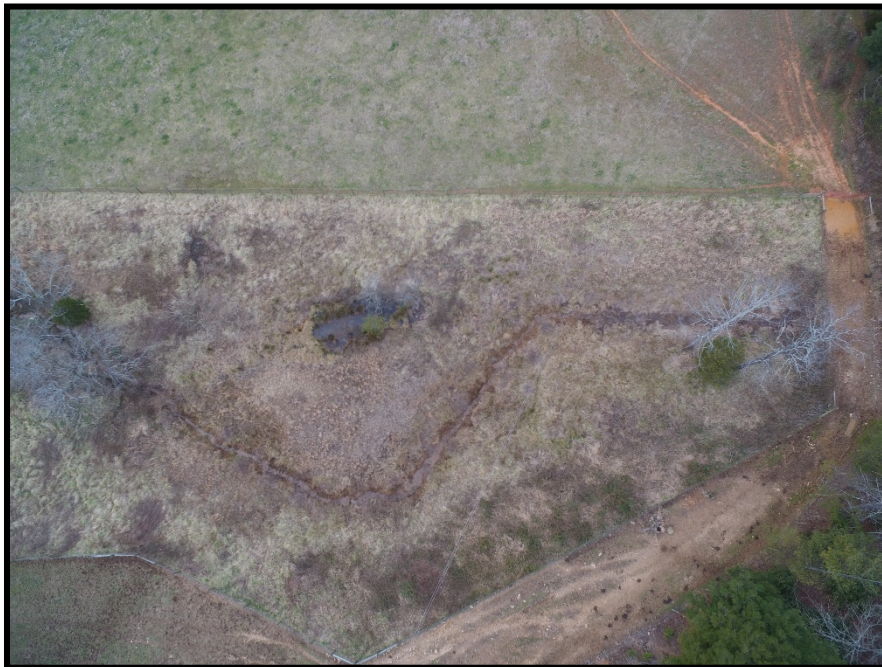
**3.12 UT 1 aerial evidence of single channel flow**

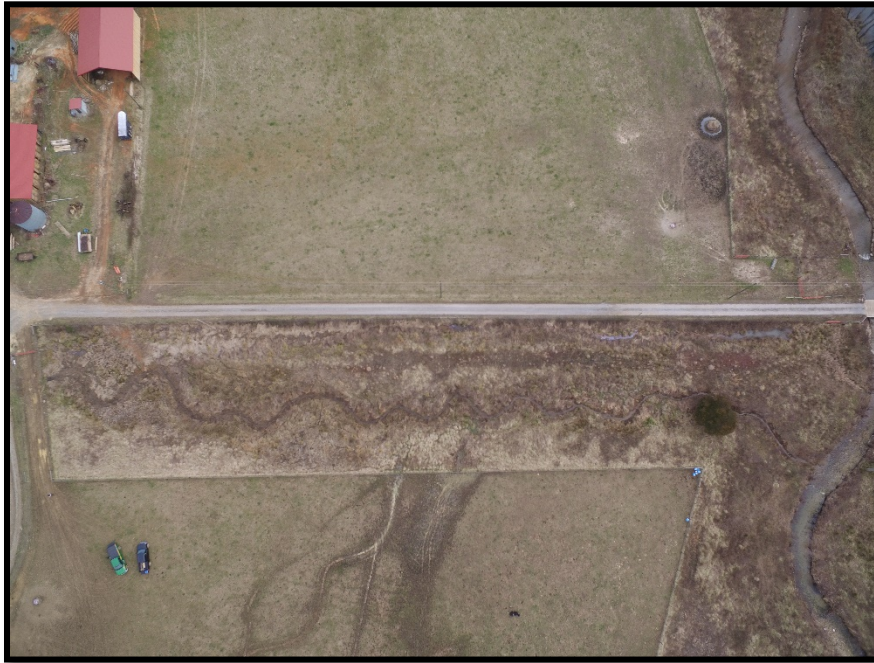
*Response: See aerial photos on Figures 3.13 and 3.14. Based on aerial evidence of single channel flow throughout UT 2 in January 2020, HDR revised the report narrative as follows:*

**3.13 UT 2 aerial evidence of single channel flow**

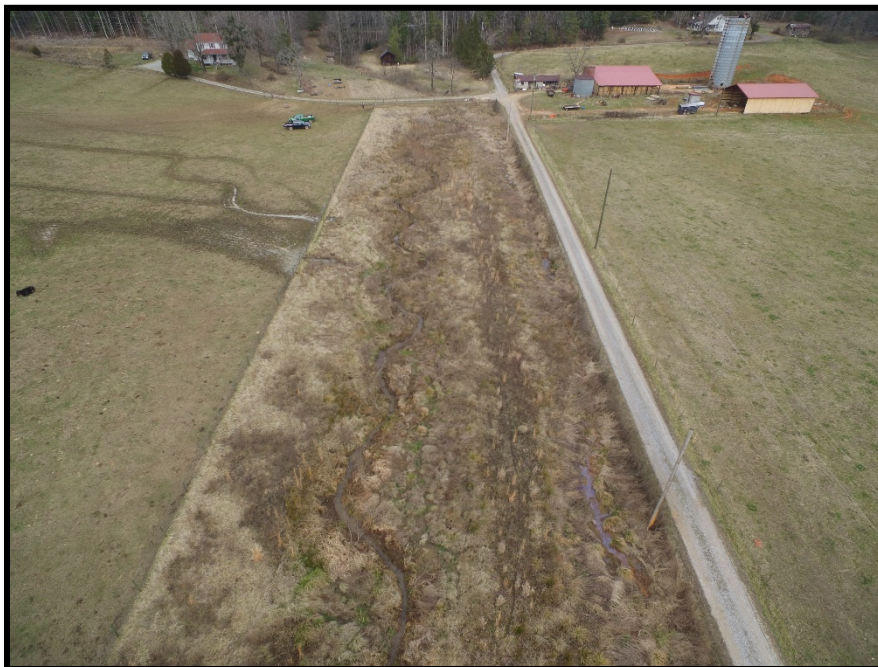
**3.14 UT 2 aerial evidence of single channel flow**

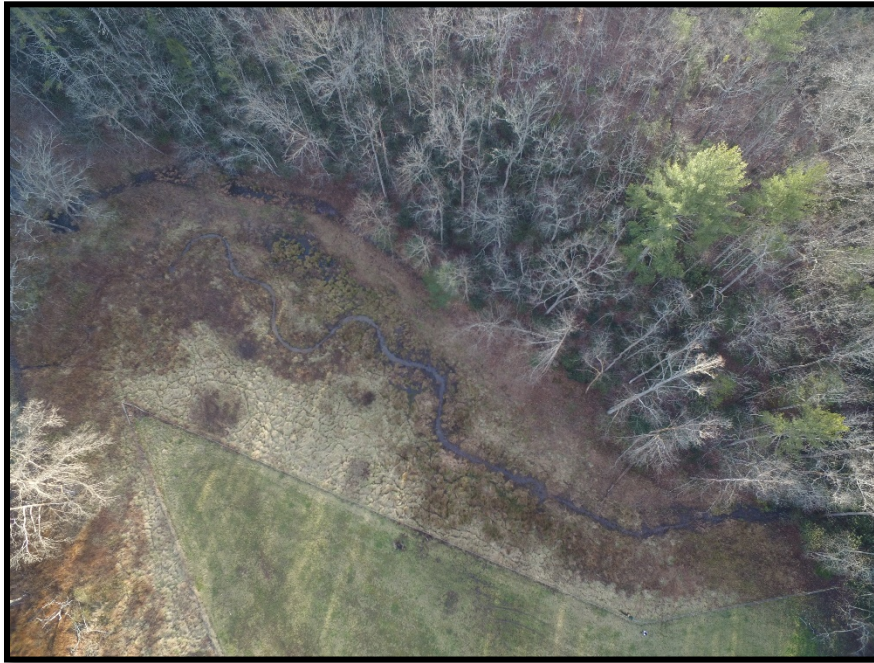
**3.15 UT 3 aerial evidence of single channel flow**

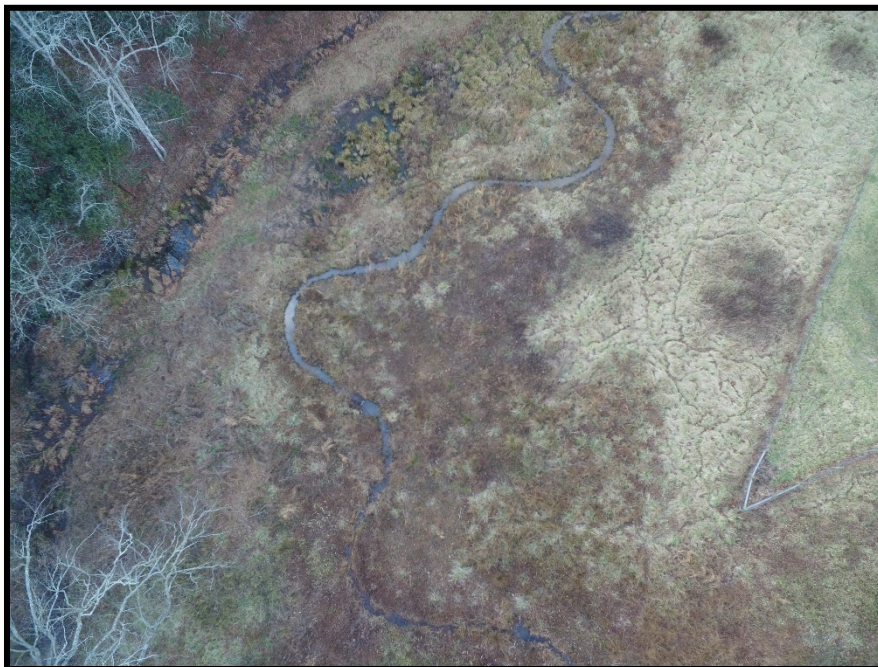
**3.16 UT 3 aerial evidence of single channel flow**
