YEAR 5 MONITORING REPORT

**ROSES CREEK STREAM MITIGATION SITE
Burke County, North Carolina
NC DMS Project # 96309**

Construction Completed: May 2016
Morphology Data Collected: February 17, 2020
Vegetation Data Collected: August 10, 2020
Submitted: January 2021

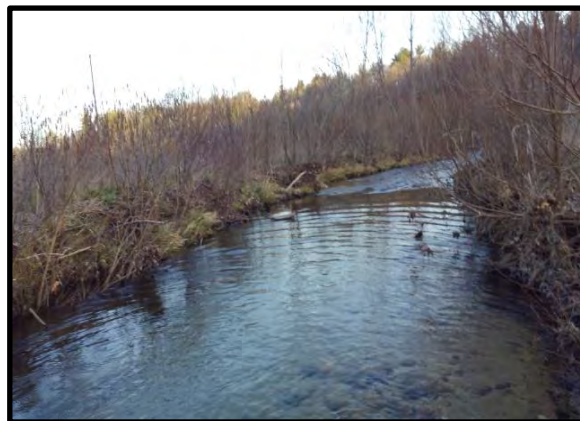
3.18 Minor erosion at station 20+00

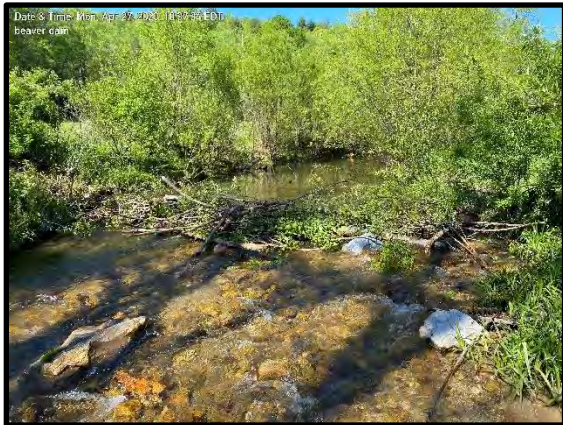
3.19 Beaver dam at station 30+00

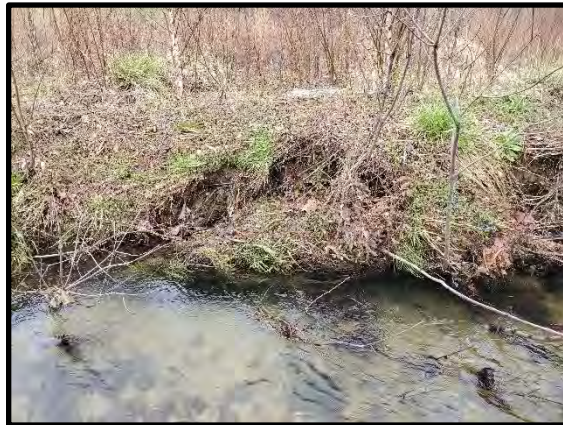
RE: The areas of mass wasting, and toe erosion were first observed and mapped in January of 2020. After a major storm event in October of 2020, LMG conducted another Site visit to assess any damage that may have resulted from the storm. During this Site visit LMG re-examined the areas and compared notes and photographs from January 2020 to November 2020 conditions and determined that both areas remained relatively unchanged throughout the year. Neither area expanded laterally into the bank due to soil loss and neither area appeared to have expanded upstream or downstream along the bank. At this time LMG does not recommend performing any remedial actions but does anticipate monitoring the area closely to determine if the areas will continue to stabilize naturally. This is now reflected in the report narrative.

3.20 Mass wasting at station 27+94 – 28+09

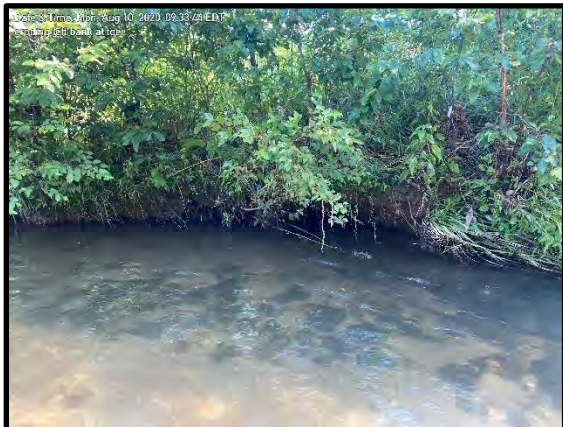
3.21 Moderate toe erosion at station 32+32-32+70. Looking perpendicular.

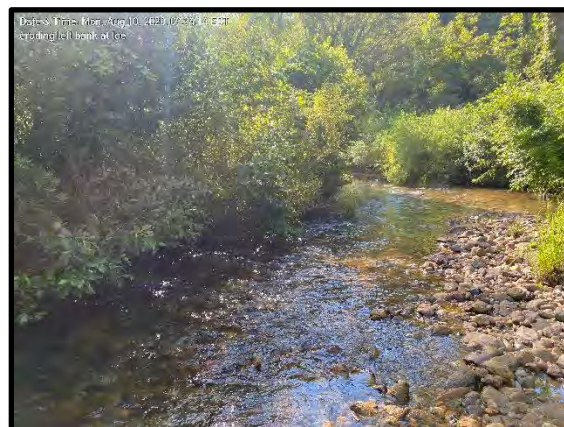
3.22 Moderate toe erosion left bank station 32+32-32+70. Looking downstream.

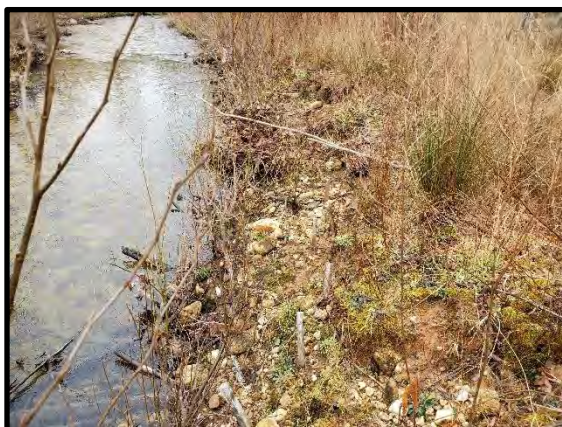
3.23 Minor erosion at station 35+00.

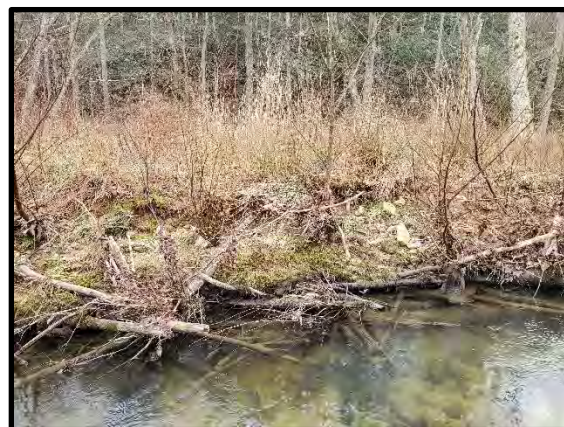
3.24 Minor erosion at station 39+30.

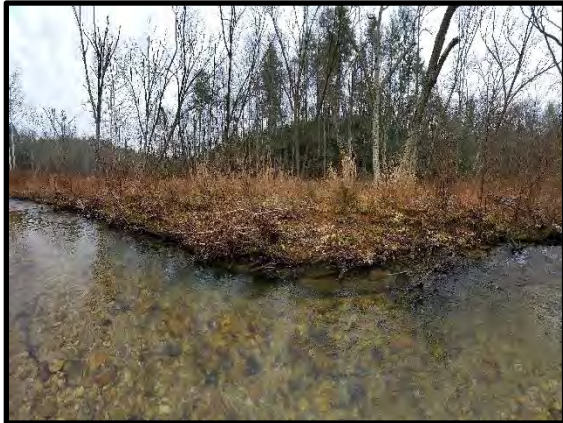
3.25 Minor Erosion at station 40+00.

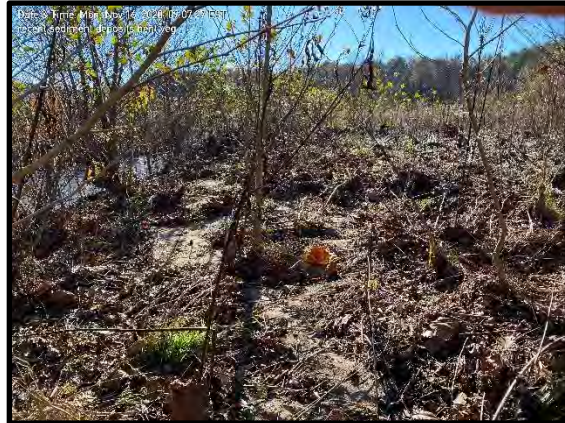
Large amounts of detritus were deposited in the floodplain of Roses Creek near station 15+00 indicating that the site has experienced multiple above bankfull flows in 2020. All four crest gauges on Site have been damaged by insects, making the gauge measurements unreadable. It should be noted that the Site had met Success Criteria of two bankfull events by Year 3 of monitoring. Flow events will continue to be recorded via the tributary gauges and visually assessed by wrack lines along the channel and floodplain areas. Crest gauge records for Years 1 – 4 are provided in Appendix E.

3.26 Wrack lines from October rain events above station 15+00.

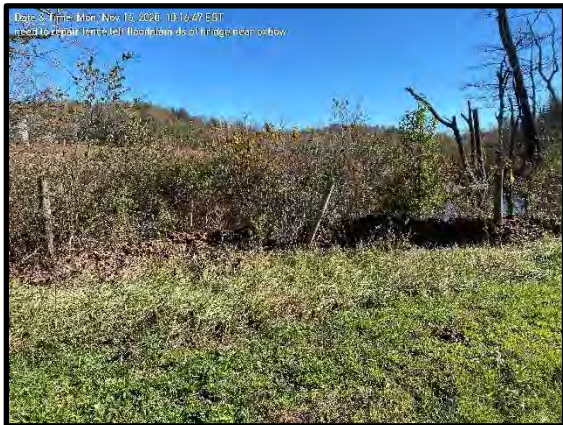
3.27 Damage to fence from October rain events.

RE: The landowner has been made aware of the downed fence. LMG cannot confirm that the fence has been repaired at this time, but LMG is working with the landowner to address the damaged area.

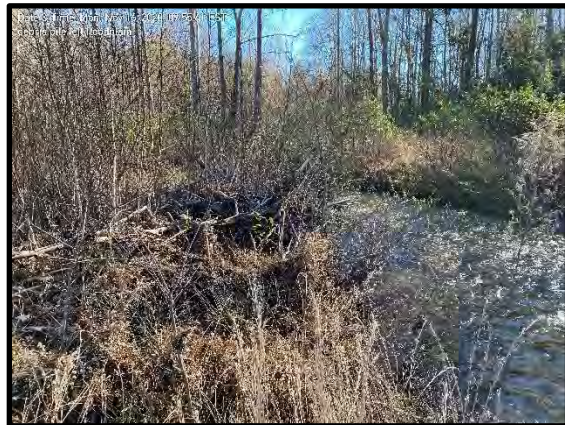
3.28 Wrack lines from October rain events below station 35+00.

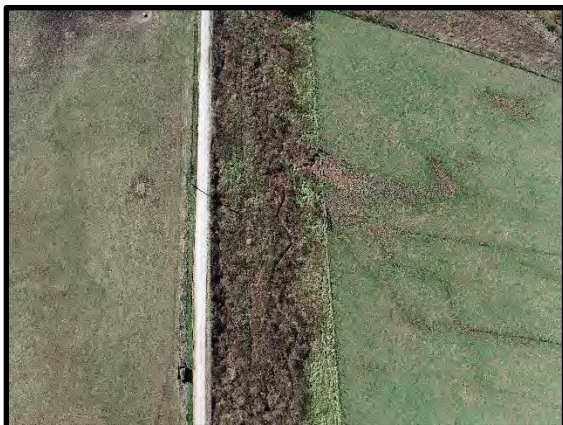
3.29 UT 2 single thread channel.

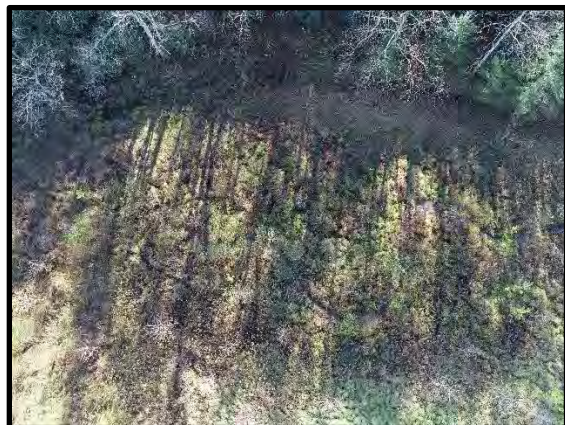
3.30 UT 3 single thread channel.

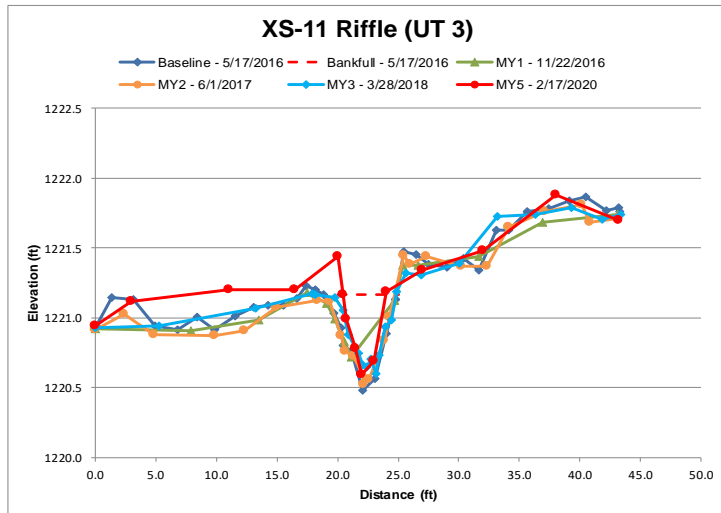
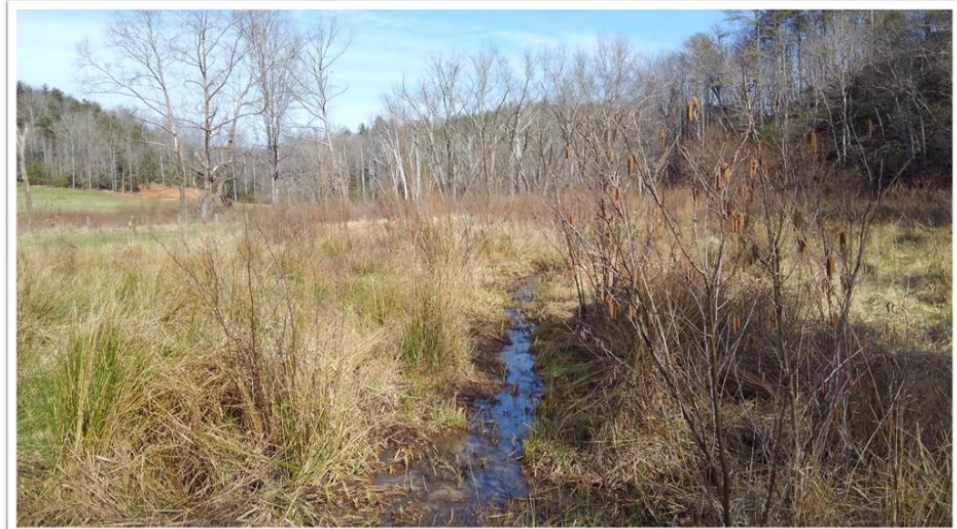
Figure 4.11

12. Please review cross section BHR calculations. Cross section 11 is reported to have a BHR of 1.16, but the BHR should be 1.4. This is being caused by an inaccurate MY0 bankfull cross sectional area (e.g. 2.19 vs. 1.4). This was verified using the Mecklenburg spreadsheet and the DMS cross section tool. The MY0 cross sectional area for XS7 also appears to be inaccurate (e.g. 2.3 vs. 1.9), so please review the MY0 cross sectional areas to determine how these affect MY5 BHR's. Additionally, for cross section 10, there is a greater than symbol. For other cross sections where the BHR is >1 the actual value is reported, so please do this for XS 10.

Dimension and substrate	Cross Section 11 (Riffle)					
	Base	MY1	MY2	MY3	MY5	MY7
Bankfull Width (ft)	6.00	7.28	5.38	6.73	7.22	
Floodprone Width (ft)	175.41	175.41	175.41	175.41	175.41	
Bankfull Mean Depth (ft)	0.36	0.21	0.37	0.24	0.30	
Bankfull Max Depth (ft)	0.69	0.46	0.65	0.57	0.76	
Bankfull Cross Sectional Area (ft ²)	2.19	1.51	2.01	1.62	2.18	
Bankfull Width/Depth Ratio	16.67	34.67	14.54	28.04	24.07	
Bankfull Entrenchment Ratio	29.24	24.09	32.60	26.06	24.3	
Low Bank Height (ft)	---	---	---	0.50	0.85	
Bank Height Ratio*	1.00	1.00	1.00	<1	1.12
