Year 7 Monitoring and Closeout Report

Roses Creek
Burke County, NC

DMS Project ID No. 96309

Submitted: February 2023

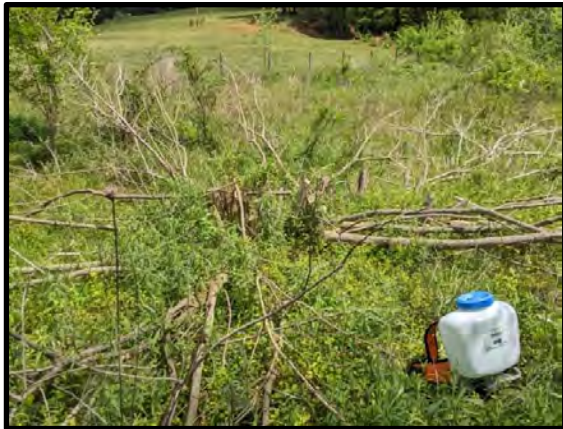
3.20 Invasive treatment results at UT1

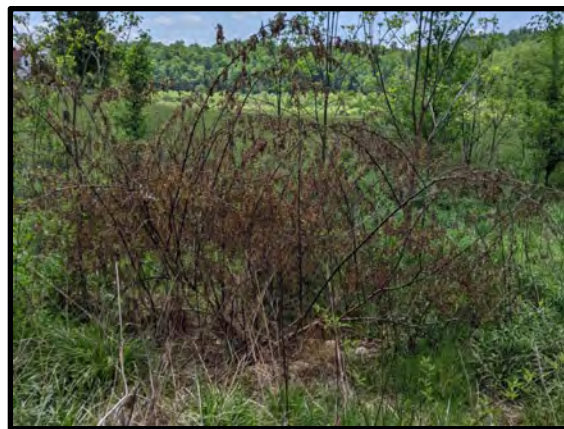
3.21 Mimosa tree removal at UT1

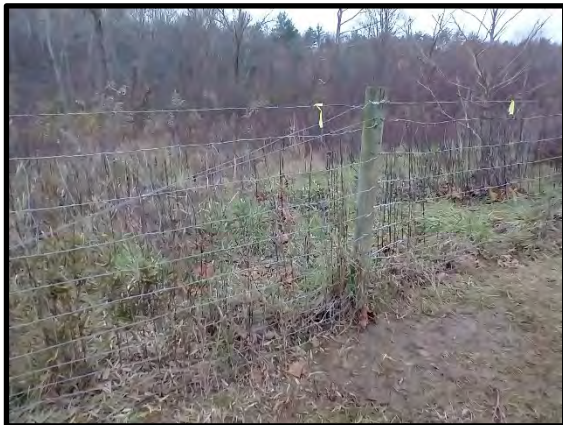
**3.26 Fence opening nearby by Roses Creek
Station 36+50**

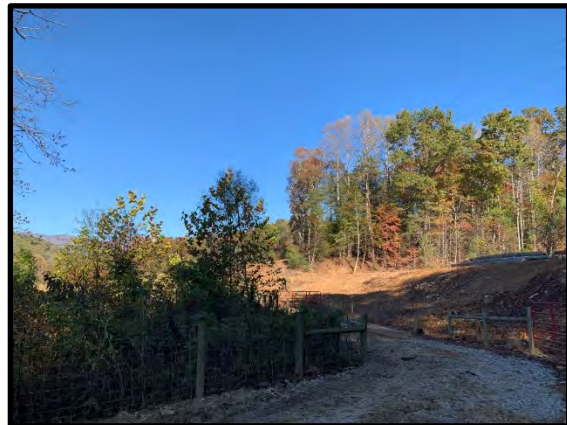
**3.27 Fence repair nearby Roses Creek
Station 36+50, December 2022**

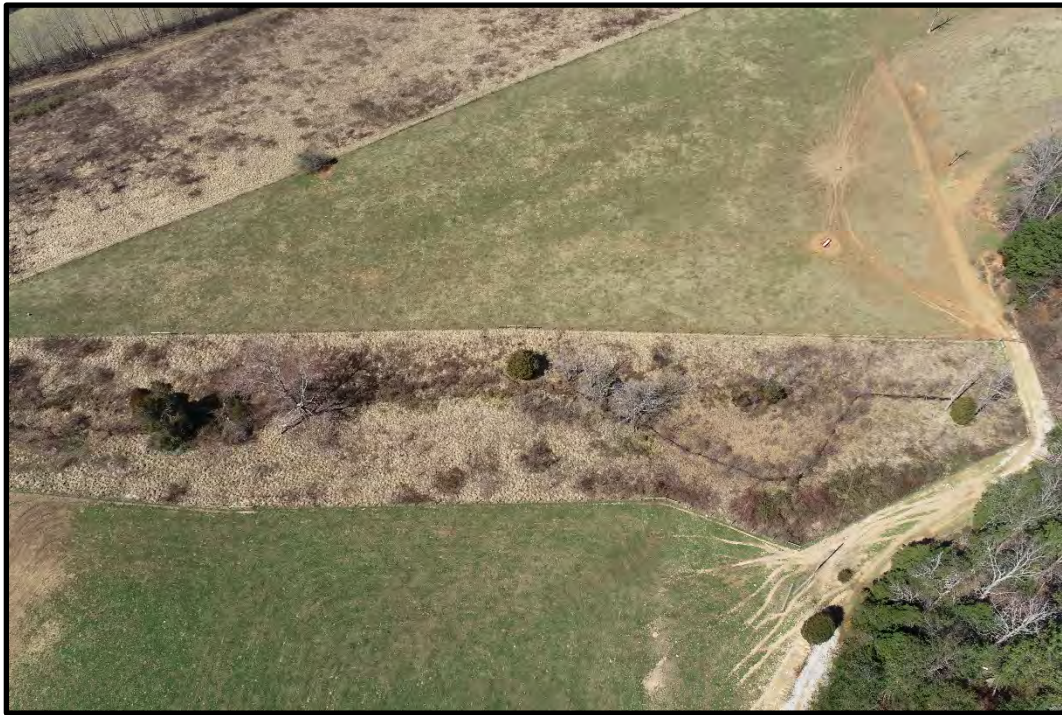
**3.28 UT 1 Powerline relocation
October 2022**

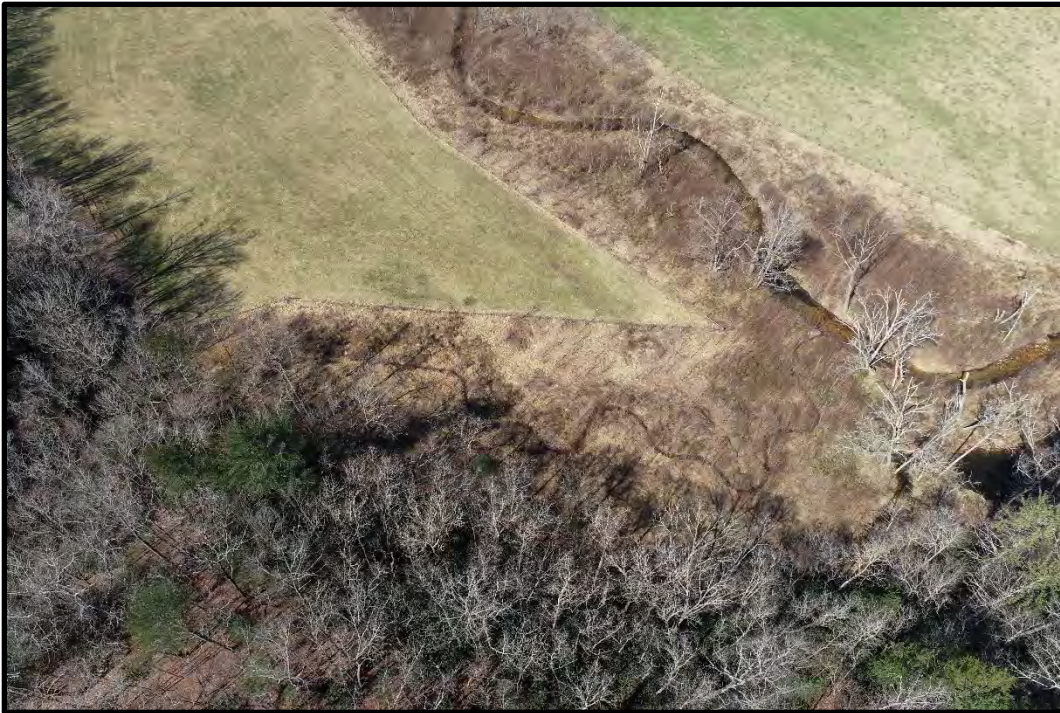
In Year 5 monitoring, deposition was seen in UT 1, 2, and 3. These conditions have improved for UT 1 and 2 based on Year 7 cross section values. UT 3 however continues a depositional trend. As noted in previous year monitoring, the likely cause is increased vegetation establishment and narrowing of the bankfull area. Each tributary maintains a single thread channel throughout the Site as seen from the aerial drone photography.

3.33 UT3 drone aerial, view 1 (March 3, 2022)

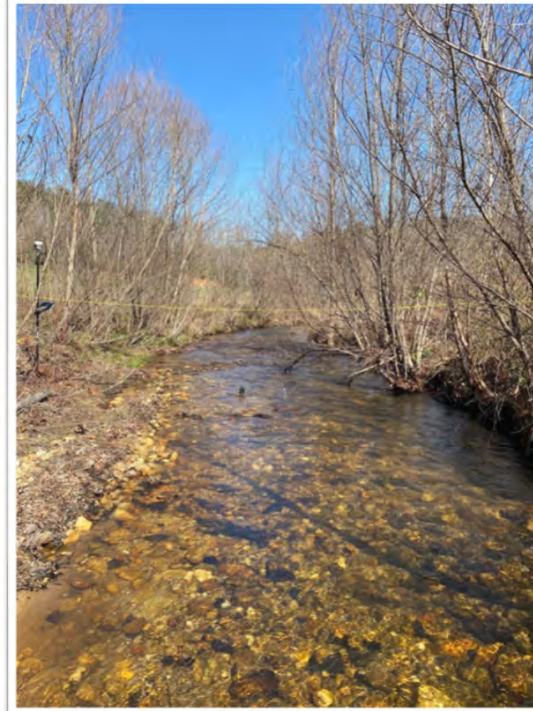
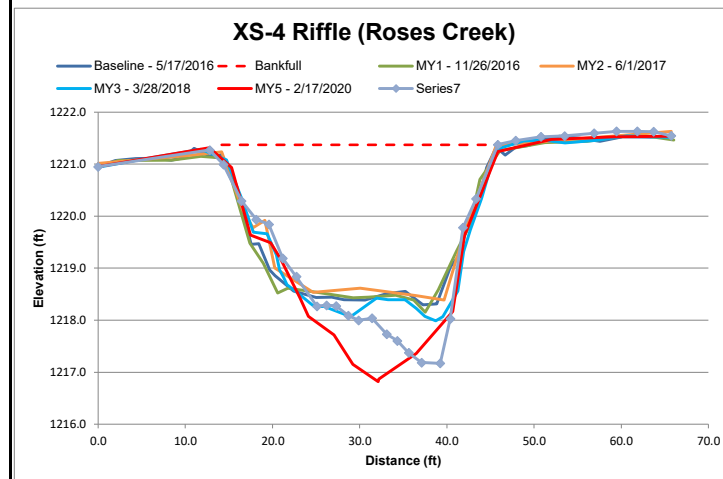
River Basin	Catawba
Watershed	03050101060030
XS ID	XS 4 (Roses Creek)
Drainage Area (Acres)	3,309
Date	3/3/2022
Field Crew	TC, WY

Dimension and substrate	Cross Section 4 (Riffle)					
	Base	MY1	MY2	MY3	MY5	MY7**
Bankfull Width (ft)	31.11	31.66	31.03	32.35	32.12	33.04
Floodprone Width (ft)	696.00	696.00	696.00	696.00	696.00	696.00
Bankfull Mean Depth (ft)	2.19	2.16	2.08	2.12	2.63	2.47
Bankfull Max Depth (ft)	2.89	3.03	2.80	3.20	4.37	4.20
Bankfull Cross Sectional Area (ft ²)	68.21	68.41	64.61	71.47	84.41	81.58
Bankfull Width/Depth Ratio	14.21	14.66	14.92	14.64	12.21	13.38
Bankfull Entrenchment Ratio	22.37	21.98	22.43	21.51	21.67	21.07
Low Bank Height (ft)	---	---	---	3.38	4.42	4.10
Bank Height Ratio*	1.00	1.00	1.00	1.05	1.15	0.97
