# MY01 MONITORING REPORT

Round Hill Branch Restoration Site  
Buncombe County, North Carolina  
French Broad River Basin - 06010105

DMS Project #100066

Monitoring Data Collected: 2022

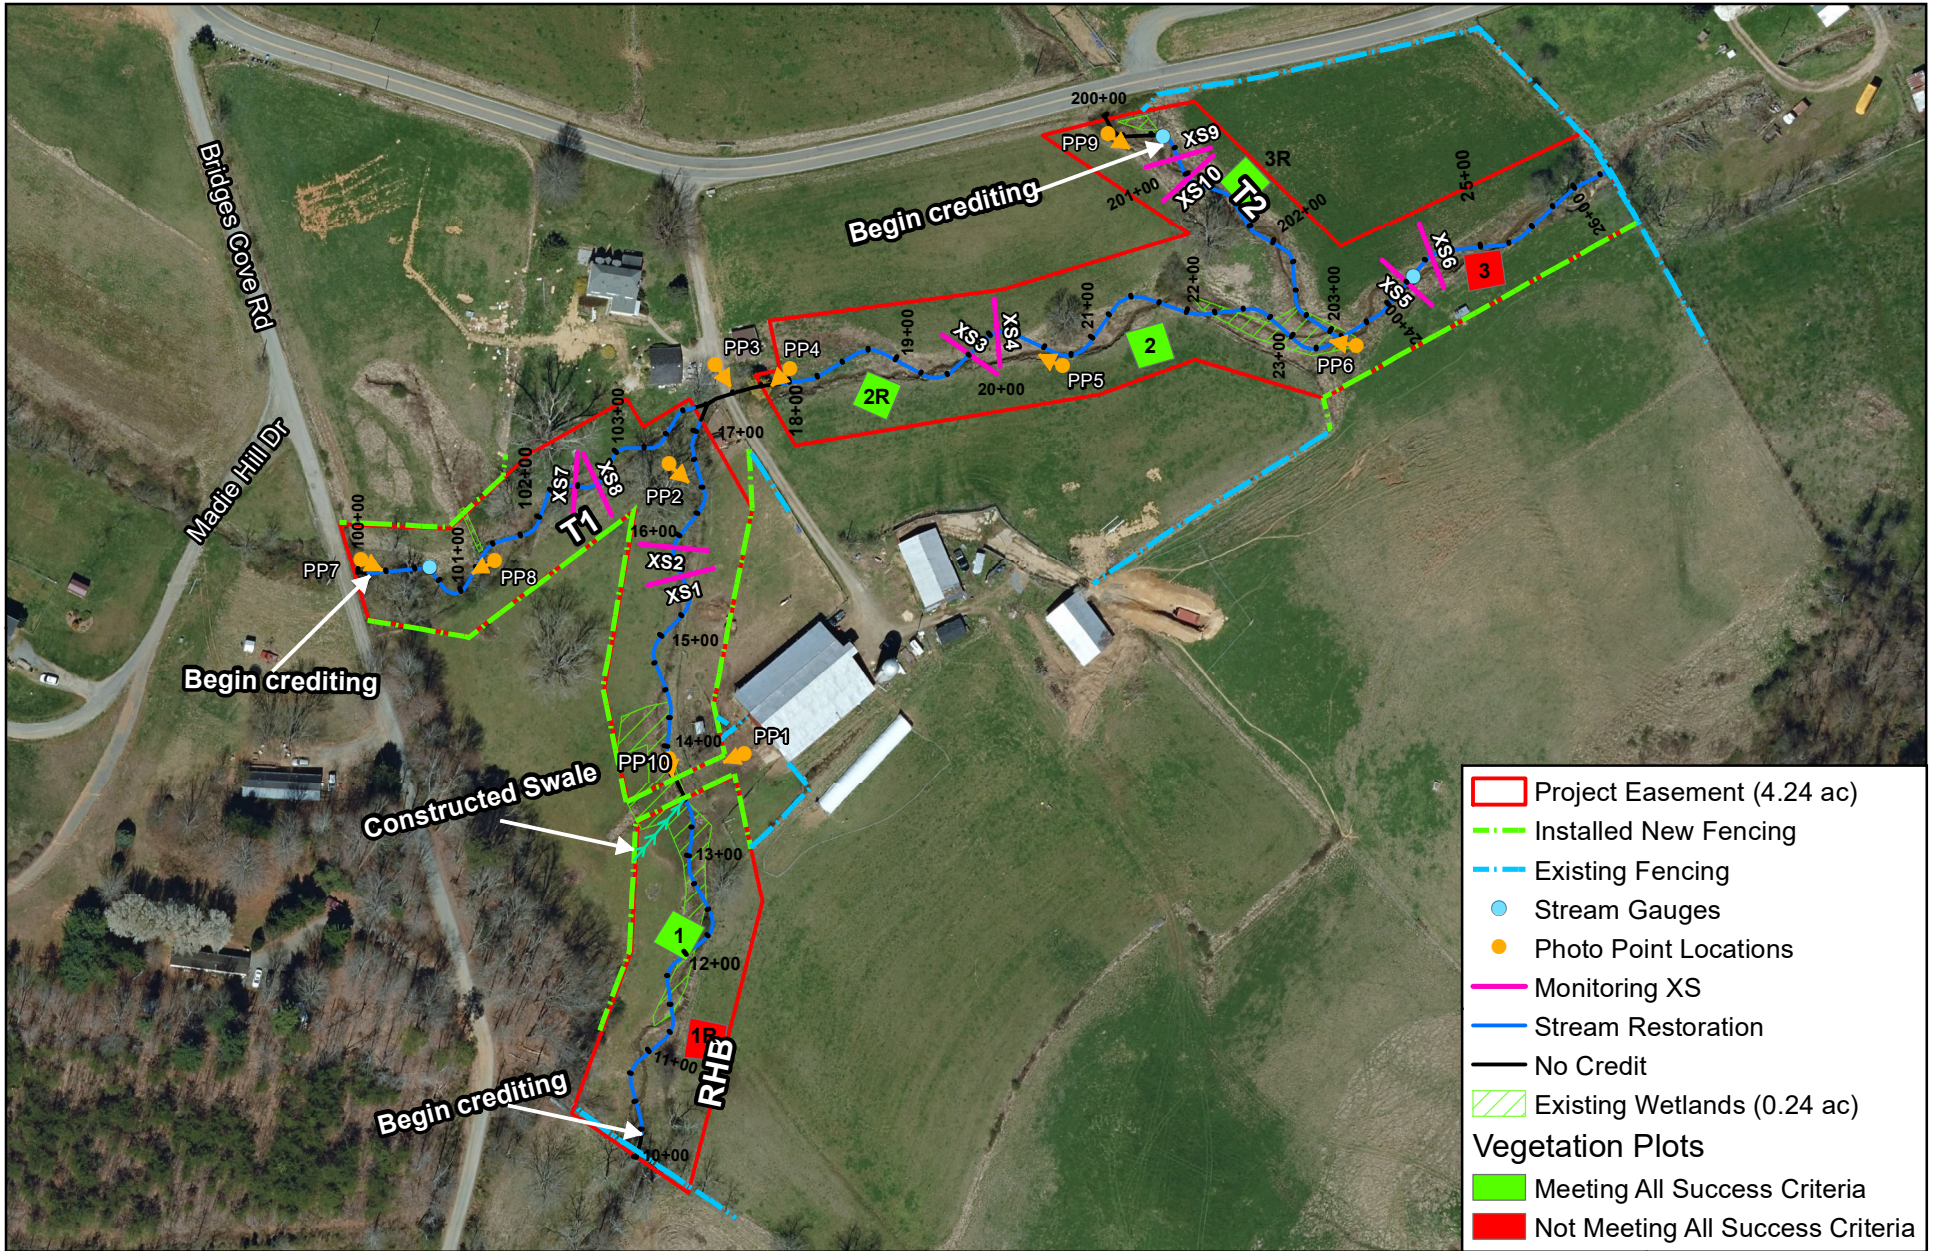
**CURRENT CONDITIONS PLANVIEW  
 ROUND HILL BRANCH RESTORATION SITE  
 BUNCOMBE COUNTY, NC**

3. CCPV: Recommend adding location of additional photo for ford crossing on RHB.  
*KCI Response: This change has been made.*
4. CCPV: Recommend adding a line to represent the constructed swale on RHB.  
*KCI Response: This change has been made.*

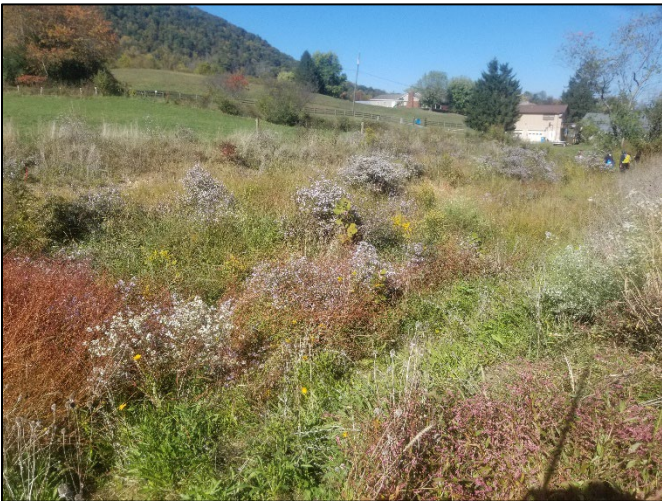
Vegetation Plot 3 – MY-01 – 10/10/22

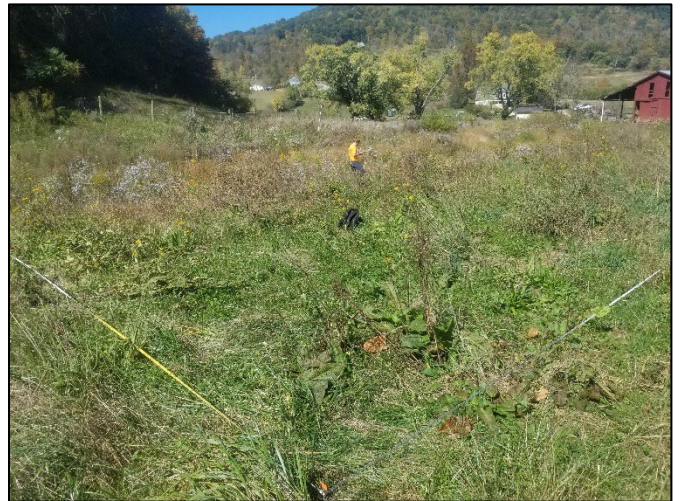
Vegetation Plot 1R – MY-01 – 10/10/22

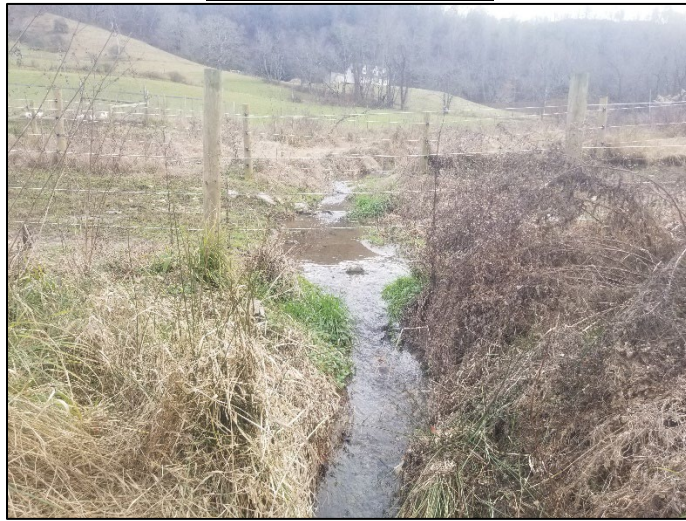
Ford Crossing on RHB – MY-01 – 10/10/22

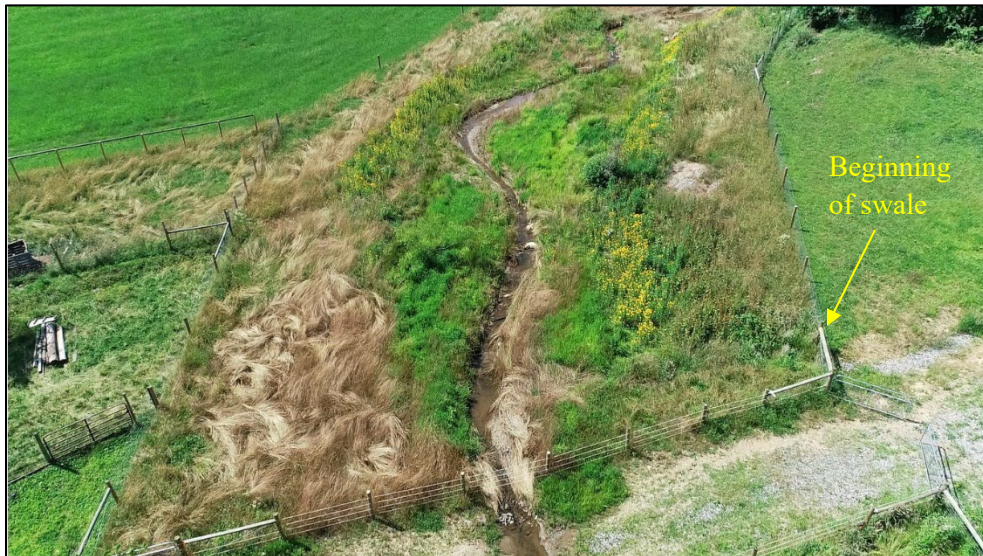
Diversion swale on RHB – MY-01 – 10/10/22

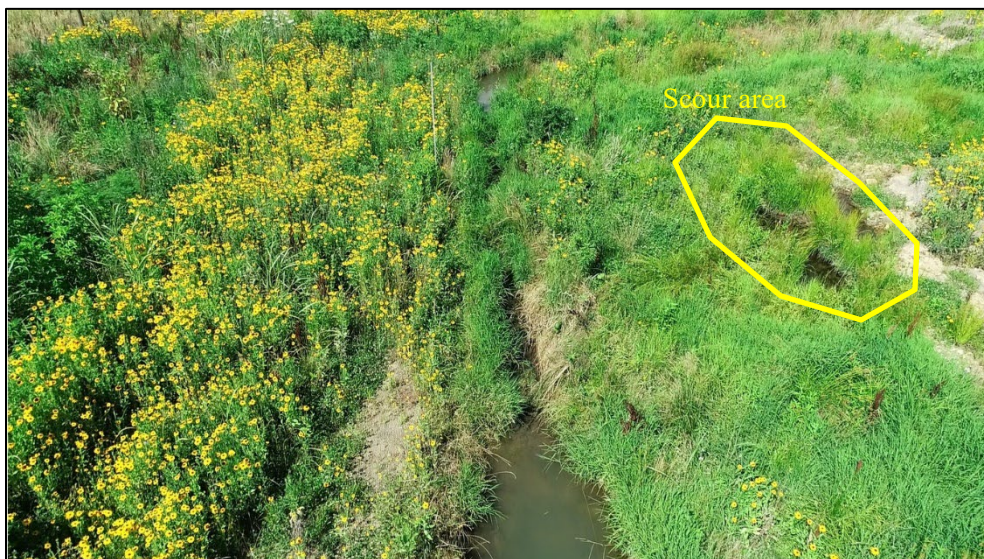
Scour area near RHB/T3 confluence – MY-01 – 10/10/22

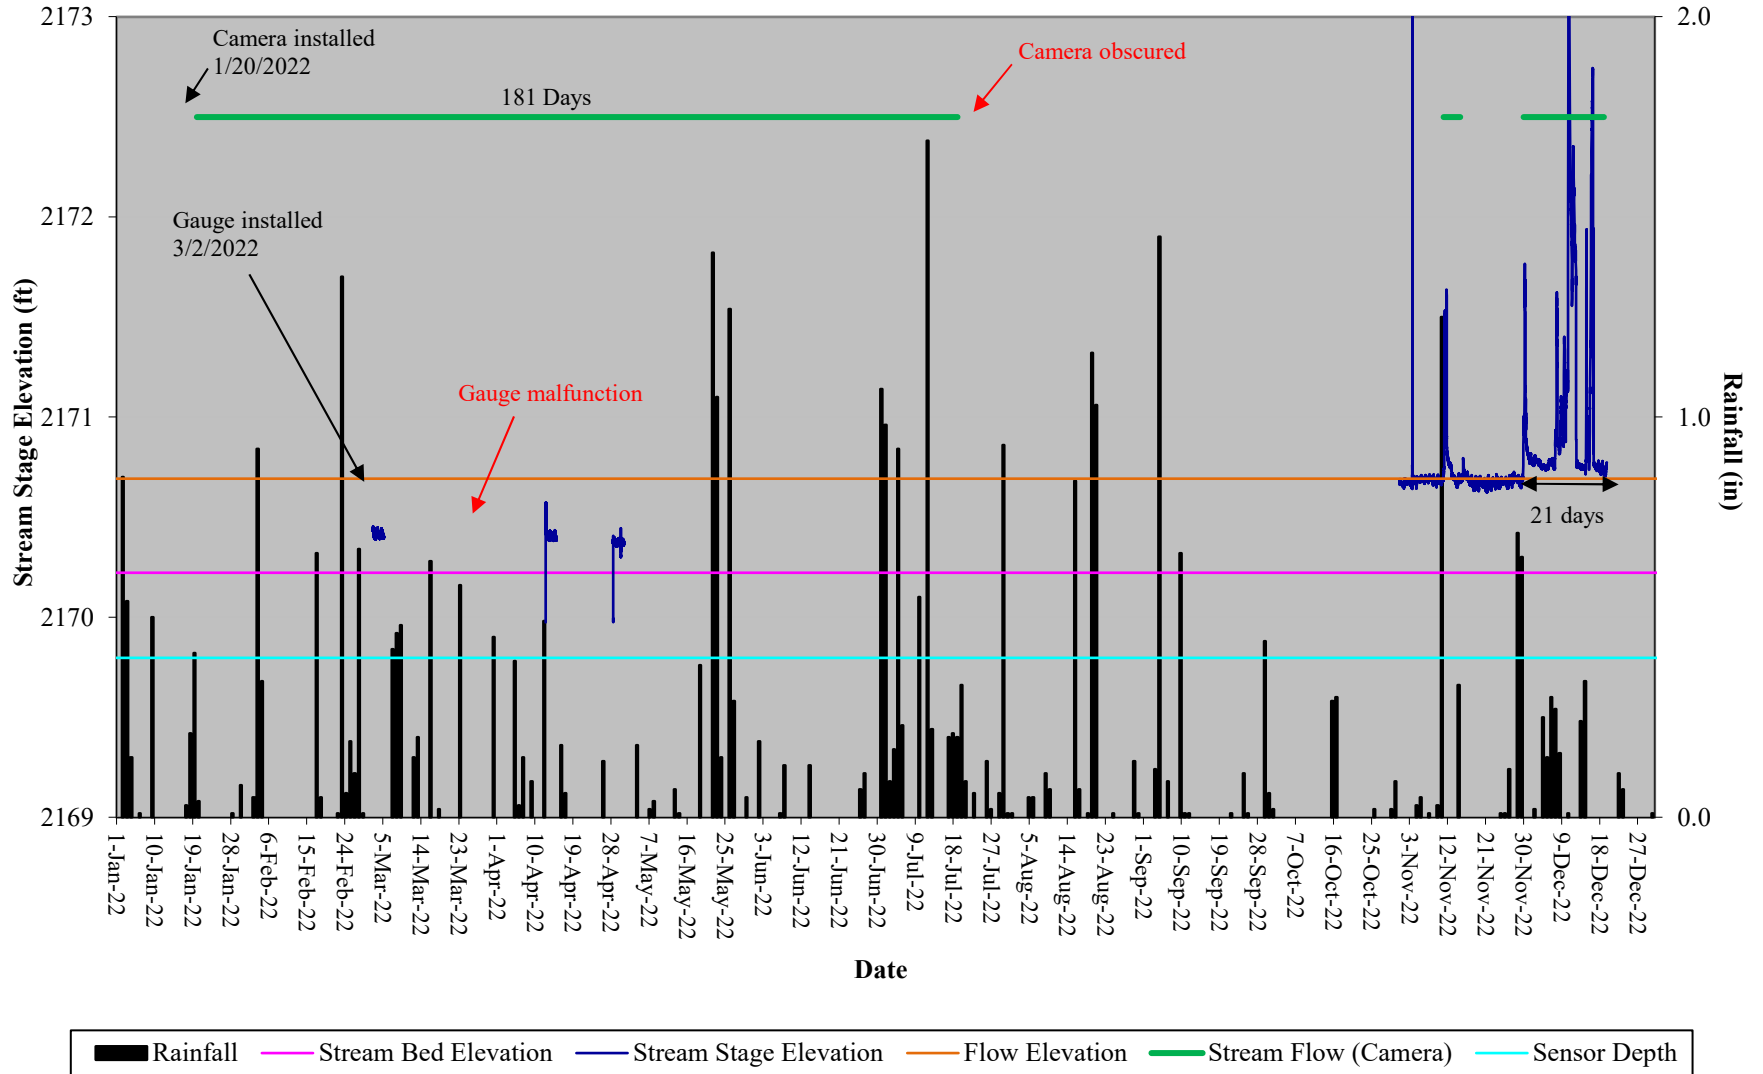
## Round Hill Branch Creek Restoration Site Hydrograph Stream Gauge T1

During 2022, the gauge on RHB recorded 10 bankfull events. The stream gauge on T1 malfunctioned and did not start recording properly until October 31, missing the majority of the time that the stream flowed in 2022. Because of this malfunction, the gauge on T1 recorded a maximum of 21 consecutive days of flow, while the flow camera on T1 recorded a maximum of 181 consecutive days of flow. The gauge on T2 recorded a maximum of 209 consecutive days of flow, while the camera on this reach recorded 83 consecutive days of flow. Differences in the number of days recorded by the cameras from those recorded by the gauges are generally due to the cameras becoming obscured by vegetation during the growing season.
