# MY02 MONITORING REPORT

Round Hill Branch Restoration Site  
Buncombe County, North Carolina  
French Broad River Basin - 06010105

DMS Project #100066

Monitoring Data Collected: 2023

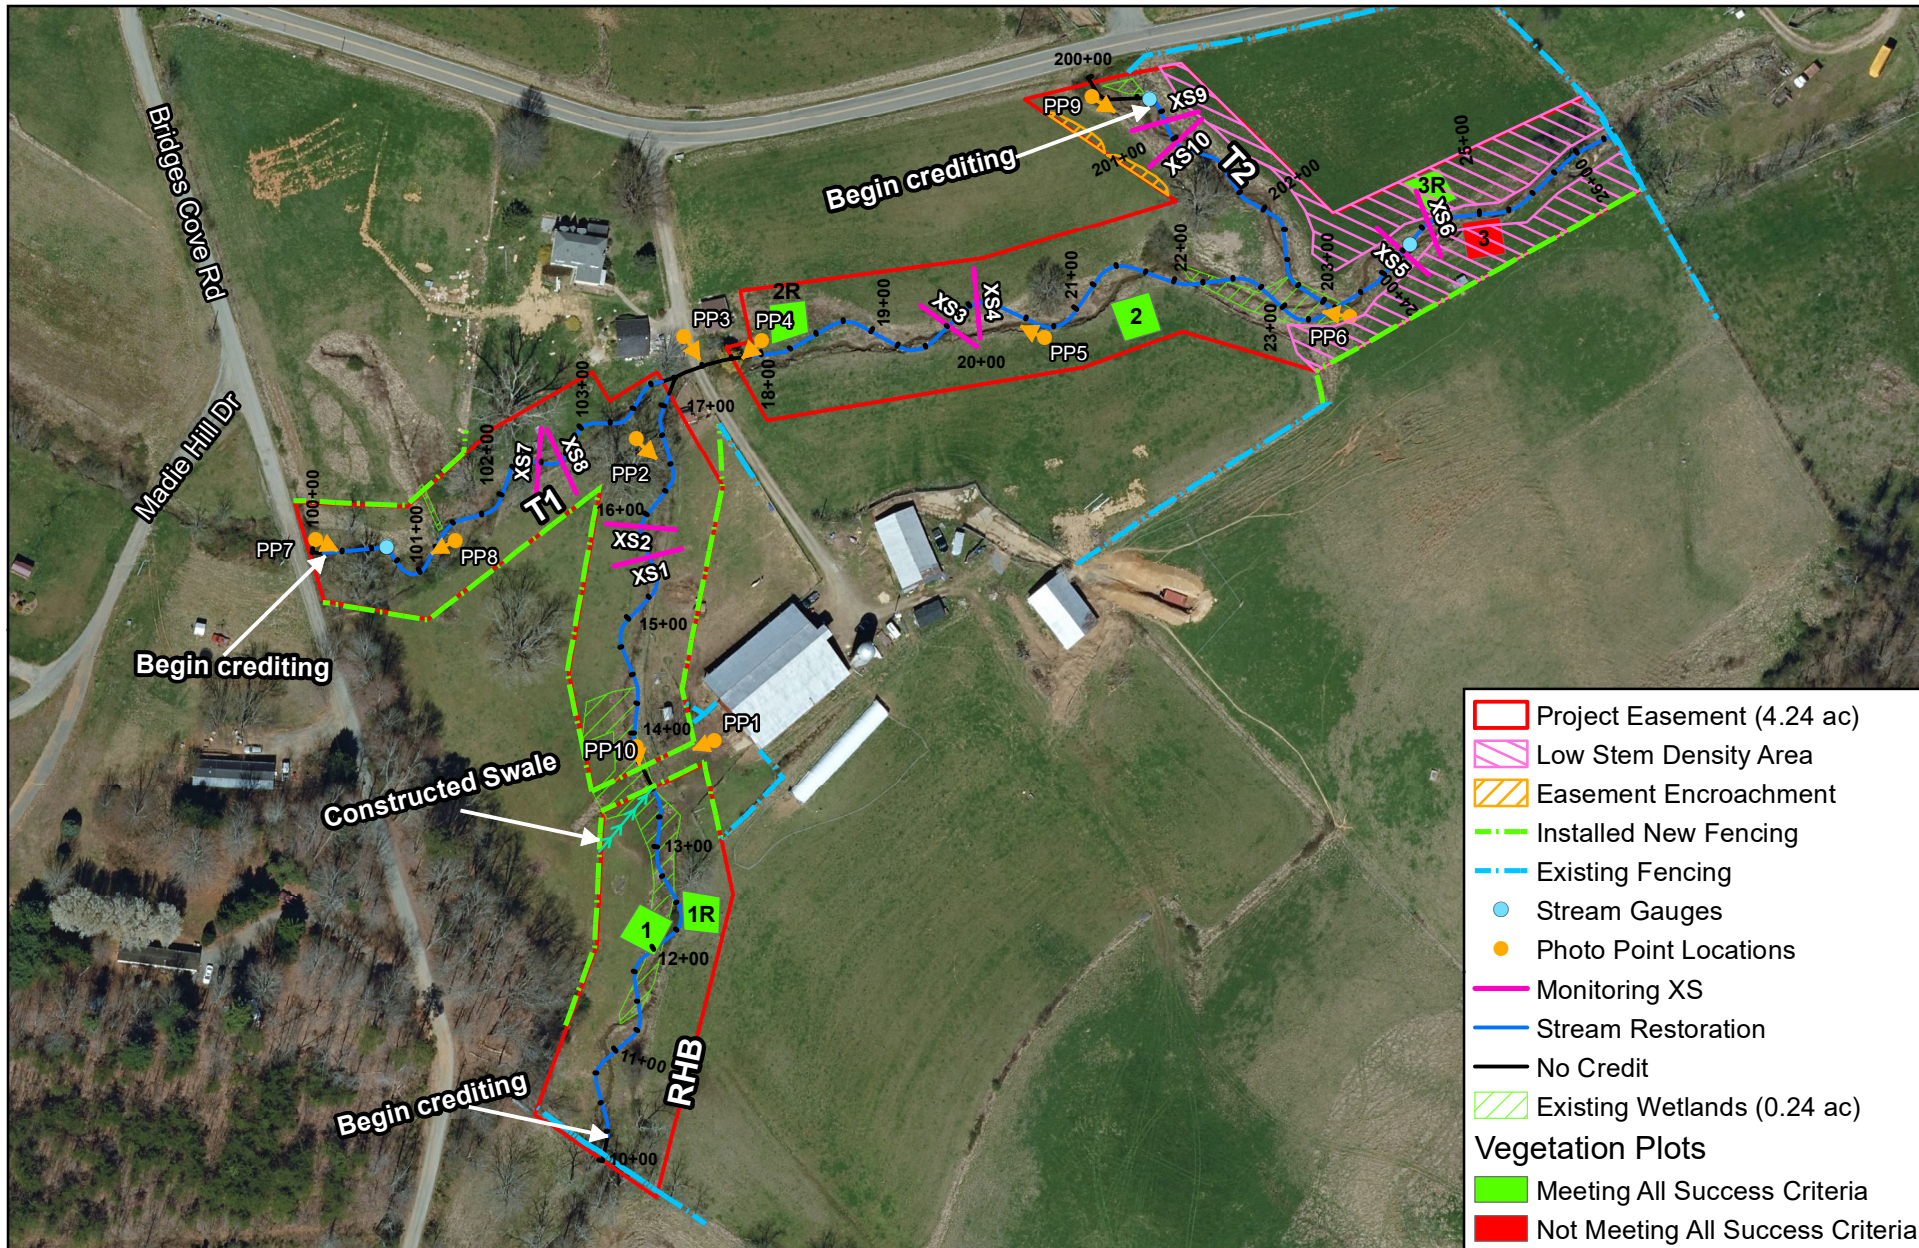
**CURRENT CONDITIONS PLANVIEW  
ROUND HILL BRANCH RESTORATION SITE  
BUNCOMBE COUNTY, NC**

There are two issue areas in terms of fencing with adjoining landowners. One area is at the top of Round Hill Branch where there is existing fence located approximately 5 feet inside of the conservation easement. The second area is at the bottom of Round Hill Branch where an existing fence pole is within the conservation easement. KCI has addressed these issues with the adjacent landowners and is planning to move the fence to the appropriate location in early 2024. The site boundaries were inspected on December 11, 2023. Besides the ongoing issue described above, no other areas of encroachment were noted.

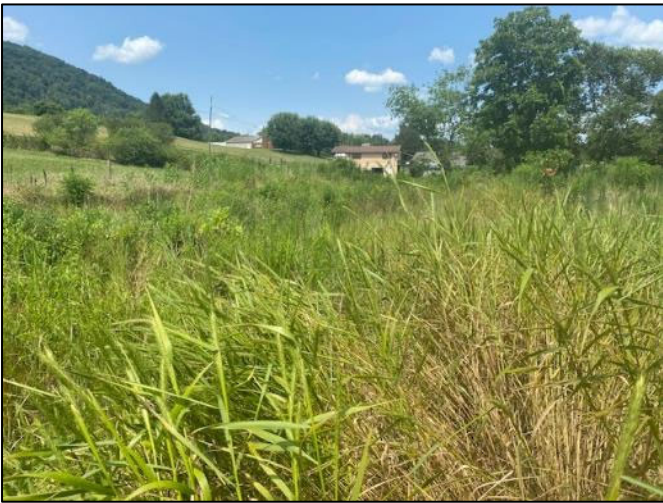
Vegetation Plot 3 – MY-02 – 8/1/23

The MY02 vegetation monitoring was conducted August 1, 2023. Five of the six vegetation monitoring plots achieved all of the success criteria. Plot 3 had only 2 native hardwood species and 208 stems/acre. This area of the site, which includes the very bottom of the main stem and the area around T2, did not see as robust growth of the planted woody stems as the rest of the site during the first two years. KCI is planning a supplemental planting in this area of the site, which will take place in the winter before the 2024 growing season. Despite this small area of poor vigor, the site as a whole is well vegetated with many healthy woody stems and a thick and diverse herbaceous layer.

1. Cover photo is from M1. Please update to a current MY2 photo of the site.  
*KCI Response: This change has been made.*
2. A supplemental planting is planned in early 2024 for the portions of T2 and the downstream section of RHB. Please include an update in the MY3 report and include species and quantities of planted material used. Please ensure that species selected are from the planting list in the approved Mitigation Plan.  
*KCI Response: We will be sure to include all of this information in the MY03 report. Species selected will be from the approved planting list.*

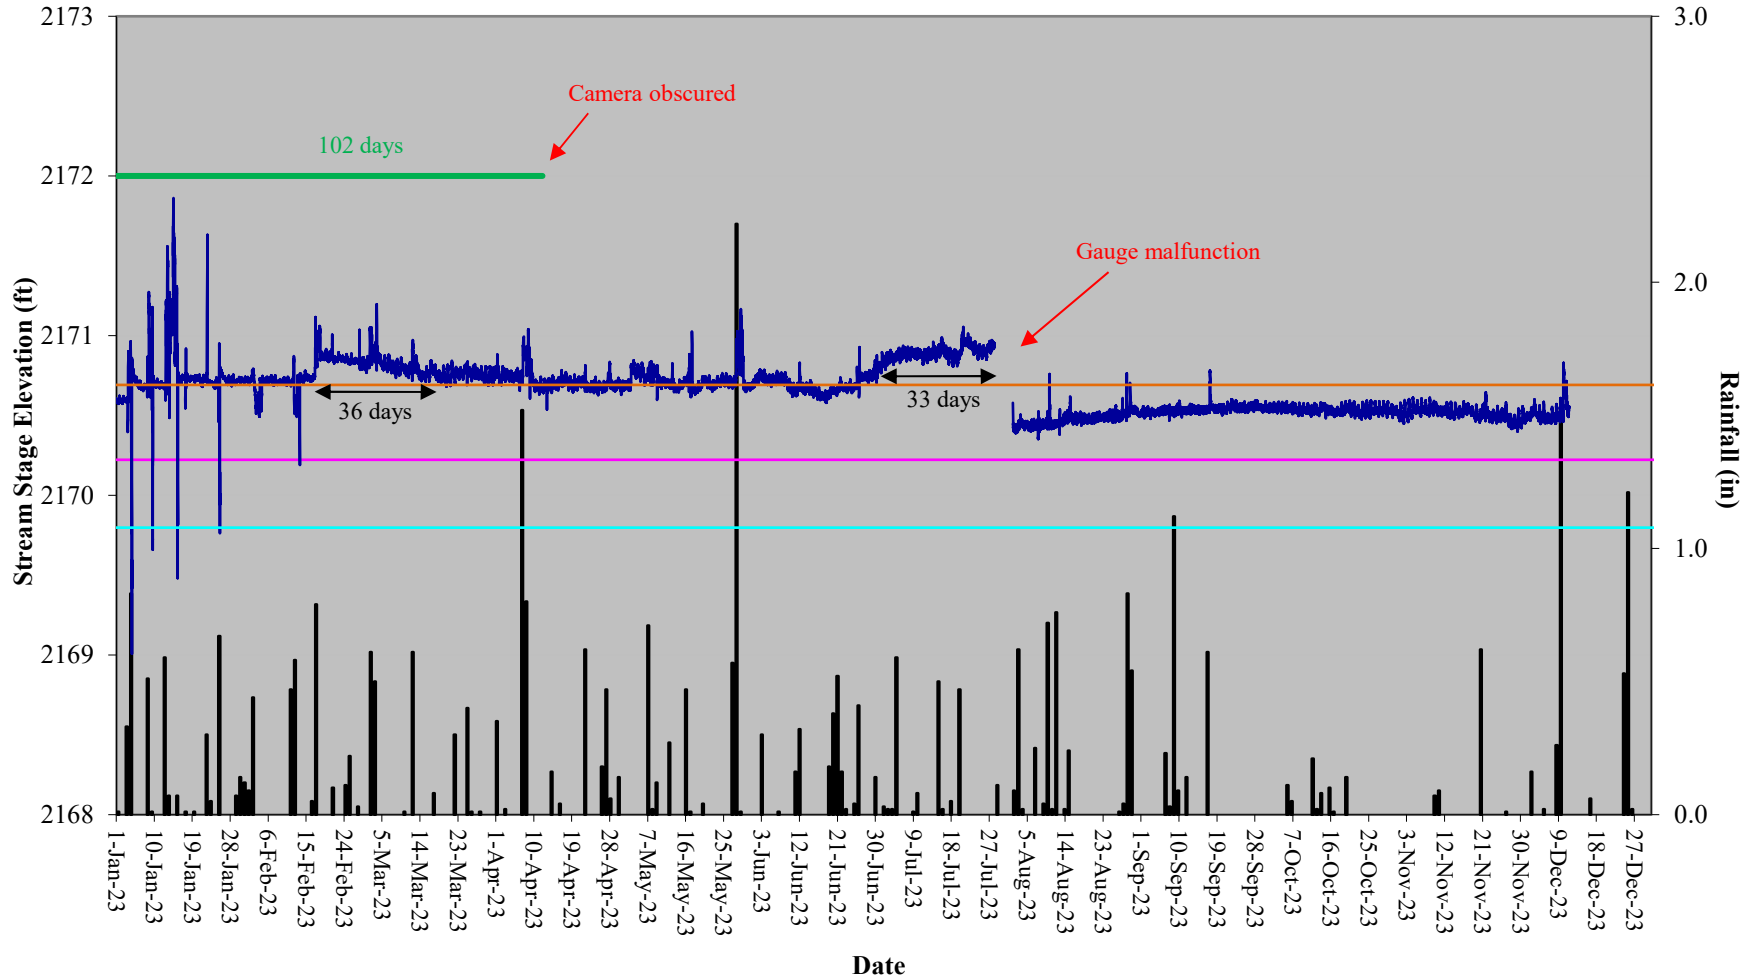
# Round Hill Branch Creek Restoration Site Hydrograph Stream Gauge T1

7. Gauge malfunctions are reported for both T1 and T2. Please verify that the gauges have been repaired/replaced and are functioning correctly.

During 2023, the gauge on RHB recorded 2 bankfull events. The stream gauge on T1 recorded a maximum of 36 consecutive days of flow, while the flow camera on T1 recorded a maximum of 102 consecutive days of flow. The gauge on T2 recorded a maximum of 136 consecutive days of flow, while the camera on this reach recorded 115 consecutive days of flow. Differences in the number of days recorded by the cameras from those recorded by the gauges are generally due to the cameras becoming obscured by vegetation during the growing season or the stream flowing at levels too low for the gauges to accurately record.

*KCI Response: These gauges have been replaced.*
