## **Russell Gap Stream Mitigation Project Year 3 (2022) Monitoring Report FINAL**

DMS Project ID No. 100003, DEQ Contract No. 6980 USACE Action ID No. SAW-2017-00826, DWR# 20150416 Alexander County, North Carolina, Catawba River Basin: 03050101-120010 MY3 Data Collection Period: January – October 2022

**INTERNATIONAL** Submission Date: February 2023

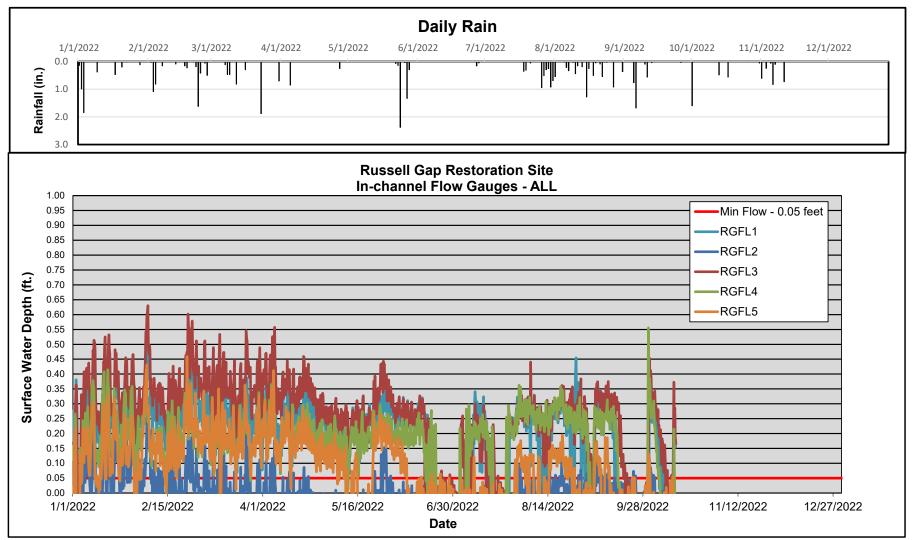
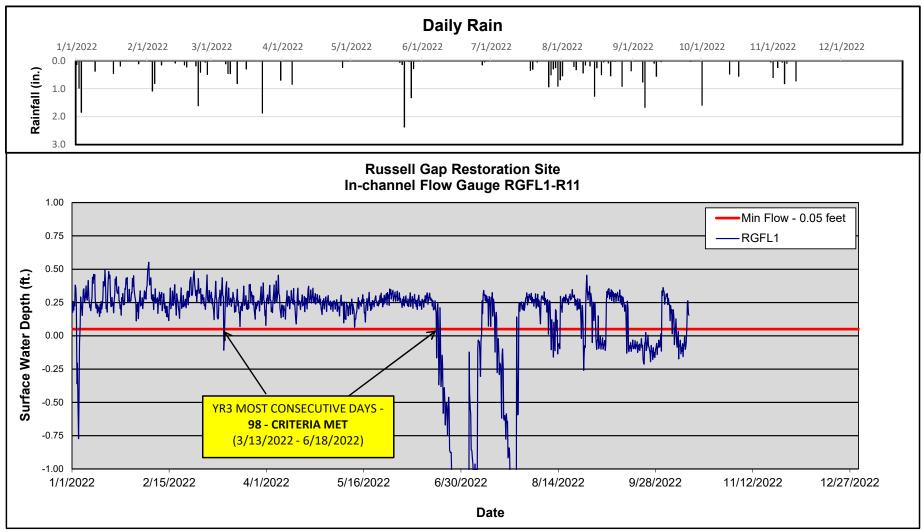
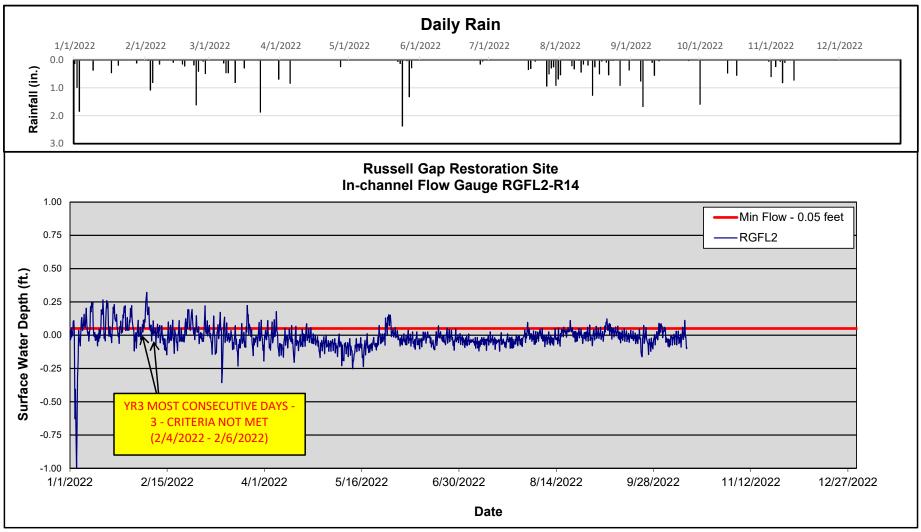
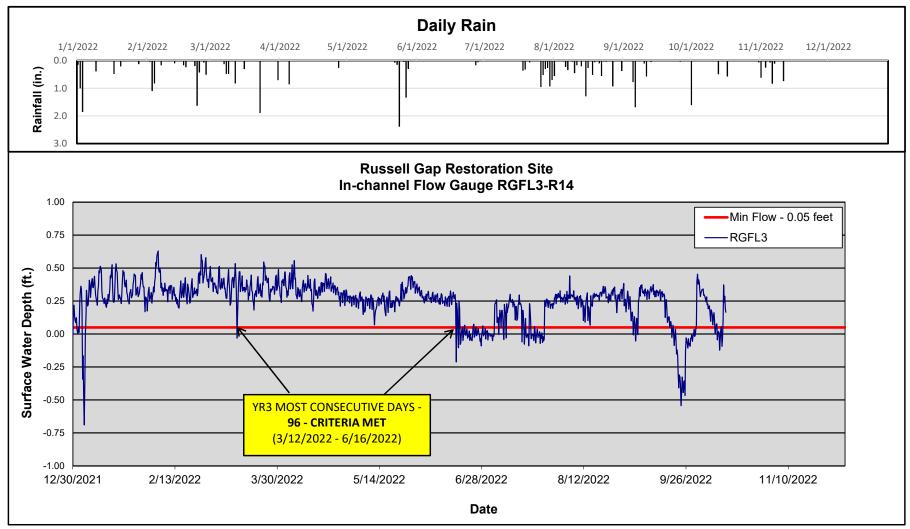
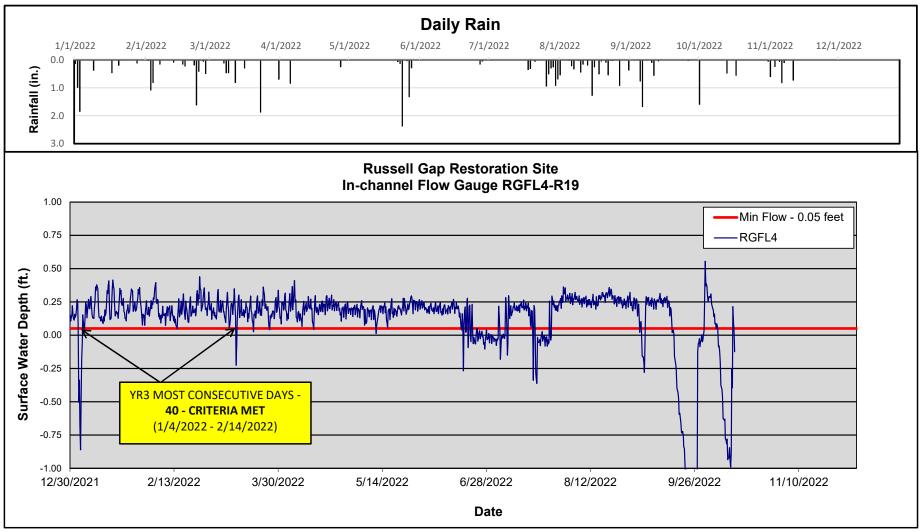
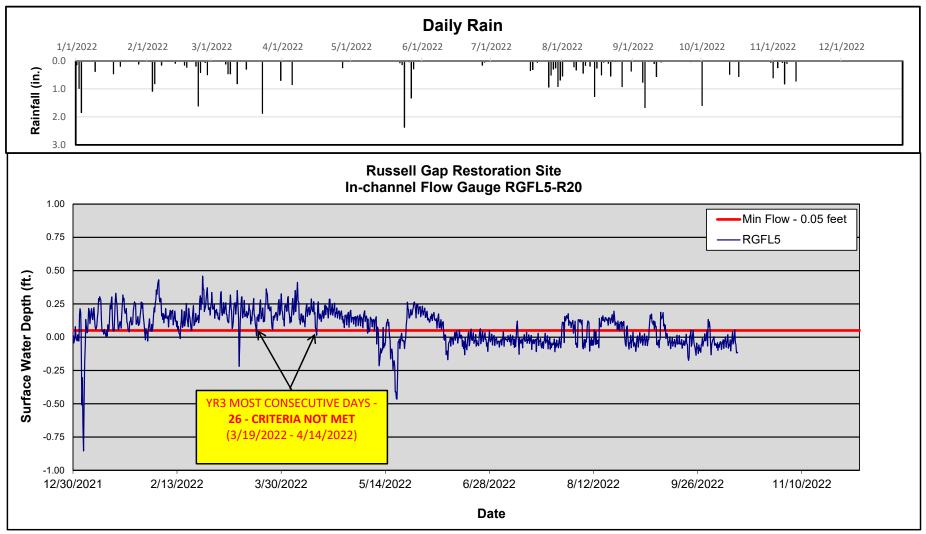
# Figure 6. Flow Gauge Success

- Flow Gauge Graphs: Graph notes for RGFL2 and RGFL5 are misleading. Note indicates that flow criteria is met; however, both gauges failed to meet the 30 day success criteria. Please revise for clarity. Also, four of the five graph notes are in red, and one is in black. Recommend using red for gauges not meeting and black for gauges that are meeting. RESPONSE: Language was changed on graph notes for clarification. Font colors have been changed to black when criteria is met and red when it is not.

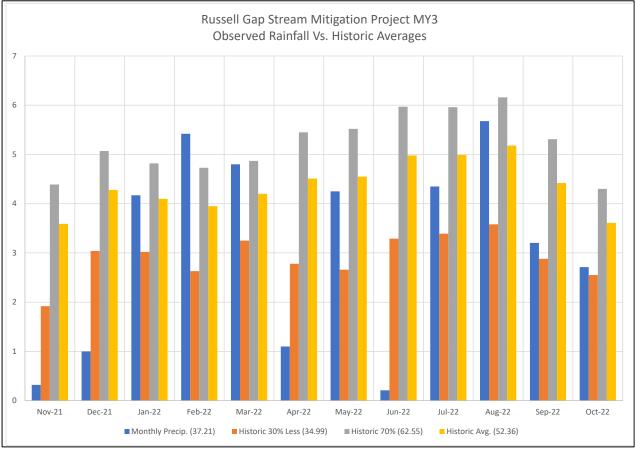
Figure 7. Observed Rainfall Versus Historic Averages

Figure 6 in Appendix E demonstrates that rainfall since November 2021 has been lower than the historic averages all months during MY3 monitoring and growing season. A total of 37.2 inches of rainfall was observed for the project which is less than the annual historic average of 52.36 inches. All observed project rainfall was collected from the North Carolina Climate Office Weather Climate Database CRONOS station TAYL, located in Taylorsville, NC.

Note: Historic average annual rainfall for Alexander County, NC is 52.36 inches, while the observed project rainfall recorded a total of 37.21 inches over the previous 12 months (Nov. 21 - Oct. 2022). Project rainfall data was collected from the NC-CRONOS station TAYL.
