# **Russell Gap Stream Mitigation Project Year 1 (2020) Monitoring Report FINAL**

DMS Project ID No. 100003, DEQ Contract No. 6980

MY1 Data Collection Period: September – November 2020

Submission Date: December 2020

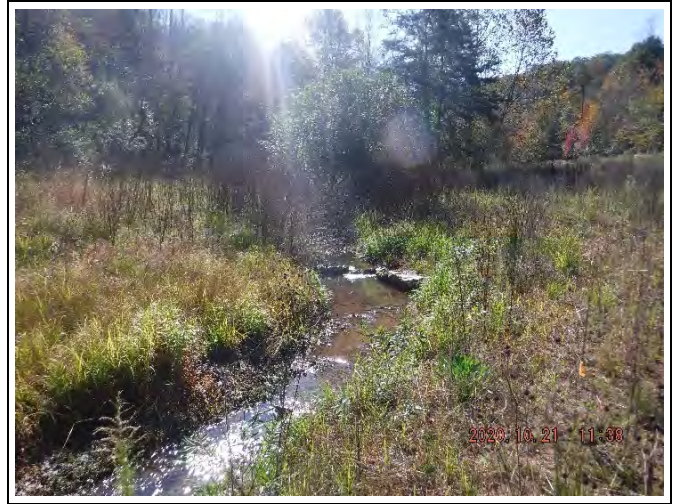
PP-32: Reach 6, view upstream at Station 17+50.  
(October 21, 2020)

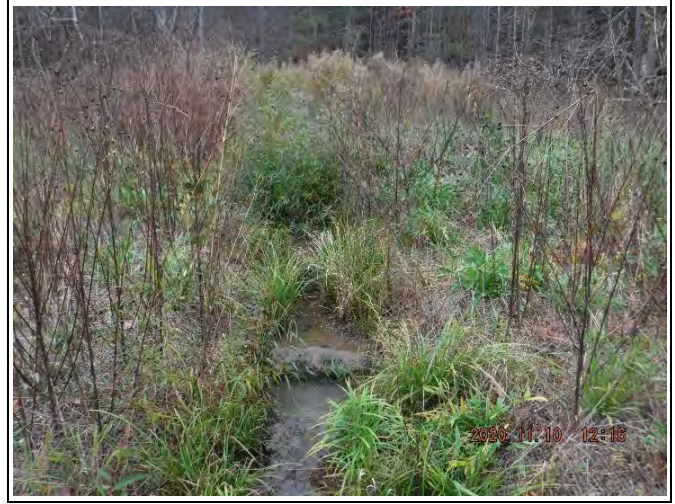
PP-34: Reach 18, view upstream at Station 12+00.  
(November 10, 2020)

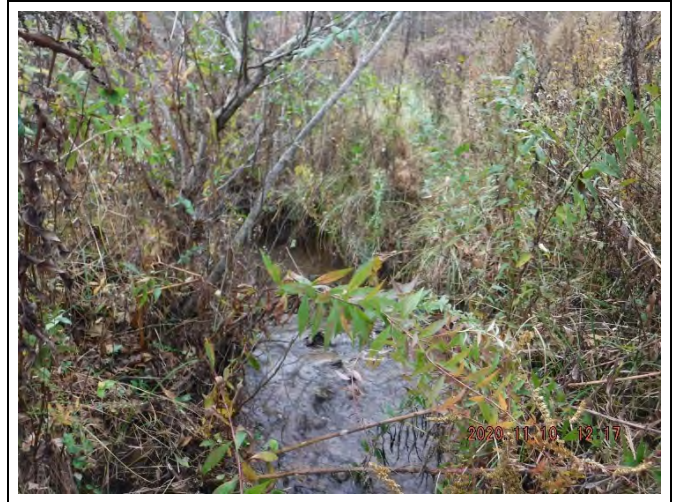
PP-36: Reach 7A, view upstream at Station 20+00.  
(November 10, 2020)

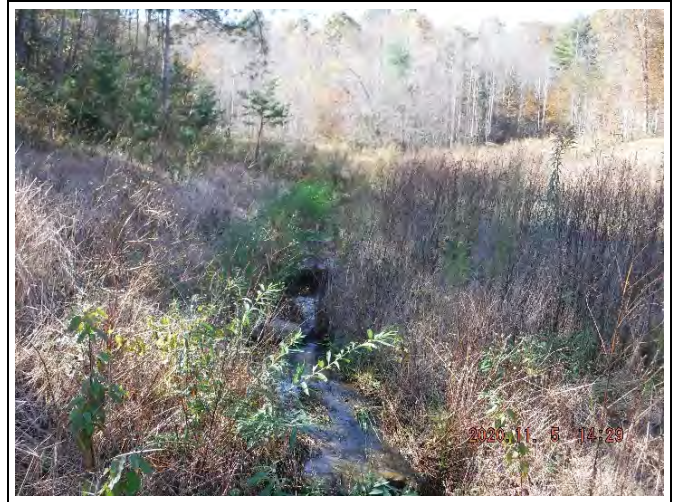
PP-44: Reach 19, view upstream at Station 11+85.  
(November 5, 2020)

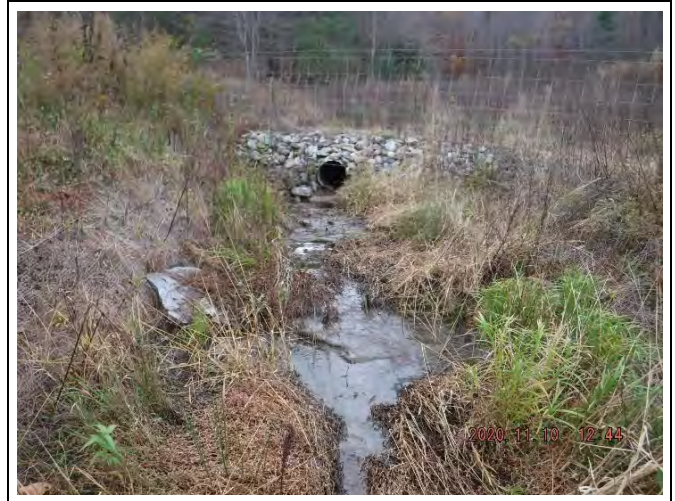
PP-46: Reach 19, view upstream at Station 13+20.  
(November 10, 2020)

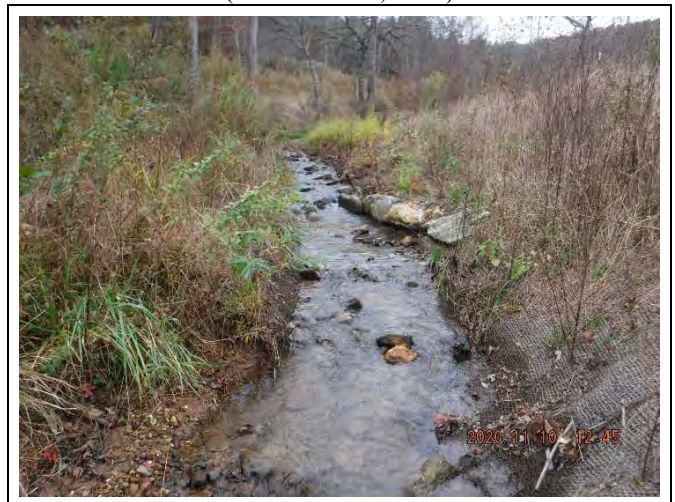
PP-48: Reach 7B, view upstream at Station 24+10.  
(November 10, 2020)

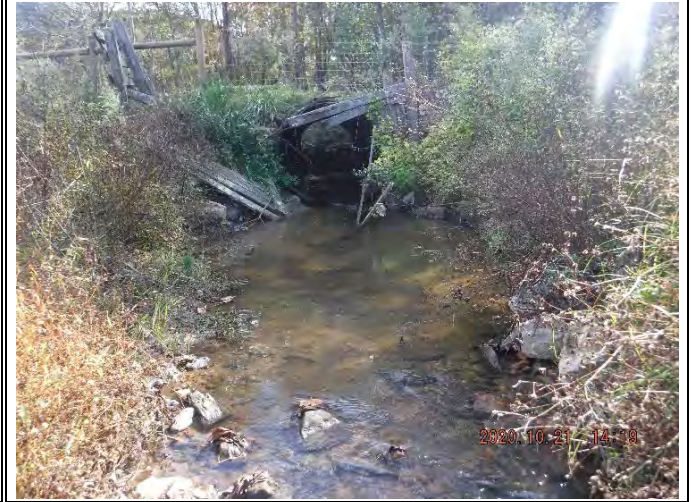
PP-62: Reach 9, view upstream at Station 39+20.  
(October 21, 2020)

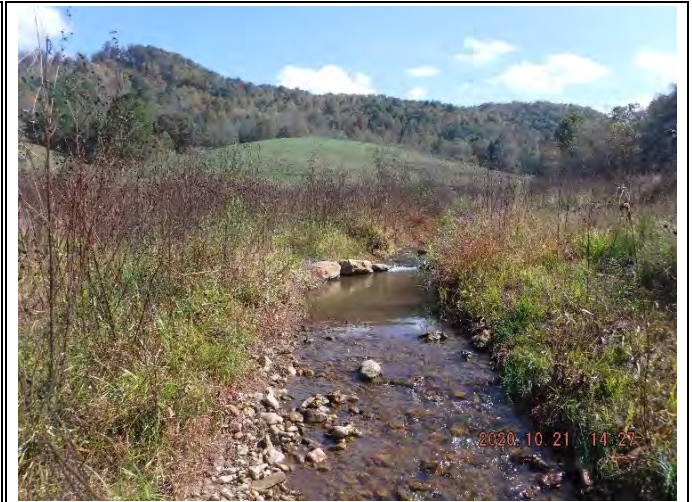
PP-64: Reach 9, view upstream at Station 42+00.  
(October 21, 2020)

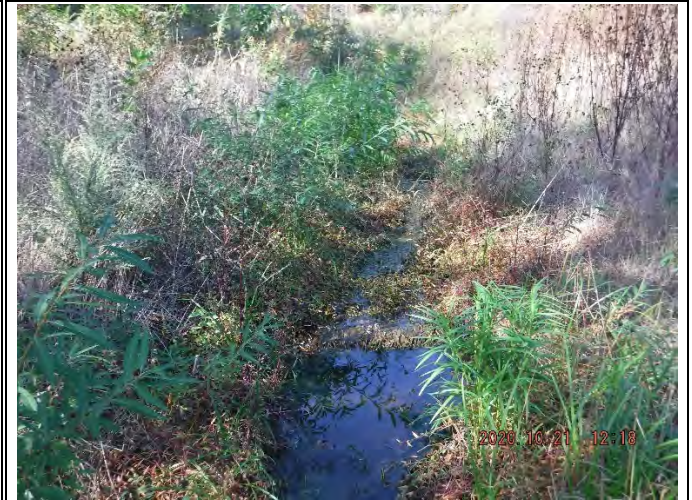
PP-66: Reach 26, view upstream at Station 11+00.  
(October 21, 2020)

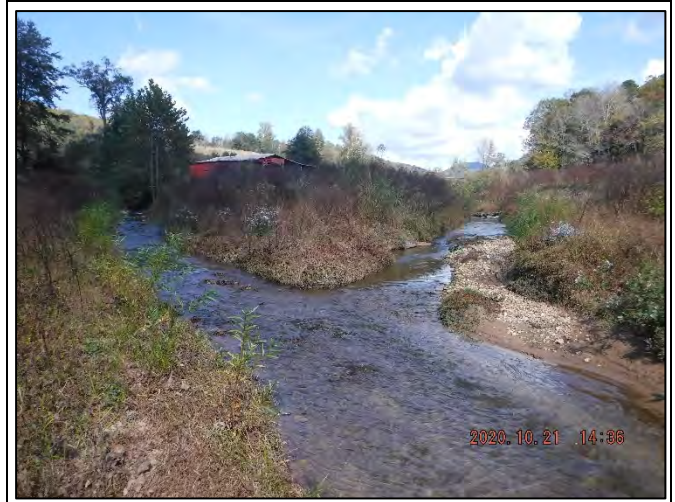
PP-80: Reach 3, view upstream at Station 33+00.  
(October 21, 2020)

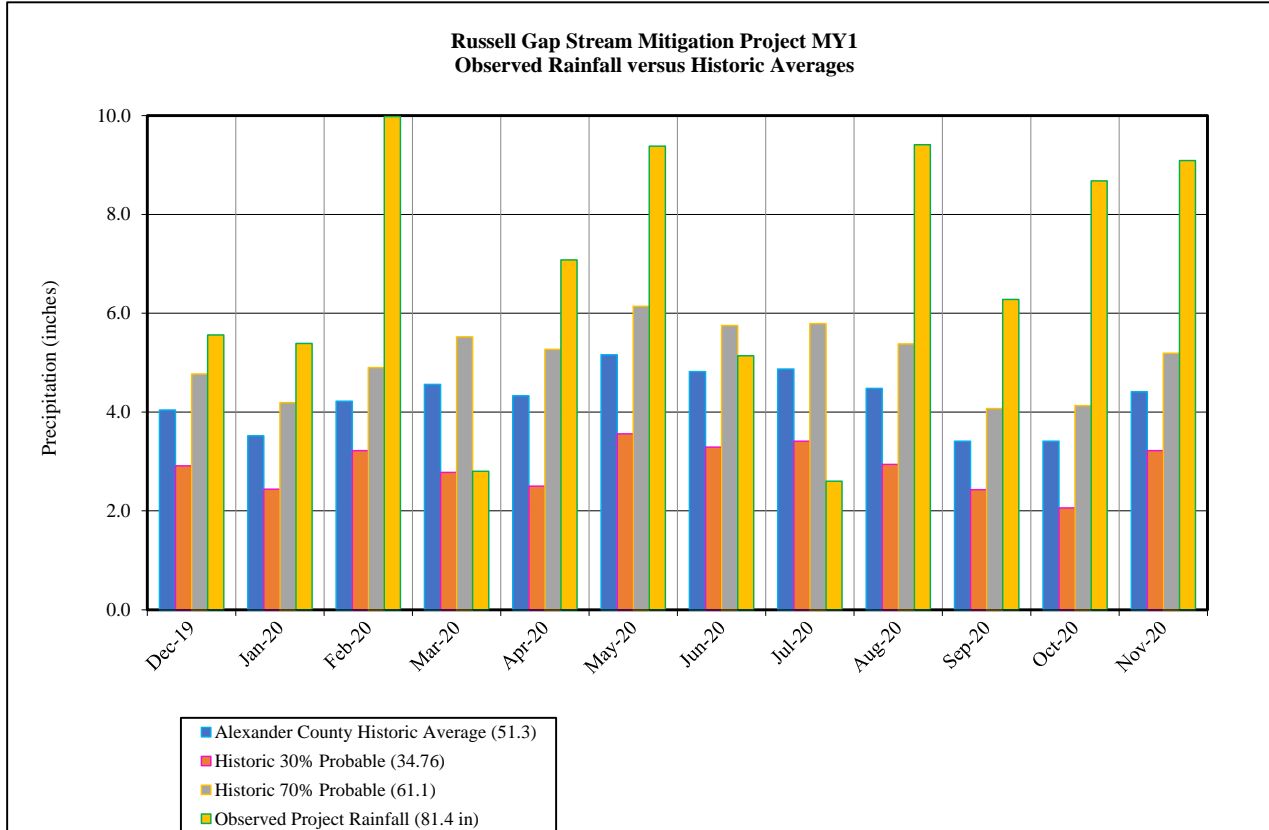
As the observed monthly rainfall data for the project presented in Figure 6 in Appendix E demonstrates, the past 12 months have varied dramatically as compared to historic average precipitation. A total of 81.4 inches of rainfall was observed for the project, while Alexander County averages 47.2 inches of annual rainfall, an excess of 34.2 inches. All observed project rainfall was collected from the North Carolina Climate Office Weather Climate Database CRONOS station TAYL, located in Taylorsville, NC.

Note: Historic average annual rainfall for Alexander County, NC is 51.3 inches, while the observed project rainfall recorded a total of 81.4 inches over the previous 12 months (Dec. 2019 - Nov. 2020). Project rainfall data was collected from the NC-CRONOS station TAYL.
