Russell Gap Stream Mitigation Project Year 2 (2021) Monitoring Report FINAL

DMS Project ID No. 100003, DEQ Contract No. 6980

Alexander County, North Carolina, Catawba River Basin: 03050101-120010

MY2 Data Collection Period: January – October 2021

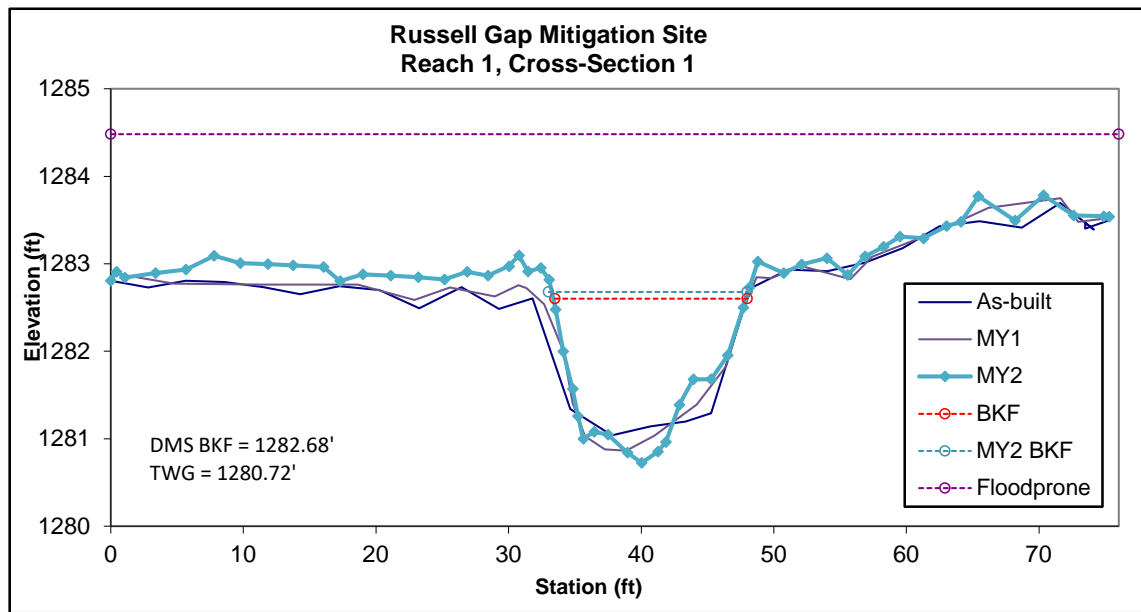
Permanent Cross-Section 1
 Year 2 Survey Collected: September 2021

Feature	Stream Type	BKF Area	BKF Width	BKF Depth	Max BKF Depth	W/D	BH Ratio	ER	BKF Elev	LTOB Elev
Riffle	C	17.6	14.5	1.2	1.96	12.0	1.1	5.2	1282.60	1282.95

Note: Per DMS/IRT request, bank height ratio for MY2 has been calculated using the bankfull elevation of 1282.68 as determined from the as-built bankfull area. All other values were calculated using the as-built bankfull elevation.

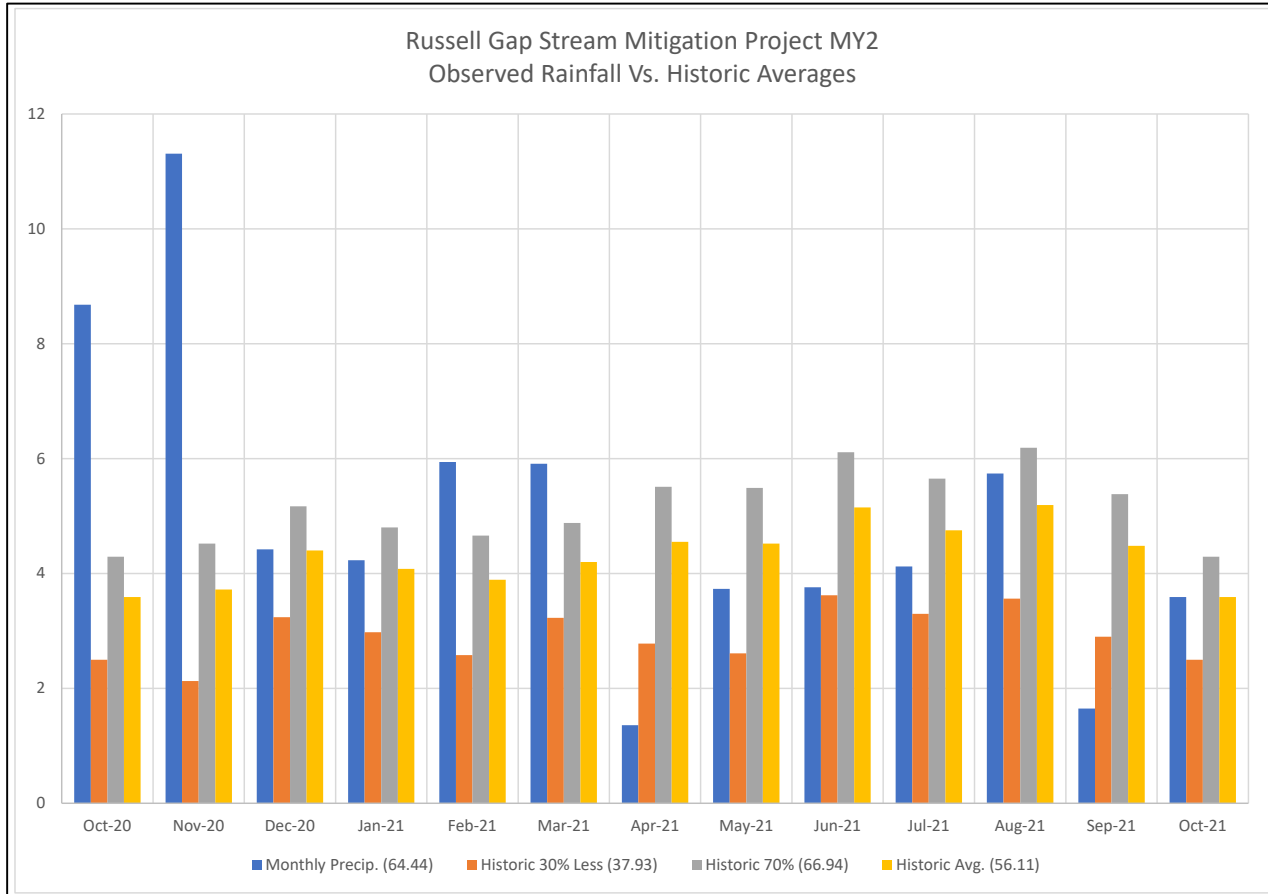
Note: Historic average annual rainfall for Alexander County, NC is 56.11 inches, while the observed project rainfall recorded a total of 64.44 inches over the previous 12 months (Oct. 2020 - Oct. 2021). Project rainfall data was collected from the NC-CRONOS station TAYL.
