Monitoring Report MY07/Closeout

**Sandy Bridge Restoration Site
DMS Contract 6400
DMS Project Number 96920**

**DWR #: 15-0414
USACE Action ID: 201500827
Rutherford County, North Carolina**

**Monitoring Data Collected: 2023
Date Submitted: December 2023**

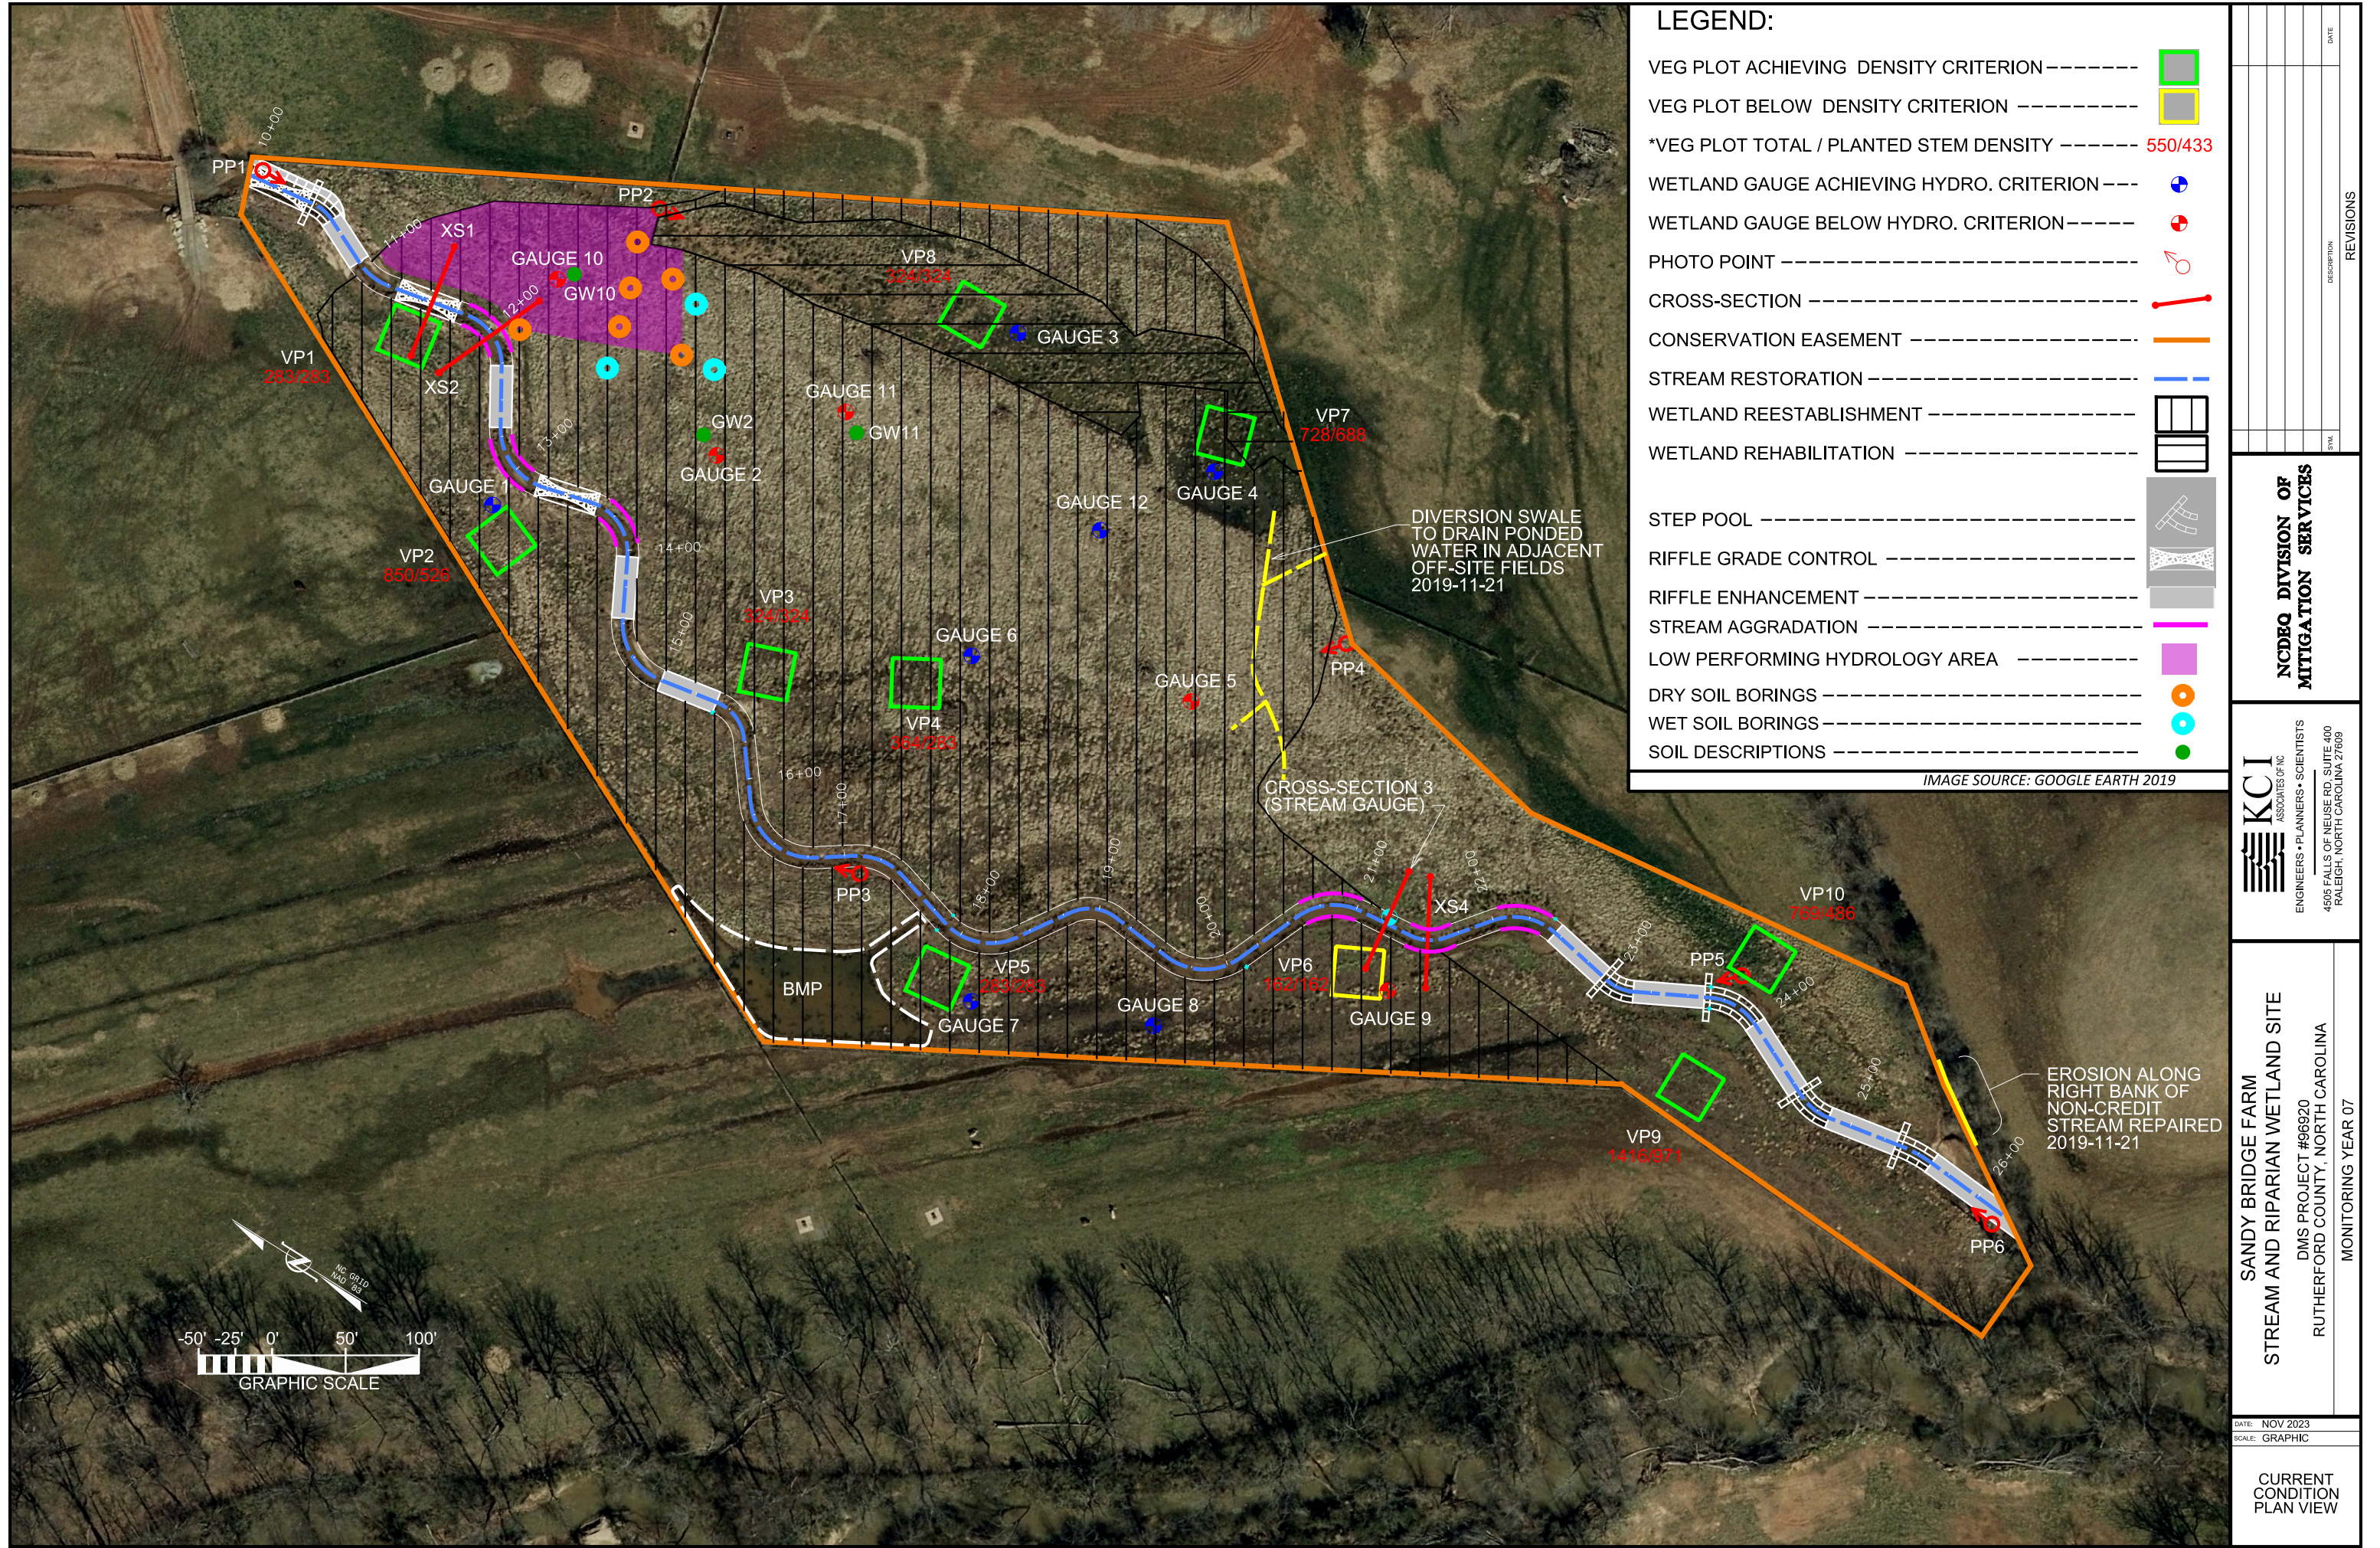
- Thank you for the 3 soil profiles conducted at/around GW2, GW10 and GW11, and symbols shown on the map; it would be helpful to show a) the soil profile photos associated with these borings, if available, and b) soil boring labels (IDs) on the CCPV.
KCI Response: Photos of the soil borings are not available but labels have been added to the CCPV.

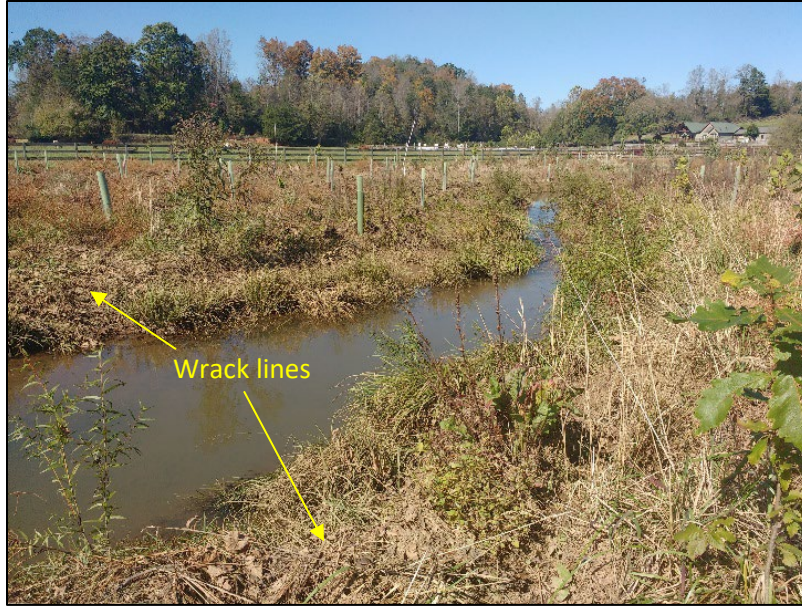
Photo 1. Sediment on plants and wrack lines above bankfull, 10/26/2017

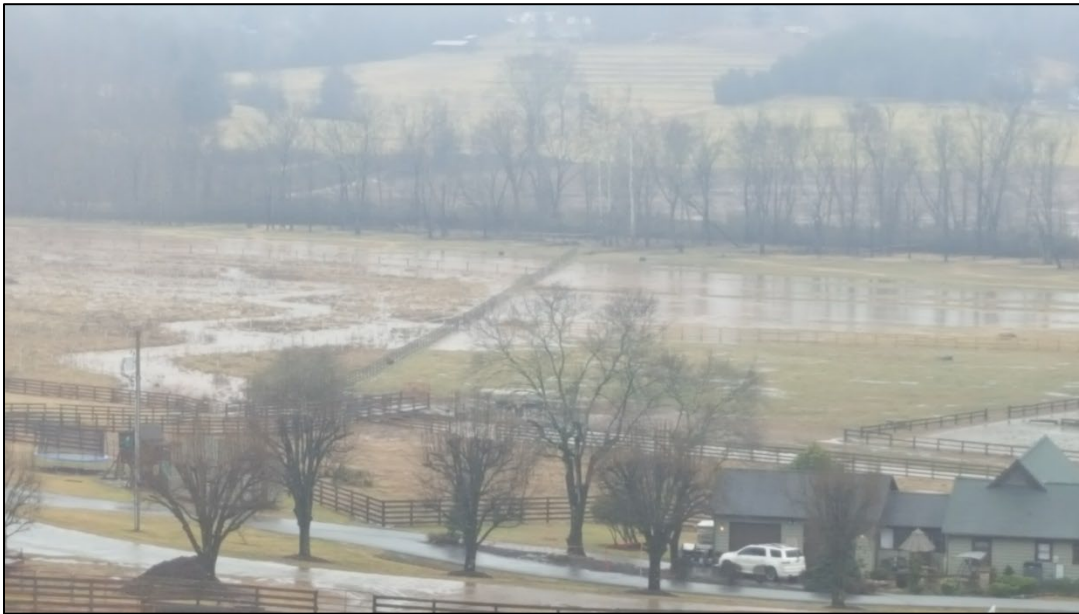
Photo 2. Bankfull event on site, 2/7/2018

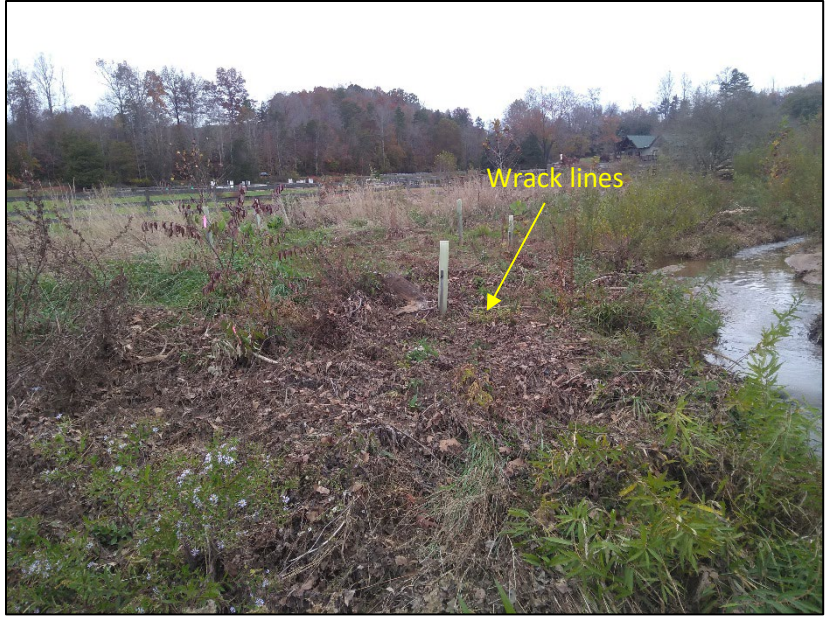
Photo 3. Wrack lines above bankfull, 11/7/2018

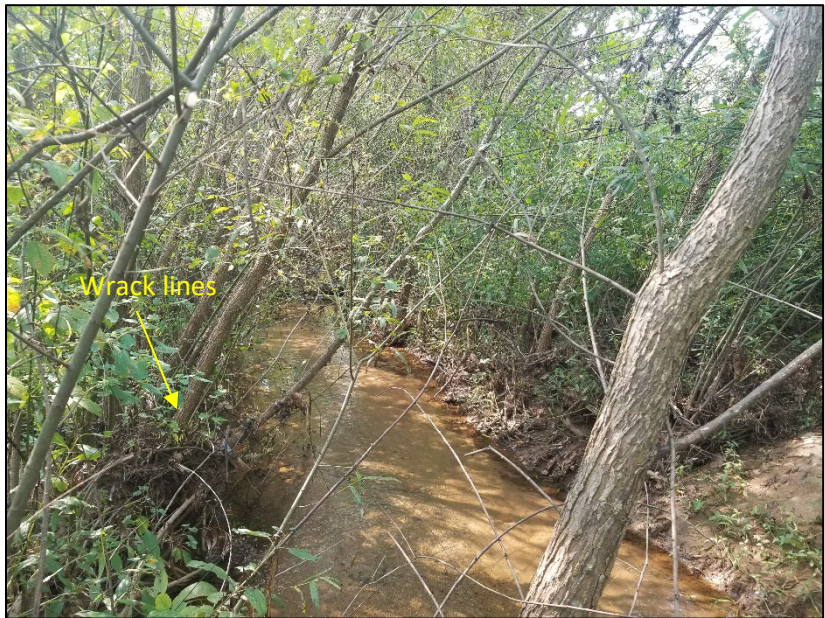
Photo 4. Wrack lines above bankfull, 9/13/2021

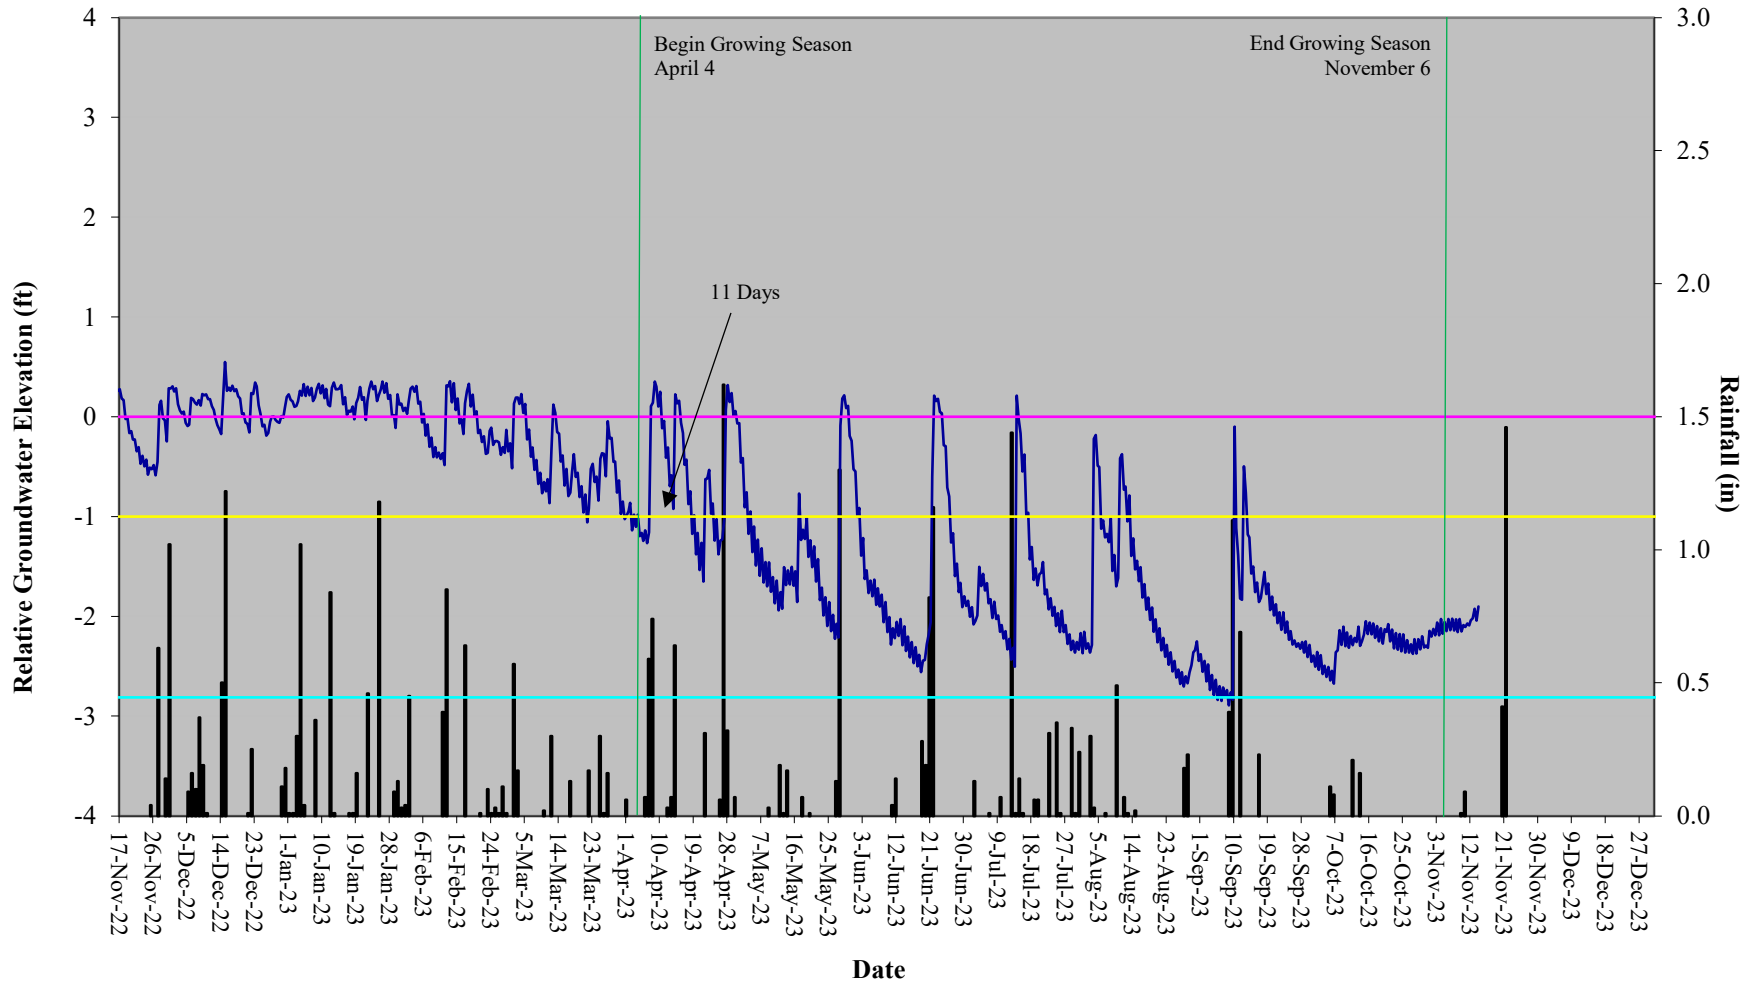
Sandy Bridge Farm Restoration Site Hydrograph Wetland Gauge 10

Gauge 10 has only achieved the success criteria in one of the six years that it has been installed and so, during the seventh growing season, KCI delineated an area around this gauge that has been designated as a "low performing area." This delineation was based on the vegetation, soils, and local relief of the area surrounding Gauge 10. An area of 0.385 acres was identified and has been removed from credit calculations for the site. This area was entirely within the wetland reestablishment area on the site and the asset table has been updated to reflect this change. Please see Appendix F – Additional Data for detailed soil profile descriptions taken in and around this area.
