MONITORING YEAR 2 ANNUAL REPORT FINAL

January 2023

SANDY BRANCH MITIGATION SITE

DMS Project No. 100060
NCDEQ Contract No. 7527
USACE Action ID No. SAW-2018-01167
NCDWR Project No. 2018-0786

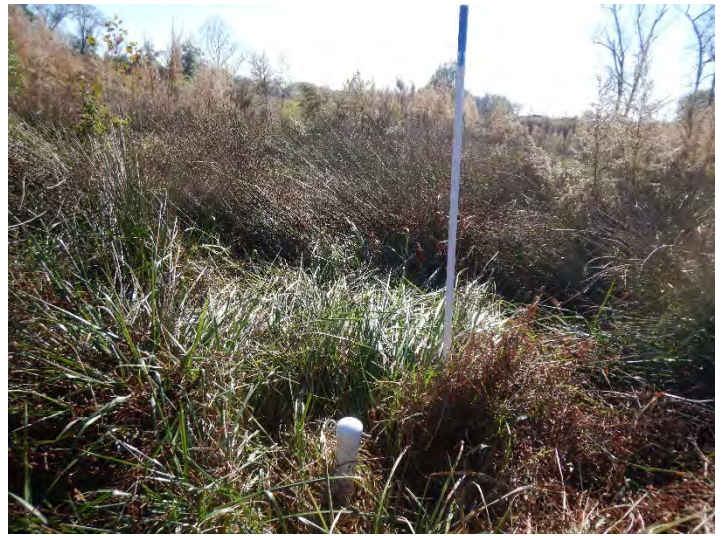
GROUNDWATER GAUGE 2 (11/18/2022)

consecutively. Groundwater gauge 2 narrowly missed with a hydroperiod of 9.5% (25 days). Annual precipitation was lower than normal throughout MY2, especially in February to mid-March, which likely contributed to not meeting success criteria. Additionally, after construction of the stream channel, it is anticipated that the groundwater table will take some time to recharge. Two gauges that failed in the previous monitoring year have since recharged post-construction and successfully meet performance criteria. It is expected that groundwater gauge 2 will also meet performance criteria in future monitoring years. Per the IRT's request, two additional groundwater gauges were installed in wetland re-establishment areas on April 28, 2022. Groundwater gauges 13 and 14 missed with a hydroperiod of 8.4% (22 days) and 3.8% (10 days) respectively. However, these gauges were installed in late April after the critical portion of the growing season was past, and groundwater levels began to drop as summer approached. Given a complete year of observation, both gauges are expected to reach success criteria. Refer to Figure 1 for the groundwater gauge locations and Appendix D for groundwater hydrology data and plots.
