MONITORING YEAR 3 ANNUAL REPORT FINAL

January 2024

SANDY BRANCH MITIGATION SITE

Chatham County, NC
Cape Fear River Basin
HUC 03030003
DMS Project No. 100060
NCDEQ Contract No. 7527
USACE Action ID No. SAW-2018-01167
NCDWR Project No. 2018-0786

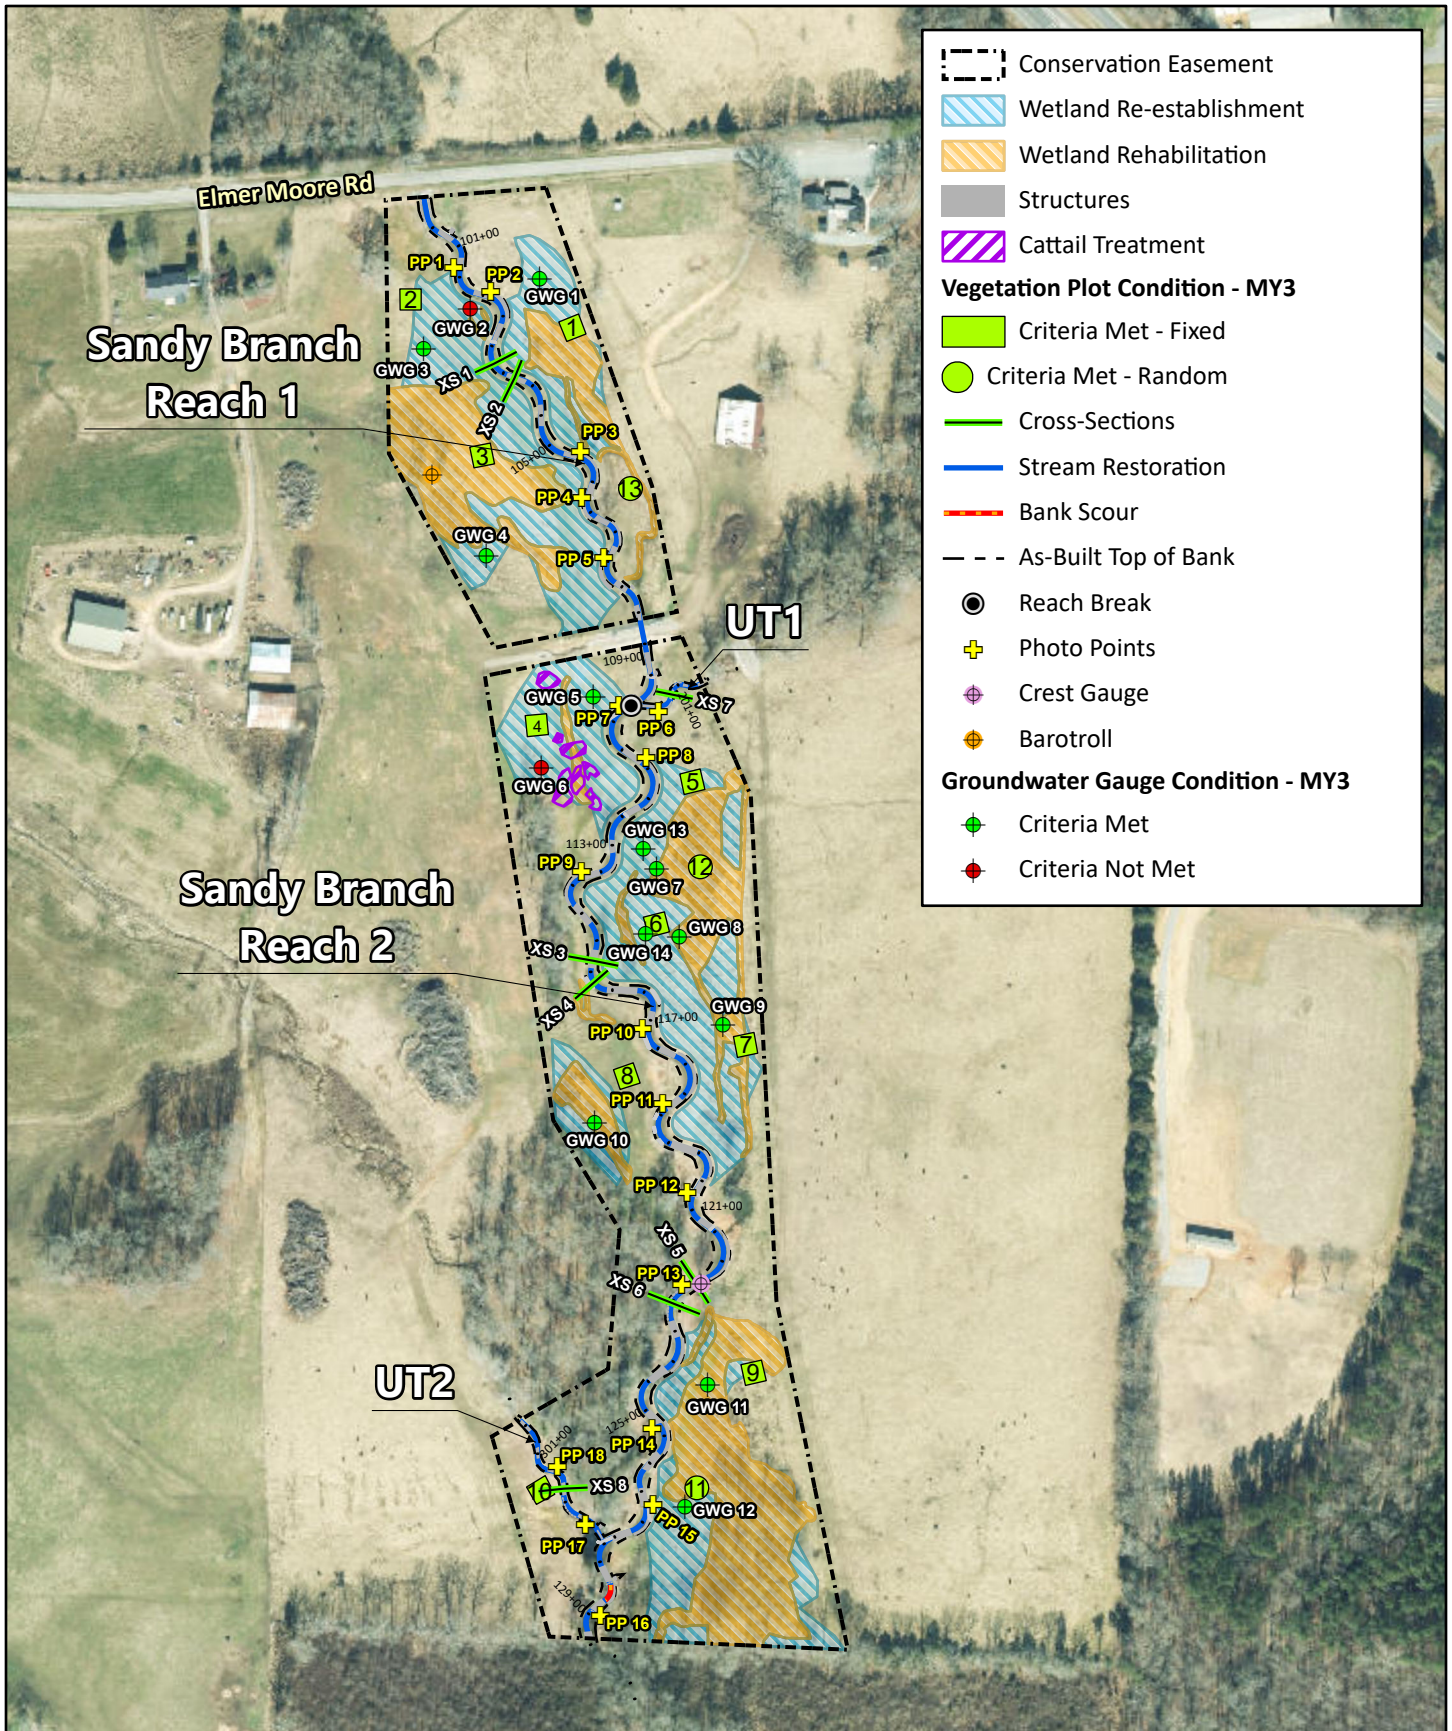
Figure 1. Current Condition Plan View
 Sandy Branch Mitigation Site
 DMS Project No. 100060
 Monitoring Year 3 - 2023

Response: The location of scour on the outside bank of a meander on Sandy Branch Reach 2 has been added to the CCPV, and text has been added to the report. Linear stream footage of the scour has been added to Table 4. Any remedial actions taken will be discussed in the MY4 report.

Scour was observed on the outside bank of a bend on the lower portion of Sandy Branch Reach 2. This area includes approximately 25 linear feet of streambank. This most likely occurred from a series of high flow events resulting from several large storms between December 2023-January 2024. Remedial action will be taken in MY4, and this area will continue to be monitored and documented. Refer to Appendix A for the Current Condition Plan View.

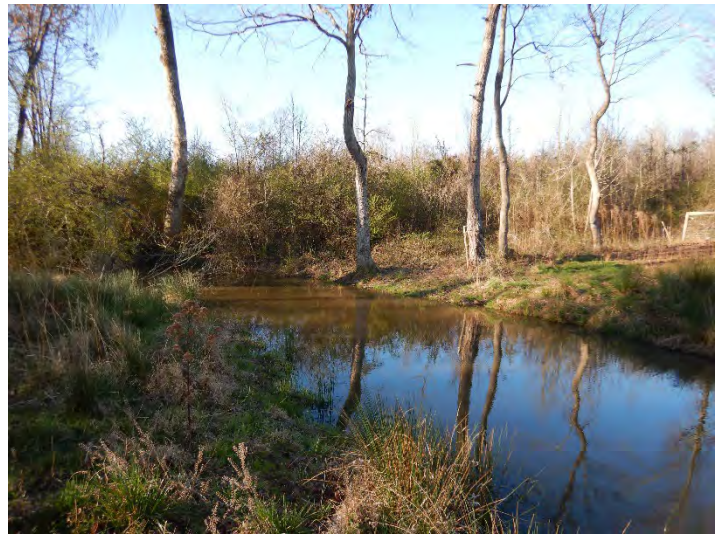
PHOTO POINT 16 Sandy Branch R2 – upstream (03/14/2023)

3. Recent scour on the outer bank in a meander was brought to DMS' attention at the 1/26/2024 site visit, located a short distance upstream of PP16. Please call out location on CCPV and discuss remedial actions taken, if any, in the MY4 report.
