Monitoring Report MY01

**Sandy Bridge Restoration Site
DMS Contract 6400
DMS Project Number 96920**

**DWR #: 15-0414
USACE Action ID: 201500827
Rutherford County, North Carolina**

**Monitoring Data Collected: October 2017
Date Submitted: January 2018**

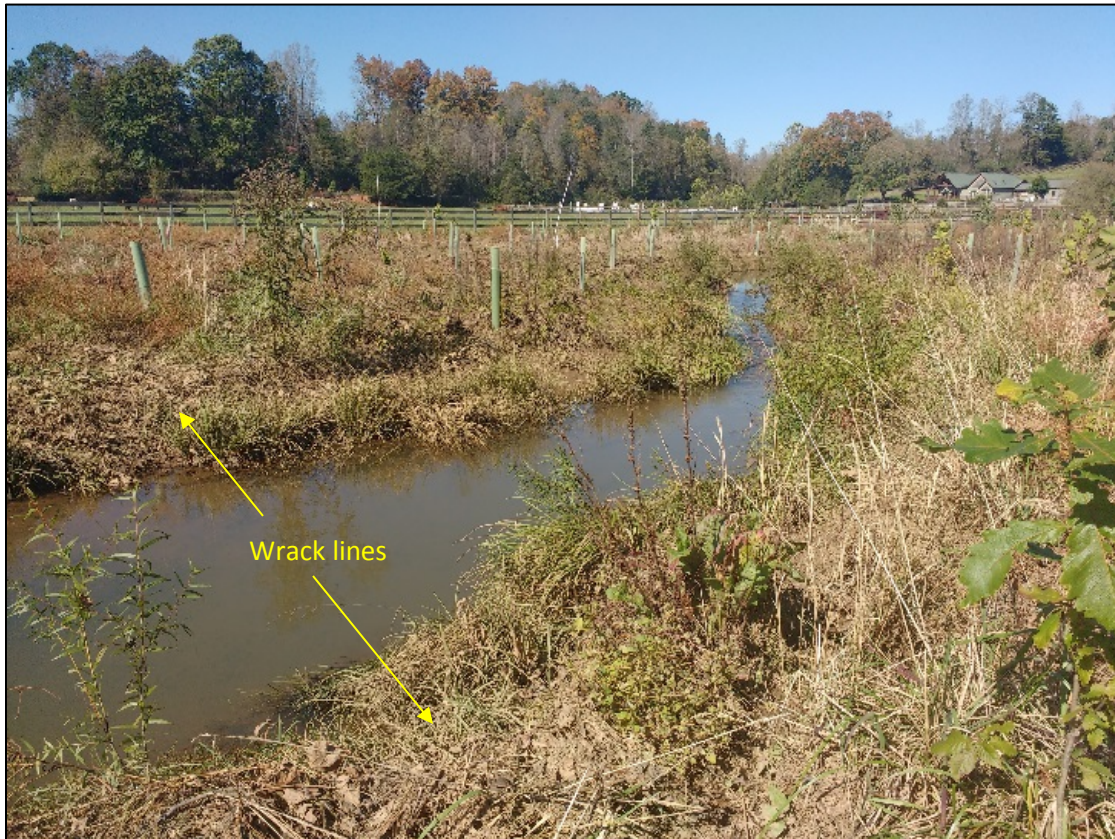
Date of Occurrence	Method	Photo Number
April 6, 2017	Onsite stream gauge	
April 24, 2017	Onsite stream gauge	
May 29, 2017	Onsite stream gauge	
August 3, 2017	Onsite stream gauge	
August 14, 2017	Onsite stream gauge	
August 15, 2017	Onsite stream gauge	
September 5, 2017	Onsite stream gauge	
October 23, 2017	Onsite stream gauge, photos taken on site	1

Photo 1. Sediment on plants and wrack lines above bankfull, 10/26/2017
