# Monitoring Report MY03

**Sandy Bridge Restoration Site  
DMS Contract 6400  
DMS Project Number 96920**

**DWR #: 15-0414  
USACE Action ID: 201500827  
Rutherford County, North Carolina**

**Monitoring Data Collected: 2019  
Date Submitted: December 2019**

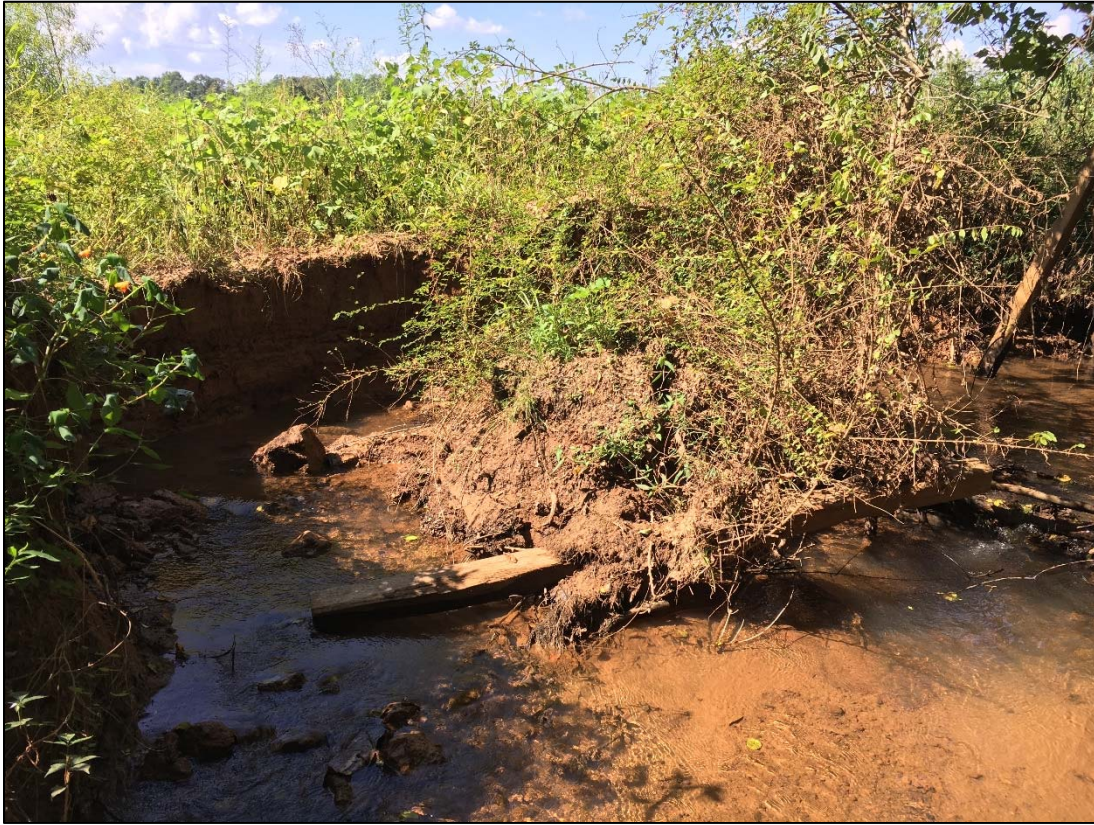
The right bank of the stream that flows along the easement's southern boundary has been experiencing significant erosion due to several areas of obstruction in the center of this channel that are diverting water into the banks. Although this stream is not part of the project, and is located outside of the easement bounds, the erosion on the right bank has encroached into the easement. In November 2019, KCI repaired and stabilize this area. This work involved removing the mid-channel obstructions and sloping back the eroding bank. This area will receive live-stake planting in early 2020. During this work, several farm gates that had become buried in the stream bank were removed and a small swale was dug to direct water into the site that had been ponding in fields adjacent to the eastern boundary of the site. This swale was designed to drain inundated areas that had formed off site and dissipate the water throughout the wetlands on-site. See Appendix B for more information.

Photo 1. Eroding stream bank that was encroaching into easement before repair, 8/29/2018

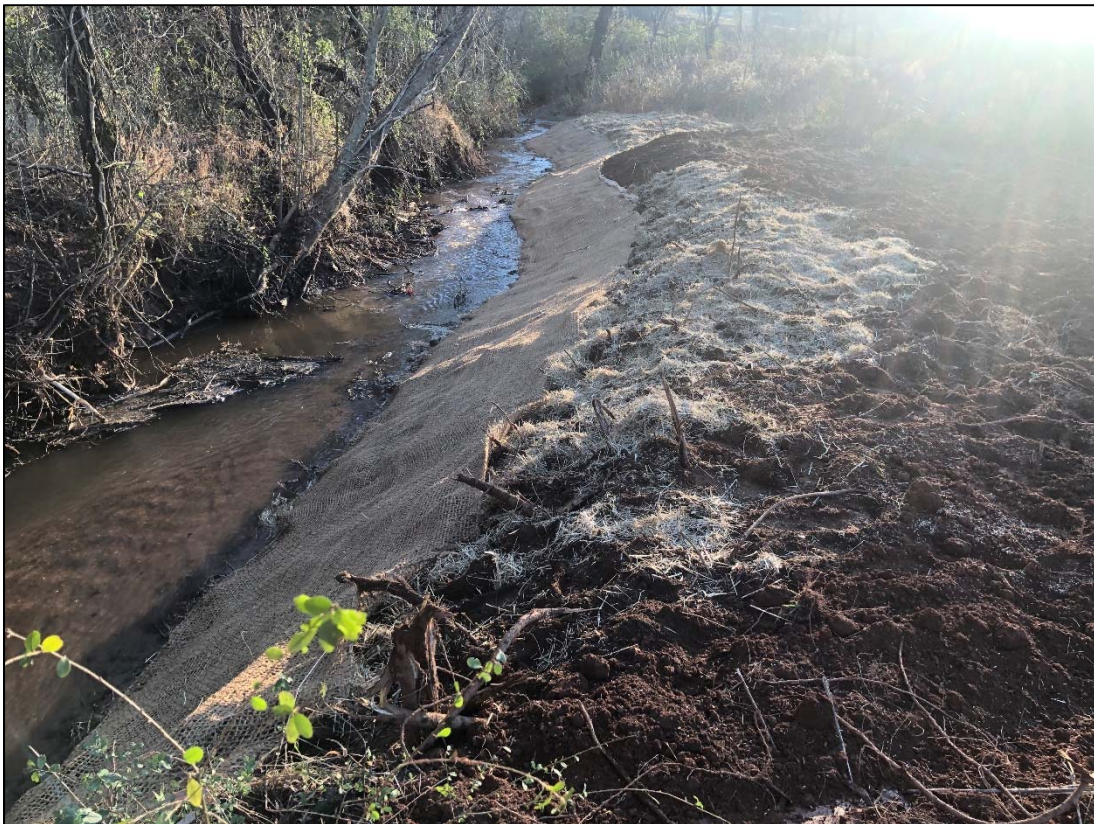
Photo 2. Stream bank after repair, 11/21/2019

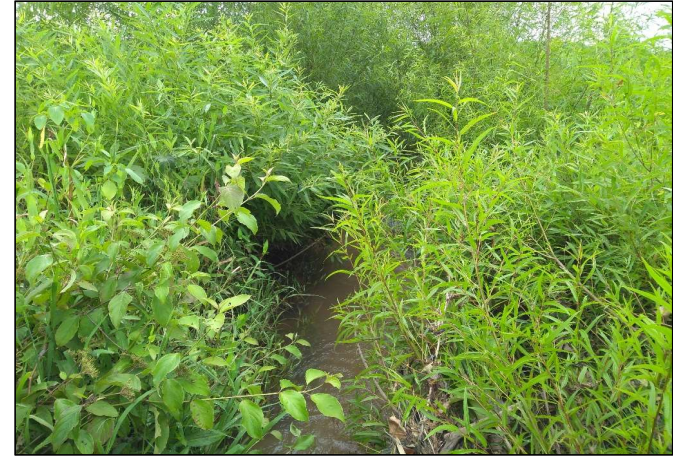
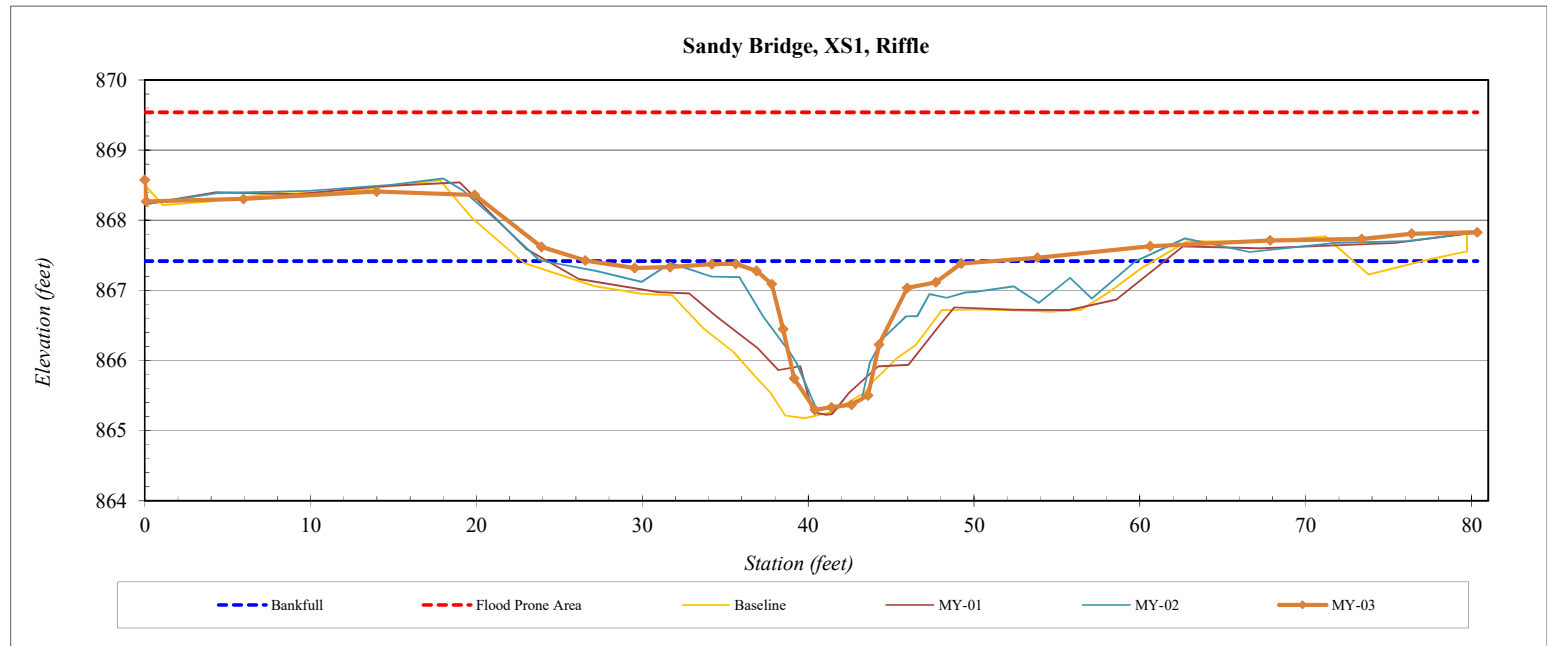
<b>River Basin:</b>	Broad
<b>Site:</b>	Sandy Bridge
<b>XS ID</b>	XS1
<b>Drainage Area:</b>	837 acres
<b>Date:</b>	6/19/2019
<b>Field Crew:</b>	T. Seelinger, A. Gutierrez

The third-year cross-section survey showed aggradation in the pool cross-sections (XS2 and 4) as well as aggradation on the banks of Cross-section 1. The cross-section survey took place only a few days after several large beaver dams had been removed. The backwater from these dams had deposited sediment throughout the project, especially in the pools. At the time the cross-sections were surveyed, this sediment had not had a chance to wash through the system. A visual inspection of the site in November 2019 revealed that almost all of this sediment had washed through and it is anticipated that next year's cross-section survey will show the cross-sections closer to their baseline conditions. A mid-channel bar reported in Cross-section 2 last year is no longer present. This bar had formed as a result of backwater from beaver activity and it was anticipated that once the dams were removed, it would wash out, which is what happened.

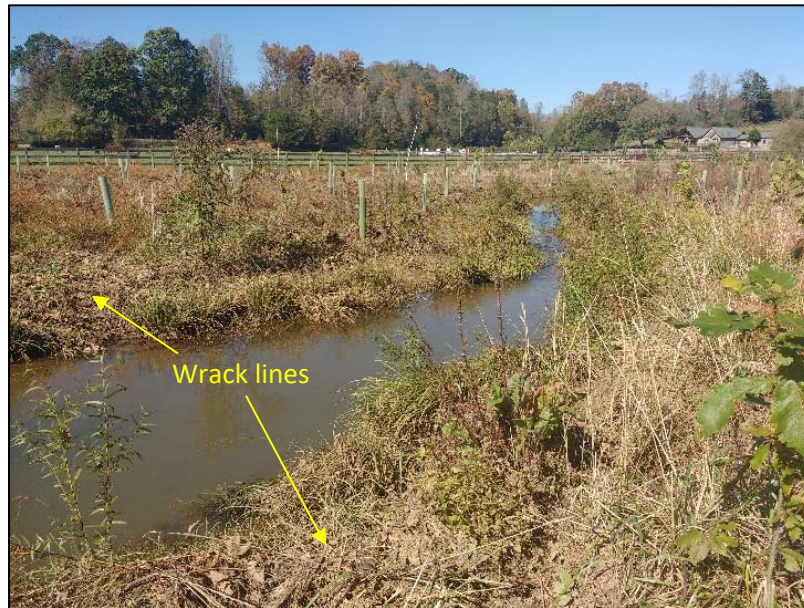
Photo 1. Sediment on plants and wack lines above bankfull, 10/26/2017

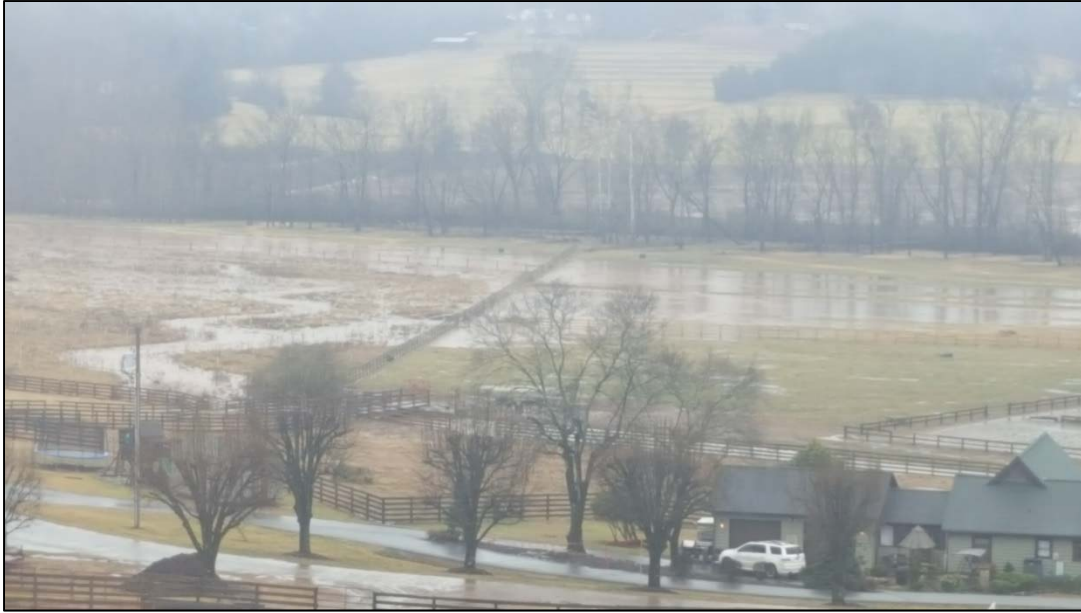
Photo 2. Bankfull event on site, 2/7/2018

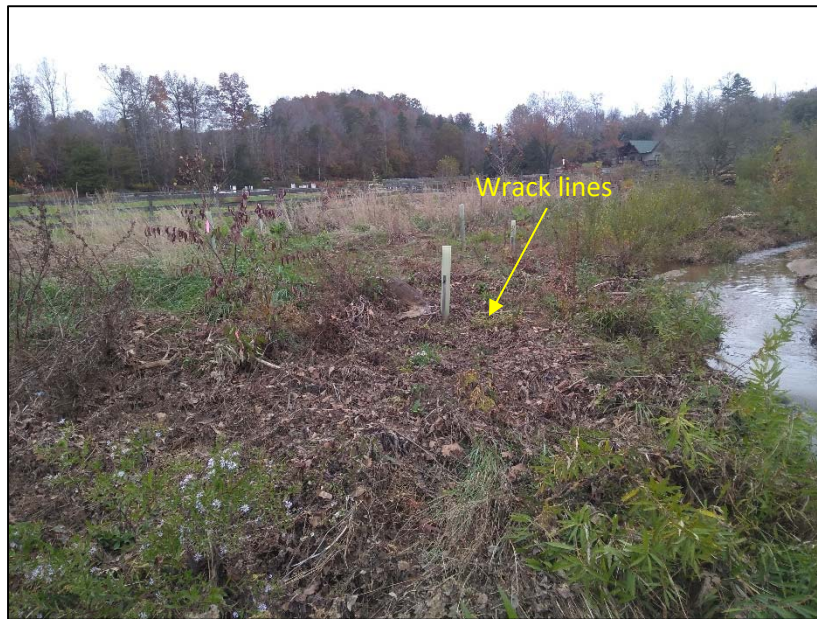
Photo 3. Wrack lines above bankfull, 11/7/2018
