Monitoring Report MY04

**Sandy Bridge Restoration Site
DMS Contract 6400
DMS Project Number 96920**

**DWR #: 15-0414
USACE Action ID: 201500827
Rutherford County, North Carolina**

**Monitoring Data Collected: 2020
Date Submitted: December 2020**

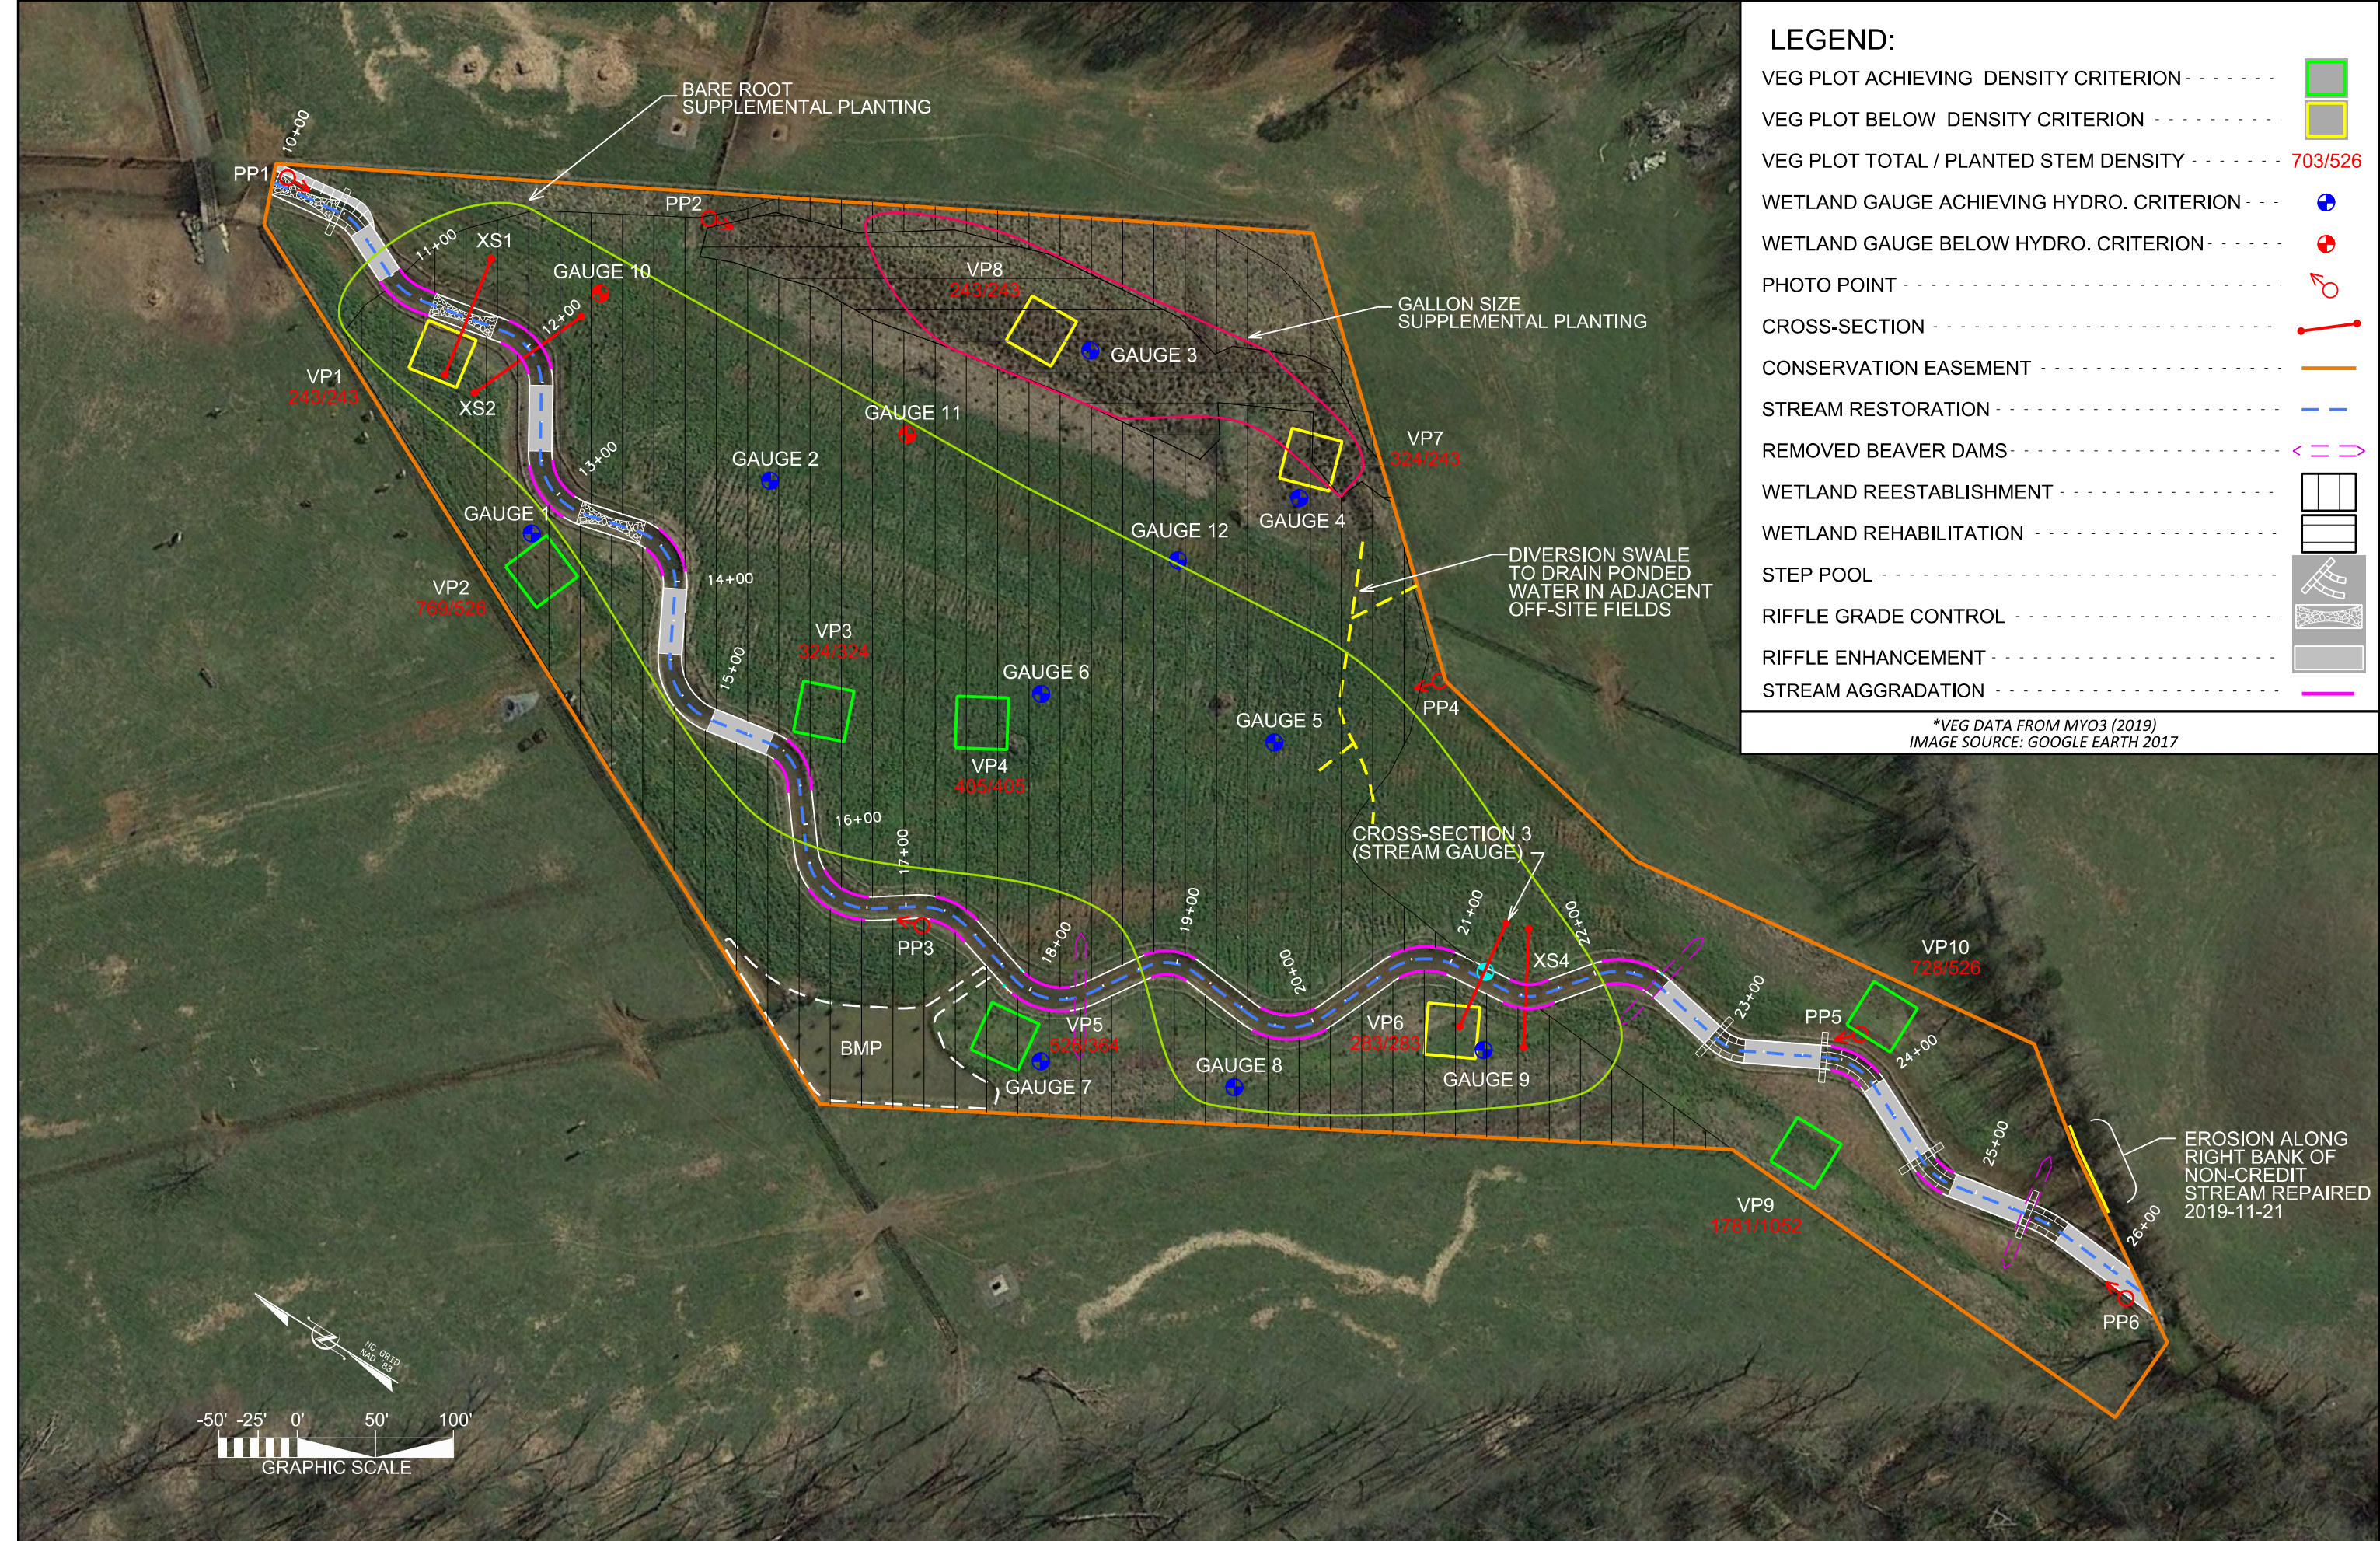
KCI Response: The Visual Assessment Table and the CCPV have been updated to reflect the aggradation that is present on-site as a result of the beaver impoundments.

Due to the presence of beavers on-site, there has been more aggradation in the stream channel than has been anticipated. KCI has been removing the beavers routinely, but when the dams are built sediment has deposited in the channel. Though not normally a part of monitoring year 4, the IRT requested that KCI conduct cross-section surveys in 2020 to monitor this situation. The fourth-year cross-section survey showed aggradation in the pool cross-sections (XS2 and 4) as well as aggradation on the banks of Cross-section 1. One of the beaver dams that was removed in June 2020 was located at the head of the riffle just below XS2. Another dam is located approximately 100 lf downstream from XS4. These dams had previously been removed in 2018 and 2019. During MY02, a mid-channel bar was recorded in the survey of XS2 as a result of backwater from the beaver dams. After the dams were removed, the sediment forming this bar washed through and it was no longer present during the MY03 survey. Due to the continued rebuilding of dams, the accumulated sediment did not have a chance to wash out of the channel in 2020. Over the next few years of monitoring we will continue to monitor this situation as we continue to remove beavers and beaver dams. It is believed that the sediment that has built up within the stream will wash out if given enough time after the removal of the beaver dams. It's important to note that even with the rebuilding of the dams, the stream flow has stayed within the restored channel and we have not seen any evidence of other channels forming in this system.

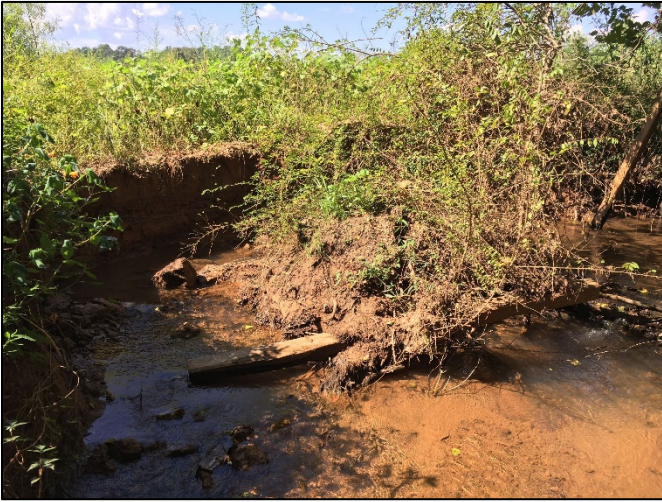
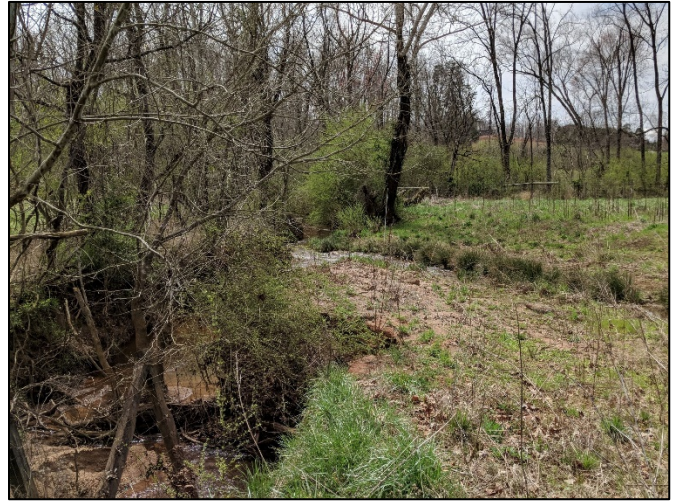
The right bank of the stream that flows along the easement's southern boundary had been experiencing significant erosion due to several areas of obstruction in the center of this channel that are diverting water into the banks. Although this stream is not part of the project, and is located outside of the easement bounds, the erosion on the right bank has encroached into the easement. In November 2019, KCI repaired and stabilize this area. This work involved removing

8/28/18 – Before repair

3/30/18 – Before repair

the mid-channel obstructions and sloping back the eroding bank. 150 live stakes were planted along this bank in March 2020. During this work, several farm gates that had become buried in the stream bank were removed and a small swale was dug to direct water into the site from fields adjacent to the eastern boundary of the site. This swale was designed to drain ponded conditions in these fields and dissipate the water throughout the wetlands on-site. See Appendix B for more information.

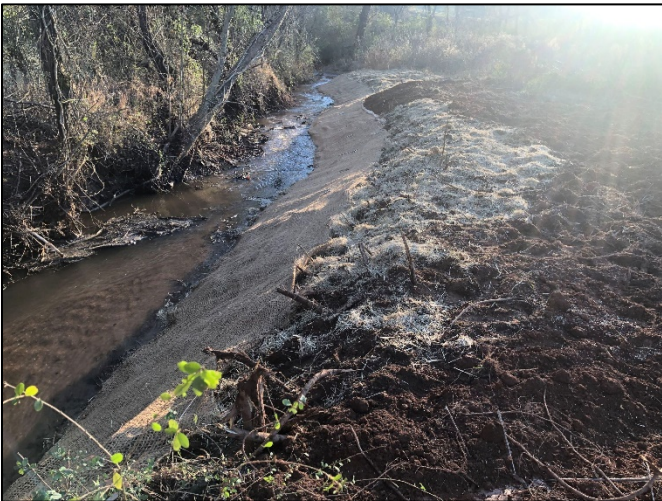
11/21/19 – Immediately after repair

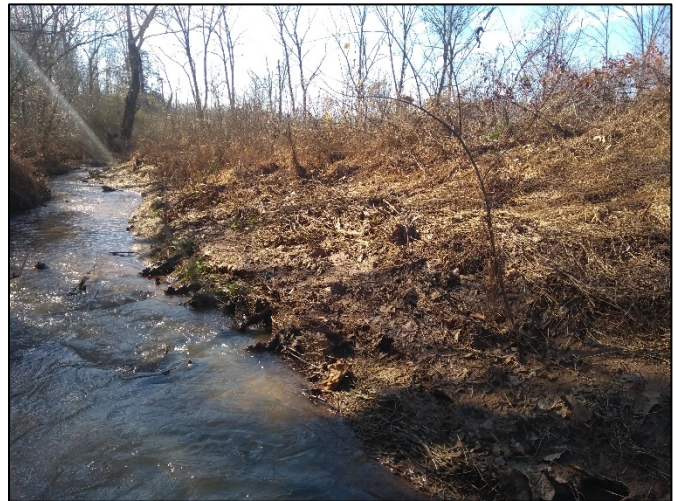
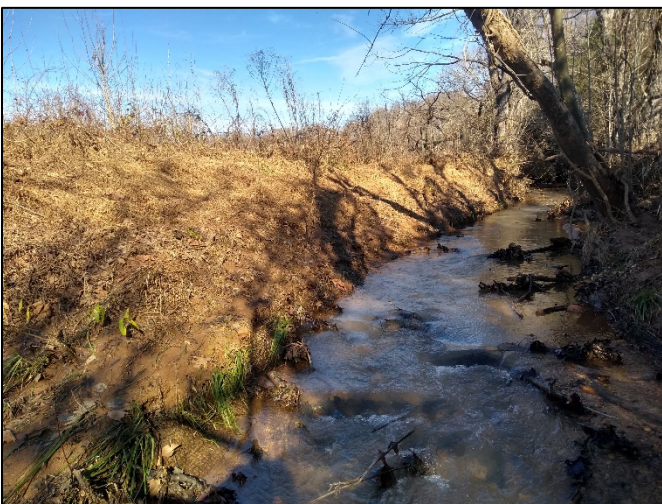
12/15/20 – One year after repair

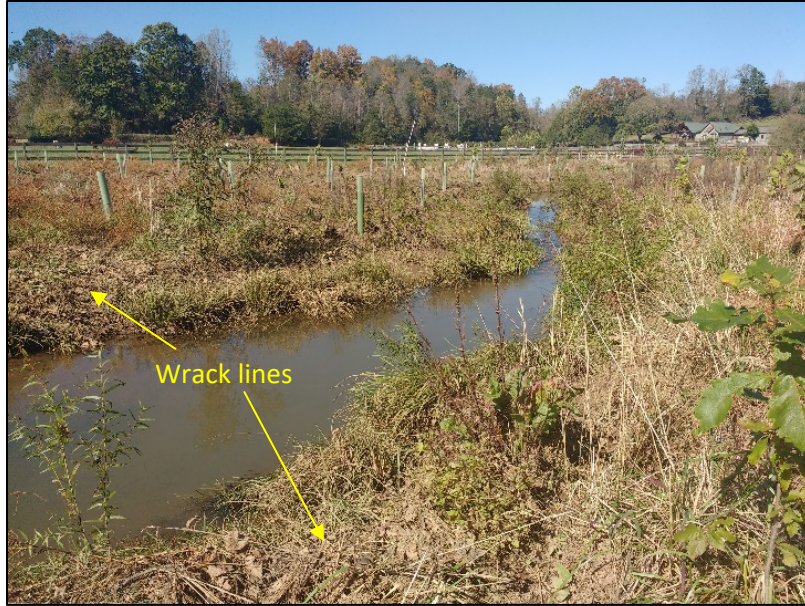
Photo 1. Sediment on plants and wrack lines above bankfull, 10/26/2017

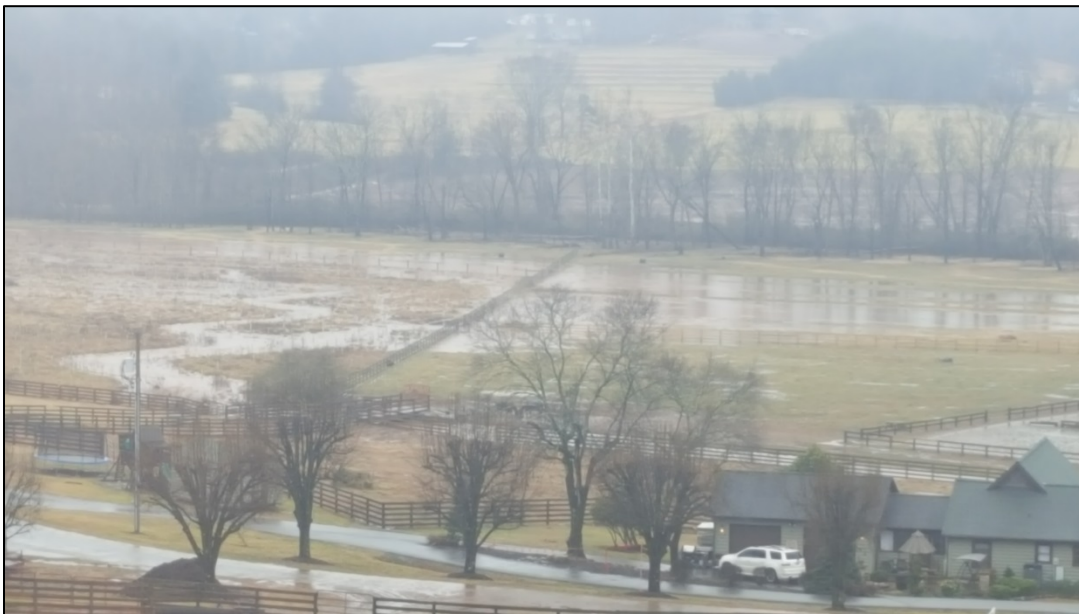
Photo 2. Bankfull event on site, 2/7/2018

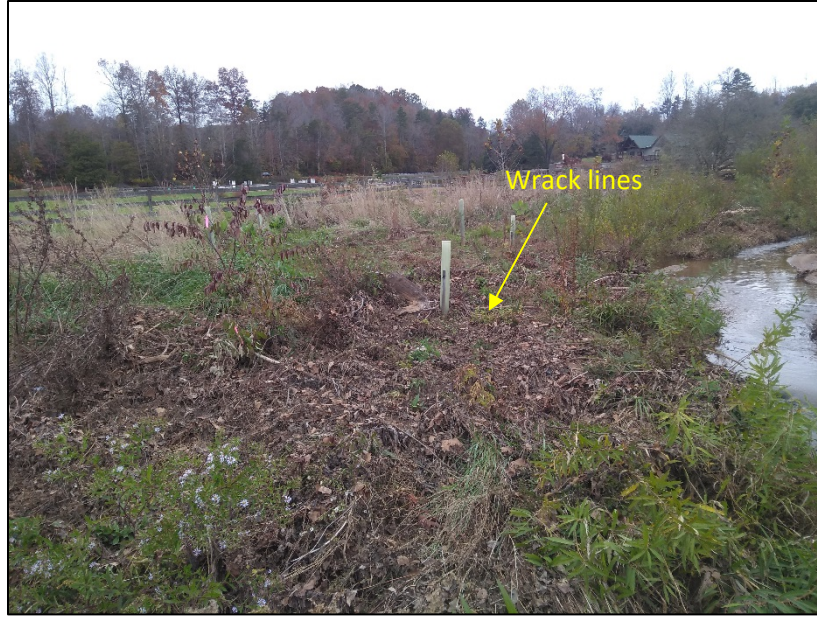
Photo 3. Wrack lines above bankfull, 11/7/2018
