# **As-Built and Monitoring Report**

**Sandy Creek Stream Enhancement And  
Wetland Restoration /Creation Project  
Durham, North Carolina  
(SCO ID# 010542301)**

**North Carolina Wetlands Restoration Program  
Raleigh, North Carolina  
September 2003**

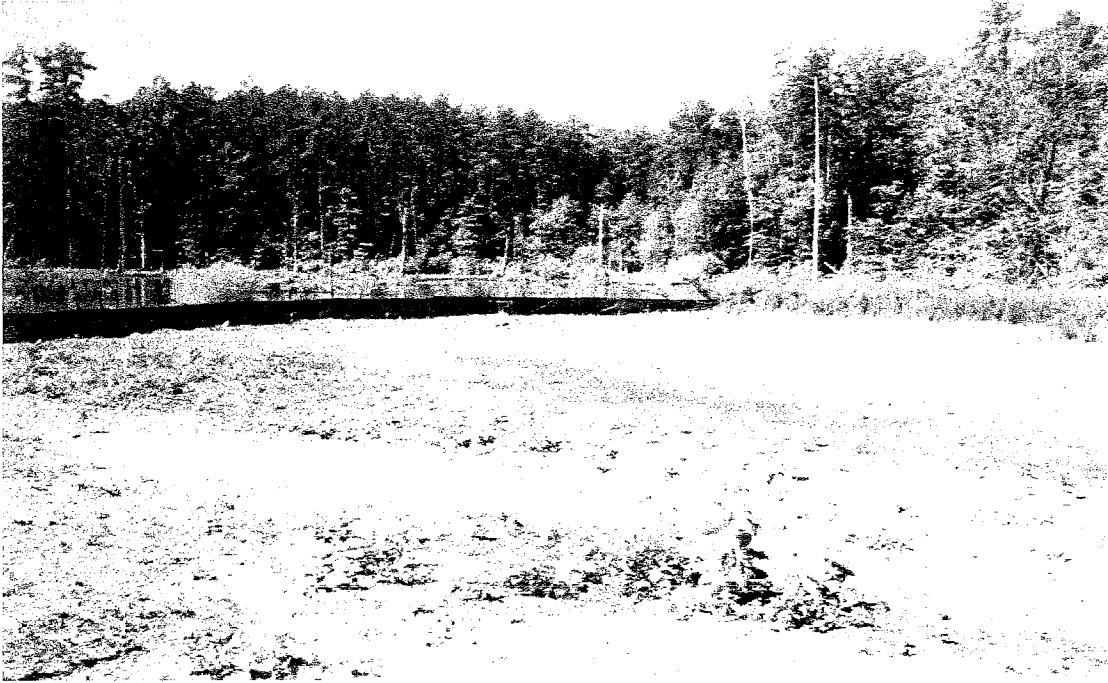
Vegetation Plot 1 – Sandy Creek Wetland Site  
July 12, 2003

Plot #1: The photograph for this plot was taken viewing the north east corner of the plot looking south towards the pond. The ground cover was also viewed in this line of site just at a closer distance.

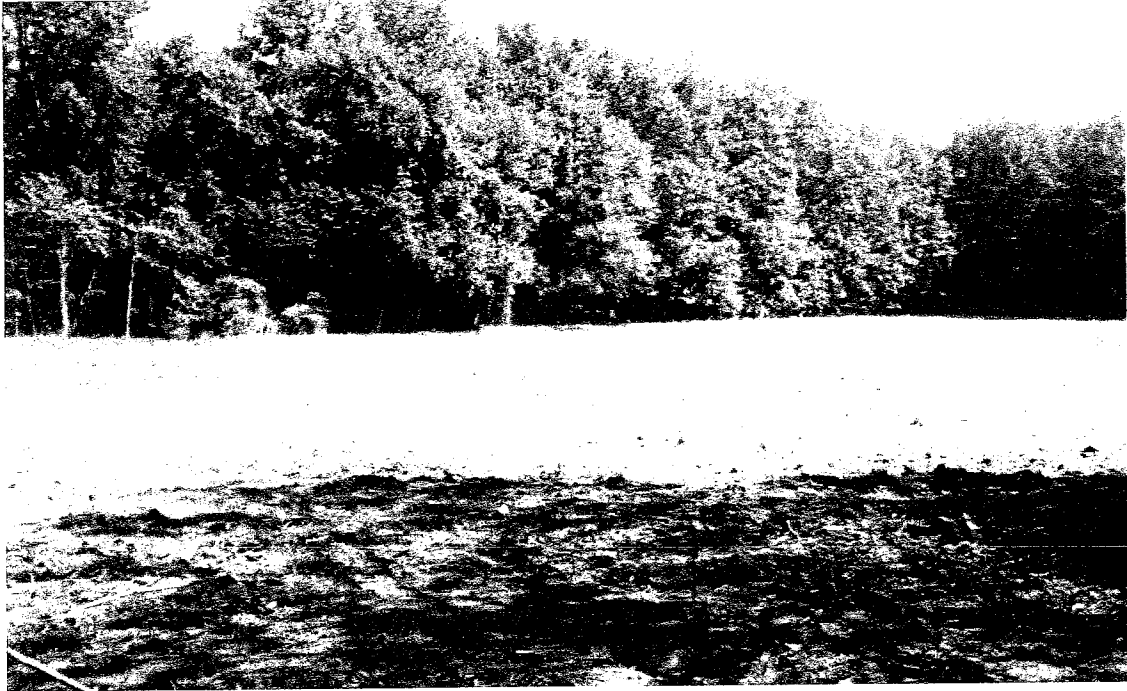
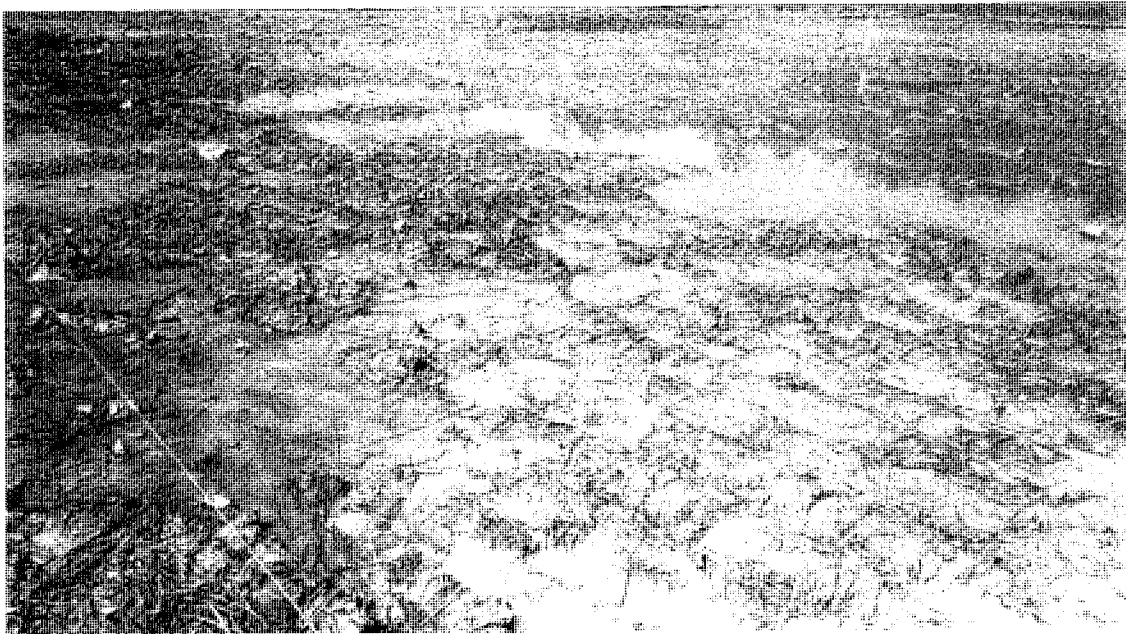
Vegetation Plot 2 – Sandy Creek Wetland Site  
July 12, 2003

Plot #2: The photo for plot 2 was taken viewing the south east corner of the plot looking north. The ground cover for this plot was also in this same direction, viewed at a closer distance.

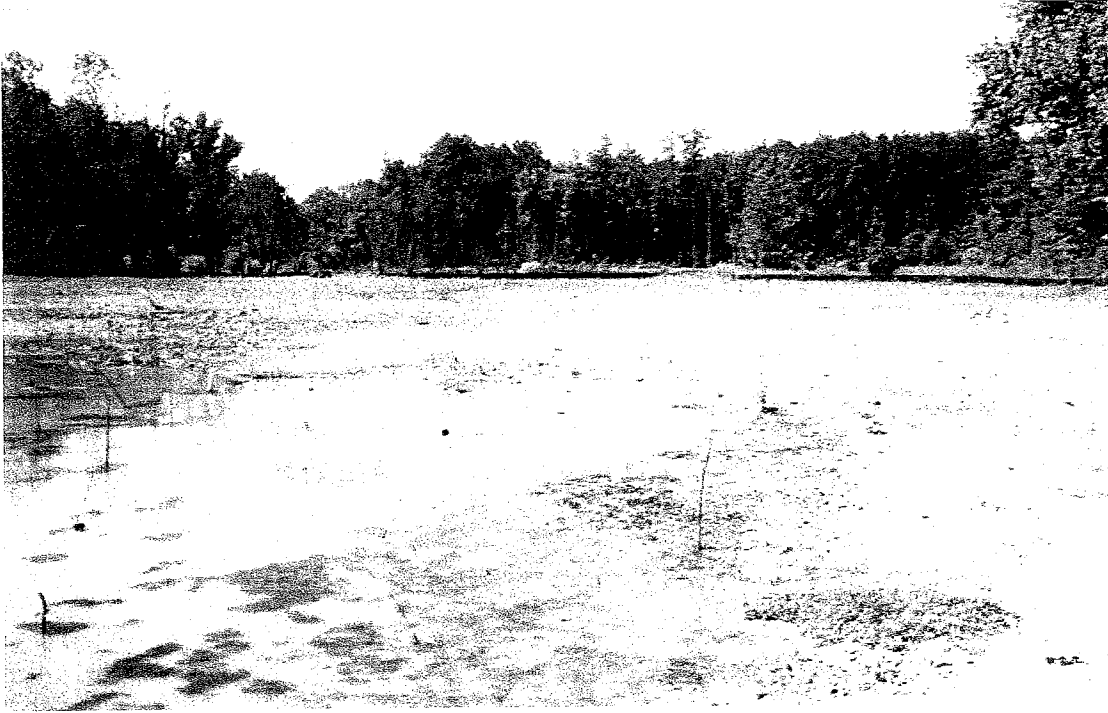
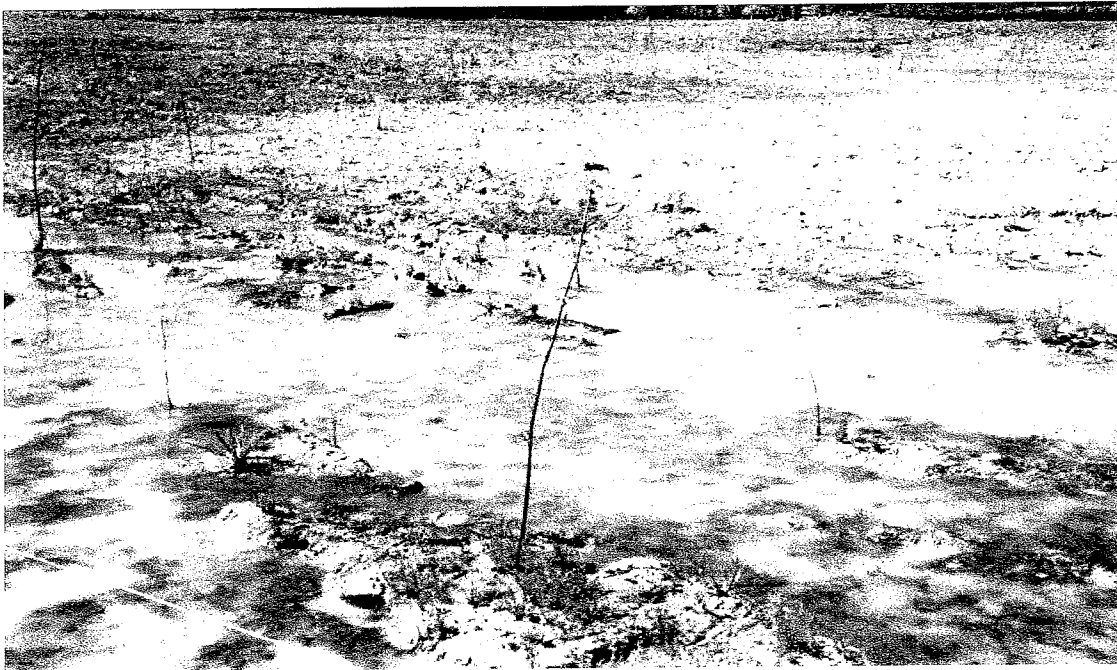
Vegetation Plot 3 – Sandy Creek Wetland Site  
July 12, 2003

Plot #3: The photograph at this location was taken viewing the north side of the plot looking south.

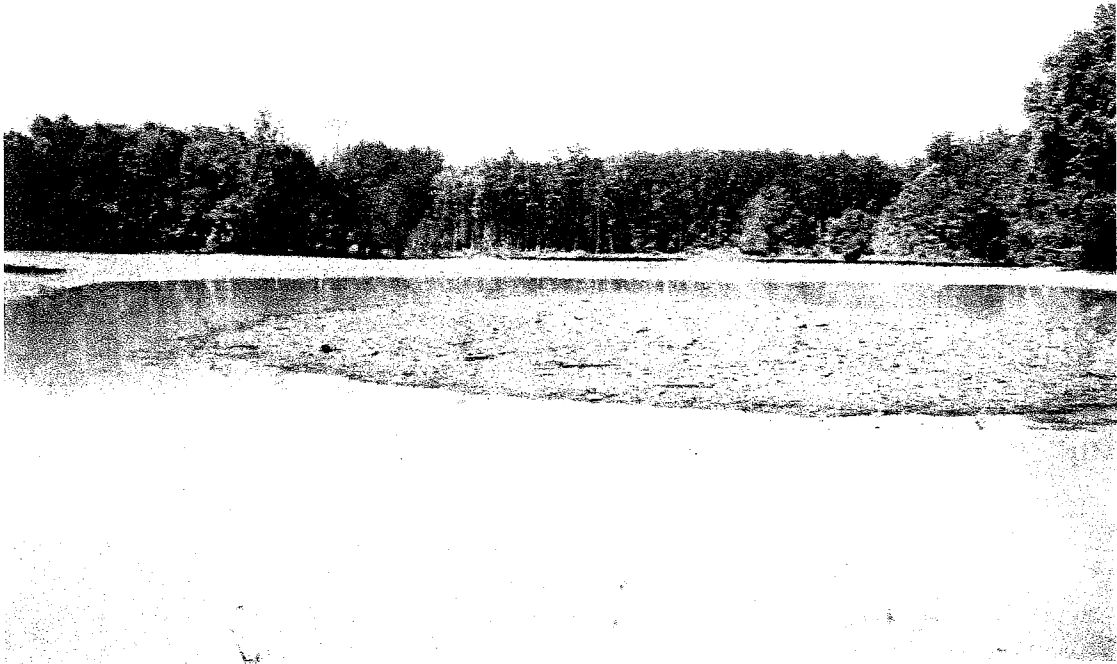
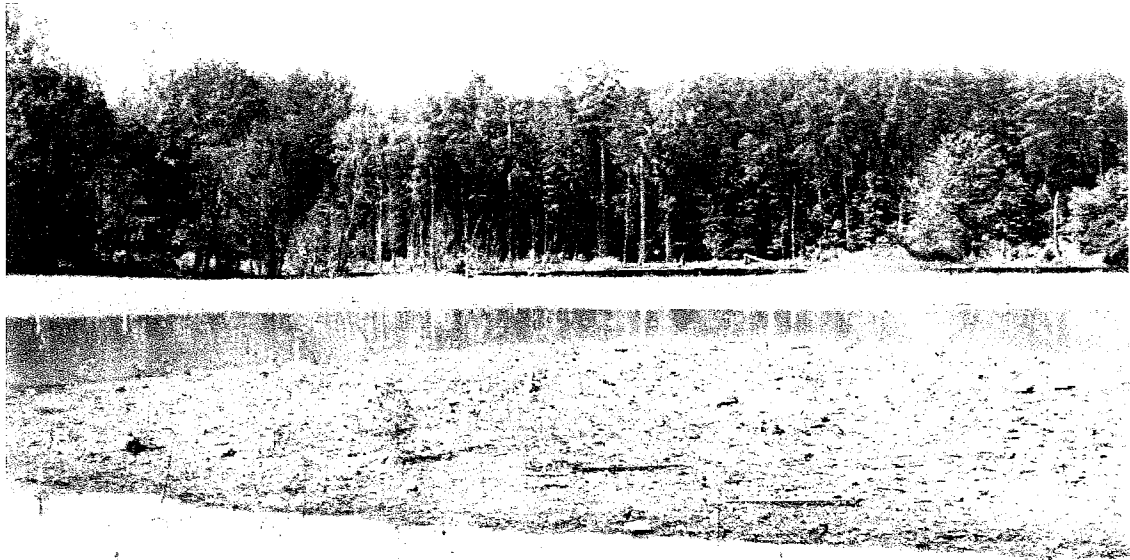
Vegetation Plot 5 – Sandy Creek Wetland Site  
July 12, 2003

Plot #5: The photo of plot 5 was taken viewing the north side of the plot on the island and looking south at the existing pond.
