**Sandy Creek Stream Enhancement
& Wetland Restoration/Creation
Durham County
North Carolina**

1st Year Monitoring Report

December 1, 2004

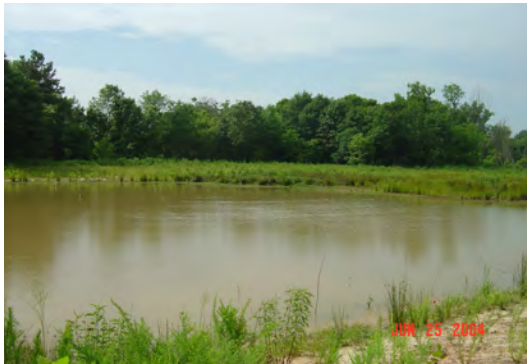
Zone 1 : Permanent Ponding

Zone 1 which surrounds the “island” was designed to remain semi-permanently flooded, which is defined as surface water persisting throughout the growing season in most years and when surface water is absent, the water table is usually at or very near the land surface. However, during the past year, the site hydrology in the low areas surrounding the “island”, or Zone 1, did not fluctuate as anticipated, but maintained a maximum depth of approximately 1.6 feet. This is more reflective of a permanently flooded wetland as opposed to the targeted semi-permanently flooded wetland. This has in turn caused poor planted tree survivorship in Plot 4. This failure is in part due to elevations that were established too low and in part the lack of water table fluctuation.

The major concern is the permanently flooded conditions of Zone 1. However, wetland sites, specifically creation sites, must be given time for vegetation to become established and soils to begin to develop. These two functions compliment each other and are self-promoting. This is likely the reason that even though the reference gauge D and site gauge C are installed at the same elevation, the reference gauge experienced saturated conditions within 12 inches of the soil surface for more that twice the number of days experienced at gauge C. Therefore, as the site surrounding Zone 1 develops, more fluctuation of the water table is anticipated. In addition, natural deposition from organic matter and sediment from overbank flooding events will slowly fill the lower areas of Zone 1.

The speed at which a creation site develops is impossible to predict. Eventually, Zone 1 will experience the seasonal fluctuations consistent with a semi-permanently flooded wetland. However, realizing that monitoring of the site is costly, it would e possible to partially fill the lower areas of Zone 1 to an elevation of 261.5. In the short term, this would increase the chance of survivorship in the planted vegetation. It has been estimated that approximately 1,300 cubic yards of soil would be required to raise the elevation. The soils could be obtained on site by excavating the eastern bank within the buffer and moving these soils into the adjacent Zone 1 as shown on Plan Sheet 1 of 5. This additional excavation would result in increasing the restored wetland acreage by 0.5 to 0.8 acres. However, it is recommended that a second year of monitoring be conducted and analyzed before attempting any site reconfigurations.

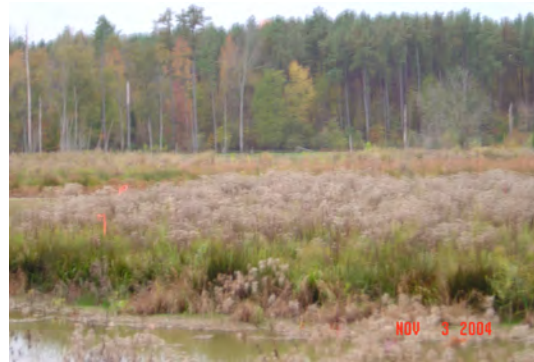
Zone 3 : Island Hydrology

Results from gauge monitoring data suggest that restored wetland regions do meet the hydrologic success criteria. This is further evidenced by the continual presence of saturated soils, ponding, drainage patterns, water stained leaves, sediment deposits, and prevalence of hydrophytic vegetation. Groundwater levels are slightly lower than expected in the “island” region of Zone 3 (saturated for 4.2% of the growing season), but this area was intended to be an upper landscape region exhibiting saturation between 5 and 12.5% of the growing season, and wetland plants are supported.

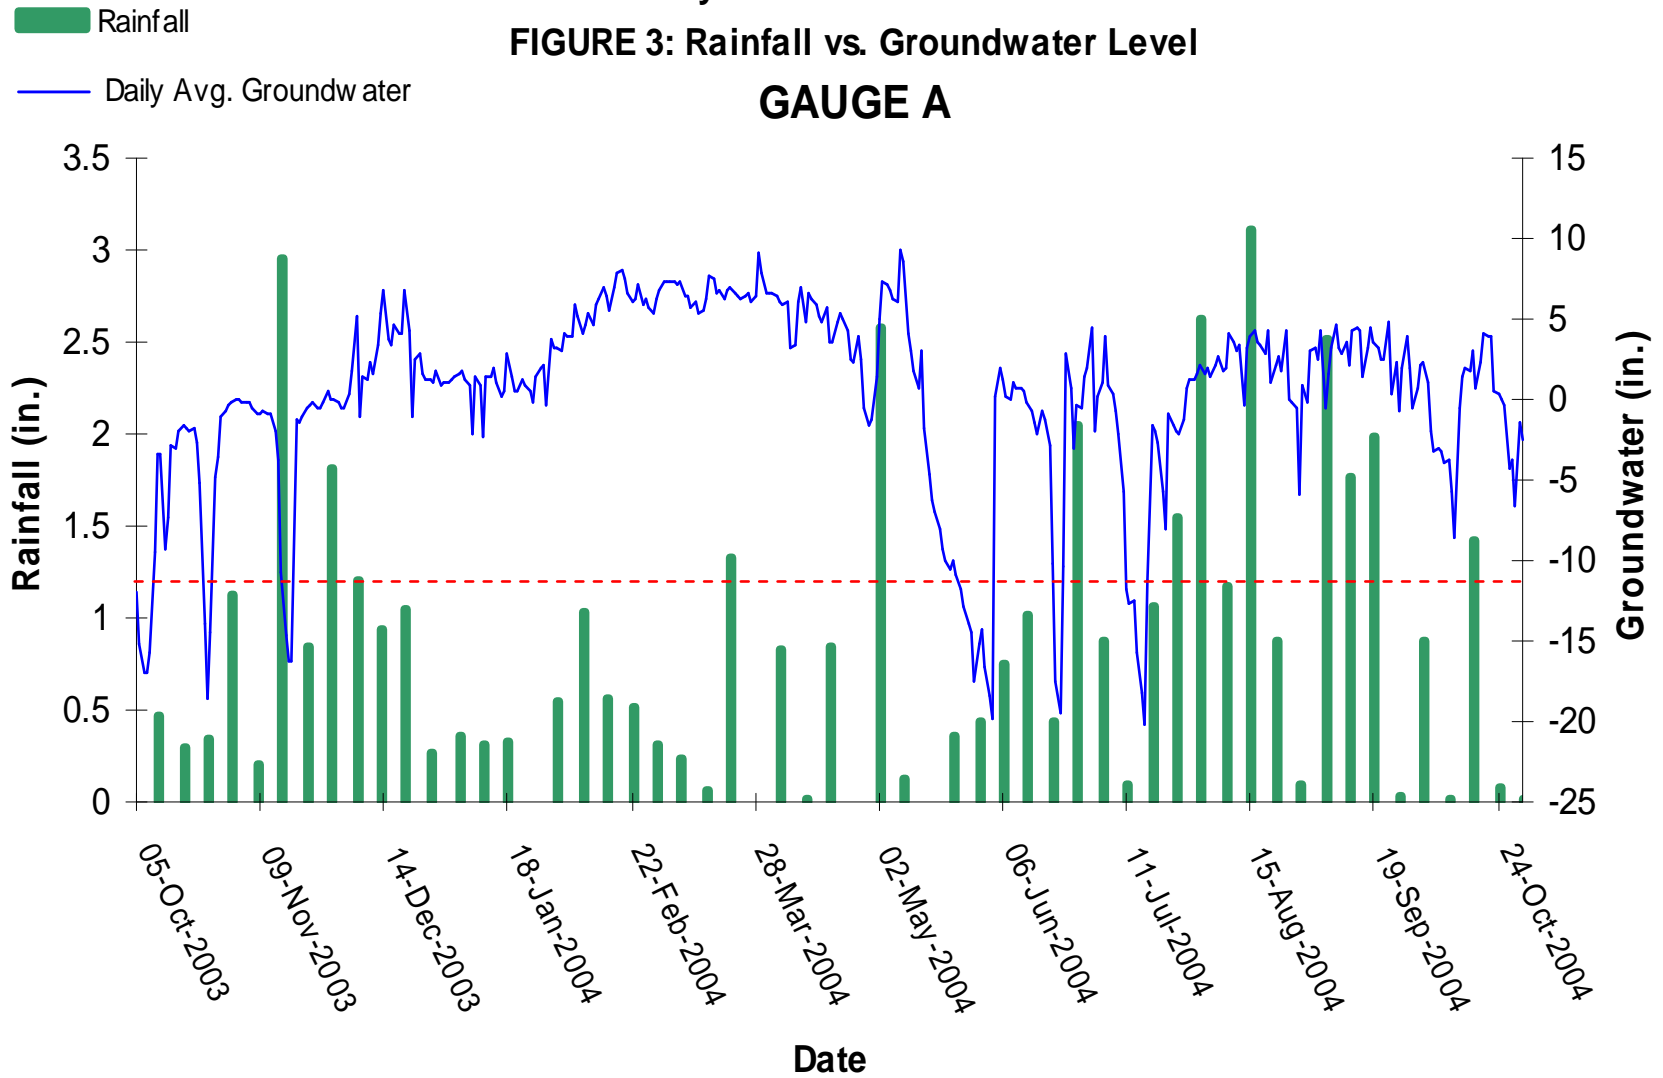
Sandy Creek Restoration Site
FIGURE 3: Rainfall vs. Groundwater Level
GAUGE A

The second monitoring of groundwater gauges commenced from early October, 2003 to October 31, 2004. The growing season is considered to be 213 days (April 5 – November 3). Gauge locations are depicted in Plan Sheet 1 of 5 and gauge monitoring results along with rainfall amounts for this time period are shown in Figures 3 through 6. Analysis of the three groundwater gauges (A, C, and D), in the intermittently exposed and semi-permanently flooded regions shows that in 2004, groundwater levels were less than 12 inches below the soil surface for more than 12.5% of the growing season (27 consecutive days). Gauge B is at the top of the temporarily flooded region and Gauge C at the bottom. Gauge C was saturated for 15% of the growing season while Gauge B was saturated for 4.2% of the growing season, which falls just short of the minimum 5%. However, it can be assumed that the temporarily flooded region between these two gauges is meeting the hydrologic criteria of 5-12%. Comparison of rainfall data with groundwater level trends indicates that groundwater levels do fluctuate in correspondence with rainfall events, and that reference gauge D indicates water levels within 12 inches of the soil surface for 71 consecutive days (33%) of the growing season. Saturated soil levels (within 12 inches of the soil surface) for the three monitoring gauges during the growing season are as follows: Gauge A: 138 consecutive days (64.8%); Gauge B: 9 consecutive days (4.2%); Gauge C: 32 consecutive days (15%).

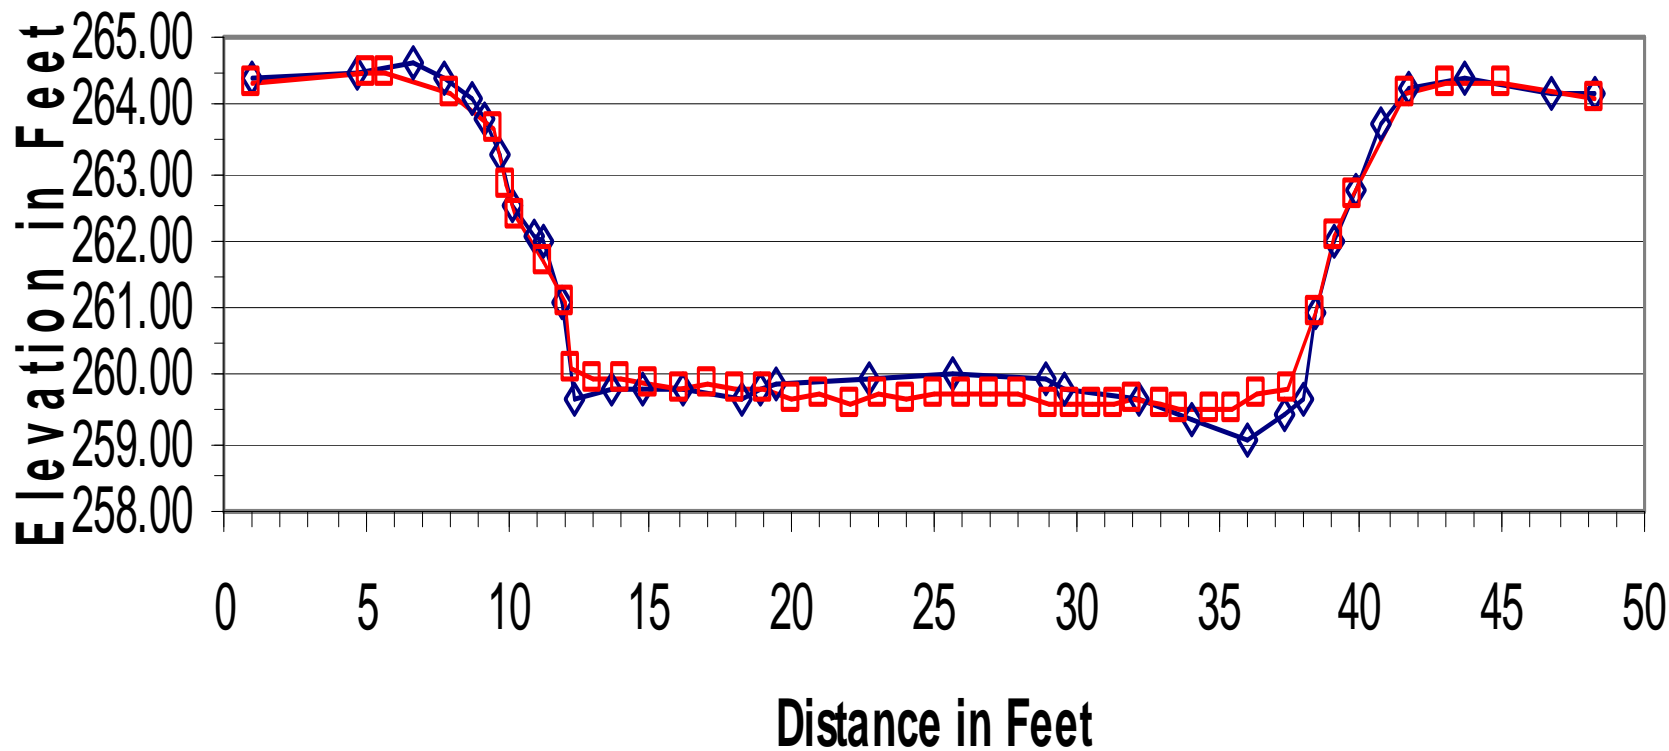
FIGURE 7: Permanent Cross Section Sandy Creek

All thirteen structures were inspected for stabilization and function. The banks adjacent to the structures are stable and showed no evidence of erosion. The vegetation is establishing slowly in these areas. The log structures have soil deposits near the bank and pools forming in the streambed. Because this is a sand bed stream the pools vary with each storm event. The logs and rocks in each feature are stable and show no evidence of any breaching. The log vanes are performing their function of bank stabilization and the creation of additional bed form features in Sandy Creek. The permanent cross section and pebble counts show no significant changes.

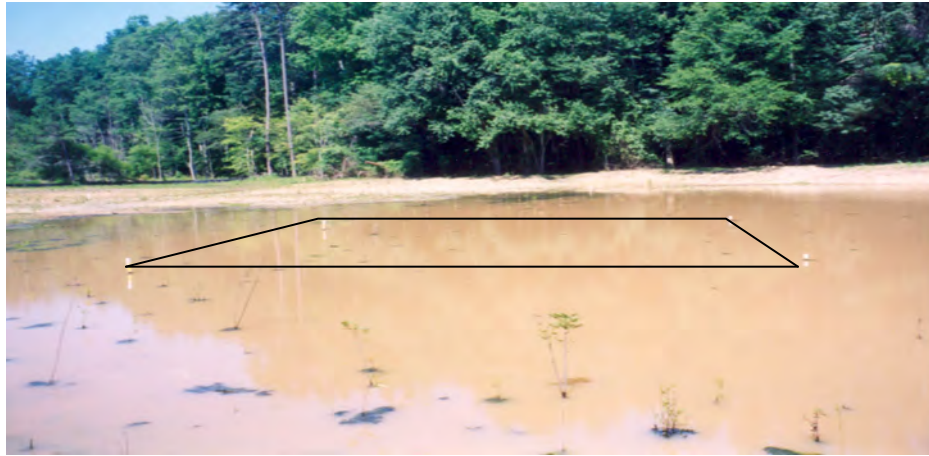
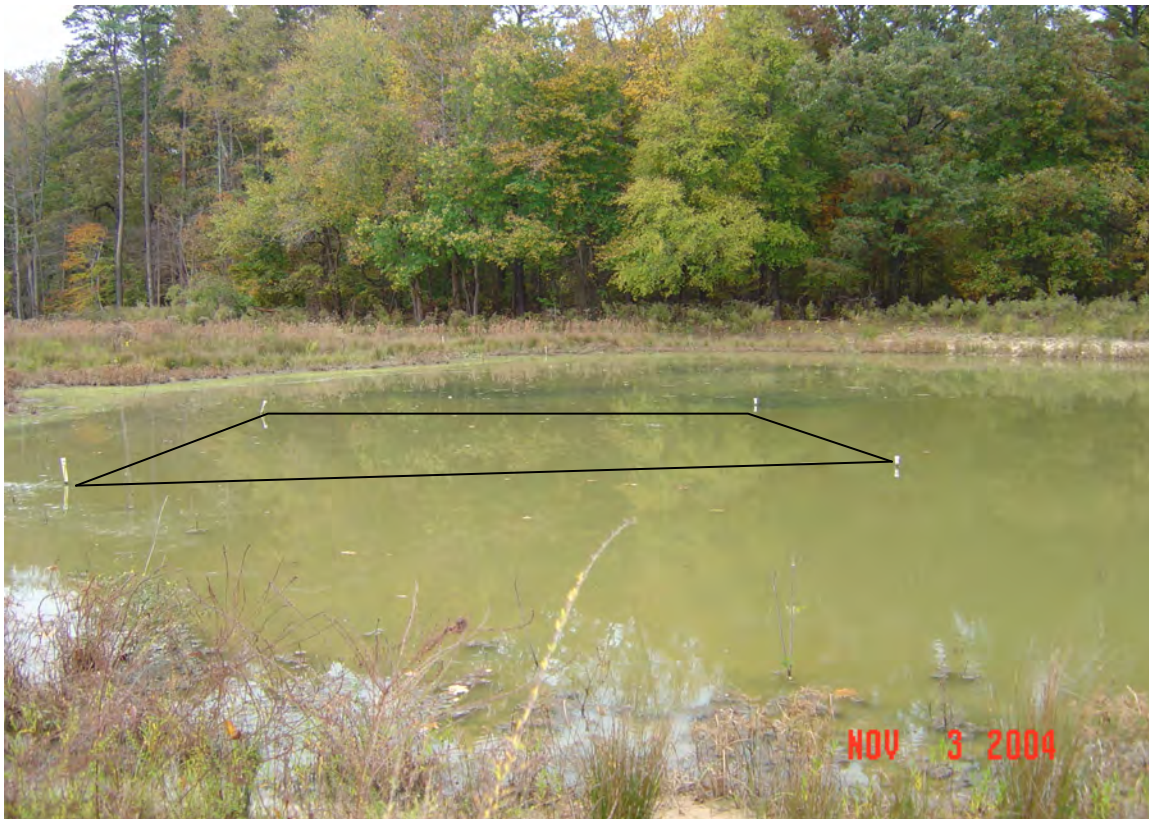
Vegetation Plot 4 – Sandy Creek Wetland Site

The second vegetation monitoring count was performed May 28, 2004 for Plot 2 (following replanting portions of Zone 3) and September 29, 2004. Results of sampled vegetation stem counts within the five plots are shown in Table 1, and estimated density of tree stems (target species) and percent cover of the herb and shrub stratum is shown in Table 2. Locations of vegetation plots are shown on plan sheet 1 of 5 and photographs of the respective plots are in the Photo Log. Repeated field observations of the site have, over the last year, suggests that survivorship of planted tree species is less than expected. Within the combined sample plots, 12 tree and 2 shrub species were recorded, and measured stem density is well over the minimum requirement of 320 stems per acre for two out of the three zones (Zones 2 and 3); however, volunteer species green ash (*Fraxinus pennsylvanica*) and black willow (*Salix nigra*) make up the bulk of measured density. Although average density for Zone 3 (2259 stems/acre) meets the minimum success criteria, planted tree survivorship was poor in Plot 5 on the "island" region. Zone 1 (Plot 4) does not meet vegetation success criteria, having stem densities of 97 stems/acre.

Reasons for poor survivorship of planted tree species are contributed to three factors: First, surface soils are waste soils and are nutrient poor. Due to cost constraints, there was no effort made to overlay a more suitable topsoil layer prior to planting. Secondly, whitetail deer and other wildlife browsed many of the planted trees before they could become well-established. Lastly, permanent inundation within the low area of Zone 1 resulted in poor survivorship of planted species and no recruitment of volunteers in Plot 4.

The above picture was taken on July 12, 2003 just after construction. The picture taken below was taken on November 3, 2004 after one growing season. The water remained in this area throughout the year.

As for the vegetation of Zone 1, additional plantings at this time would not be practical. For the same reasons noted for the hydrological alterations, the site must be allowed to further develop before considering additional plantings. In summary, no vegetation alterations are recommended at this time unless the option to raise the elevation of Zone 1 is pursued and replanting in construction areas are necessary.
