**SANDY CREEK STREAM ENHANCEMENT  
AND WETLAND RESTORATION SITE  
2005 Annual Monitoring Report (Year 2)**

**Durham County  
EEP Project No. 322  
Design Firm: Becky L. Ward Consulting**

**February, 2006**

**Prepared by: ECOSCIENCE CORPORATION  
1101 Haynes Street, Suite 101  
Raleigh, NC 27604**

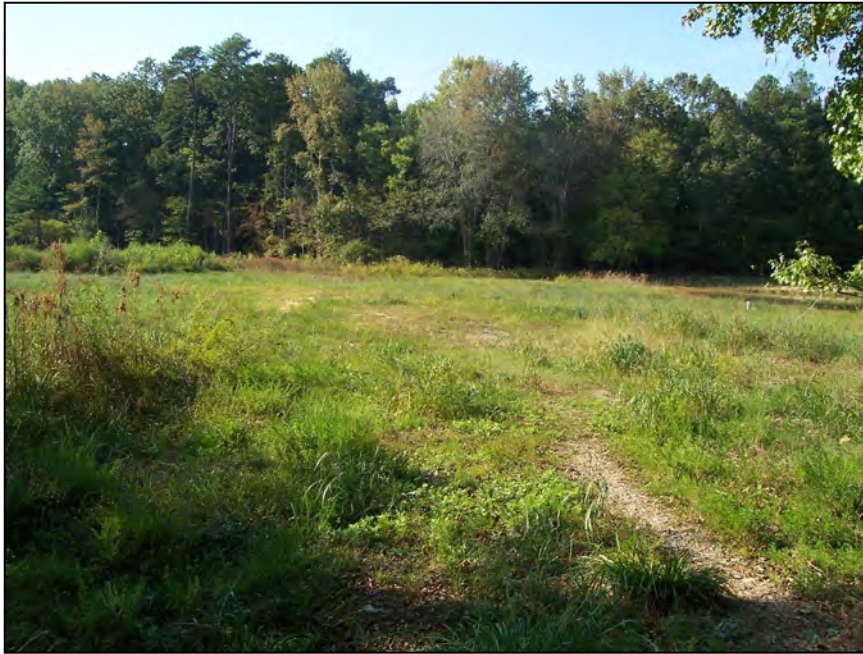
Low survival of many of the planted species is attributed to permanent flooding and mowing by City of Durham maintenance staff. The surviving stems are most likely volunteer individuals of the planted species recruited from the surrounding woods. Initial plantings were previously reported to be largely destroyed by geese, and this event is assumed to be responsible for low species diversity at the Site at Year 2. Poor soil composition (Urban land occupies approximately 5.5 acres of the site) is another factor in poor survival. Maintenance on the Site is scheduled to be performed during Spring of 2006. The maintenance will include grading and planting of appropriate species to help remedy poor vegetation establishment.

| Feature / Issue | Station # / Range | Probable Cause | Photo # |
|---|--|--|---|
| Poor Tree Establishment and Recruitment | Buffer Areas | Mowing | 1 |

Photo 1. Poor Tree Establishment and Recruitment

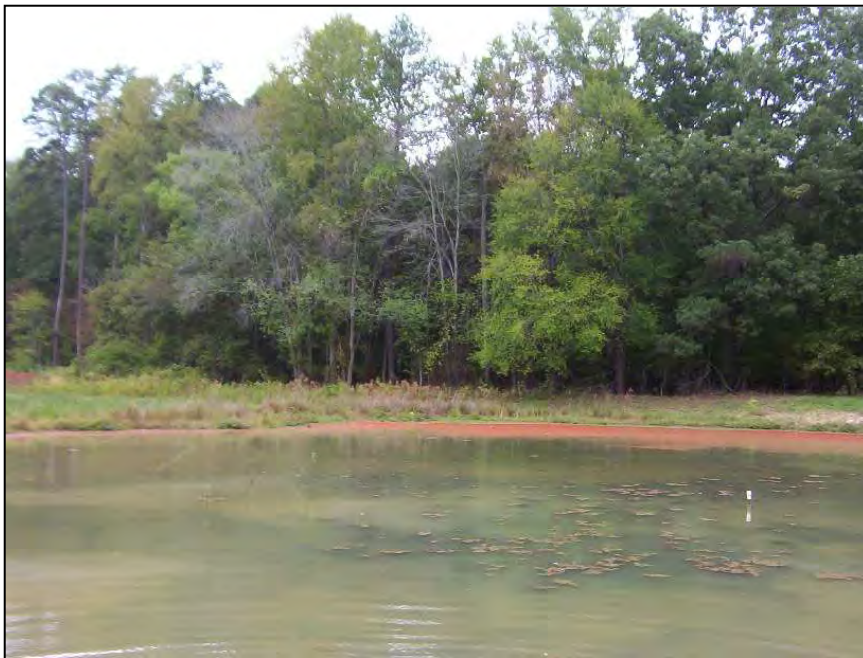
| Feature / Issue | Station # / Range | Probable Cause | Photo # |
|---|--|--|---|
| Poor Tree Survival | Semi-permanent flooded zone: Vegetation Plot 4 | Flooding from pond creation; poor soil composition; mowing | 2 |

Photo 2. Poor Tree Survival

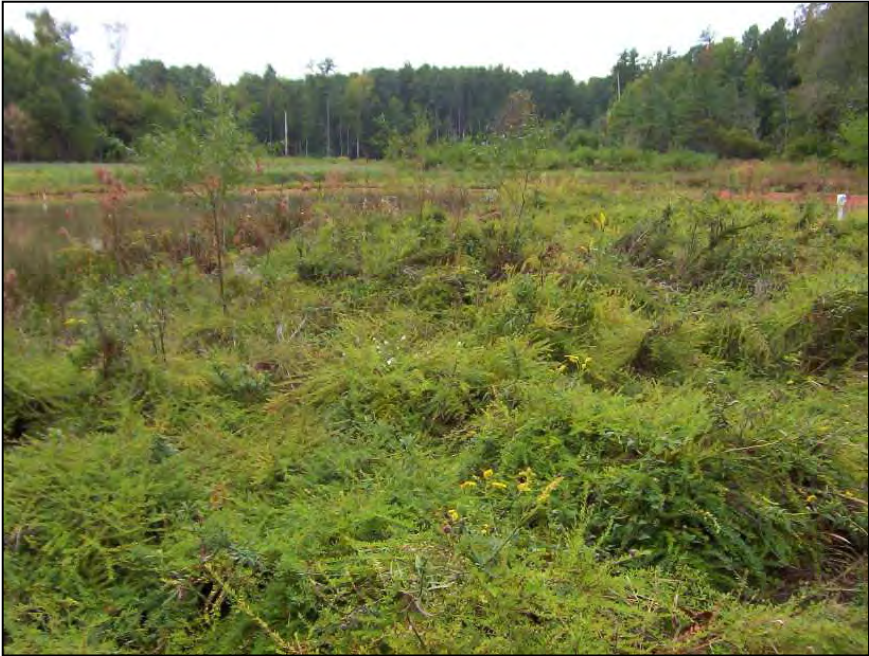
| Feature / Issue | Station # / Range | Probable Cause | Photo # |
|---|--|--|---|
| Poor Tree Survival | Island: Vegetation Plot 5 | Poor soils, competition by lespedeza | 3 |

Photo 3. Poor Tree Survival

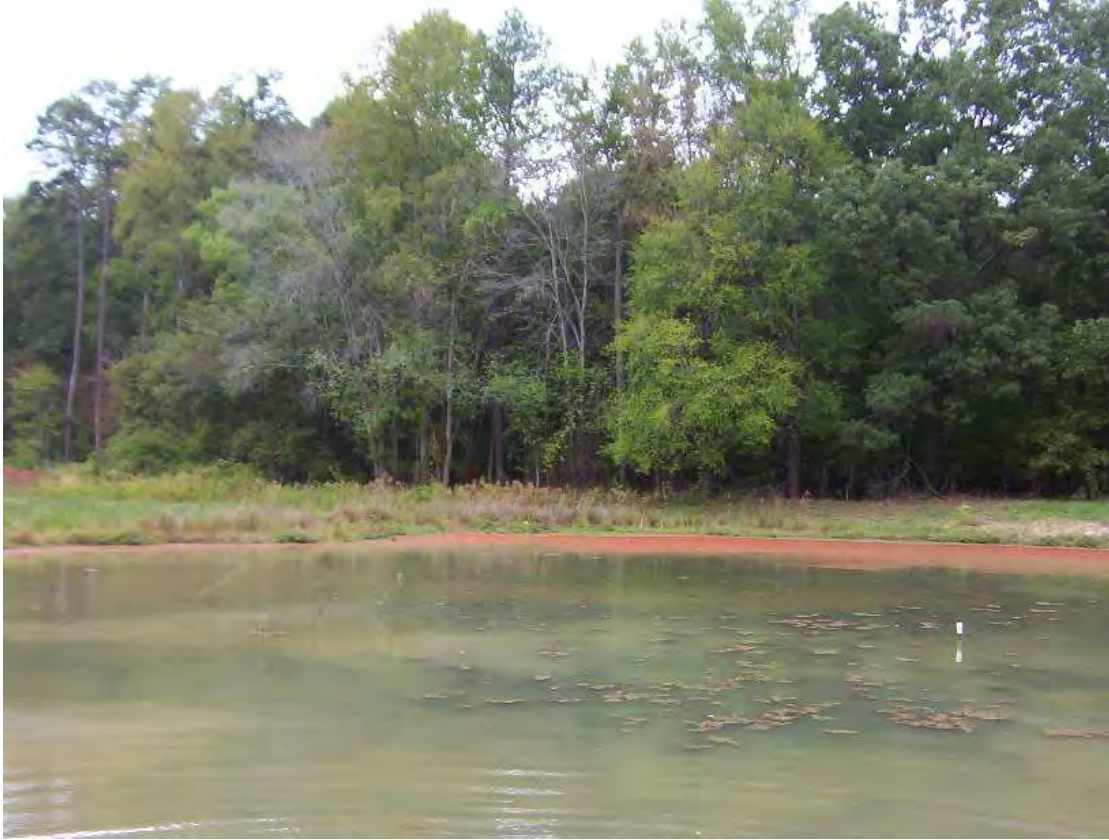
Photo 4

The above picture was taken on October 14, 2005, after two seasons of growth on-site. The water remained in this area throughout the year.

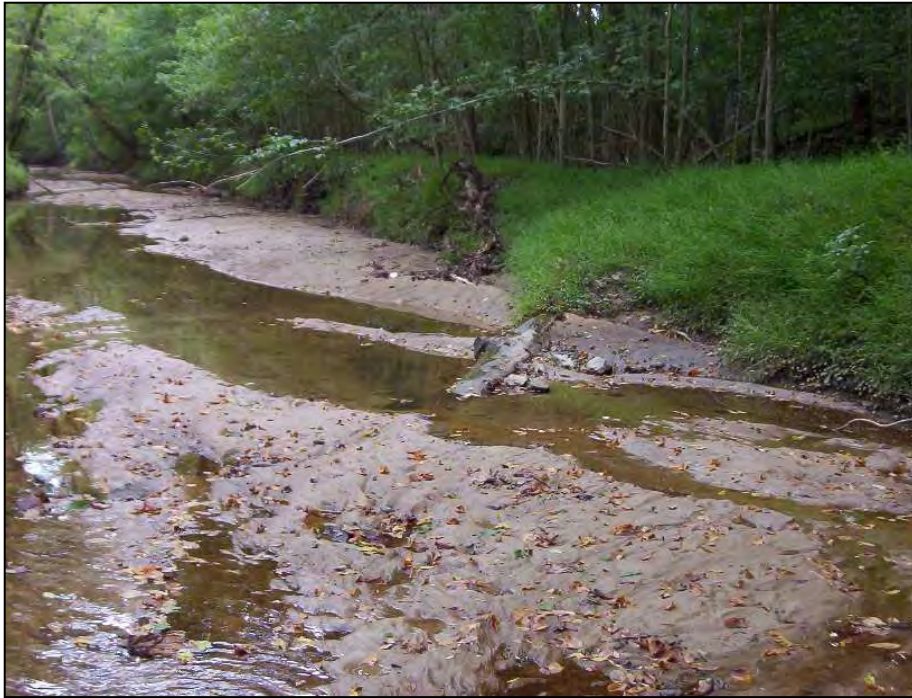
| <b>Feature Issue</b> | <b>Station Numbers</b> | <b>Suspected Cause</b> | <b>Photo Number</b> |
|---|---|---|---|
| Aggradation/Bar Formation | 00+00 to 27+00 | Excessive sediment load from upstream sources | 1 |

Photo 1. Excessive sediment load from upstream sources.
