**SANDY CREEK STREAM ENHANCEMENT
AND WETLAND RESTORATION SITE**
2006 Annual Monitoring Report (Year 3)

**Durham County
EEP Project No. 322
Design Firm: Becky L. Ward Consulting**

January 2007

**Prepared by: ECOSCIENCE CORPORATION
1101 Haynes Street, Suite 101
Raleigh, NC 27604**

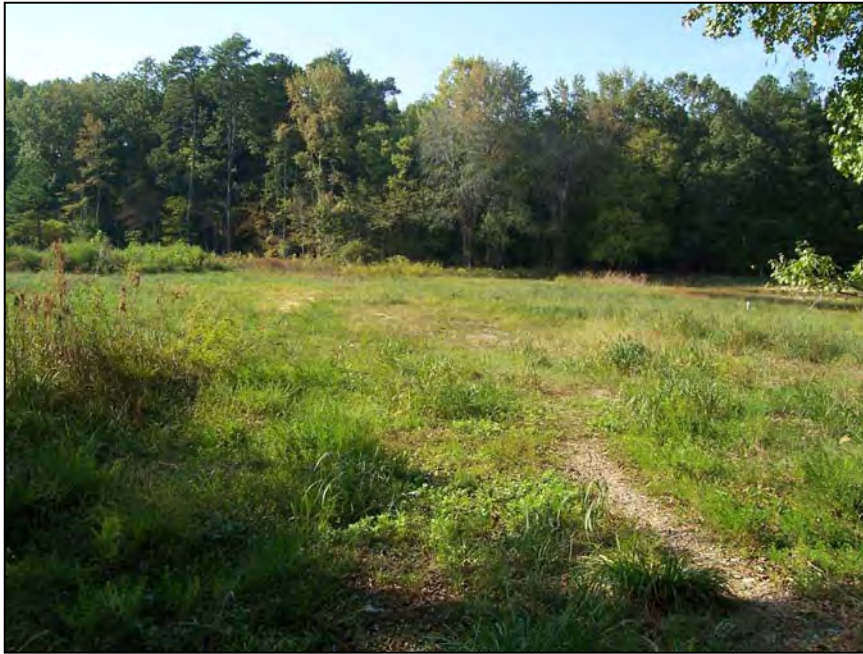
Photo 1. Poor Tree Establishment and Recruitment

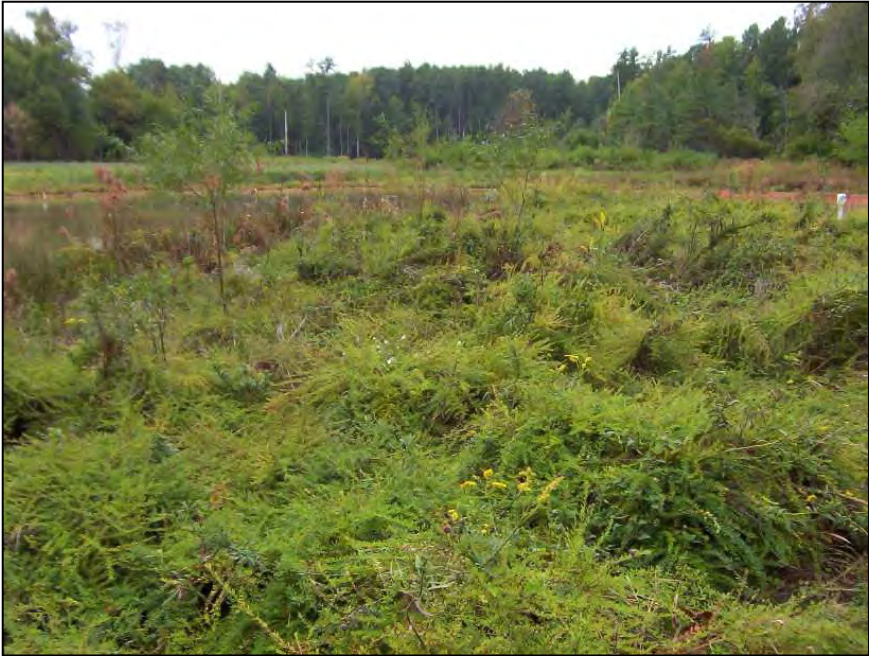
Photo 3. Poor Tree Survival

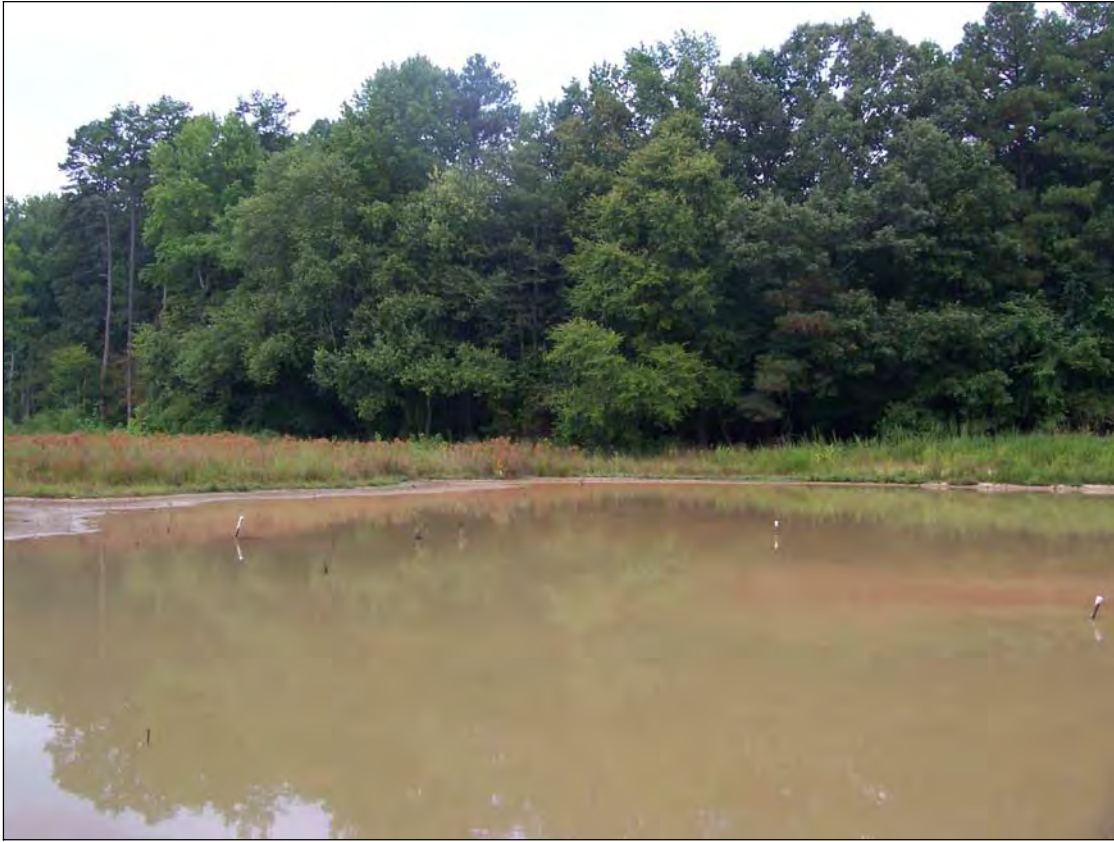
Photo 4

Exhibit Table VI. Vegetative Problem Areas			
Feature / Issue	Station # / Range	Probable Cause	Photo #
Bare Floodplain	Vegetation Plot 4	Flooding from pond creation;	4
Poor Survival	Vegetation Plot 5	Invasive exotics	5, 5a

Low survival of many of the planted species can be attributed to flooding at Plot 4 (located in an on-site pond) and invasive exotics at plot 5. The surviving stems are most likely volunteer individuals of the planted species recruited from the surrounding woods. Initial plantings were previously reported to be largely destroyed by geese, and this event is assumed to be responsible for low species diversity at the site at Year 2. Poor soil composition (Urban land soils occupy approximately 5.5 acres of the Site) is another factor in poor survival. High occurrences of *Fraxinus pennsylvanica* and *Salix nigra* are likely due to volunteer individuals of planted species. The original planted species could not be differentiated from the volunteers for any identified species in Table 7.

Plot 4 is the only vegetation plot to fail the density criterion for success at the Site. However, since only three planted species were recorded in the aggregated vegetation plots, the Site as a whole fails the diversity criterion.

The above picture was taken on August 23, 2006, after three seasons of growth on-site. The water remained in this area throughout the year.

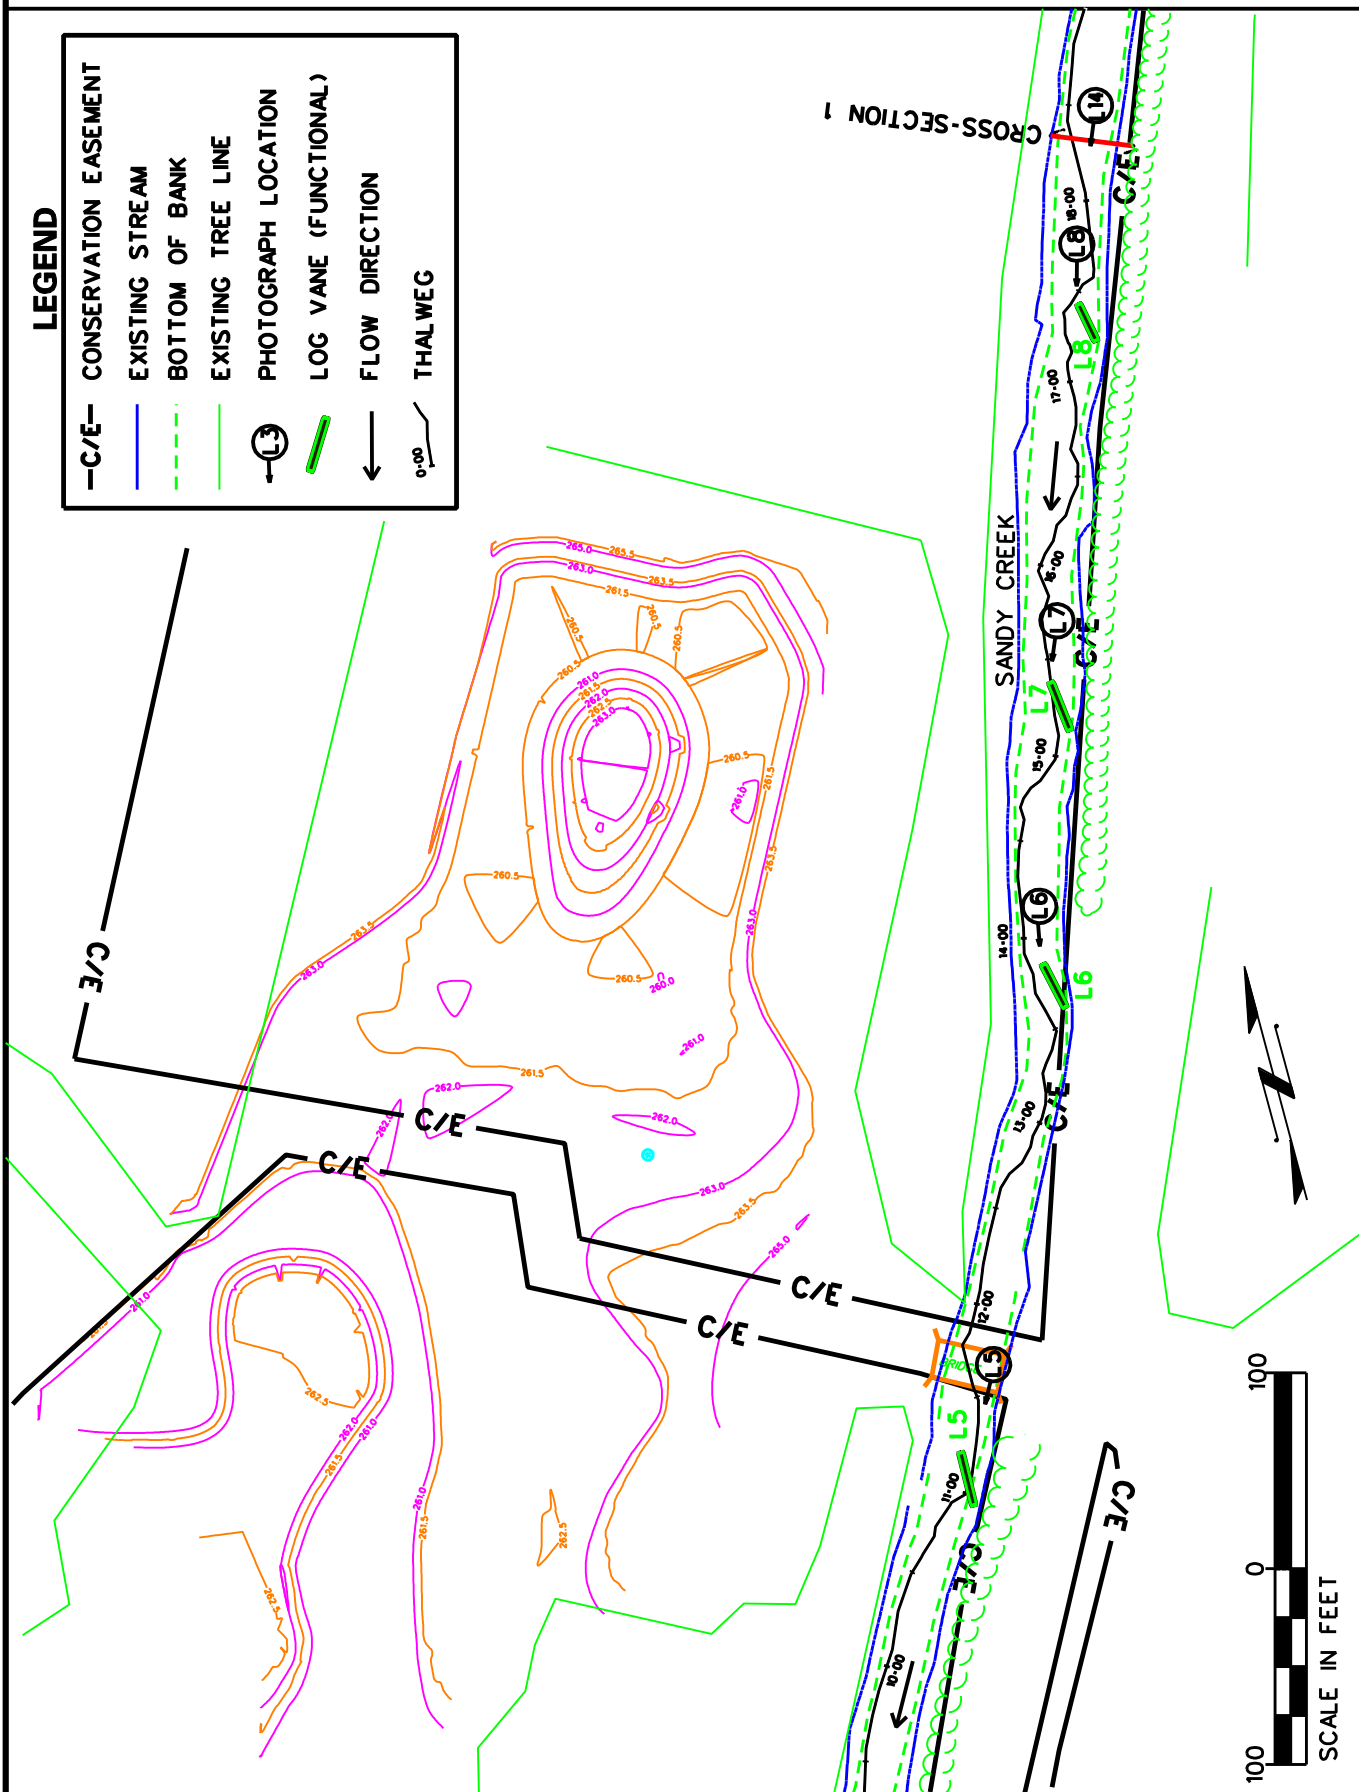
FIGURE **C2**

Exhibit Table X. Stream Problem Areas Sandy Creek Stream Enhancement and Wetland Restoration Site / EEP Project No. 322			
Feature Issue	Station Numbers	Suspected Cause	Photo Number
Aggradation/Bar Formation	00+00 to 27+00	Excessive sediment load from upstream sources	3

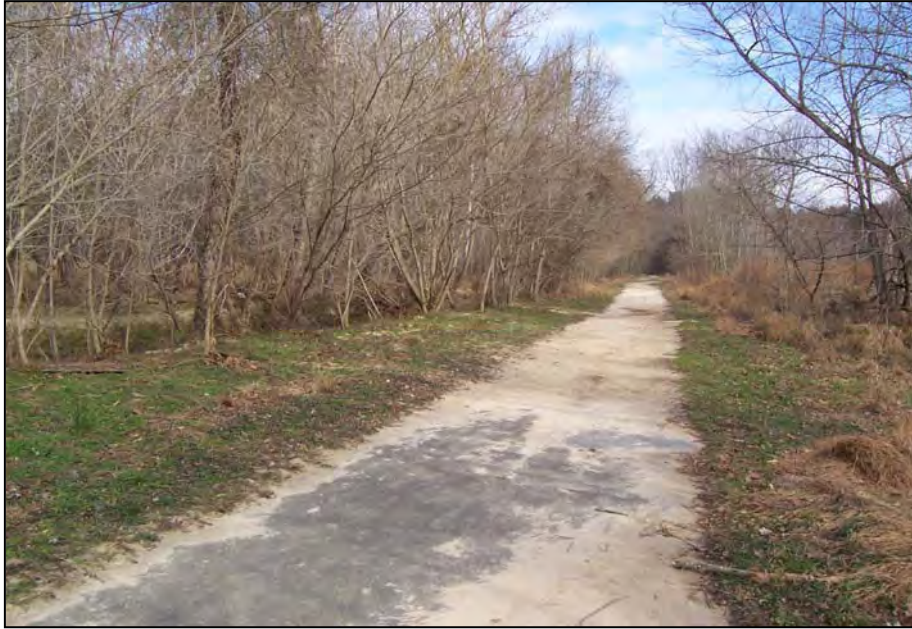
Photo 1. Sediment layer covering adjacent greenway path after a bankfull event

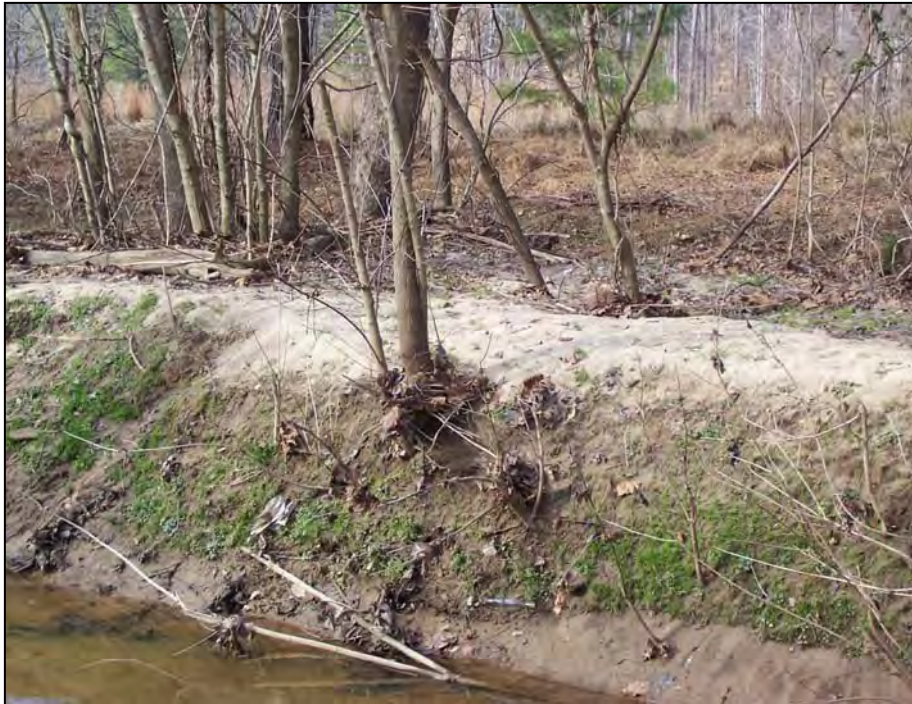
Photo 2. Sediment deposited at top of bank following a bankfull event

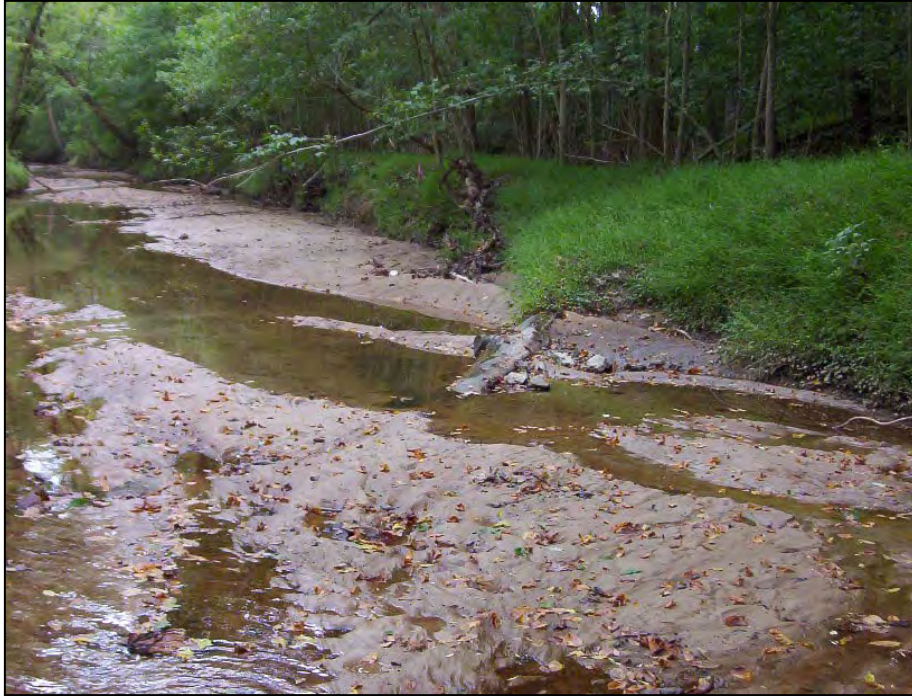
Photo 3. Excessive sediment load from upstream sources.

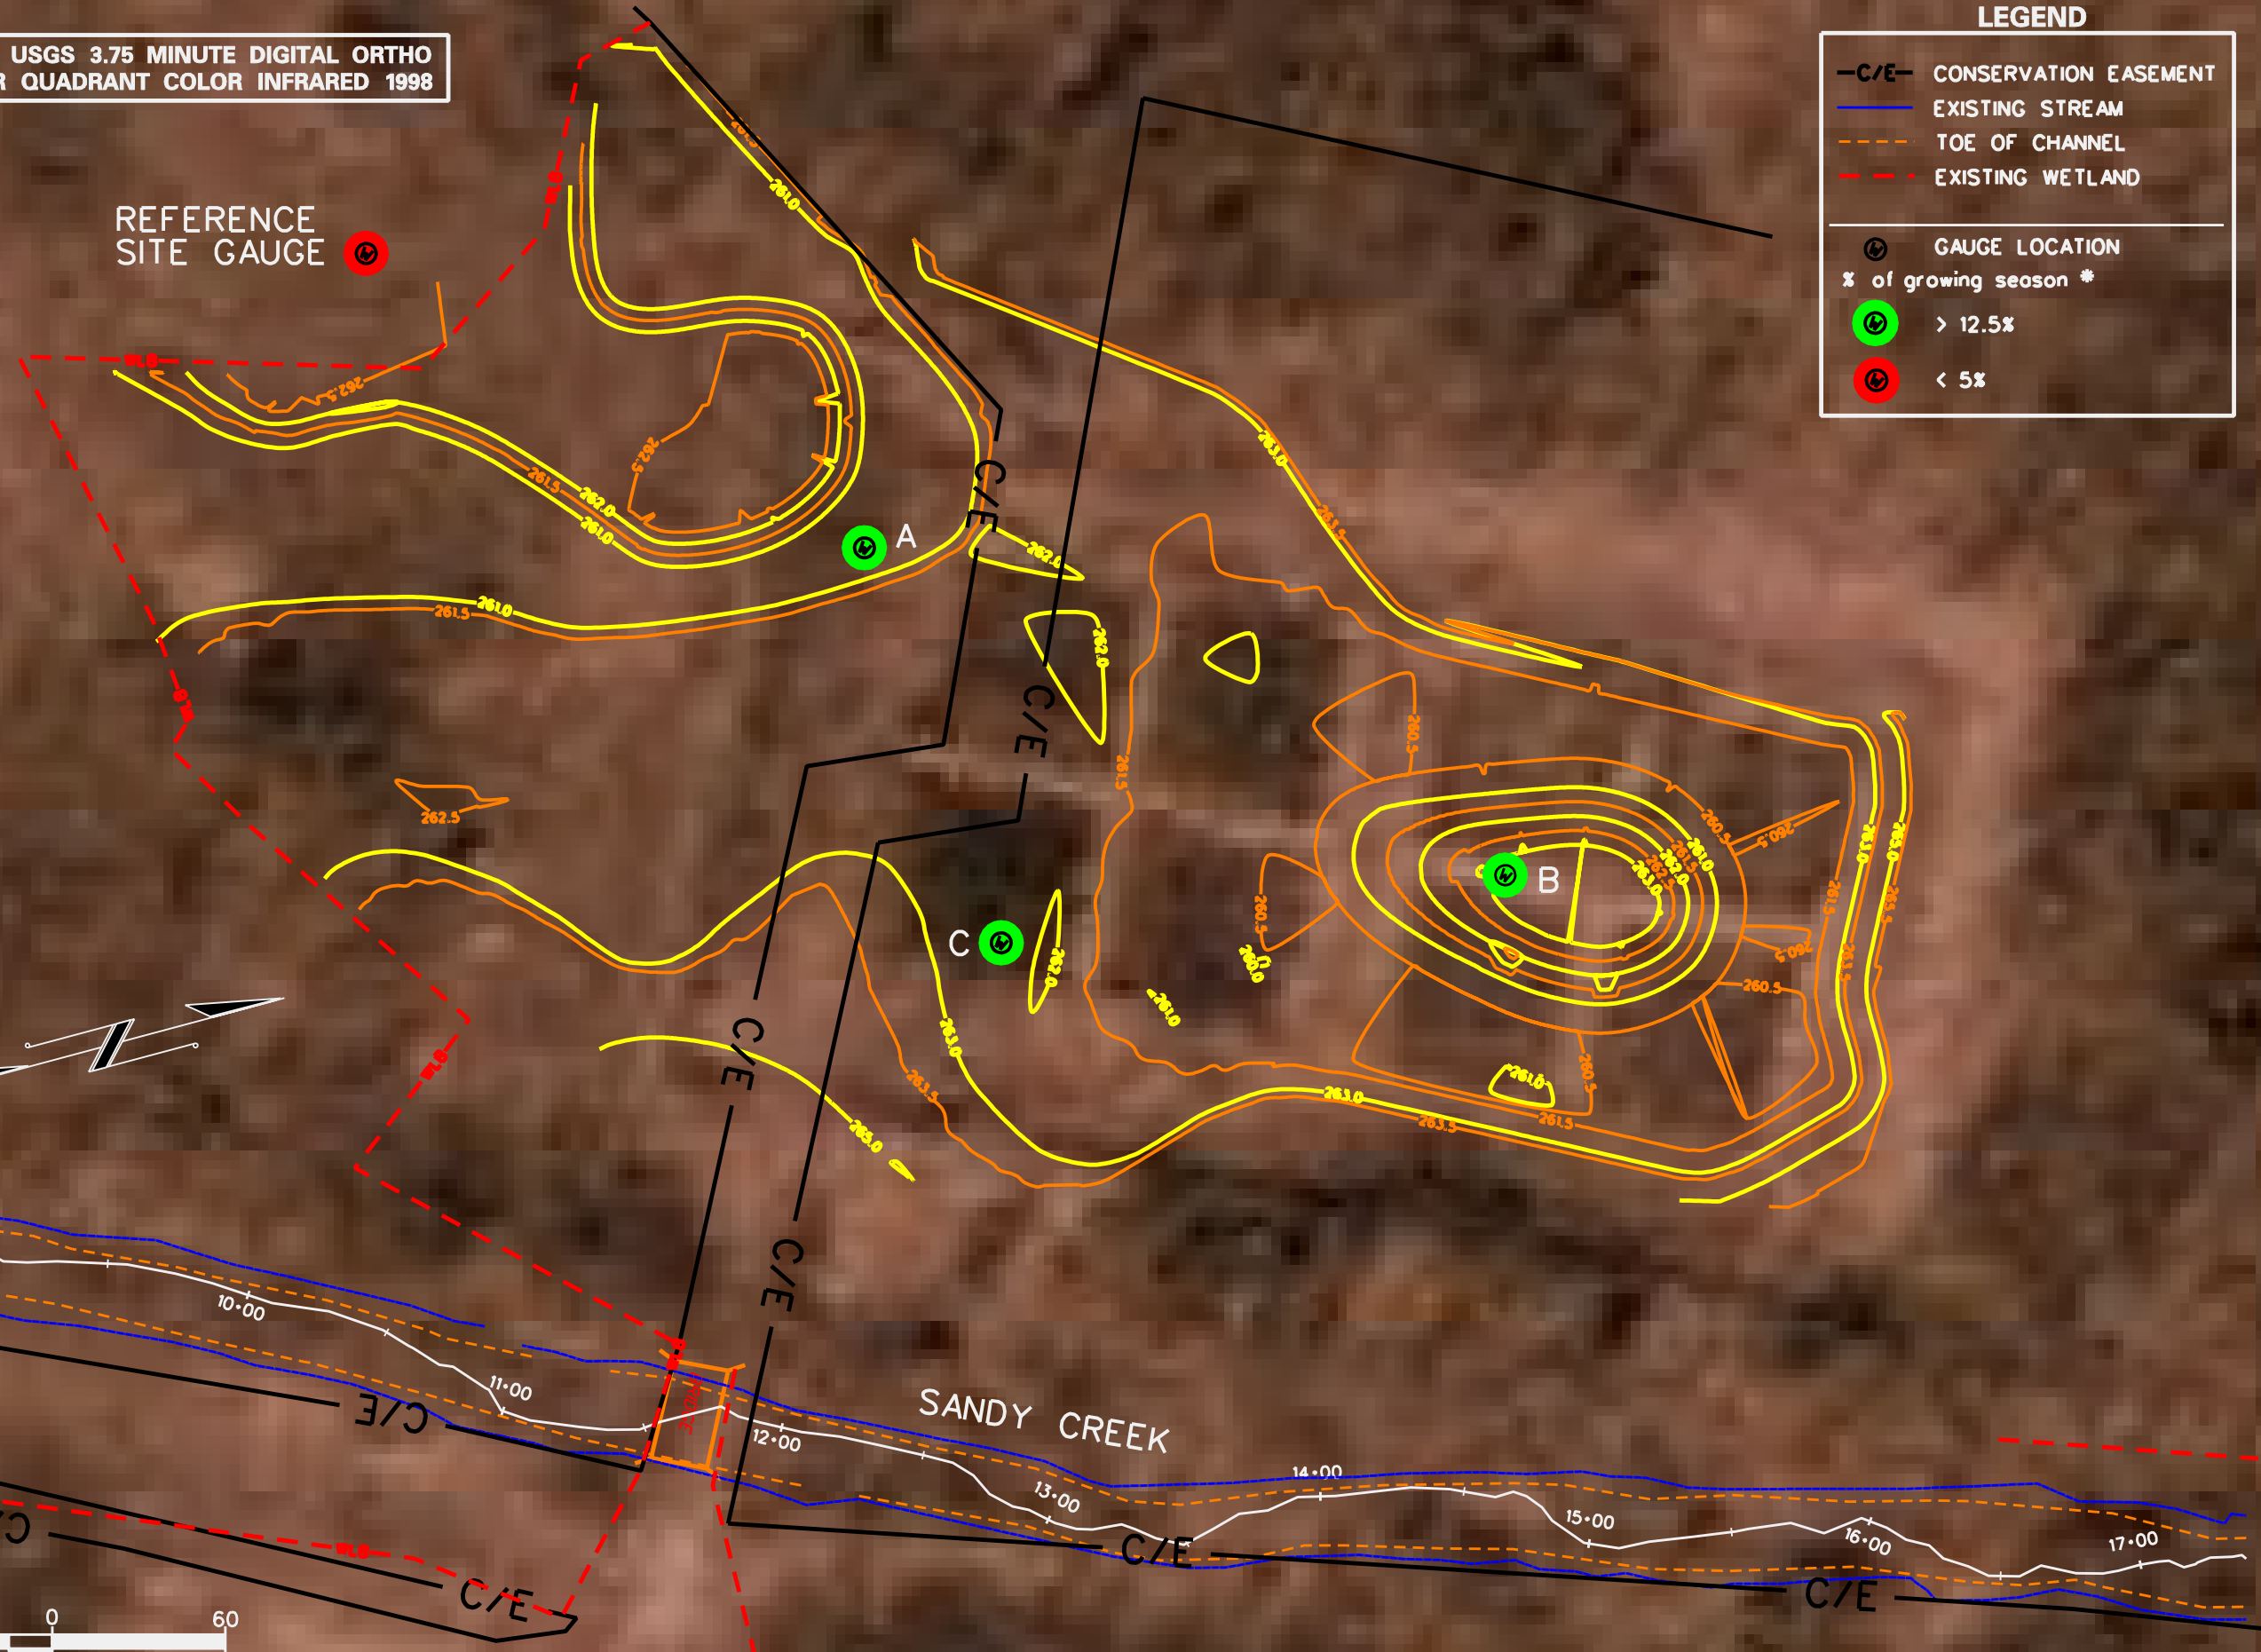
**WETLAND
 PROBLEM
 AREAS**

The 2006 hydrologic monitoring results indicate continued hydrologic success within the Site. All three on-site groundwater monitoring gauges exhibited saturation within 12 inches of the ground surface for at least 12.5 percent (consecutive days) of the growing season (March 30 – November 11 or 227 days).
