**SANDY CREEK STREAM ENHANCEMENT
AND WETLAND RESTORATION SITE
2007 Annual Monitoring Report (Year 4)**

**Durham County
EEP Project No. 322
Design Firm: Becky L. Ward Consulting**

February 2008

**Prepared by: ECOSCIENCE CORPORATION
1101 Haynes Street, Suite 101
Raleigh, NC 27604**

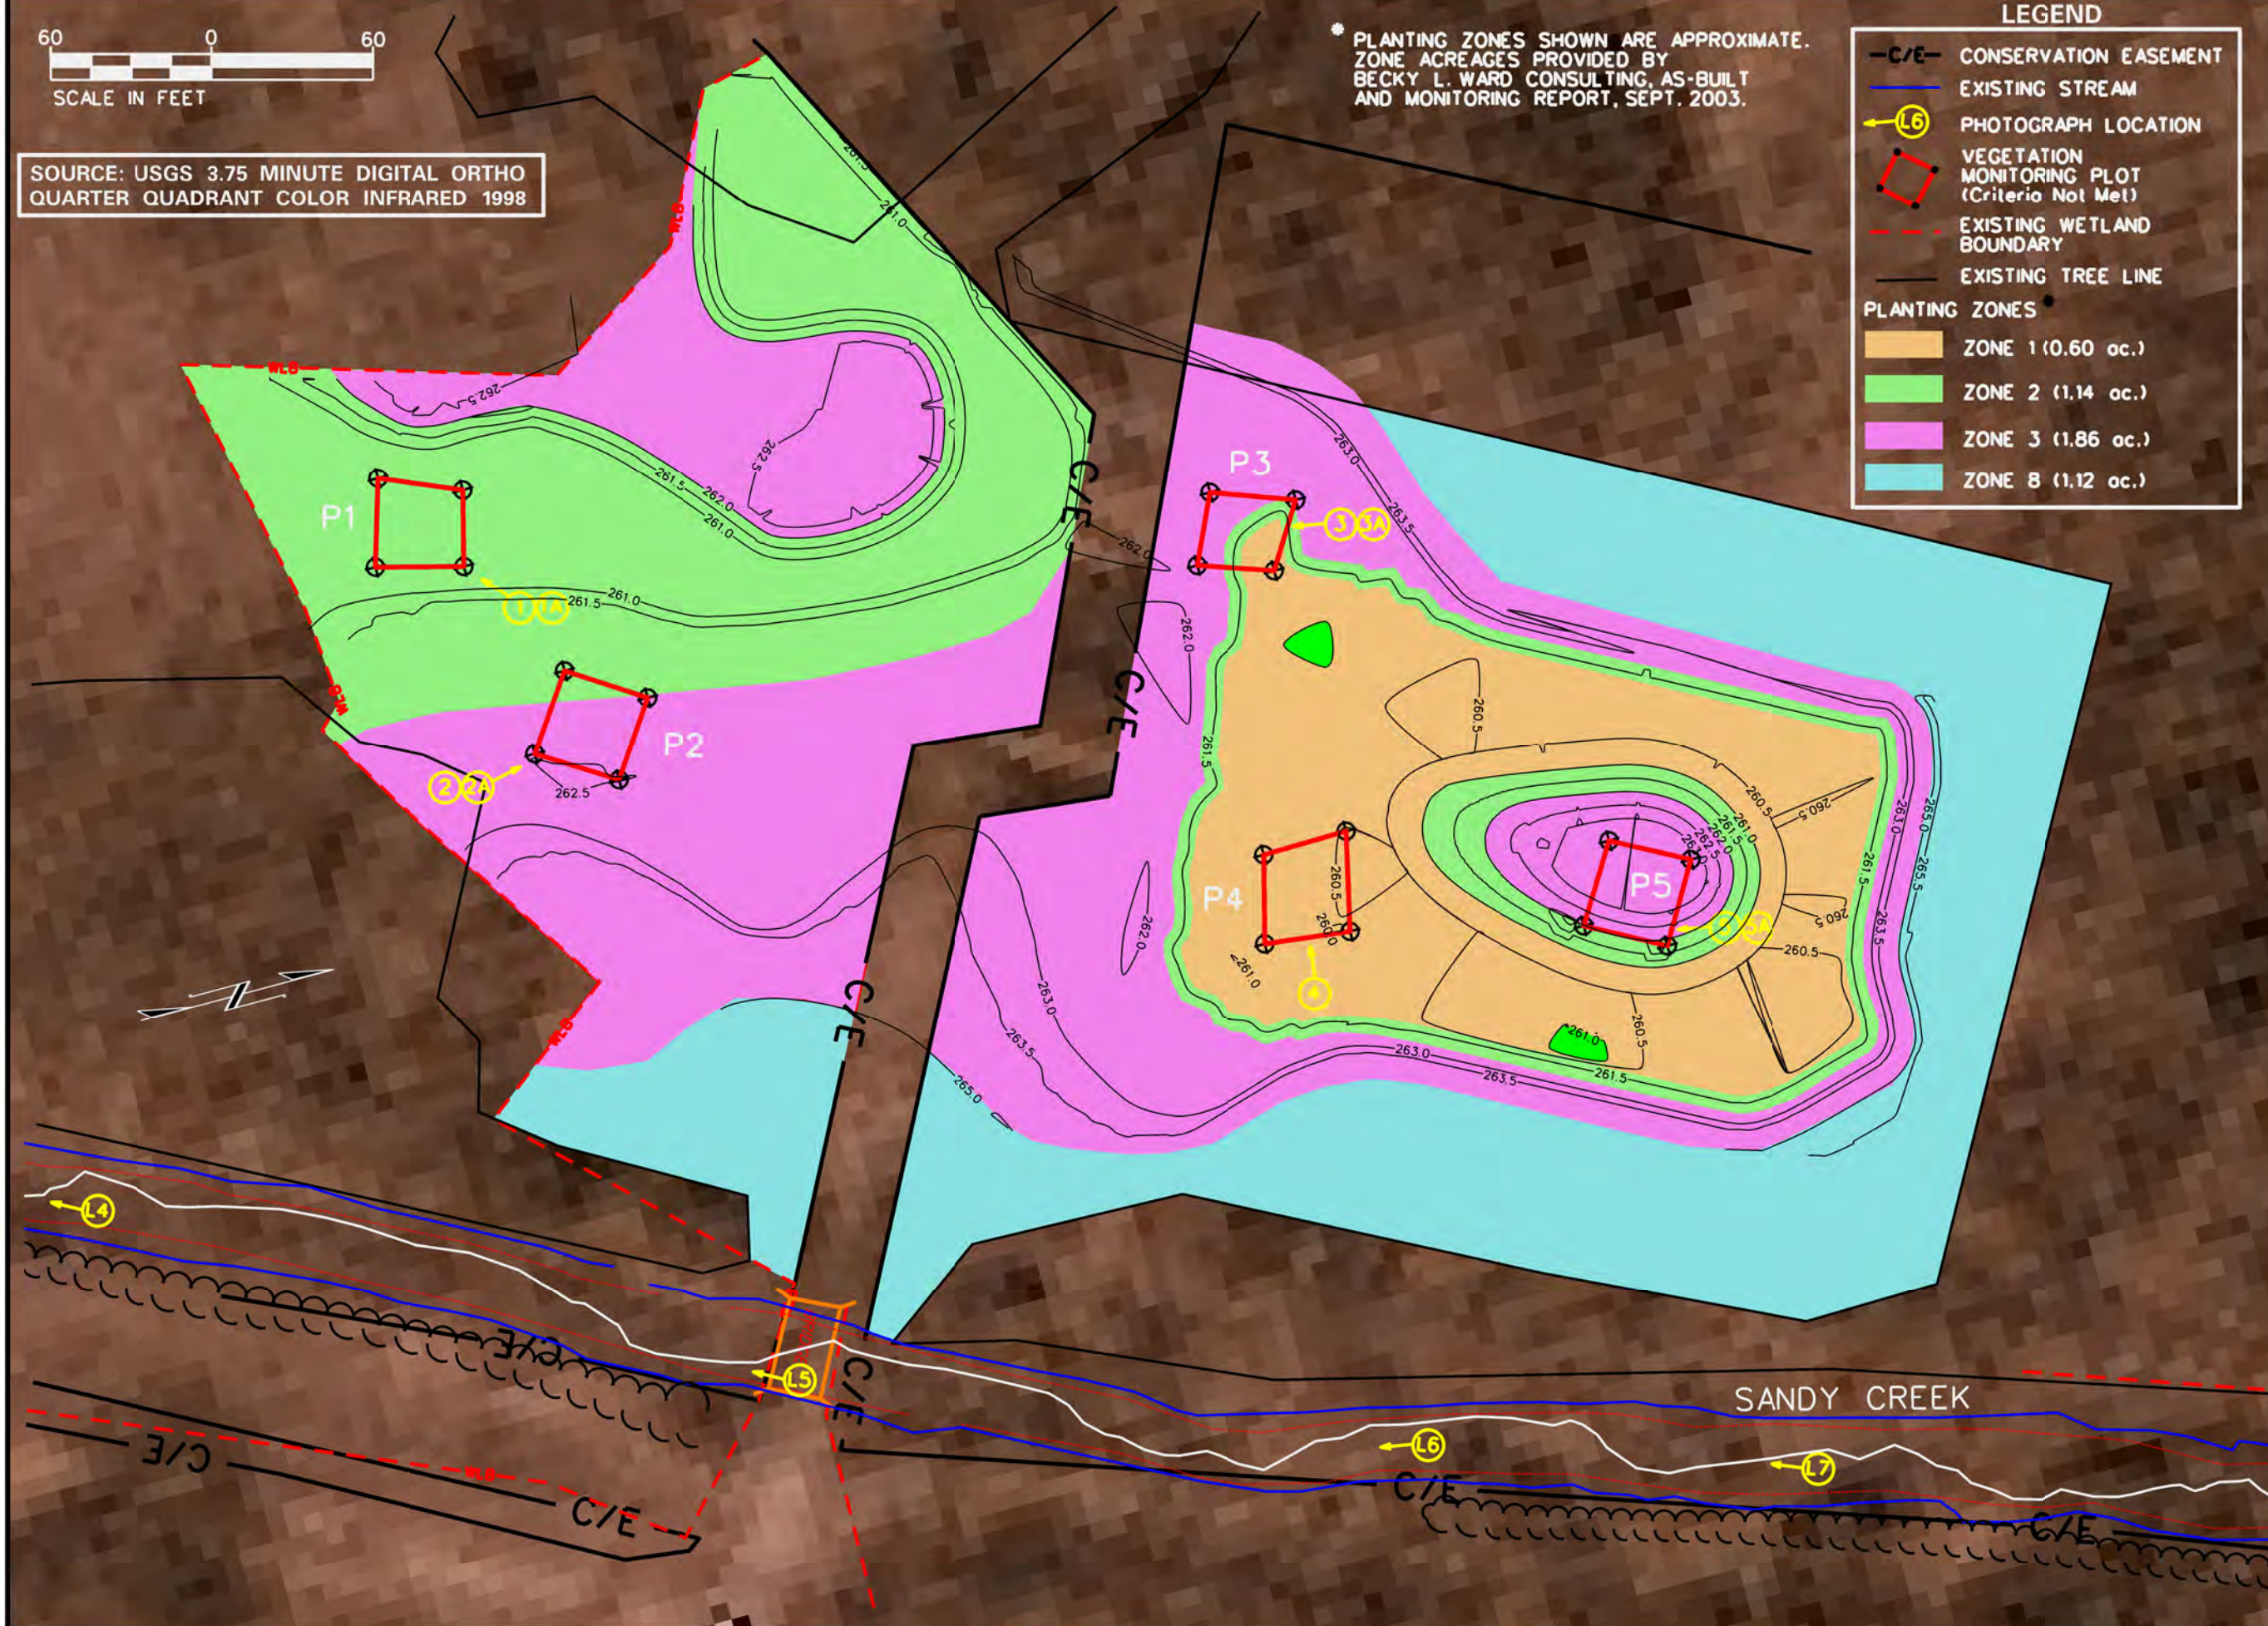
Title: **VEGETATION PROBLEM AREAS**

Low survival of many of the planted species can be attributed to permanent flooding of Plot 4 (located in an on-site pond) and invasive exotics at Plot 5. Initial plantings were previously reported to be largely destroyed by geese, and this event is assumed to be responsible for low species diversity at the site in Year 4. High occurrences of *Fraxinus pennsylvanica* and *Salix nigra* are likely due to volunteer individuals of planted species. Poor soil composition (Urban land soils occupy approximately 5.5 acres of the Site) is another factor in poor survival. A Vegetation Problem Areas Table, Vegetation Problem Area Plan View, and photos are provided in Appendix A.

Exhibit Table 6. Vegetative Problem Areas			
Sandy Creek Stream Enhancement and Wetland Restoration Site / EEP Project No. 322			
Feature / Issue	Station # / Range	Probable Cause	Photo #
Bare Floodplain	Vegetation Plot 4	Flooding from pond creation	VPA1
Poor Survival	Vegetation Plot 5	Invasive exotics	VPA 2

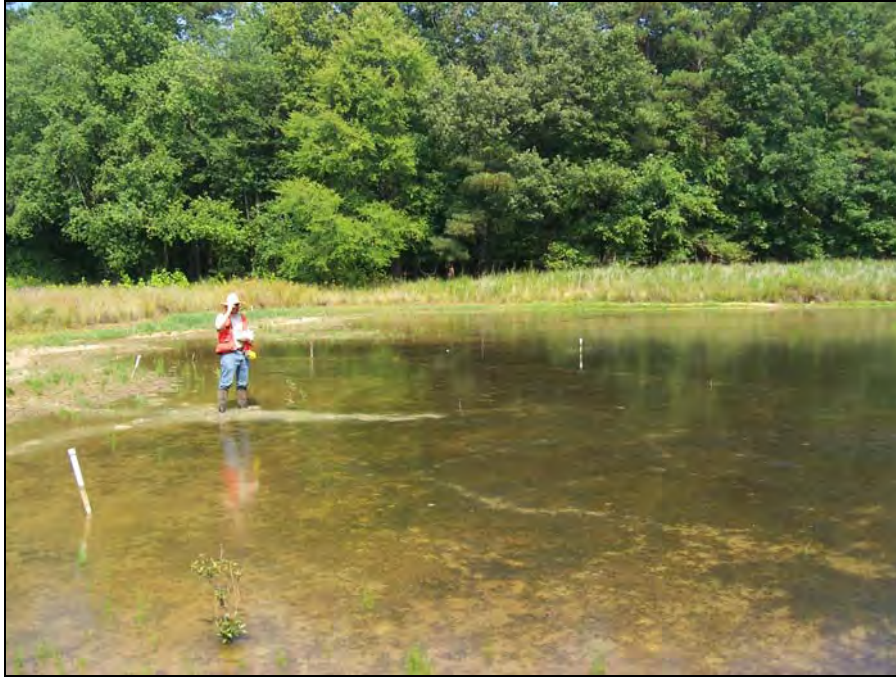
VPA Photo 1. Low species survival and flooding at Plot 4.

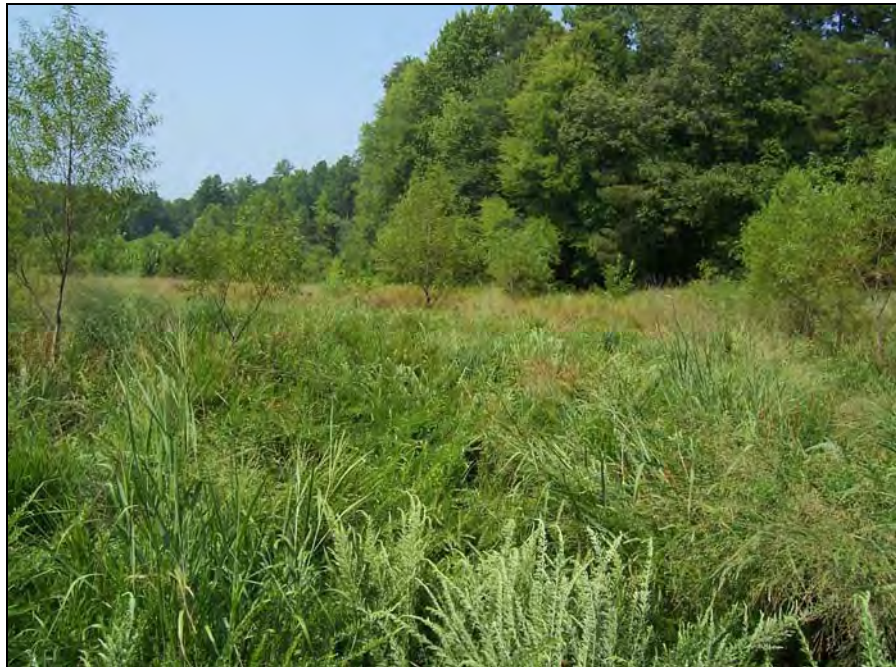
VPA Photo 2. Invasive exotics within Plot 5.

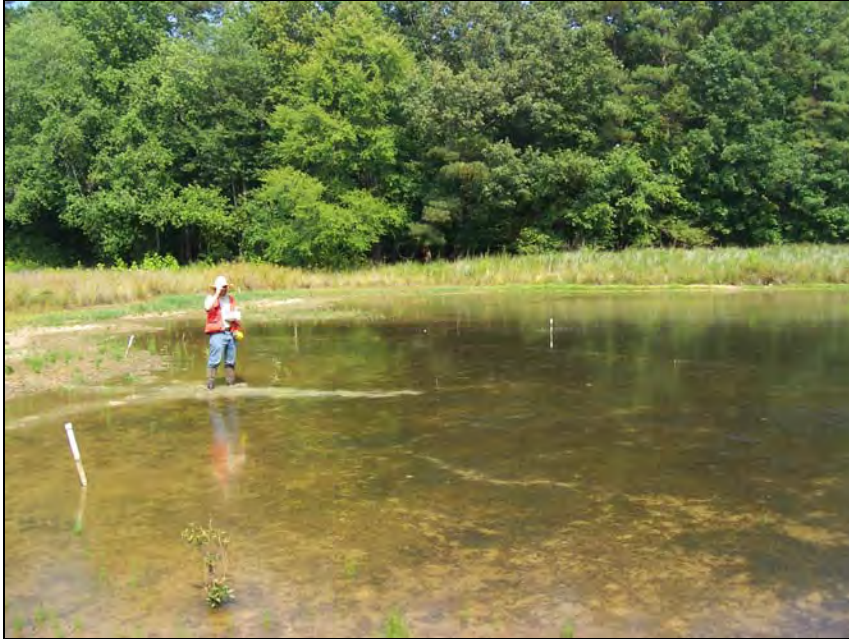
Photo 4

Low survival of many of the planted species can be attributed to flooding at Plot 4 (located in an on-site pond) and invasive exotics at Plot 5. The surviving stems are most likely volunteer individuals of the planted species recruited from the surrounding woods. Initial plantings were previously reported to be largely destroyed by geese, and this event is assumed to be responsible for low species diversity at the site at Year 4. Poor soil composition (Urban land soils occupy approximately 5.5 acres of the Site) is another factor in poor survival.

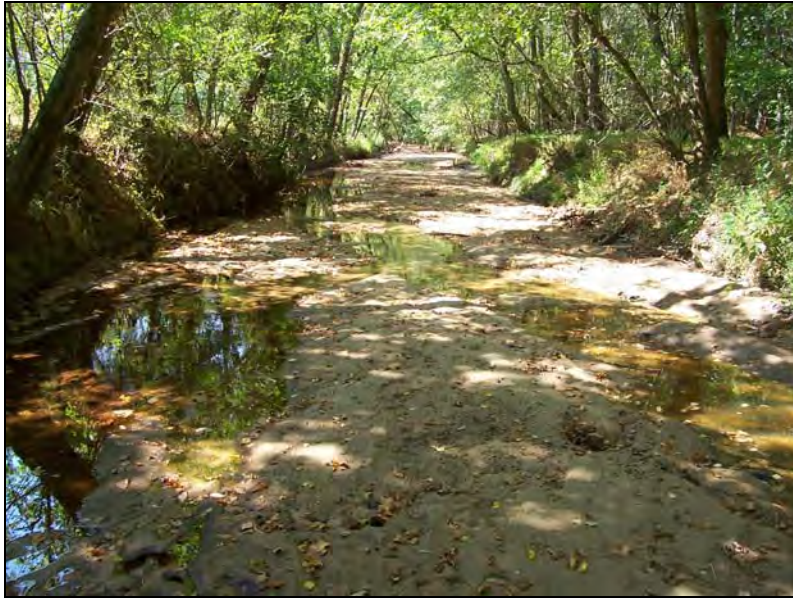
An analysis of stream features was performed in order to evaluate the current condition of Sandy Creek. Identified problem areas exist in the form of an overall aggradation of sediment throughout the restored reach of Sandy Creek, presumably from an upstream source. The Stream Problem Areas Table and photos are located in Appendix B.

Table B1. Stream Problem Areas			
Sandy Creek Stream Enhancement and Wetland Restoration Site / EEP Project No. 322			
Feature Issue	Station Numbers	Suspected Cause	Photo Number
Aggradation/Bar Formation	00+00 to 27+00	Excessive sediment load from upstream sources	SPA1, 2

SPA Photo 1. Excessive sediment load from upstream sources.

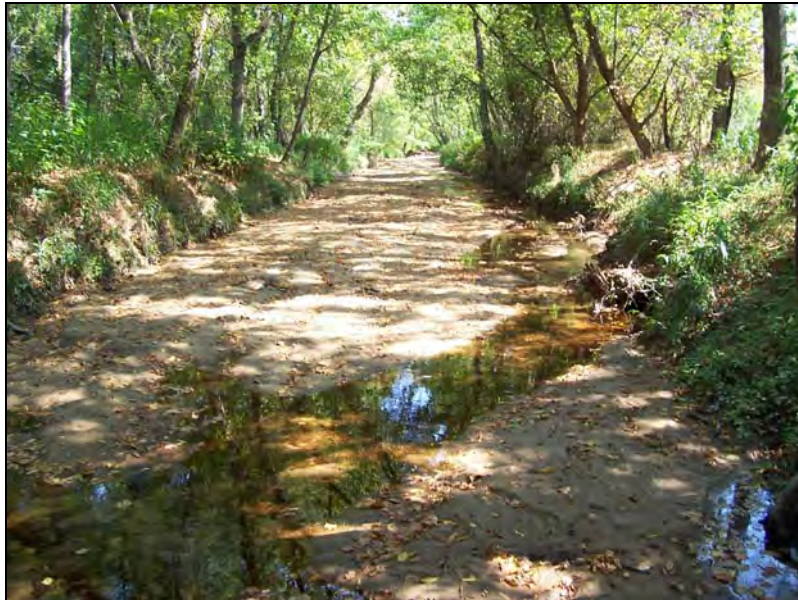
SPA Photo 2. Excessive sediment load from upstream sources.

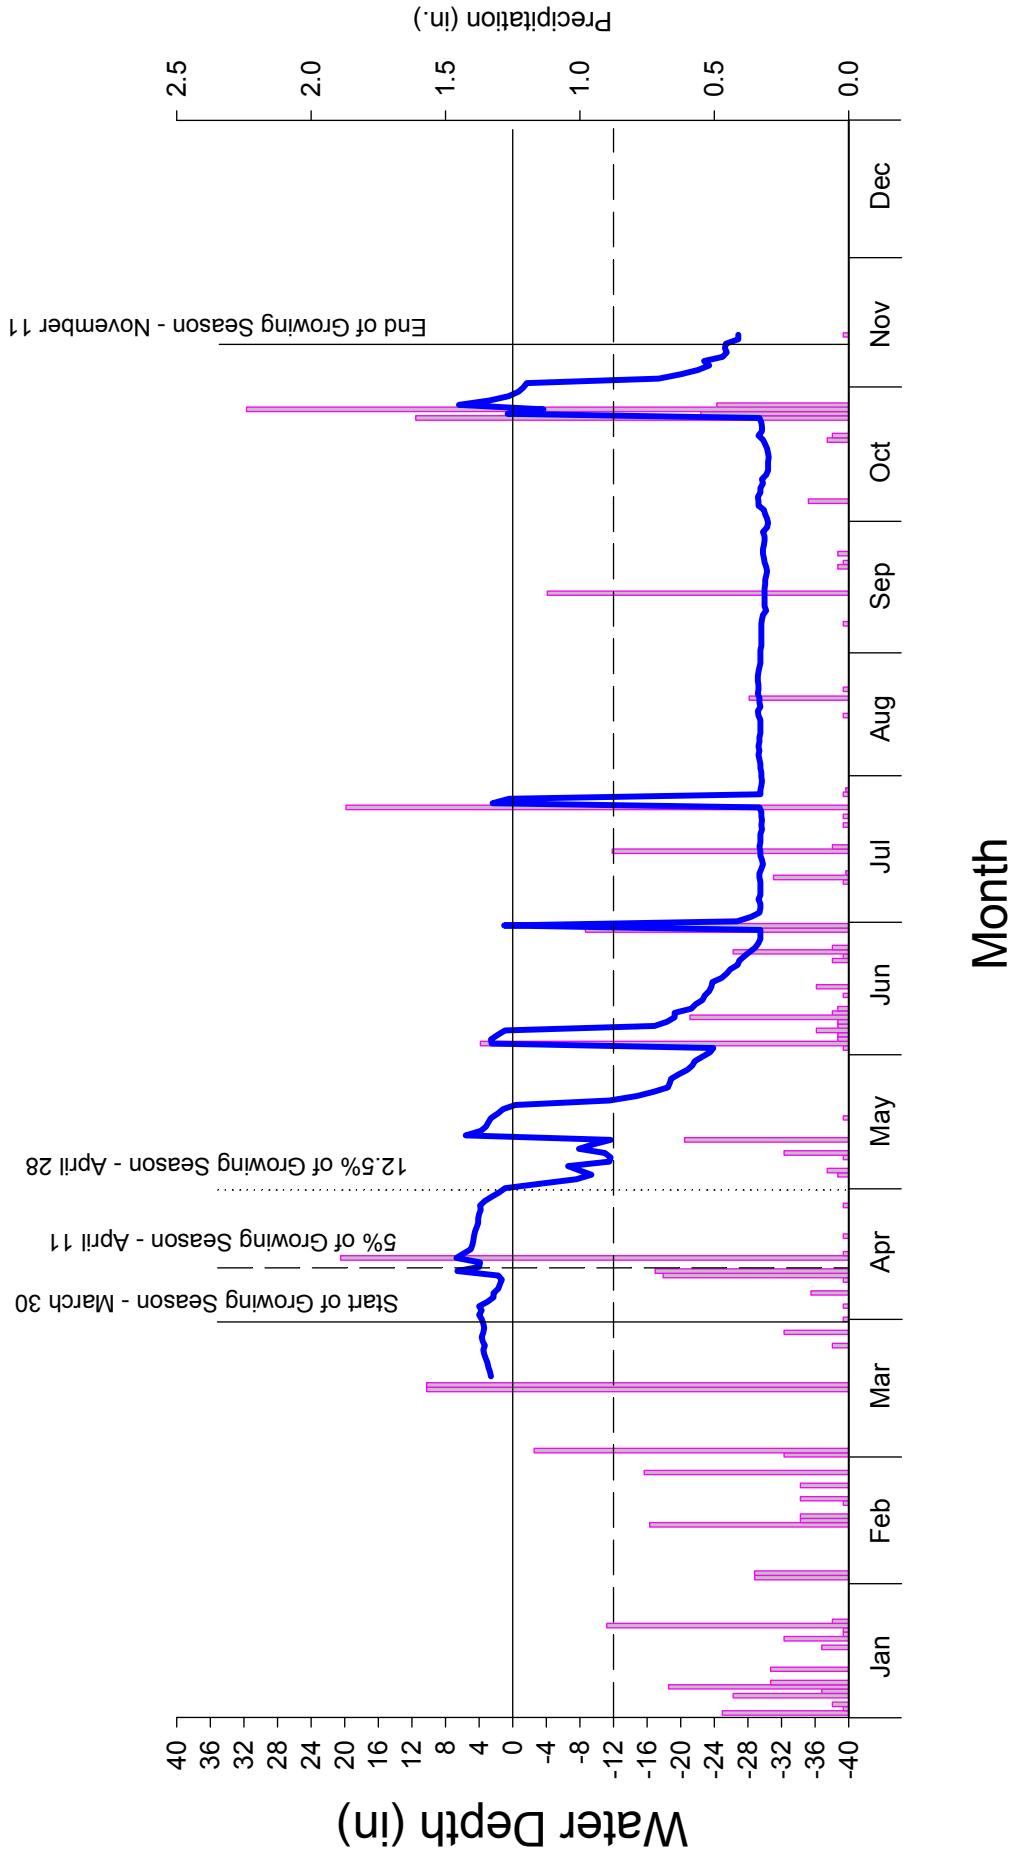
Monitoring Gauge A - AB3546A

The 2007 hydrologic monitoring results indicate limited hydrologic success within the Site. Only one gauge (Gauge A) exhibited saturation within 12 inches of the ground surface for at least 12.5 percent (consecutive days) of the growing season (March 30 – November 11 or 227 days). Gauges B and C

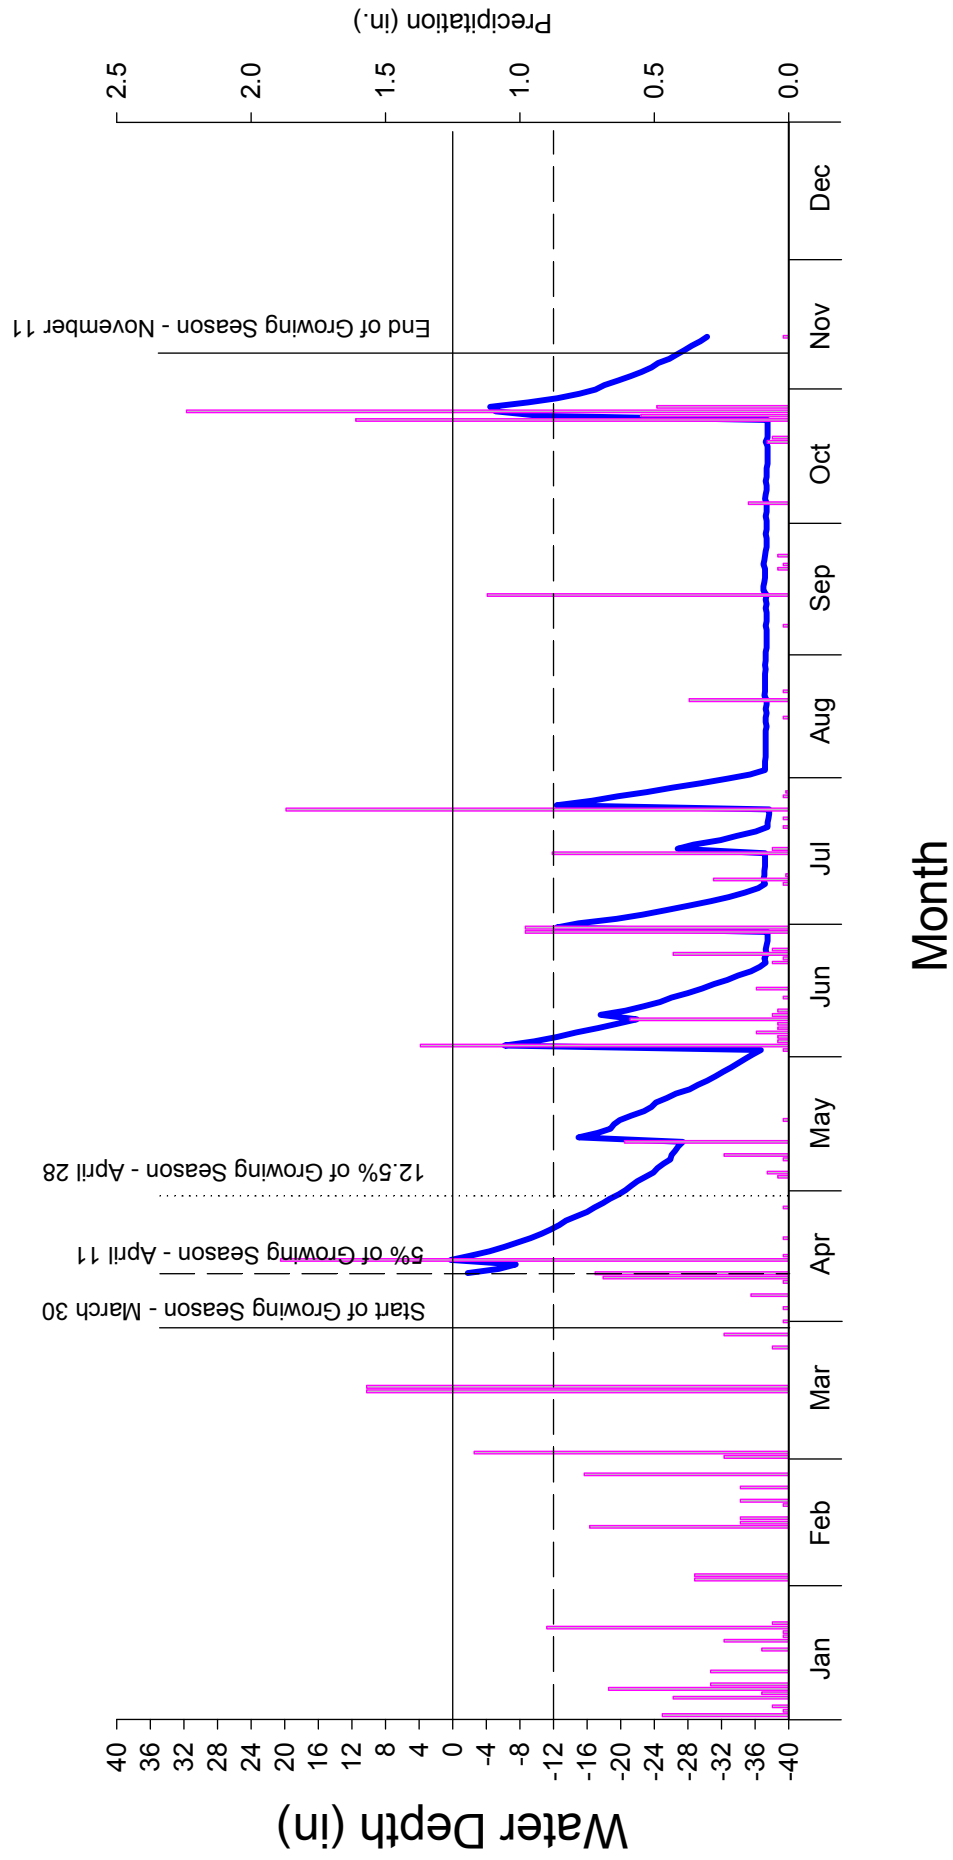
Sandy Creek 2007 Monitoring Gauge B-9DE54F2

exhibited saturation within 12 inches of the ground surface for 5-12.5 percent of the growing season. Drought conditions throughout the monitoring period contributed to the limited hydrologic saturation.
