SANDY CREEK

Durham County, North Carolina
EEP Project No. 322

2011 Annual Monitoring Report
(Measurement Year-6 – MY6 (2011) – 2nd year post-repair)
Site Constructed 2003/Repaired 2008-2009

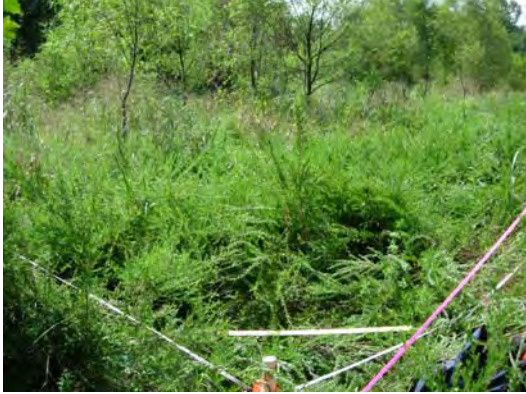
Plot 1

low stem densities and invasive exotic species. Low stem densities occurred within the immediate vicinity of plots 1. Several stands of Chinese lespedeza (*Lespedeza cuneata*), were observed along the woodland margins, plot 1, and 3. These areas along the woodland margin have remained undisturbed throughout the monitoring period.

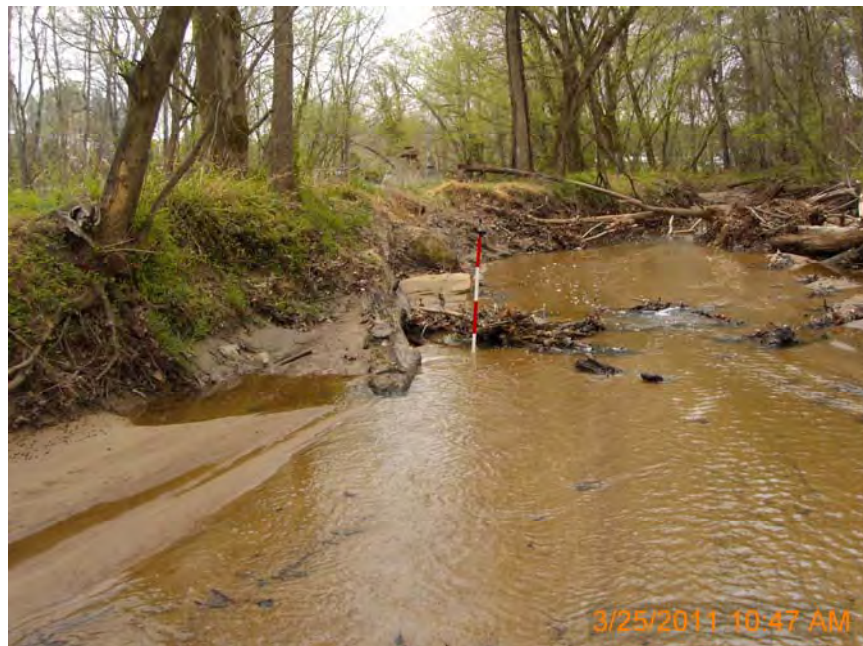
Photo Station 2: Log Vane #2 (Station 4 + 12)

Woody debris obstruction

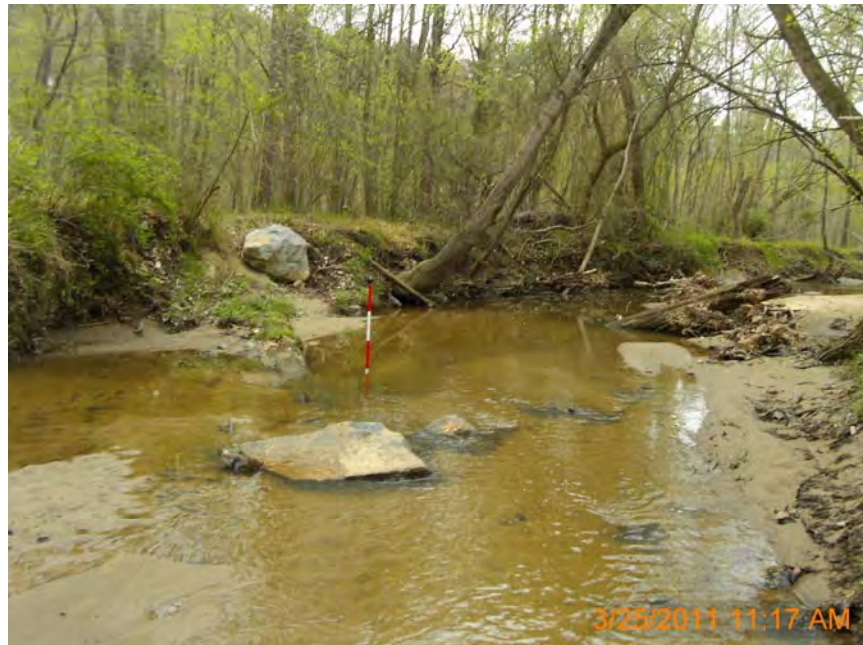
Photo Station 12: Log Vane #12 (Station 24 + 20)

The stream banks are well vegetated and stable. The log vanes are stable and functioning as intended. Some erosion was observed around the anchor boulder at the top of log vane 12. Aquatic habitat in the form of woody debris was observed at several locations along the stream. Two areas of minor debris buildup are located at stations 3+50 and 24+00, which do not span the entire width of the stream and are not causing bank instability issues presently. A debris pile at station 10+00, reported in MY-05, caused by a fallen tree is still present. This debris spans the entire width of the stream but is not currently causing bank instability. Woody debris is partially blocking the left two of the existing three box culverts at the downstream end of the project.

Note Woody Debris and Exposed Boulder

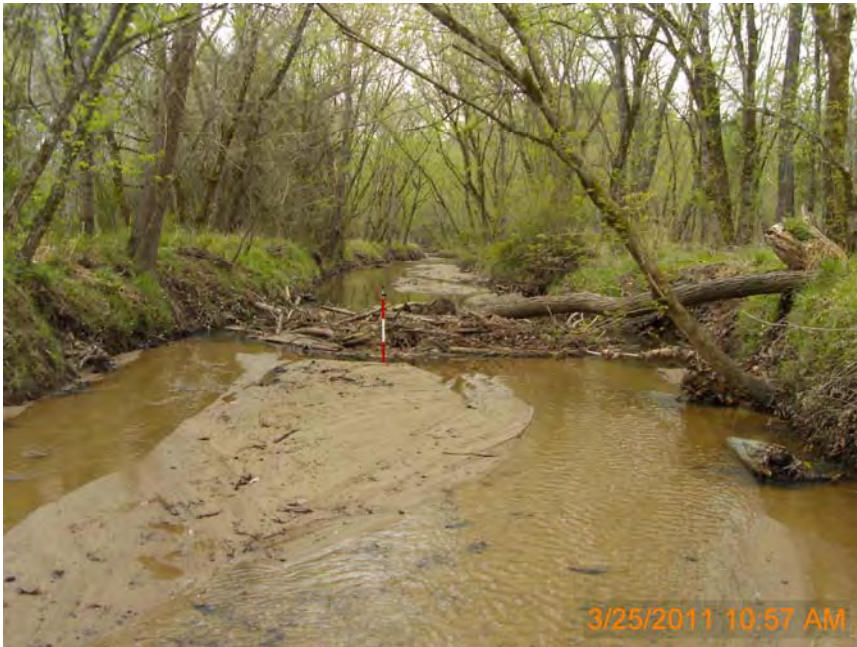
Woody Debris in Stream (Station 10 + 00)

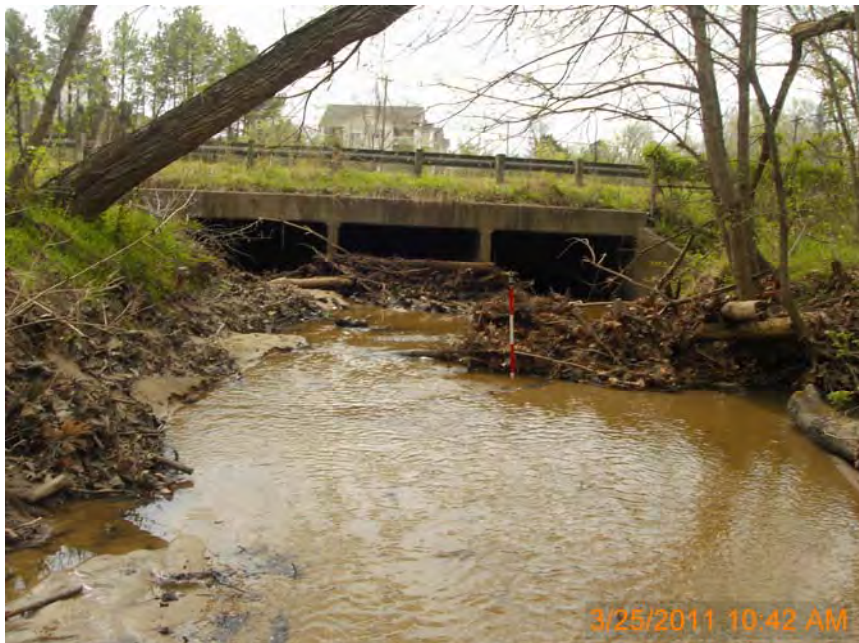
Culverts and Debris (Station 0 + 00)
