**CHARLES WILLIAMS STREAM, WETLAND, AND BUFFER SITE**  
**DMS Project No. 80**

**MONITORING YEAR 3 (2015)**  
**Construction Completed February 2013**  
**Planting Completed February 2014**

**Randolph County, NC**  
**State Construction Project No. 07-07125-01A**

**FINAL REPORT November 2015**

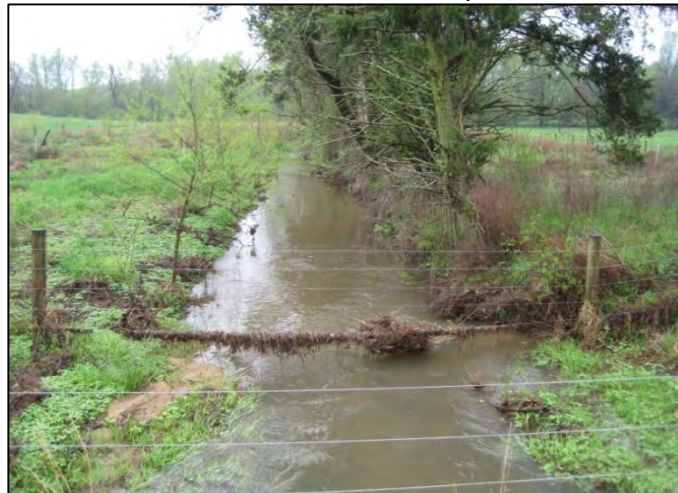
A bankfull event was actively observed on April 17<sup>th</sup>, 2015 during a rainfall event. Additional evidence of this and other subsequent bankfull events was documented on June 30, 2015. Evidence consisted of wrack material and sediment staining above the bankfull indicators along the channel and alluvial deposits outside the channel. The crest gauge was checked in June 2015, but could not be successfully read due to a large aggregation of ants within the gauge. Annual photograph comparisons of the stream channel are depicted in Appendix B and hydrologic data associated with this year's monitoring assessment are provided in Appendix E.

1. Overbank Event Observed 17 April 2015

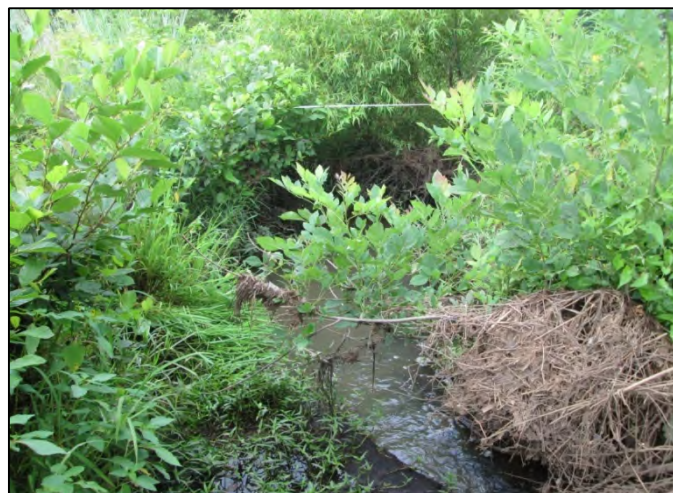
3. Wrack Documented 30 June 2015

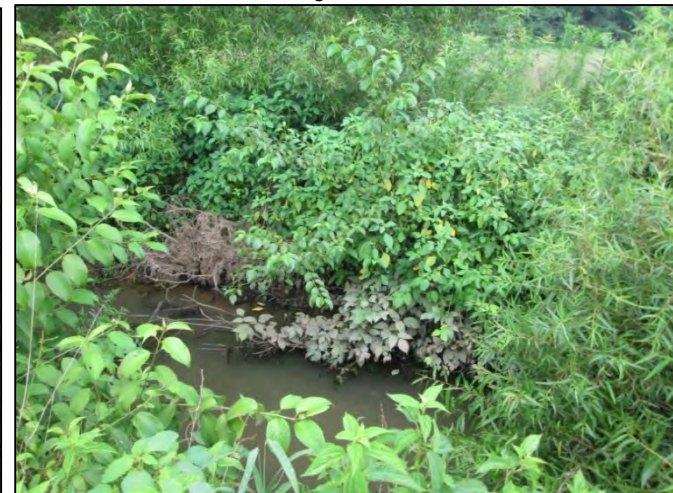
4. Sediment Staining Documented 30 June 2015

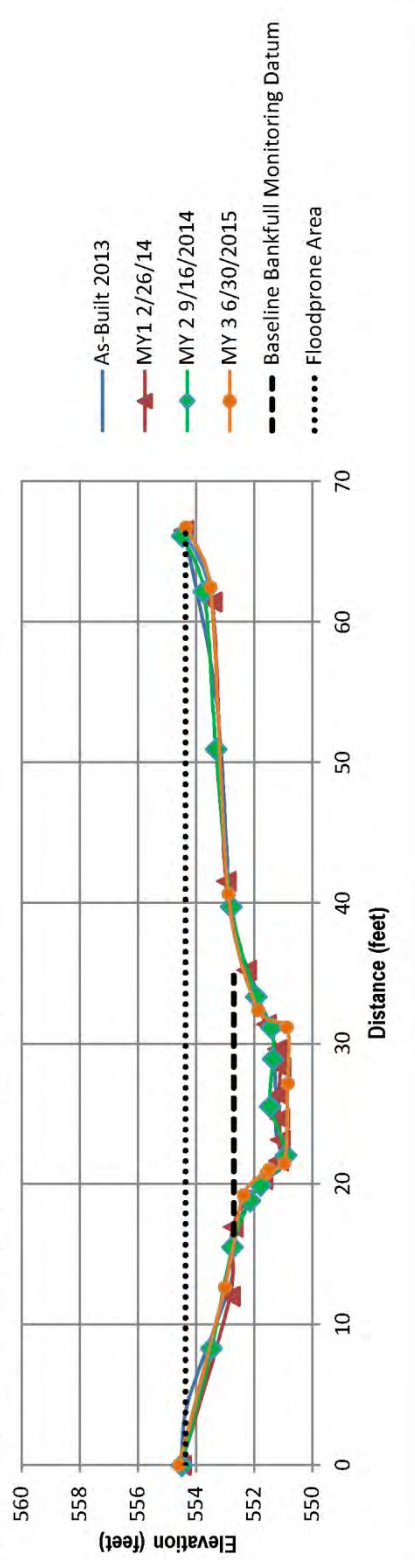
UT to Sandy Creek, Cross Section 1, Riffle, Station: 14+41

SUMMARY DATA	
Bankfull Elevation:	552.8
Bankfull Cross Sectional Area:	22.7
Bankfull Width:	23.9
Flood Prone Area Elevation:	554.7
Flood Prone Width:	66.1
Max. Depth at Bankfull:	1.8
Mean Depth at Bankfull:	0.9
Width/Depth Ratio:	25.2
Entrenchment Ratio:	2.8
Bank Height Ratio:	1.0

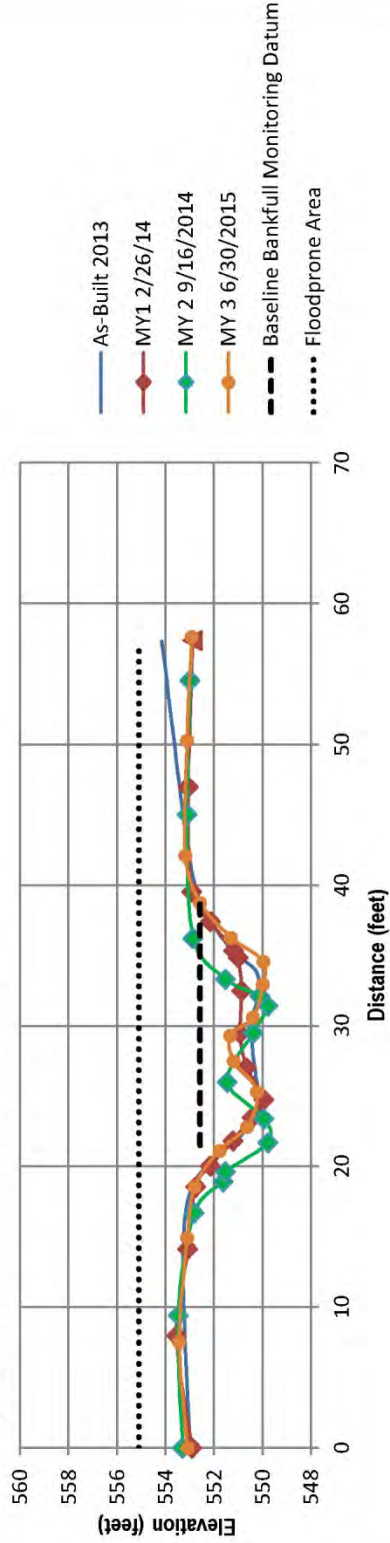
UT to Sandy Creek, Cross Section 2, Run, Station: 19+36

SUMMARY DATA	
Bankfull Elevation:	552.83
Bankfull Cross Sectional Area:	35.3
Bankfull Width:	19.4
Flood Prone Area Elevation:	555.9
Flood Prone Width:	200+
Max. Depth at Bankfull:	3.1
Mean Depth at Bankfull:	1.8
Width/Depth Ratio:	10.7
Entrenchment Ratio:	>10
Bank Height Ratio:	1.0

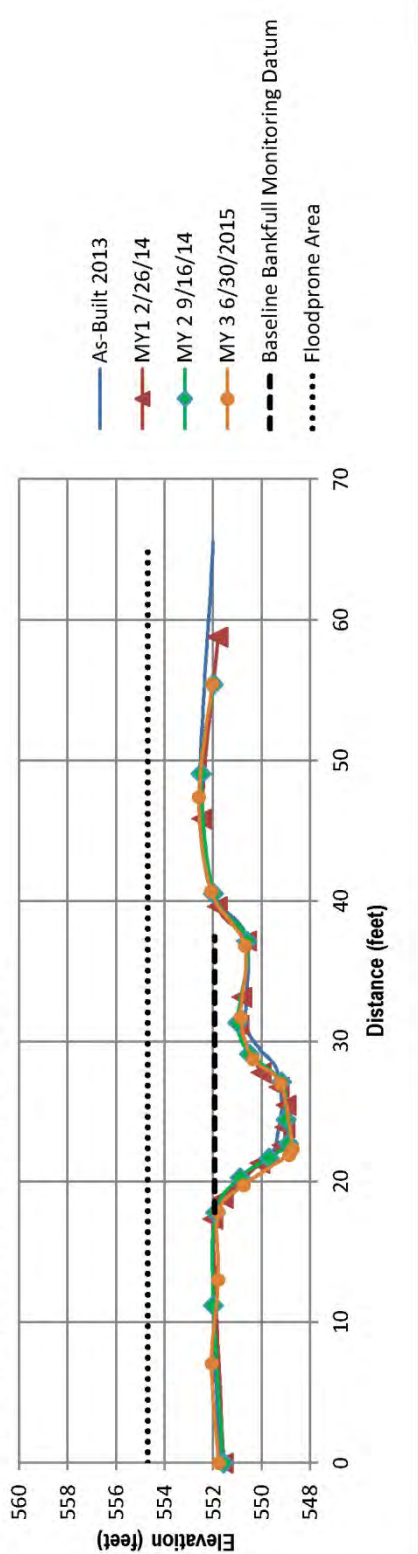
UT to Sandy Creek, Cross Section 3, Glide, Station: 23+49

SUMMARY DATA	
Bankfull Elevation:	551.9
Bankfull Cross Sectional Area:	33.5
Bankfull Width:	20.1
Flood Prone Area Elevation:	554.9
Flood Prone Width:	200+
Max. Depth at Bankfull:	3.0
Mean Depth at Bankfull:	1.7
Width/Depth Ratio:	12.1
Entrenchment Ratio:	>8
Bank Height Ratio:	1.0

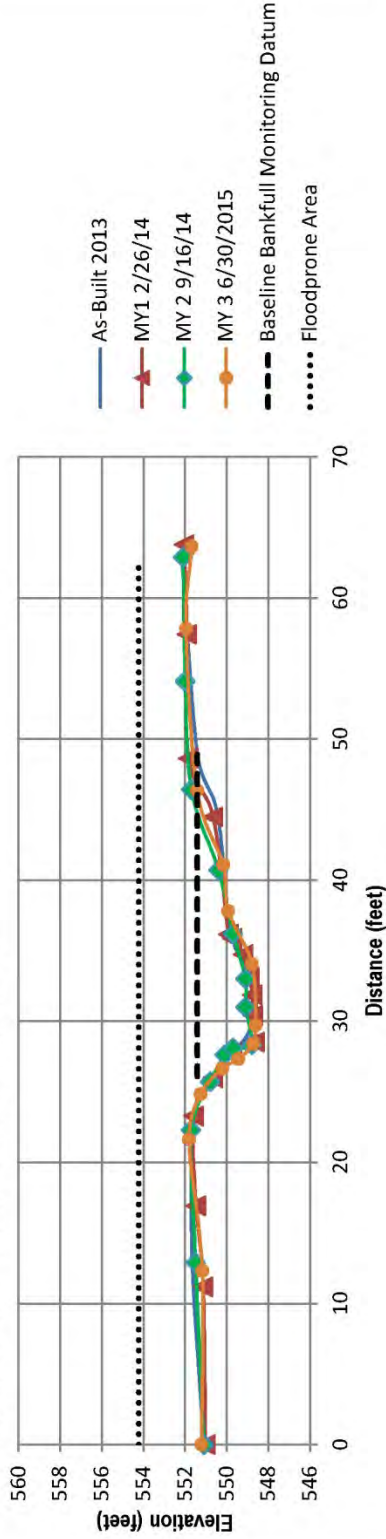
UT to Sandy Creek, Cross Section 4, Riffle, Station: 27+14

SUMMARY DATA	
Bankfull Elevation:	551.7
Bankfull Cross Sectional Area:	37.1
Bankfull Width:	24.1
Flood Prone Area Elevation:	554.6
Flood Prone Width:	200+
Max. Depth at Bankfull:	2.9
Mean Depth at Bankfull:	1.5
Width/Depth Ratio:	15.6
Entrenchment Ratio:	>8.0
Bank Height Ratio:	1.0

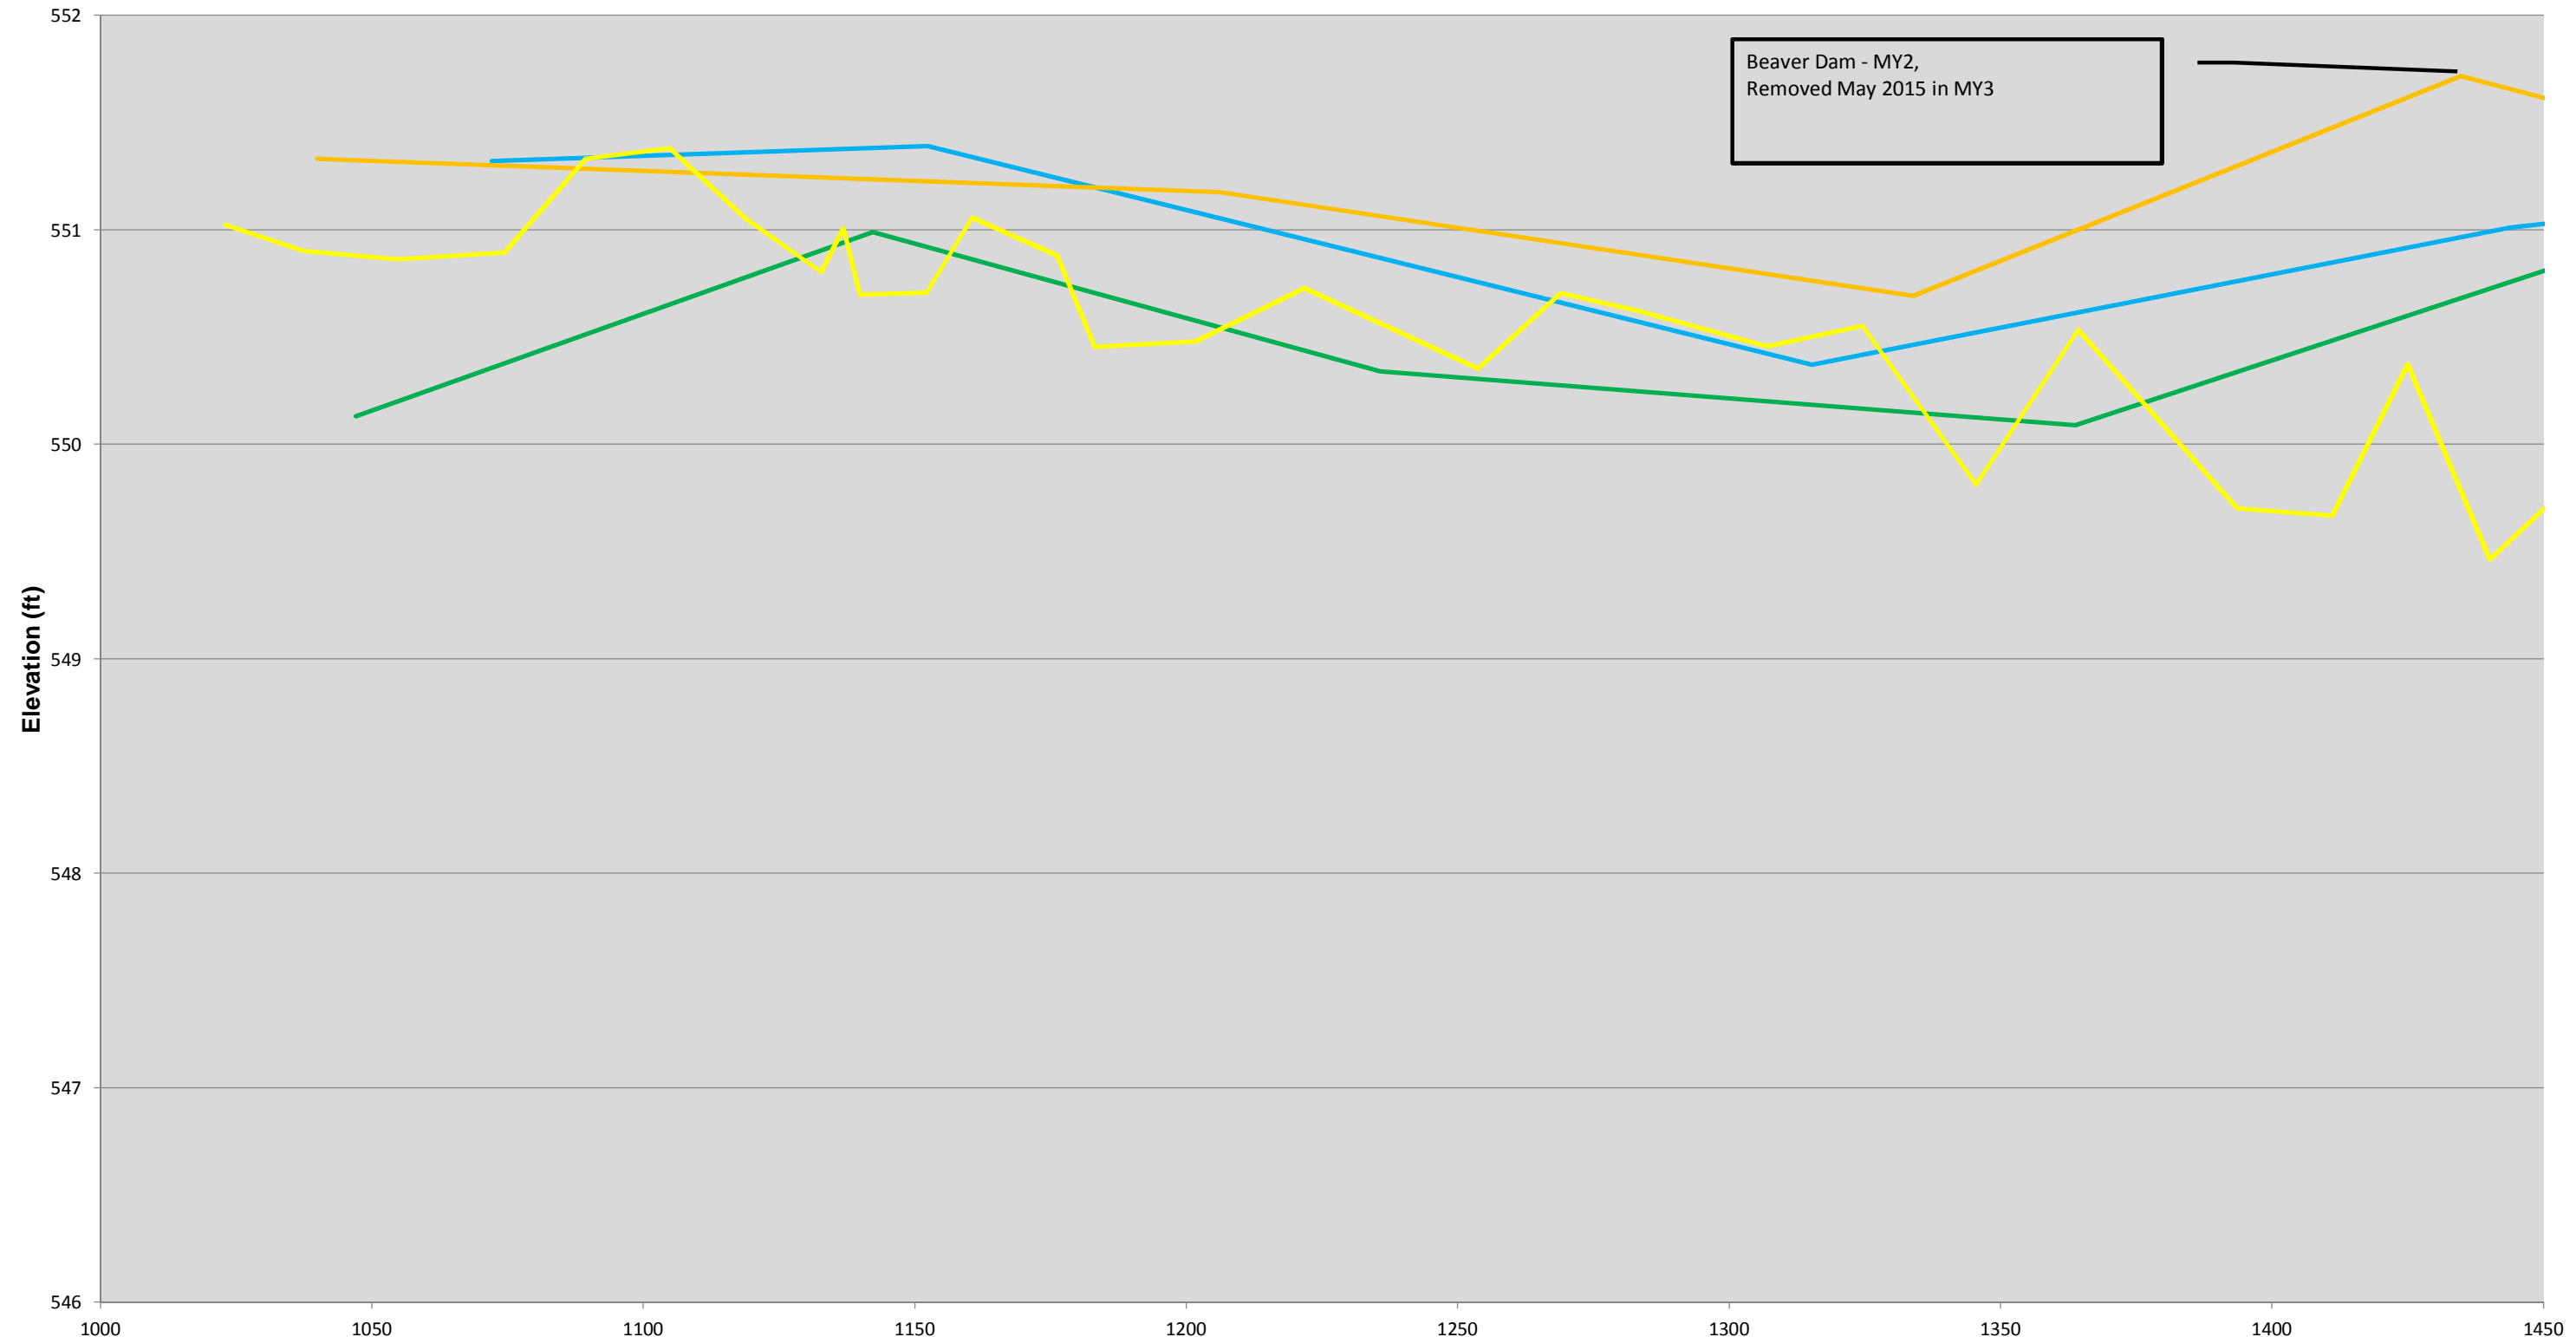
### Profile Reach (UT to Sandy Creek Sta. 10+00 to 14+50)

During MY2 monitoring, a recently constructed beaver dam was observed within the channel at approximately station 14+34.75. In May of 2015 during MY3 monitoring, another recently constructed beaver dam was observed immediately upstream of the culverted road crossing at approximately station 19+51.50. During June of 2015, these dams were removed by hand and beaver trapping was

Beaver Dam - MY2,  
Removed May 2015 in MY3

conducted by APHIS. As of June 30, 2015, no additional beaver activity was observed within the easement area. Please refer to Appendix B for representative photographs.
