CHARLES WILLIAMS STREAM, WETLAND, AND BUFFER SITE
DMS Project No. 80

MONITORING YEAR 4 (2016)
Construction Completed February 2013
Planting Completed February 2014

Randolph County, NC
State Construction Project No. 07-07125-01A

November 2016

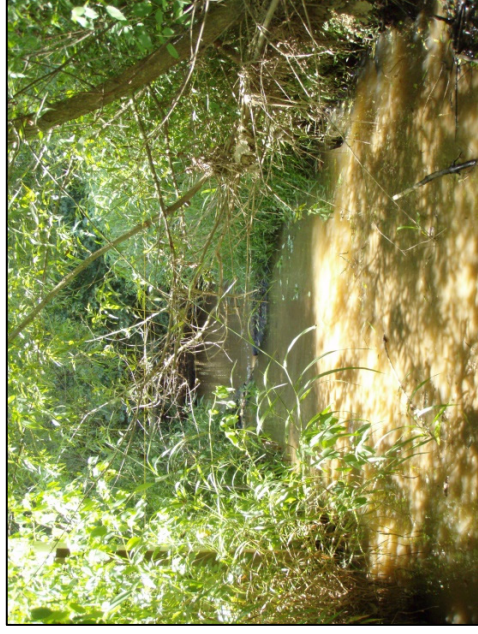
UT to Sandy Creek, Cross Section 4, Riffle, Station: 27+14

Stream Type: C5 Photograph facing downstream @ XS 4

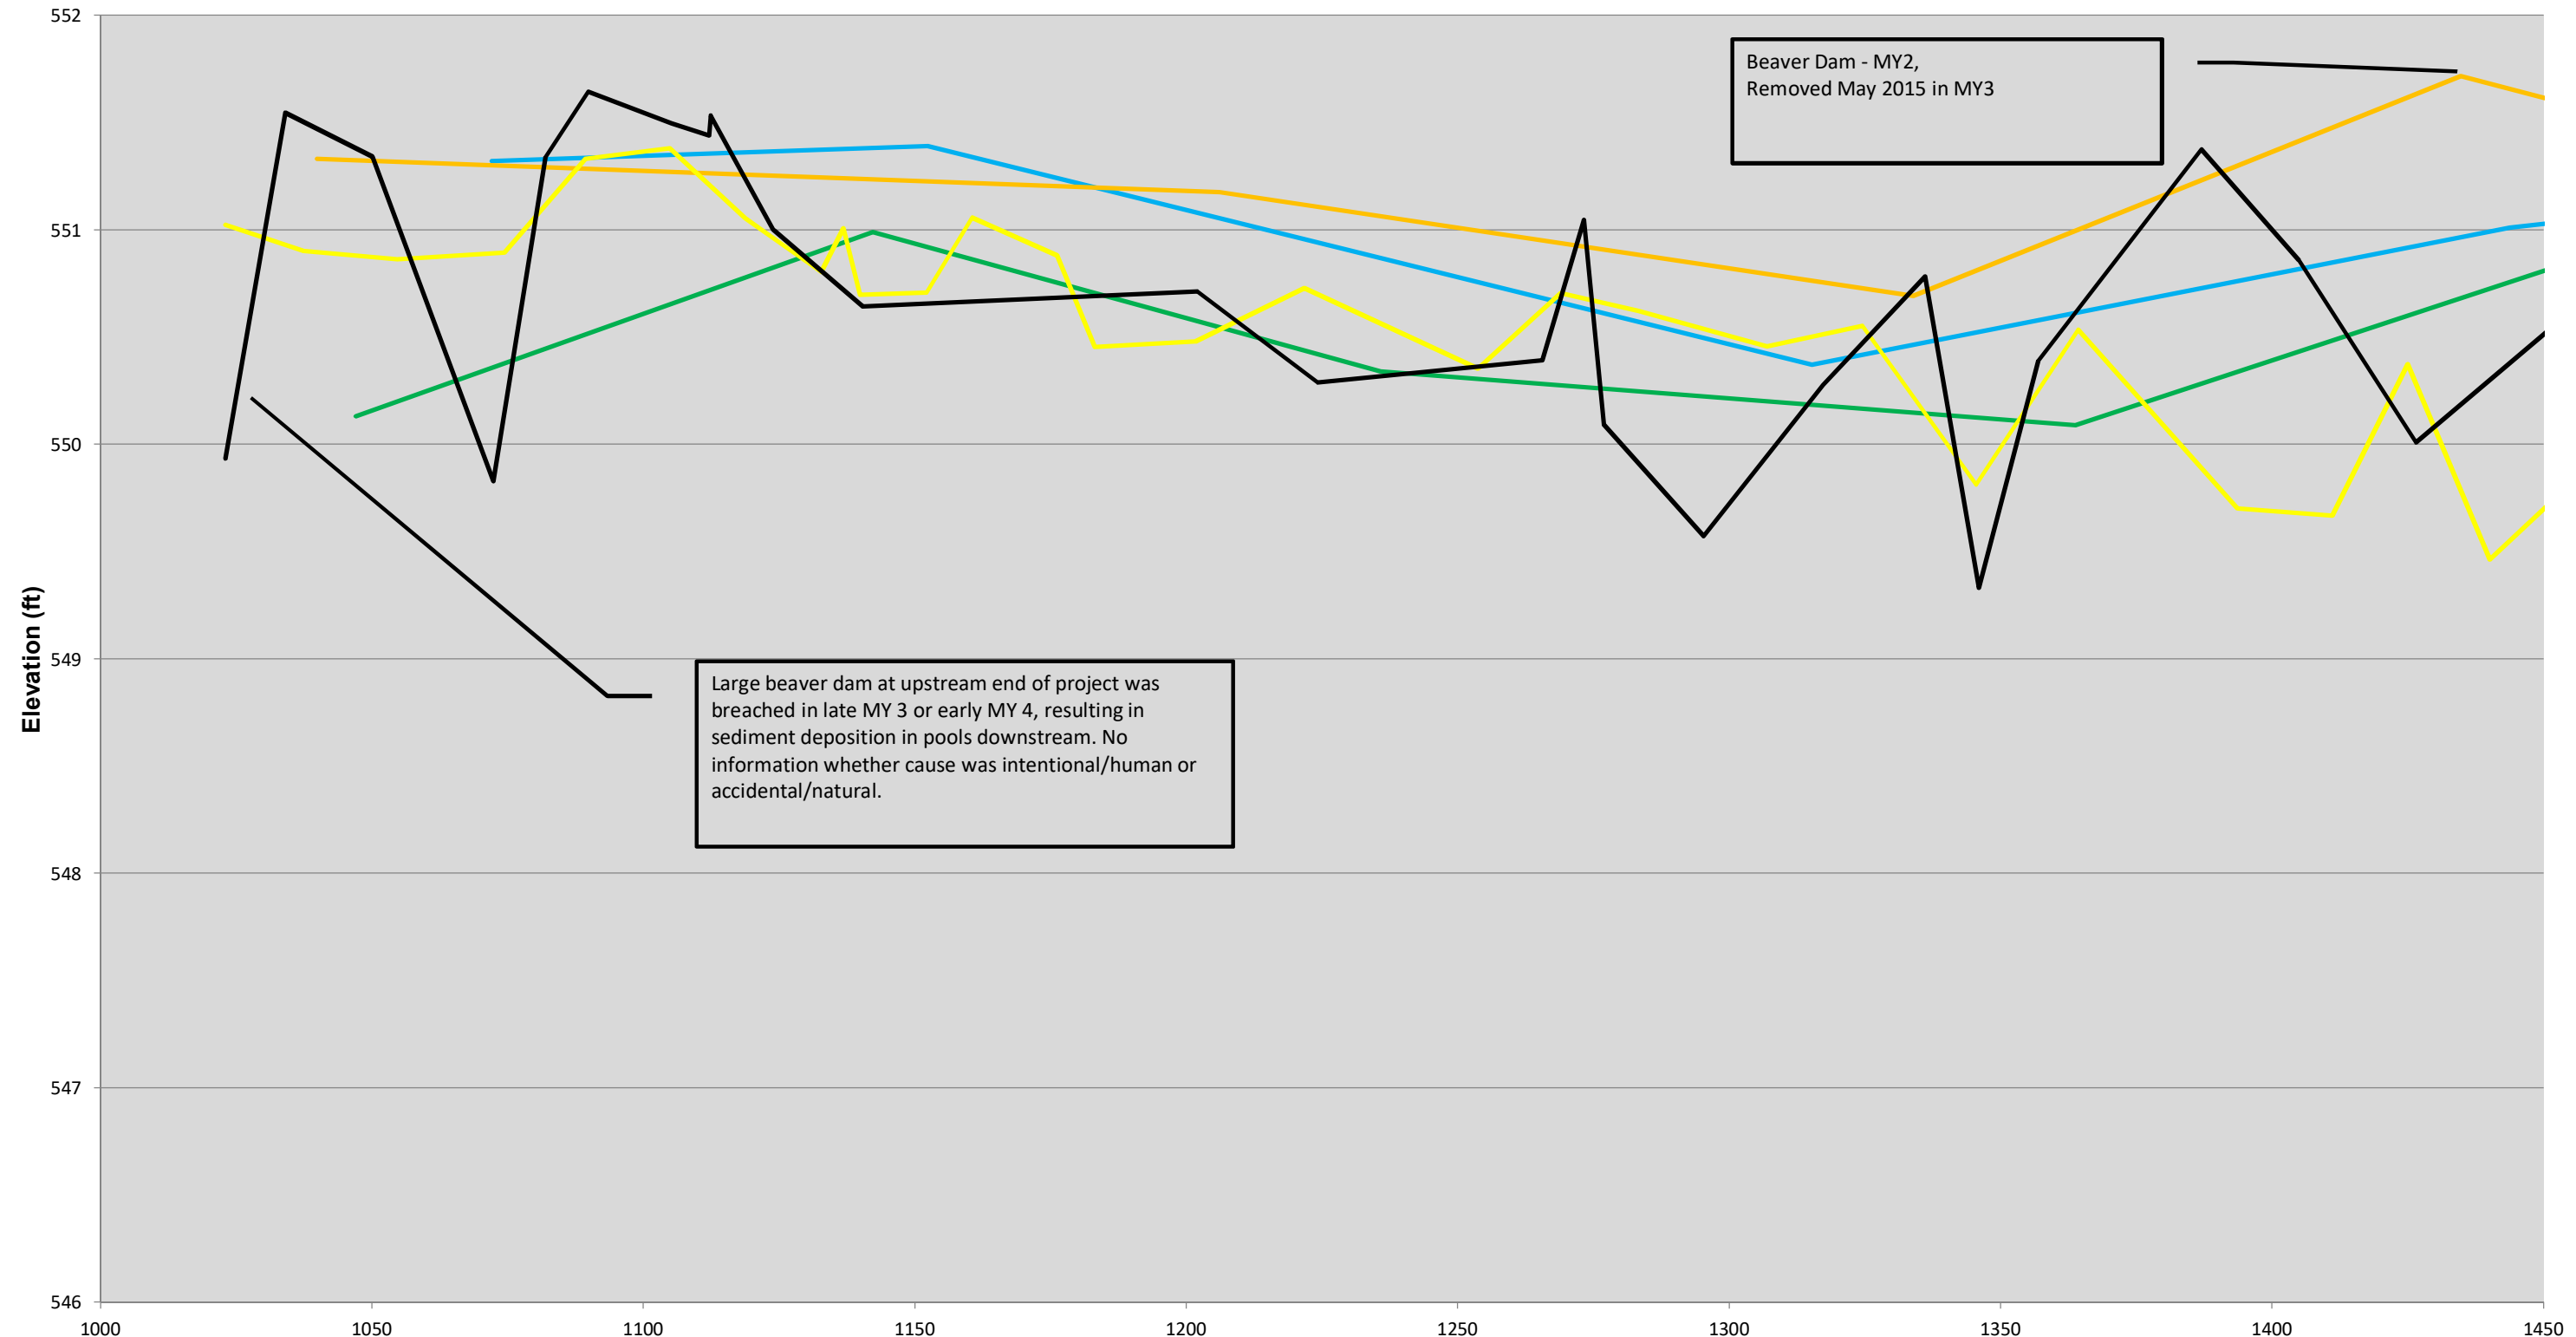
Profile Reach (UT to Sandy Creek Sta. 10+00 to 14+50)

Large beaver dam at upstream end of project was breached in late MY 3 or early MY 4, resulting in sediment deposition in pools downstream. No information whether cause was intentional/human or accidental/natural.

Beaver Dam - MY2, Removed May 2015 in MY3
