**CHARLES WILLIAMS STREAM, WETLAND, AND BUFFER SITE  
DMS Project No. 80**

**MONITORING YEAR 5 (2017)  
Construction Completed February 2013  
Planting Completed February 2014**

**Randolph County, NC  
State Construction Project No. 07-07125-01A**

**December 2017**

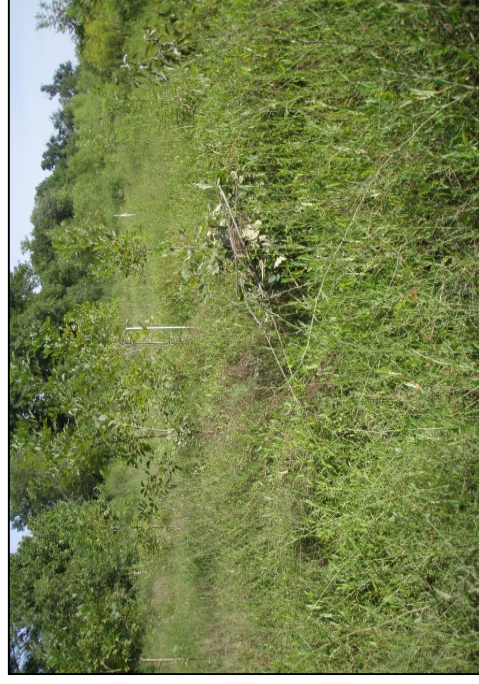
Evidence of overbank events was documented on February 10, 2017 and July 20, 2017. Evidence of overbank events consisted of wrack material and sediment staining above the bankfull indicators along the channel, alluvial deposits outside the channel, and flattened vegetation far into the floodplain. The crest gauge documented bankfull events at 31.5" and 28" during MY5. Annual photograph comparisons of the stream channel are depicted in Appendix B and hydrologic data associated with this year's monitoring assessment are provided in Appendix E.

1. Wrack at High Elevation, Documented 20 July 2017

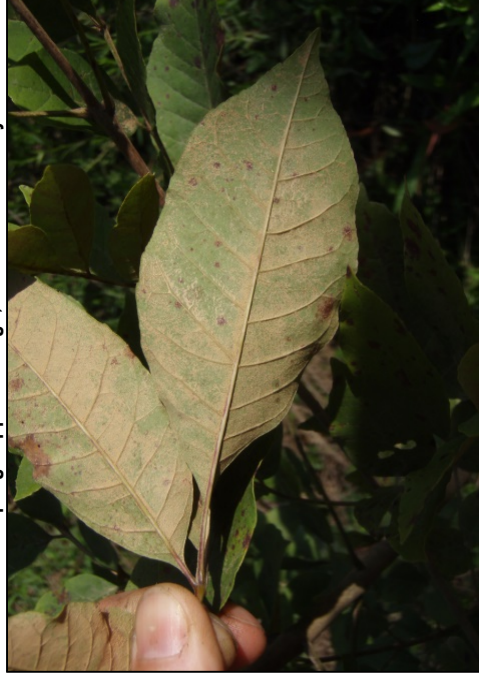
2. Sediment on Saplings Approx. 5' High, Documented 20 July 2017

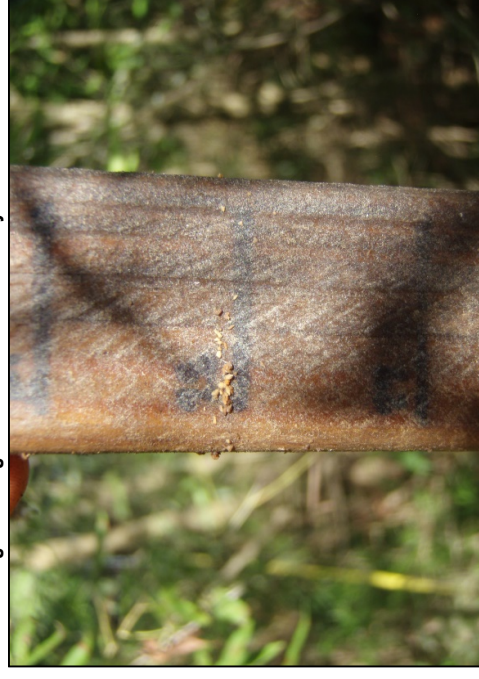
A crest gauge was installed near the downstream end of the Site along the UT to verify the on-site occurrences of bankfull events. In addition to the crest gauge, observations of recently deposited overbank wrack and/or sediment serve to validate gauge observations, as necessary. Documentation of the highest stage during the monitoring interval is assessed during each site visit and the gauge is reset. The data related to bankfull verification are summarized in each year's report. Based on the elevation of the crest gauge, any readings observed higher than 22 inches on the gauge reflect a bankfull or above bankfull event.

3. Crest Gauge Reading at 28" Documented 20 July 2017

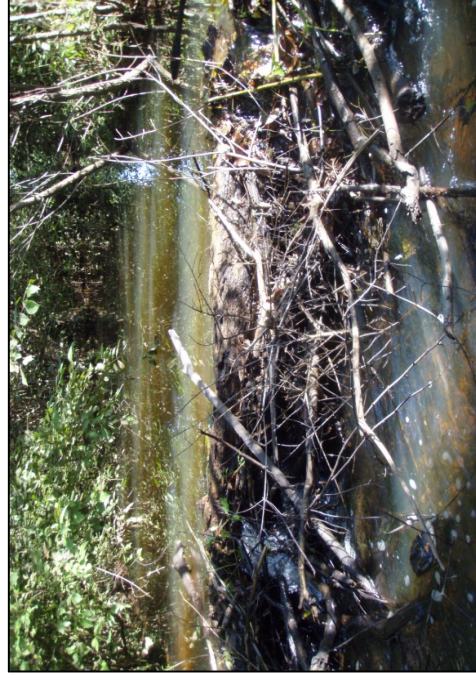
During MY2 monitoring, a recently constructed beaver dam was observed within the channel at approximately station 14+34.75, near cross-section 1. In May of 2015 during MY3 monitoring, another recently constructed beaver dam was observed immediately upstream of the culverted road crossing at approximately station 19+51.50. During June of 2015, these dams were removed by hand and beaver trapping was conducted by APHIS. No additional beaver activity was observed within the easement area until October 4, 2016, at which time the beaver dam upstream of the road crossing was observed to have been reconstructed. During 2017/MY5 monitoring, the beaver dam upstream of

the road crossing was gone again, but the dam near cross-section 1 had been reconstructed as of September 8, 2017. This dam was again removed in November, 2017 and was not observed to have been reconstructed as of December 8, 2017. Please refer to Appendix B for representative photographs.

1. Beaver Dam at Cross-section 1, Reconstructed as of Sept. 2017, Removed Nov. 2017

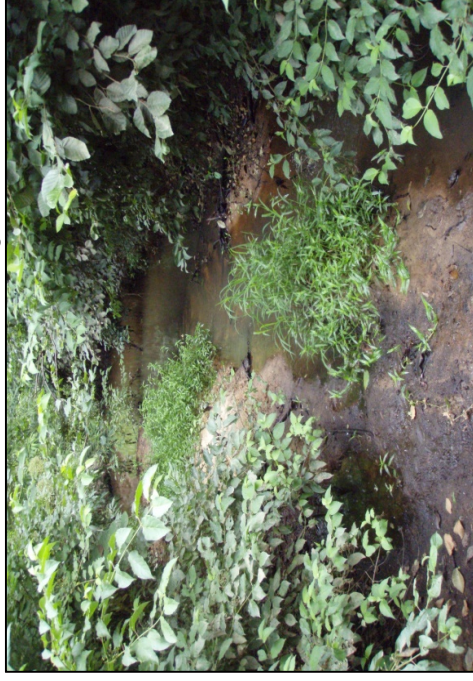
During late MY3 or early MY4, the large beaver impoundment at the upstream end of the project area was breached. It is not clear whether the breach was intentional, or whether the dam naturally breached as a result of a storm event. In February 2016, evidence of very high water and strong overbank flow was observed, likely from this breach, but a full assessment of the channel was not possible at the time due to high water and turbidity. Banks were observed to be generally stable and vegetated, and no structure instability or failure was observed. The large beaver dam was not reconstructed as of September 8, 2017 during MY5 monitoring.

2. Site of Previous Beaver Dam at Road Crossing, Not Reconstructed as of 8 Sept. 2017
